FURNACE-TUBE CONTAMINATION  
NASA Grant NGR 05-010-041  
Dept. of Electrical Engineering  
Univ. of Calif., Santa Barbara

## FURNACE-TUBE CONTAMINATION

NASA Grant NGR 05-010-041  
Department of Electrical Engineering\*  
Solid-State Laboratory  
University of California, Santa Barbara

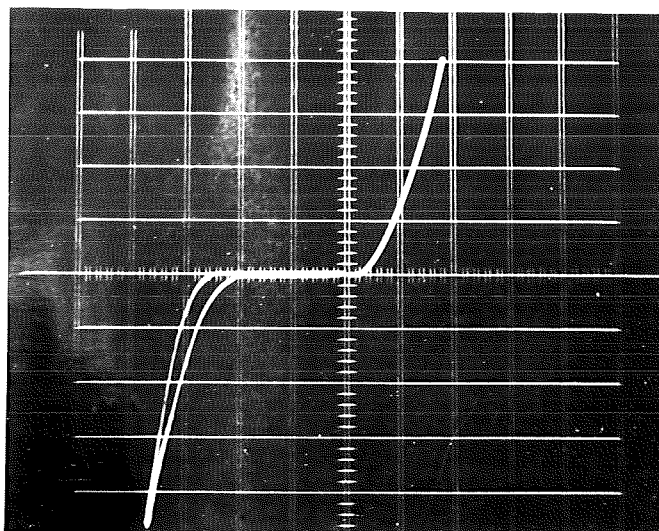
As an interesting tangent, Figs. 6 and 7 show the characteristics of a  $n^+-n$  (ohmic) junction. The characteristics were measured by means of probing prior to metallization. The shapes of the characteristics are fixed almost entirely by the nature of the probe-silicon point contact.

Fig. 6  $n^+$ - $n$  junction (Oxide grown in boron drive furnace) Leakage current, 40na. @20v.

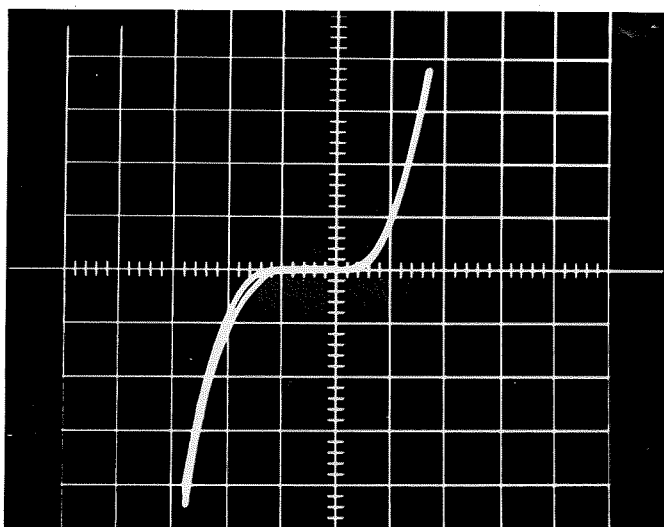
Fig. 7  $n^+$ - $n$  junction (Oxide grown in boron drive furnace)
