# REPORT OF APOLLO 13 REVIEW BOARD

**APPENDIX B - REPORT OF MISSION  
EVENTS PANEL**

**APPENDIX C - REPORT OF MANUFACTURING  
AND TEST PANEL**

**APPENDIX D - REPORT OF DESIGN PANEL**

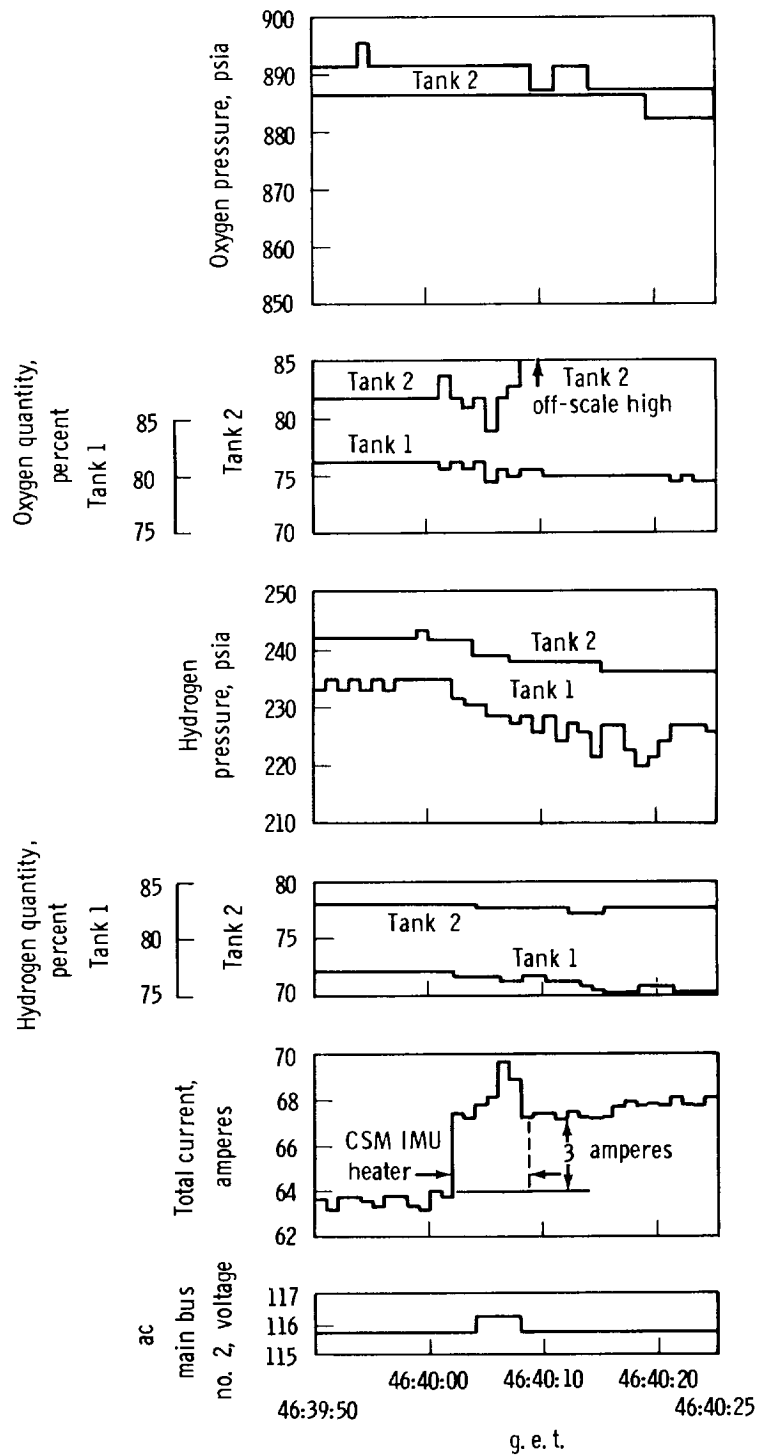
At 47:40:08 the oxygen quantity changed from approximately 82 percent to 100 percent, or full-scale high. This change in reading or quantity system malfunction occurred just after or at the time the oxygen tank no. 2 fans were turned on. Because of the way the system recovered at the time of the accident, the data indicate that the probe or its associated wiring shorted. Since the instrumentation system was in low bit rate, it is possible to determine exactly when the oxygen

tank no. 1 and no. 2 fans were turned on. The electrical data indicate that the oxygen tank no. 1 and no. 2 fans were turned on between the times of 47:40:05 and 47:40:08. A plot of cryogenic pressures, quantities, total CSM current, and ac main bus 2 is shown in figure B4-12. Therefore, the oxygen tank no. 1 and no. 2 fans were turned on in a period of time between 3 seconds prior to the probe malfunction and the time that the probe malfunctioned.

Figure B4-12.- Fan cycle at 46:40.

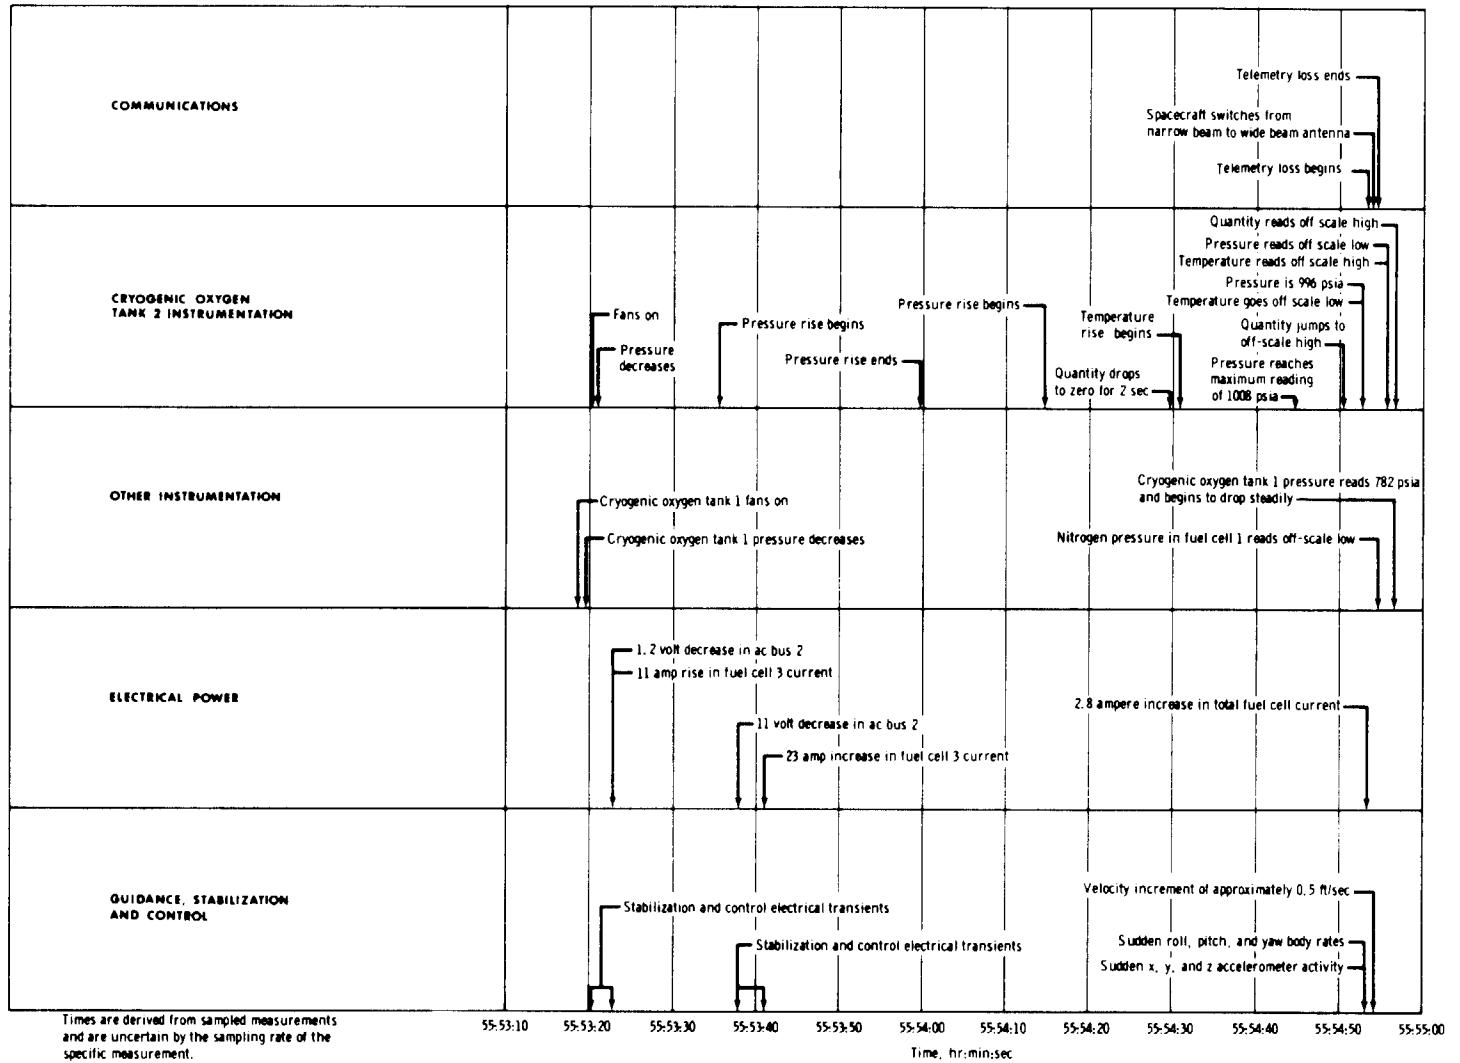
Figure B5-1.- Sequence of events immediately preceding the accident.

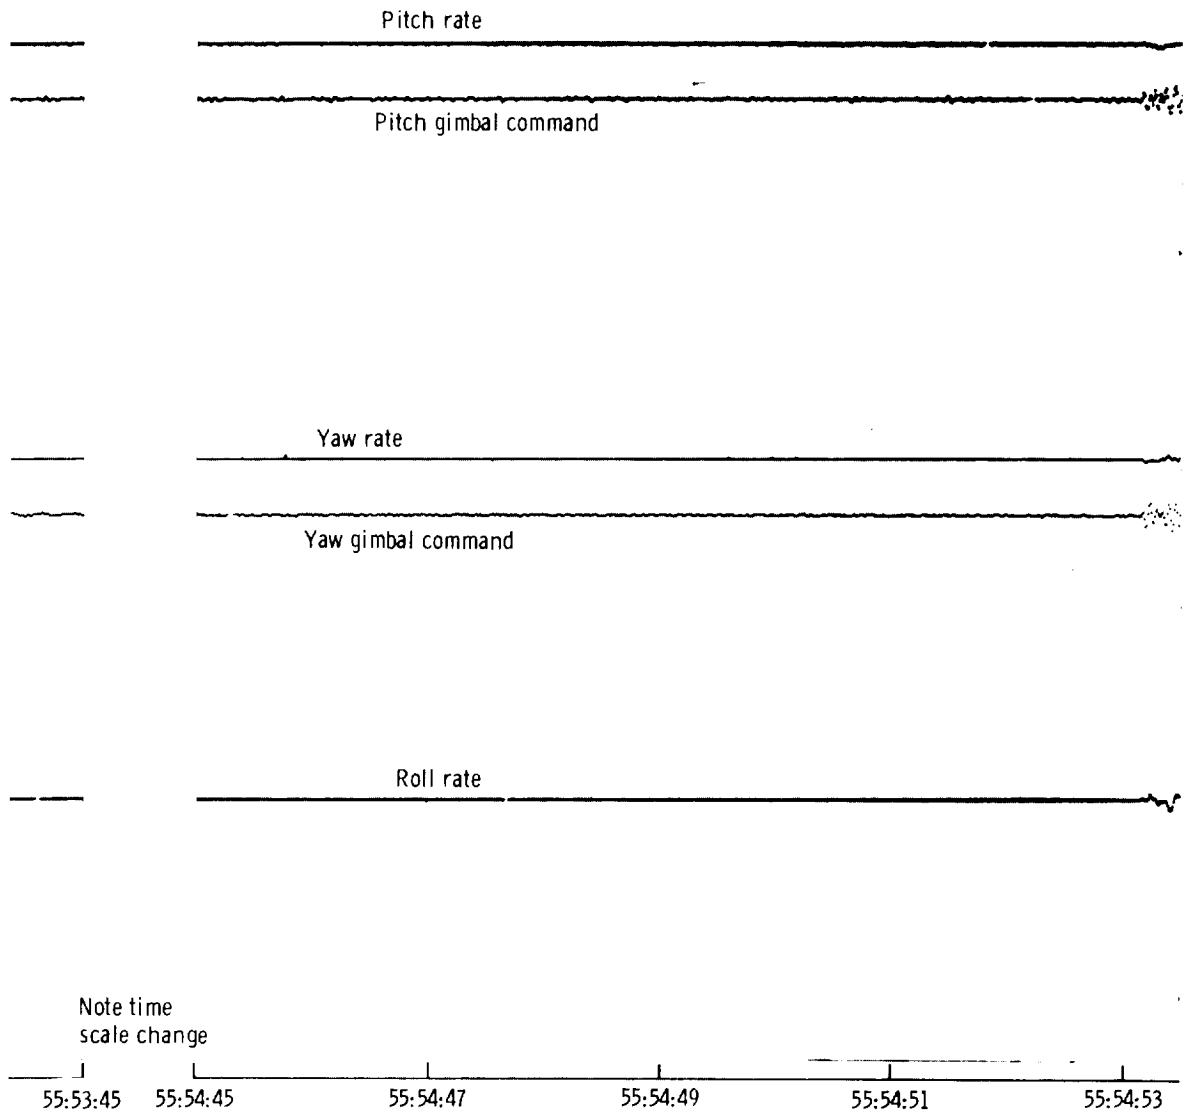
Figure B5-5.- Disturbances observed on thrust vector control gimbal command signals.

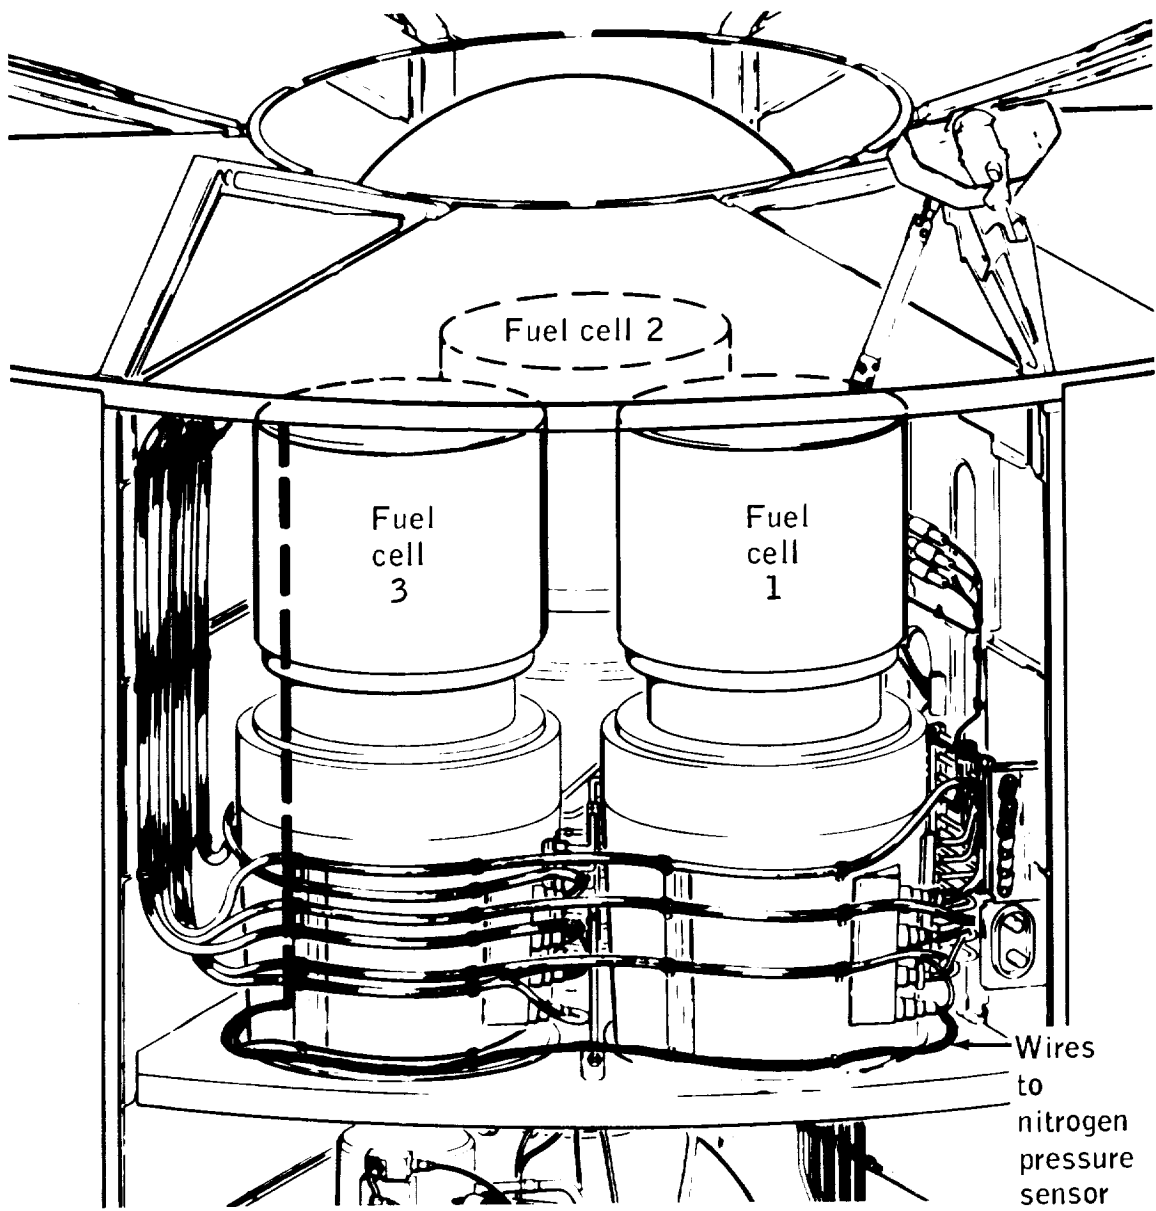
Figure B5-7.- Location of wiring to nitrogen pressure sensor in fuel cell 1.

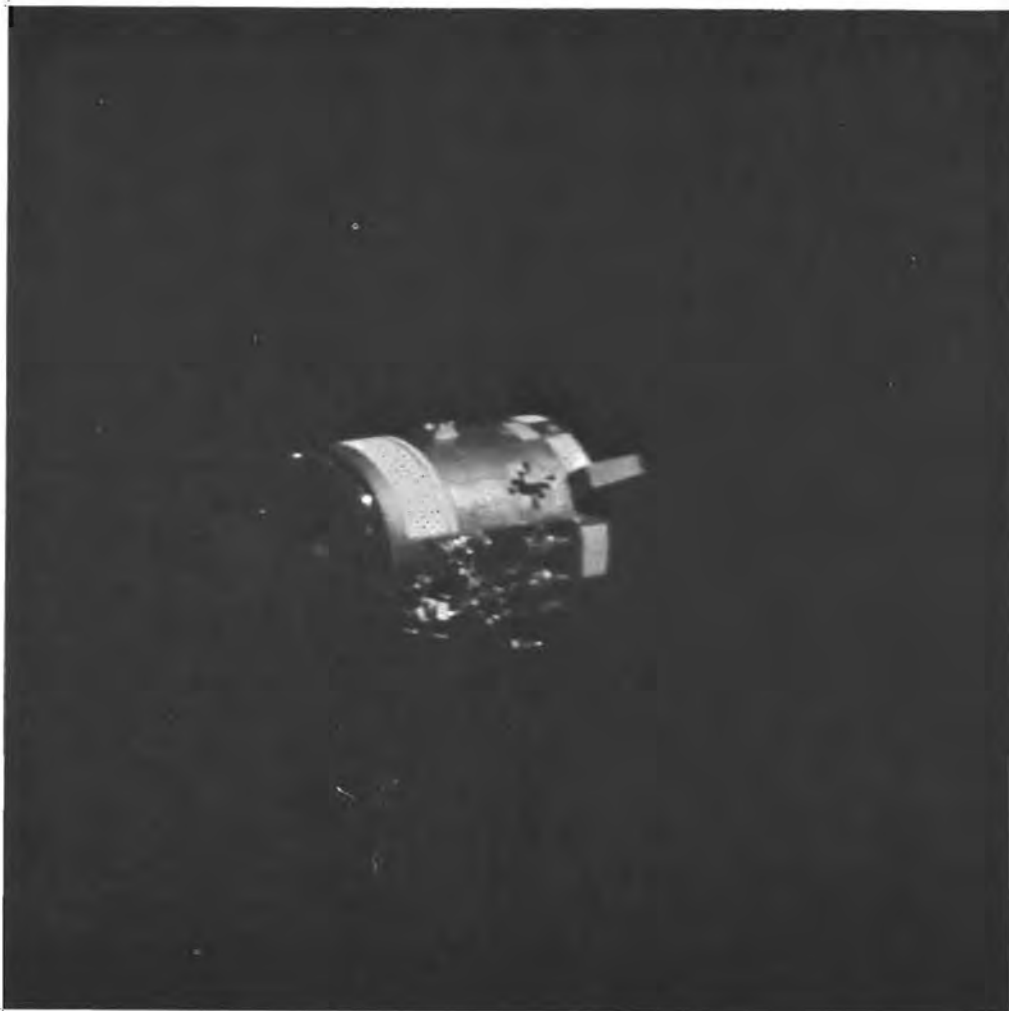
Photographs later taken by the crew show the panel covering bay 4, the bay containing the cryogenic oxygen tanks, cryogenic hydrogen tanks, and fuel cells, to be missing. One of these photographs is reproduced in figure B5-9 and a photograph prior to launch is shown in figure B5-10. The high-gain antenna located adjacent to bay 4 shows a misalignment of one of the four dishes. The photographs also show that the axes of fuel cells 1 and 3 have shifted 7 degrees in such a way that the tops of the fuel cells point outward. It is not possible to determine conclusively from the photographs whether or not cryogenic oxygen tank no. 2 is present, partially missing, or totally missing. It is probable that the loud bang heard by the crew was caused by the separation of the panel from the spacecraft approximately at the time of telemetry loss.

Figure B5-9.- Photograph of service module taken by crew.

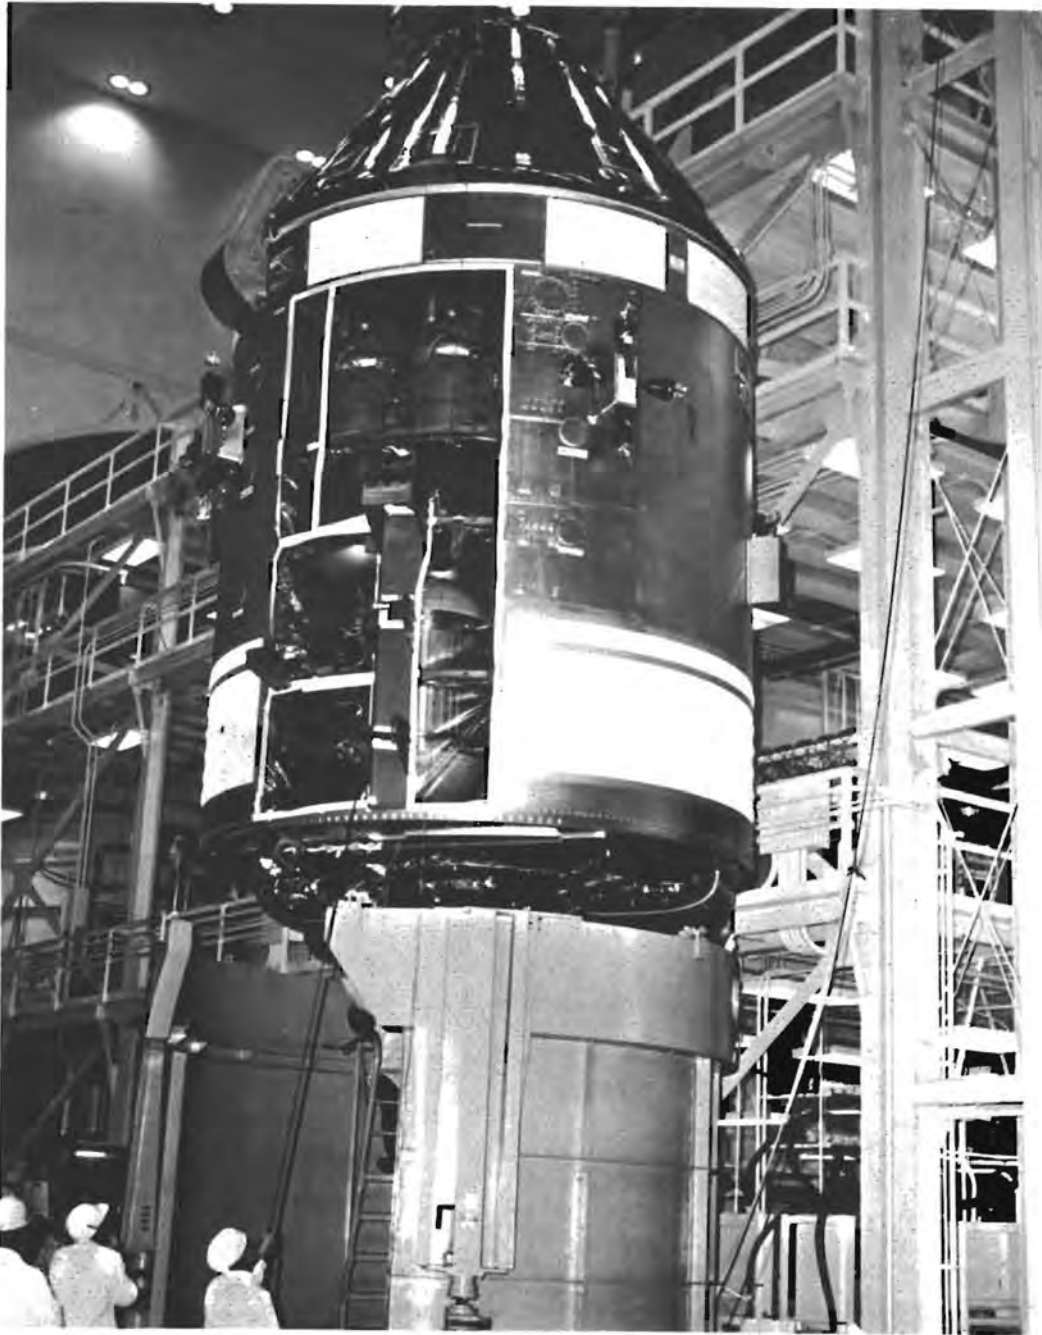
Figure B5-10.- Bay 4 of service module.

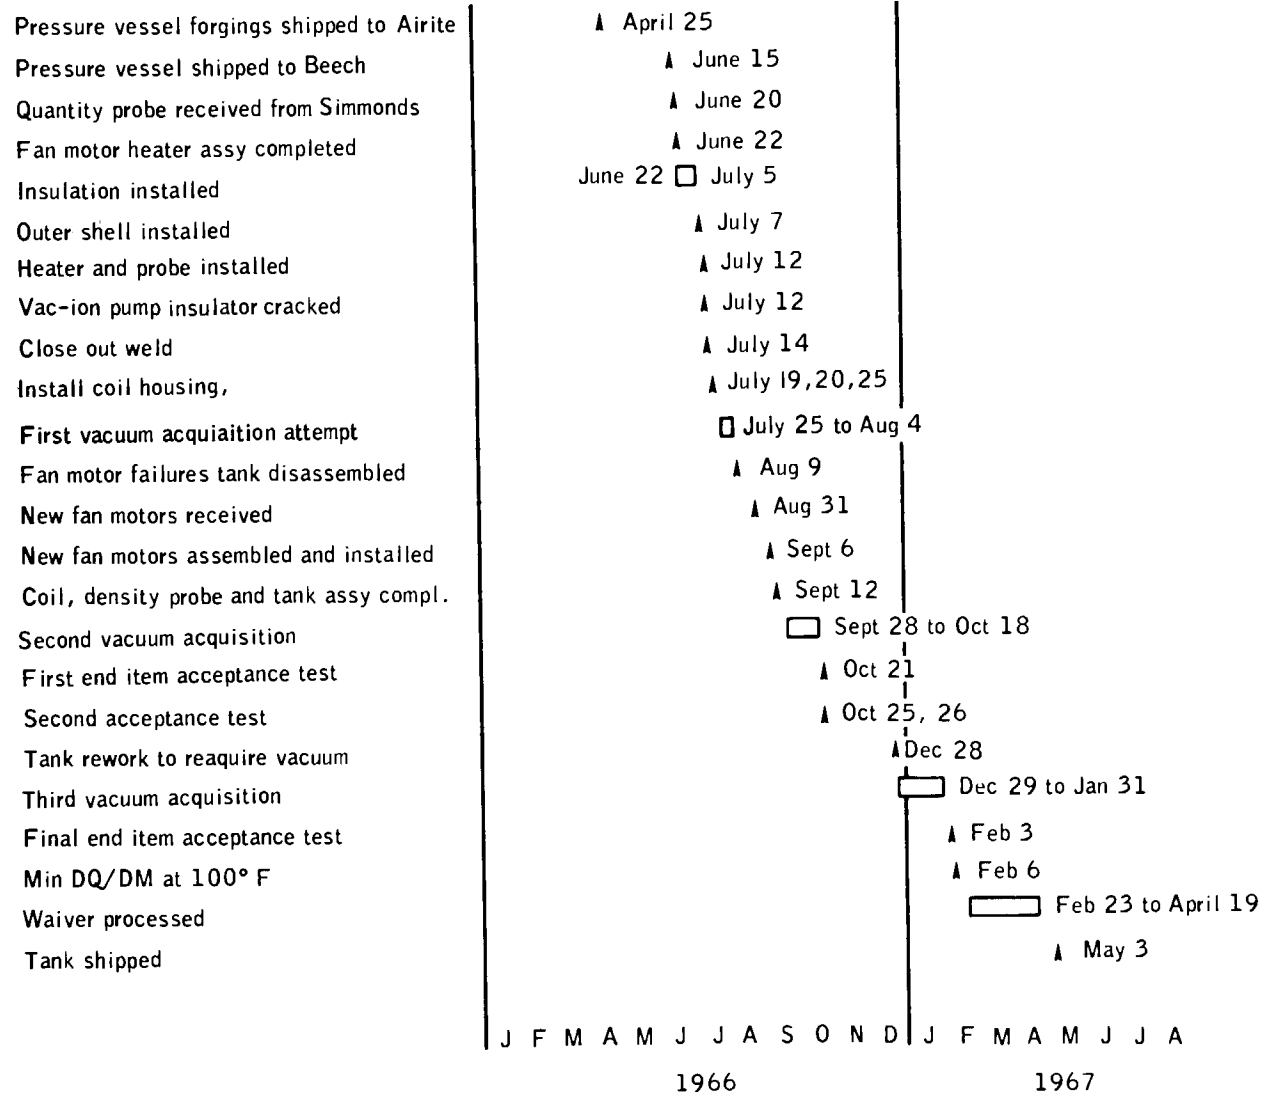
Figure C4-48.- Manufacturing and test flow for the oxygen tank at Beech.

The manufacturing and test flow for cryogenic oxygen storage tank serial no. 10024XTA0008 is shown in figure C4-48. The item of particular significance is the recycle that was required in the manufacturing process brought on by motor failures.

A listing of the inspection discrepancies issued against serial no. 10024XTA0008 are listed in table C4-I. In the Beech nomenclature these discrepancies are known as Withholding Forms. As stated previously, the motor problem is considered the significant item. The heat-leak problem was not considered serious because many missions required use rates above the minimum flow capability of tank 0008.

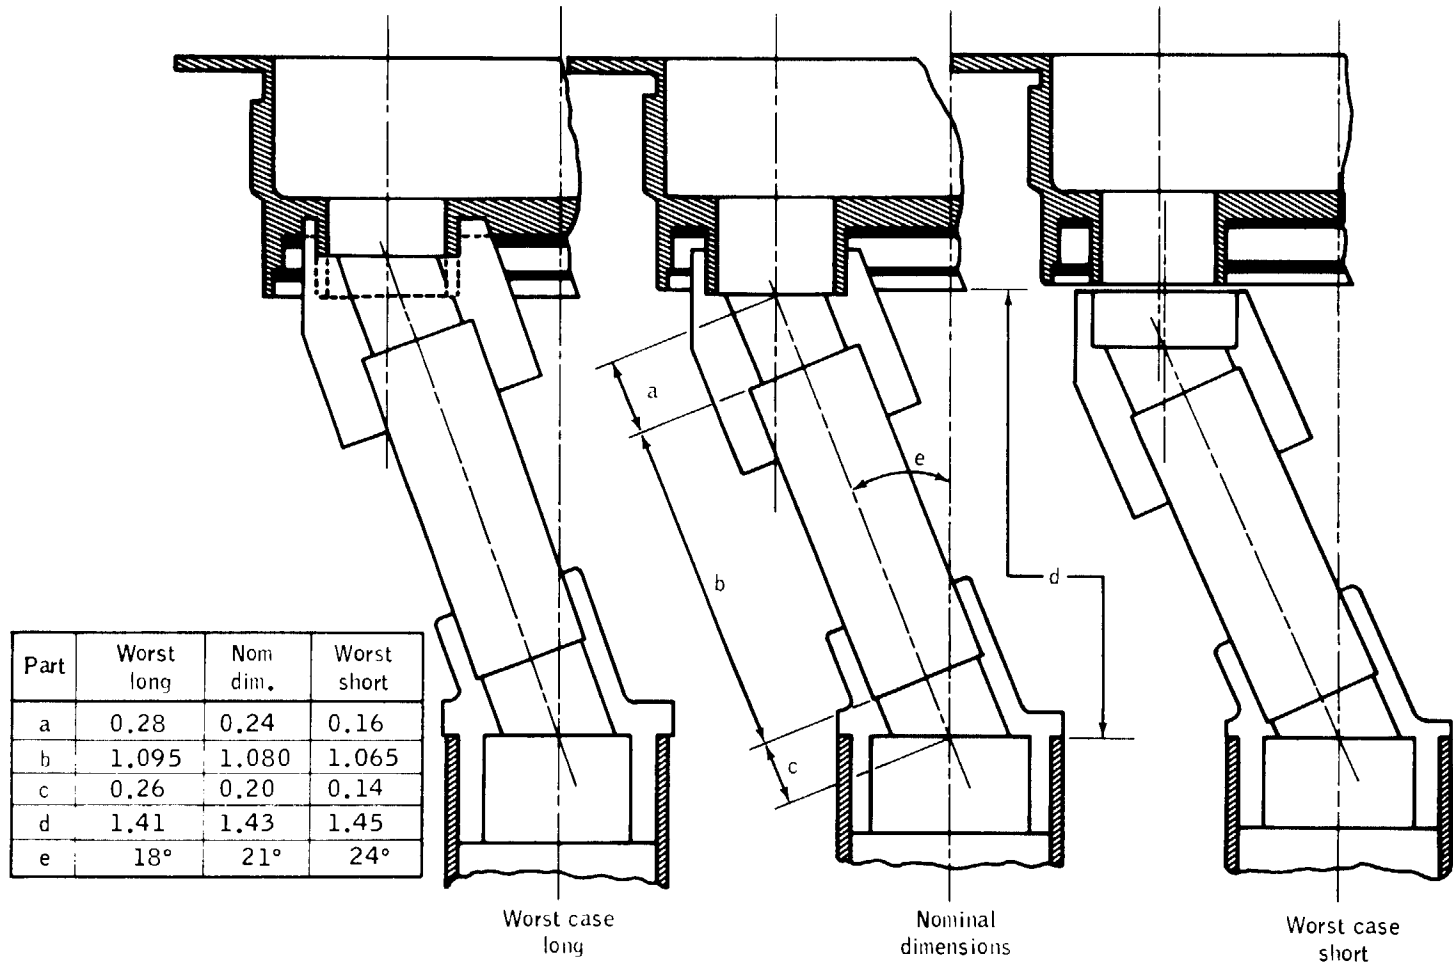
Figure C4-49.- Extreme and nominal tolerance cases for fill tube connection parts.

In addition to the tolerance condition that can exist for the fill tube connecting parts, the center tube of the quantity probe could move downward due to Teflon cold flow. The center tube is supported in the axial position by two Teflon bushings installed in the center tube and a semi-tubular rivet. Prolonged heating, such as the vacuum pumpdown cycles (three cycles for this tank assembly resulting in a total of 1532 hours at 190 to 220° F), could result in the thin walls of the center tube slowly cutting into the Teflon bushings.

Table C4-II shows the range of diametral clearances that can exist at ambient conditions (73° F) and at a typical detanking condition (-278° F, which corresponds to the saturation temperature of liquid oxygen at 40 psia). The fit between the Teflon bushing and the tank adapter fitting can result in a maximum 0.003-inch interference. The only other clearance that results in an interference fit occurs if the minimum size holes are provided where the Teflon bushings slide on the 3/8-inch Inconel tube. Tests at liquid nitrogen temperature (-320° F) indicate that the Teflon is not overstressed and does not crack when subjected to interference fits of this type.

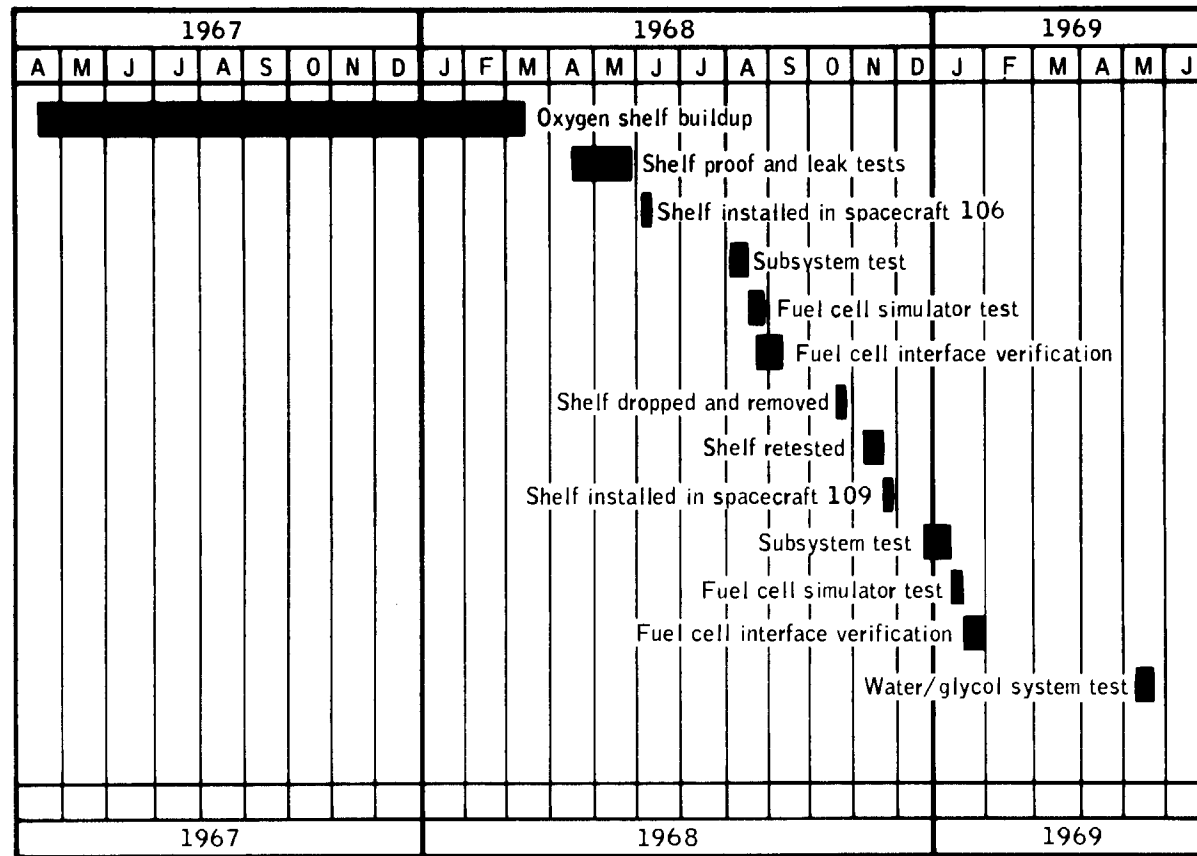
Figure C4-52.- Manufacturing and test flow for the oxygen shelf.

North American Rockwell, Downey, California.- Oxygen storage tank 10024XTA0008 was installed in the no. 2 (outside) position of oxygen shelf S/N 06362AAG3277 at North American Rockwell, Downey, California, soon after receipt in May 1967. Two disposition reports were written during October 1967 to require reheat and reinspection of brazed tubing joints on the oxygen shelf found unacceptable in reading of X-rays. These joints were reheated and accepted. Completion of oxygen tank installation, including tank 10024XTA0009 in the no. 1 position, was accomplished March 11, 1968. Manufacturing and test flow for the oxygen shelf is displayed chronologically in figure C4-52.

During April and May 1968, 11 disposition reports were written to log tank no. 2 anomalies found during proof-pressure, leak-check, and functional checkout of the assembled oxygen shelf. Eight of these were ascribed to test procedure problems, two to a valve module (check valve) tubing leak and one to an electrical connector pin. The leak was rewelded by a Parker technician and passed leak test. The pin was repaired by NR and checked.

The oxygen shelf moved and came to rest on the supporting beams through what was at the time described as a "2-inch drop". Observation of adjacent portions of SM 106 identified minor damage, including a dent in the underside of the fuel cell shelf above.

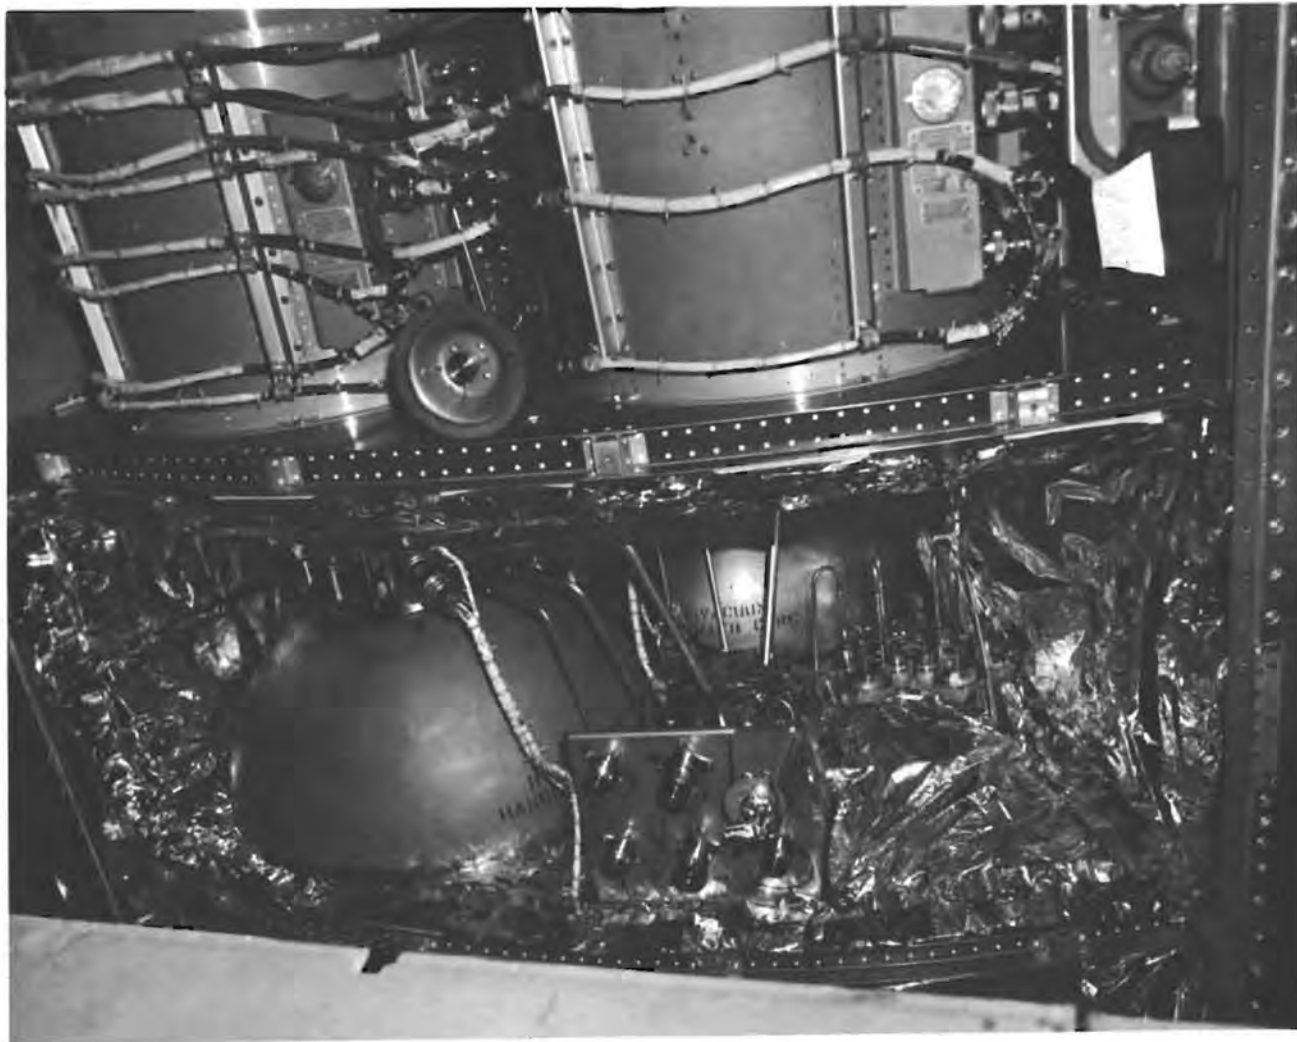
Figure C4-57.- Progress photograph of oxygen shelf taken at KSC  
November 14, 1969

A progress photograph (fig. C4-57) taken at KSC on November 14, 1969, shows the visible condition of the oxygen shelf with tanks, valves, tubing, and cables.

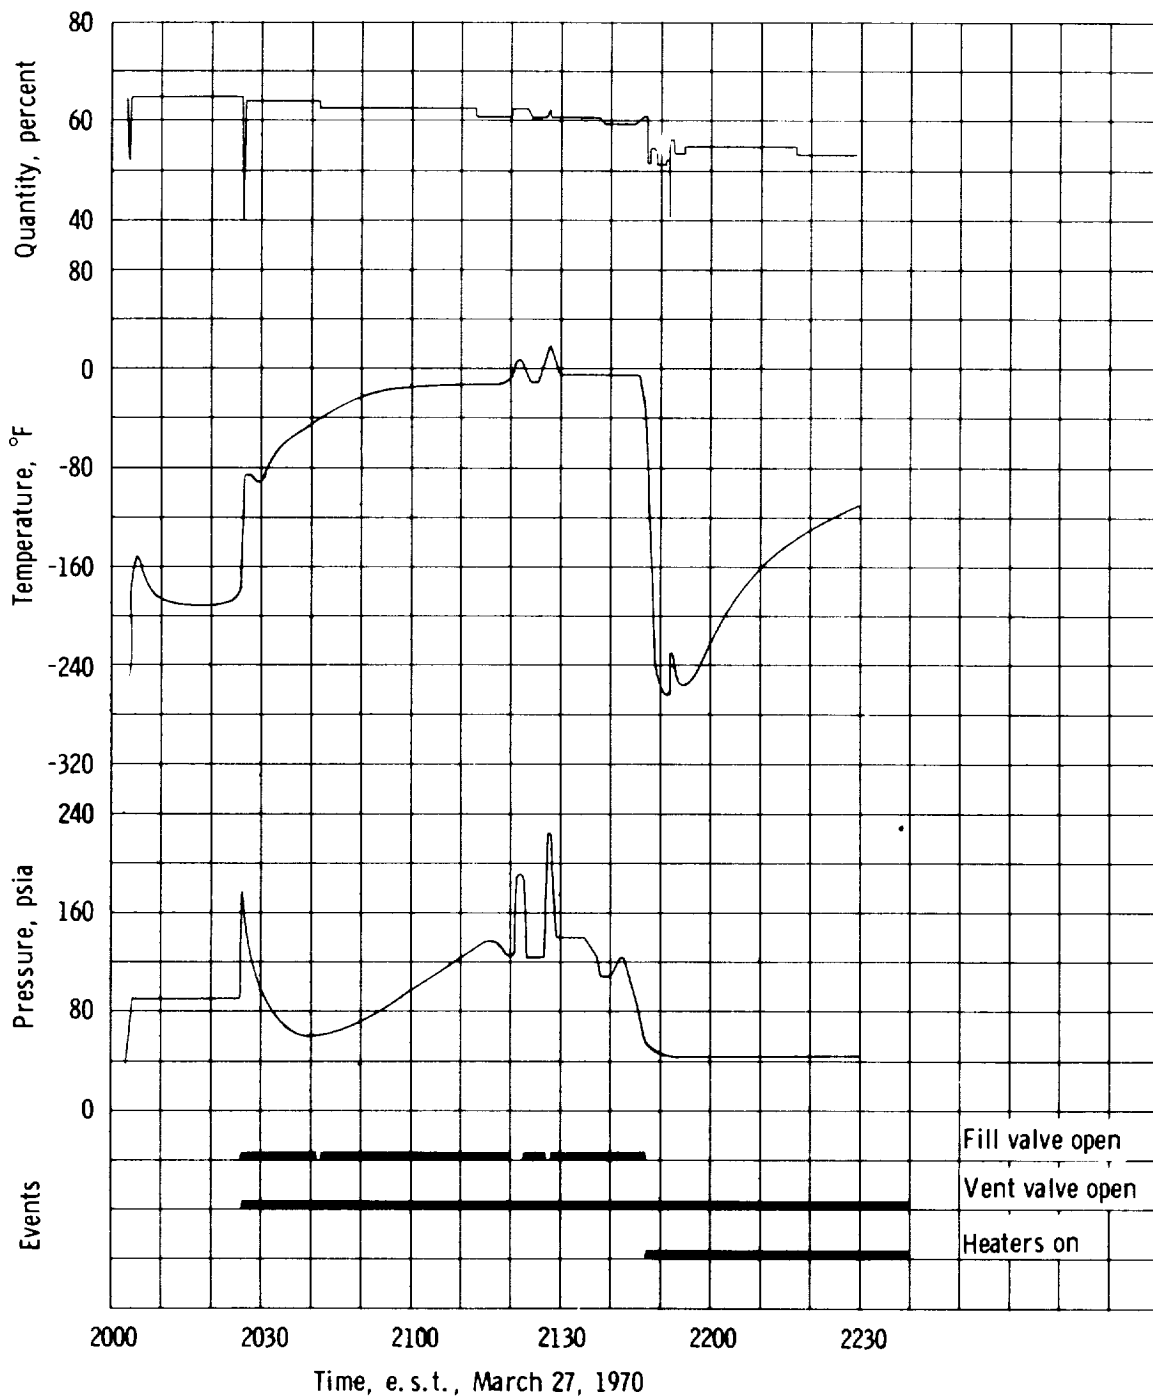
Figure C4-59.- Oxygen detanking attempt using varying purge pressure.

Attempts were made over an 80-minute period to deplete the oxygen content of tank no. 2 by cycling up to various pressures and down, but did not reduce the indicated quantity below 54 percent (fig. C4-59). An attempt was made to expedite oxygen expulsion through the use of the tank heaters operated at maximum voltage and the fans. These were turned on for nearly 6 hours while the vent port remained open (fig. C4-60). Still the indicated quantity remained above 30 percent.

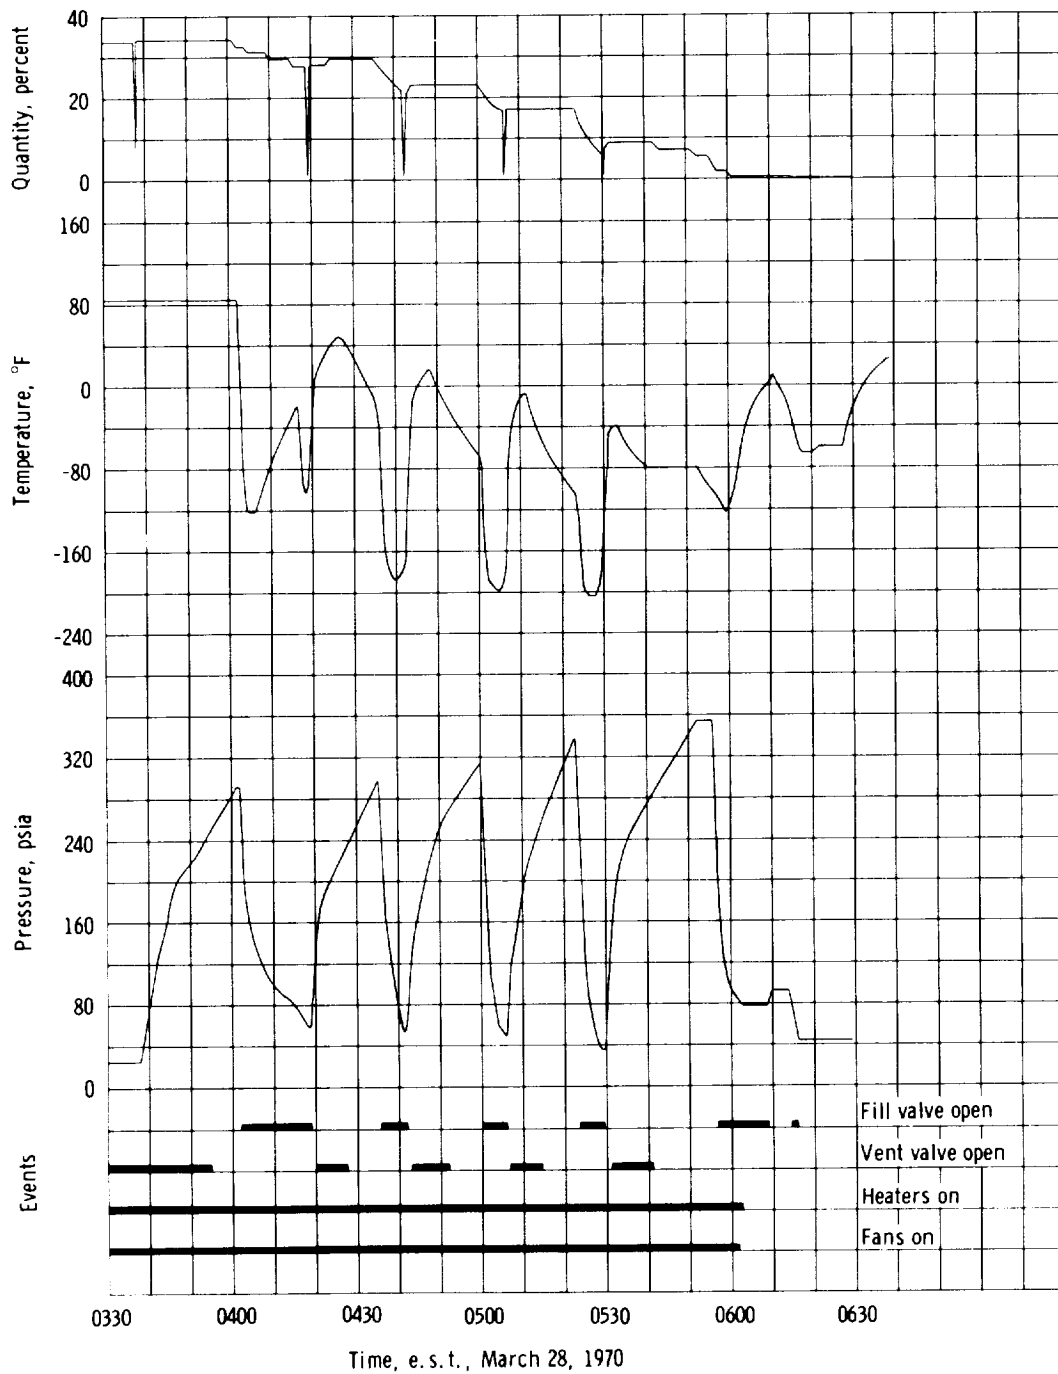
Figure C4-61.- Oxygen detanking using pressure cycles and tank heaters.

Then a pressure cycling technique was employed over a 2-1/2 hour period with maximum power being applied continuously to both tank heaters and fan circuits (fig. C4-61). This technique involved raising the tank pressure by external gaseous oxygen to approximately 300 psia and then opening the fill line to induce rapid boil-off. After five cycles, the oxygen tank quantity indicated zero.

Fan responses were observed to be normal throughout these operations. The temperature sensor on the quantity probe reached its indicating limit (+84 F) halfway through the 6-hour heating period. No observations of whether the heaters cycled on and off were made and subsequent review of the power supply voltage recording showed no indication of heater cycling.

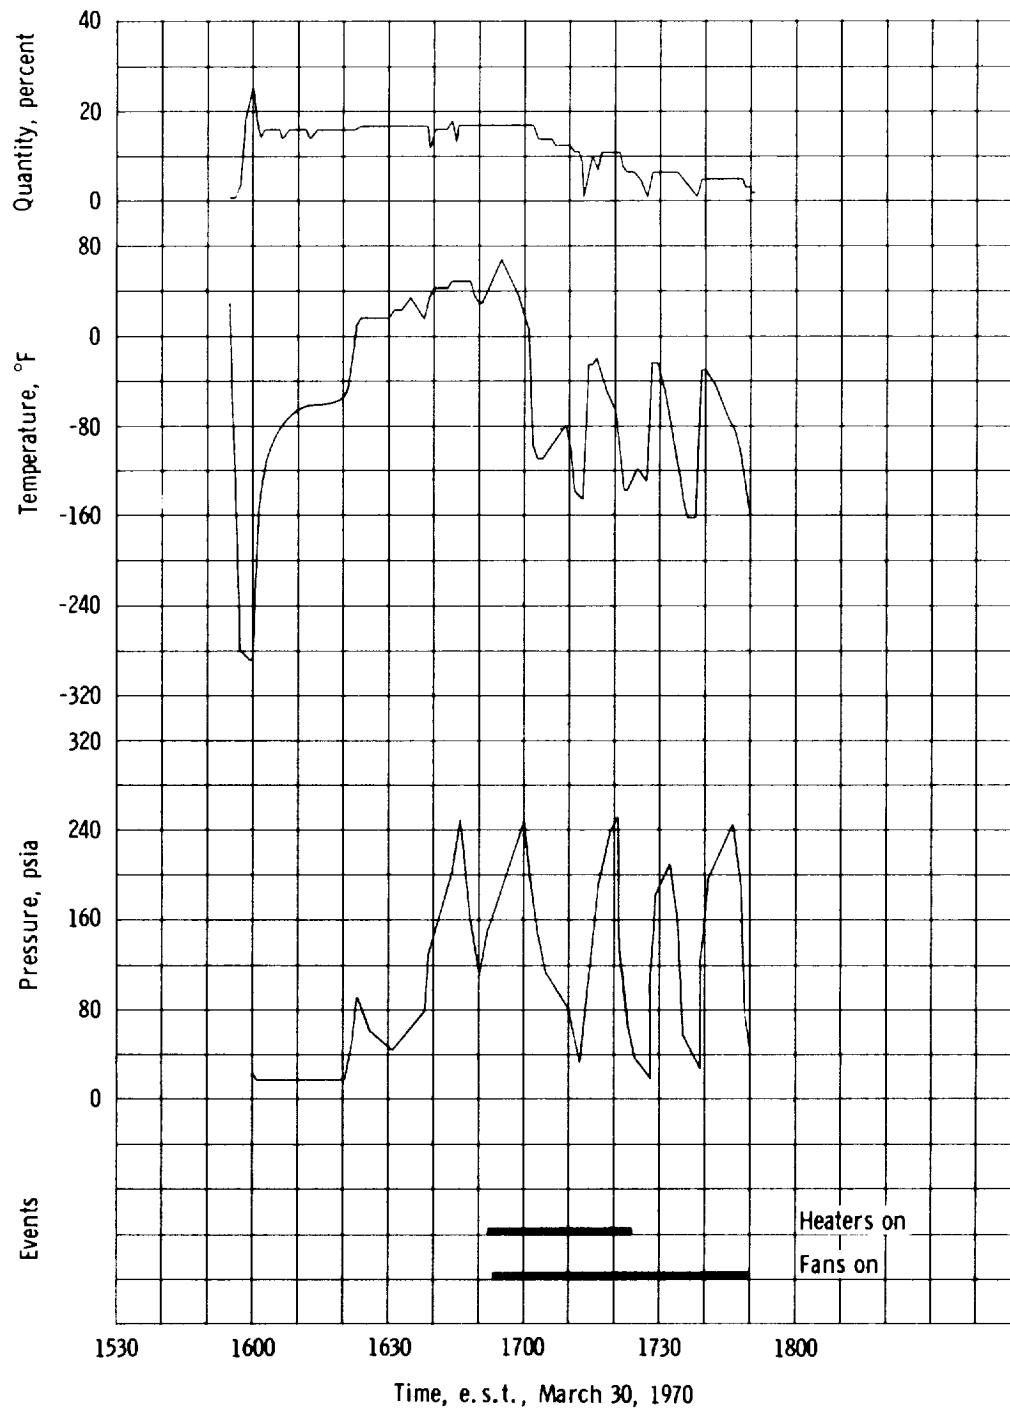
Figure C4-63.- Oxygen detanking using pressure cycles and tank heaters.

To verify this judgment and to assure countdown operability, both tanks were filled on March 30 to about 20 percent in approximately 2.5 minutes. Tank no. 1 detanked normally; tank no. 2 did not. Again the procedure of applying heat at maximum voltage and the cyclic application of gas pressure of approximately 250 psia and then venting was used. Five cycles were applied in a 1-1/4 hour period and tank no. 2 was emptied (fig. C4-63). The fan responses were observed to be normal and no indications of heater cycling were observed.

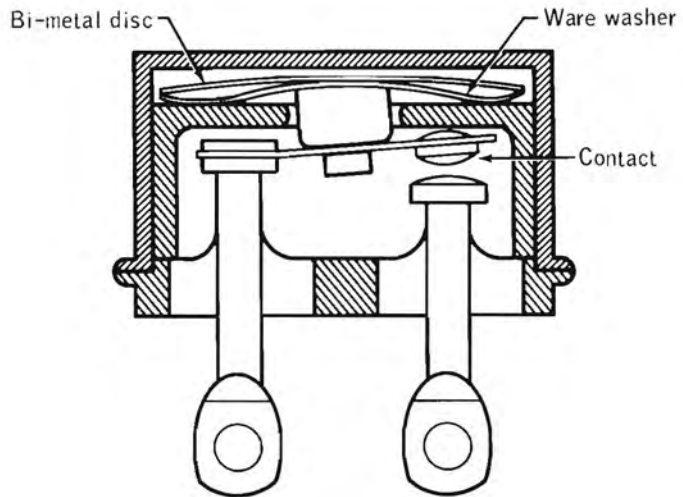
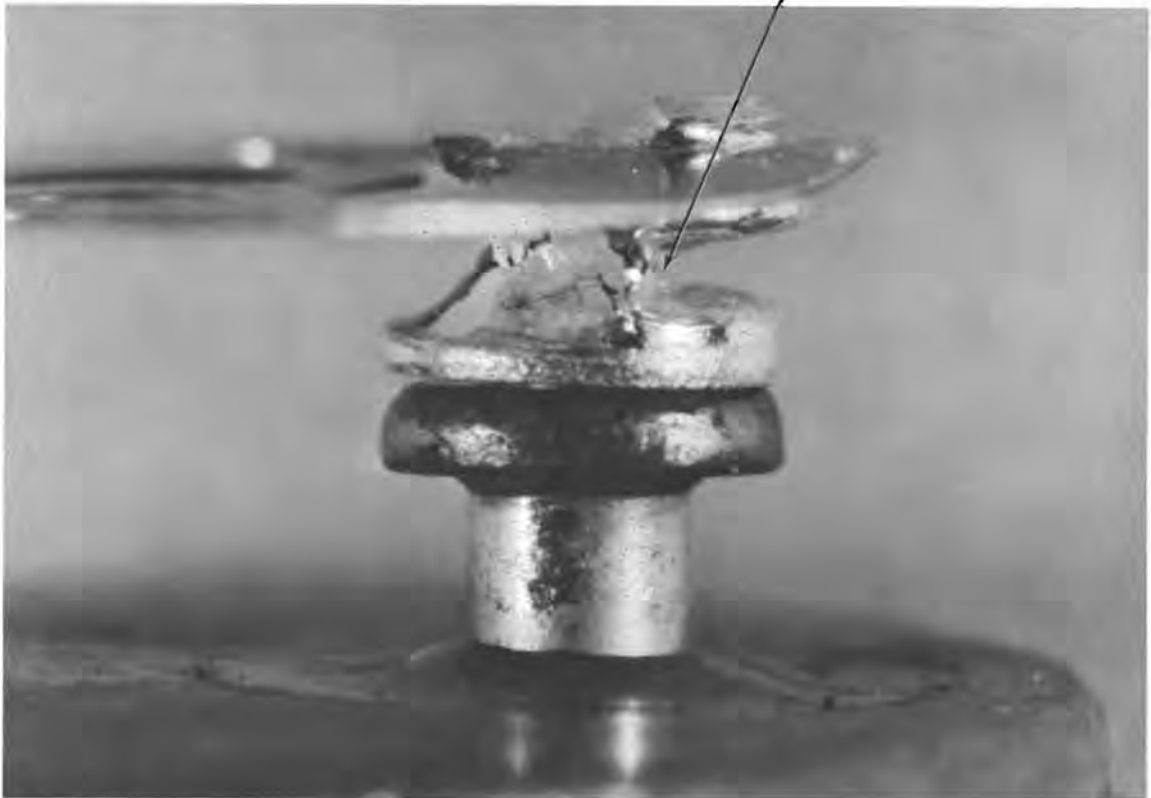
Figure C4-67.- Thermostat configuration and welded contacts.

The test was started and after a few cycles in this mode the previously nonfunctioning (open) thermostat started indicating normal function. At this time it was decided to revert to the originally intended test configuration, i.e., the thermostats directly controlling the heaters. Data from that point on indicated that the thermostats were not cycling the heaters. The heater tube temperature data looked just like the nonthermostat test run. The test terminated at this point and the thermostats were removed and X-rayed. The X-rays indicated that the contact gap was bridged. One thermostat had its case carefully removed to examine the conditions of the contacts (fig. C4-67).

At no time during standard checkout, prelaunch, and launch operations are these thermostats required to interrupt the 65 V dc ground power supply current. As far as could be determined, the special detanking operation was the only time that any thermostats were ever called upon to interrupt this load.

Melted silver contacts
