# REPORT OF APOLLO 13 REVIEW BOARD

**APPENDIX B - REPORT OF MISSION  
EVENTS PANEL**

**APPENDIX C - REPORT OF MANUFACTURING  
AND TEST PANEL**

**APPENDIX D - REPORT OF DESIGN PANEL**

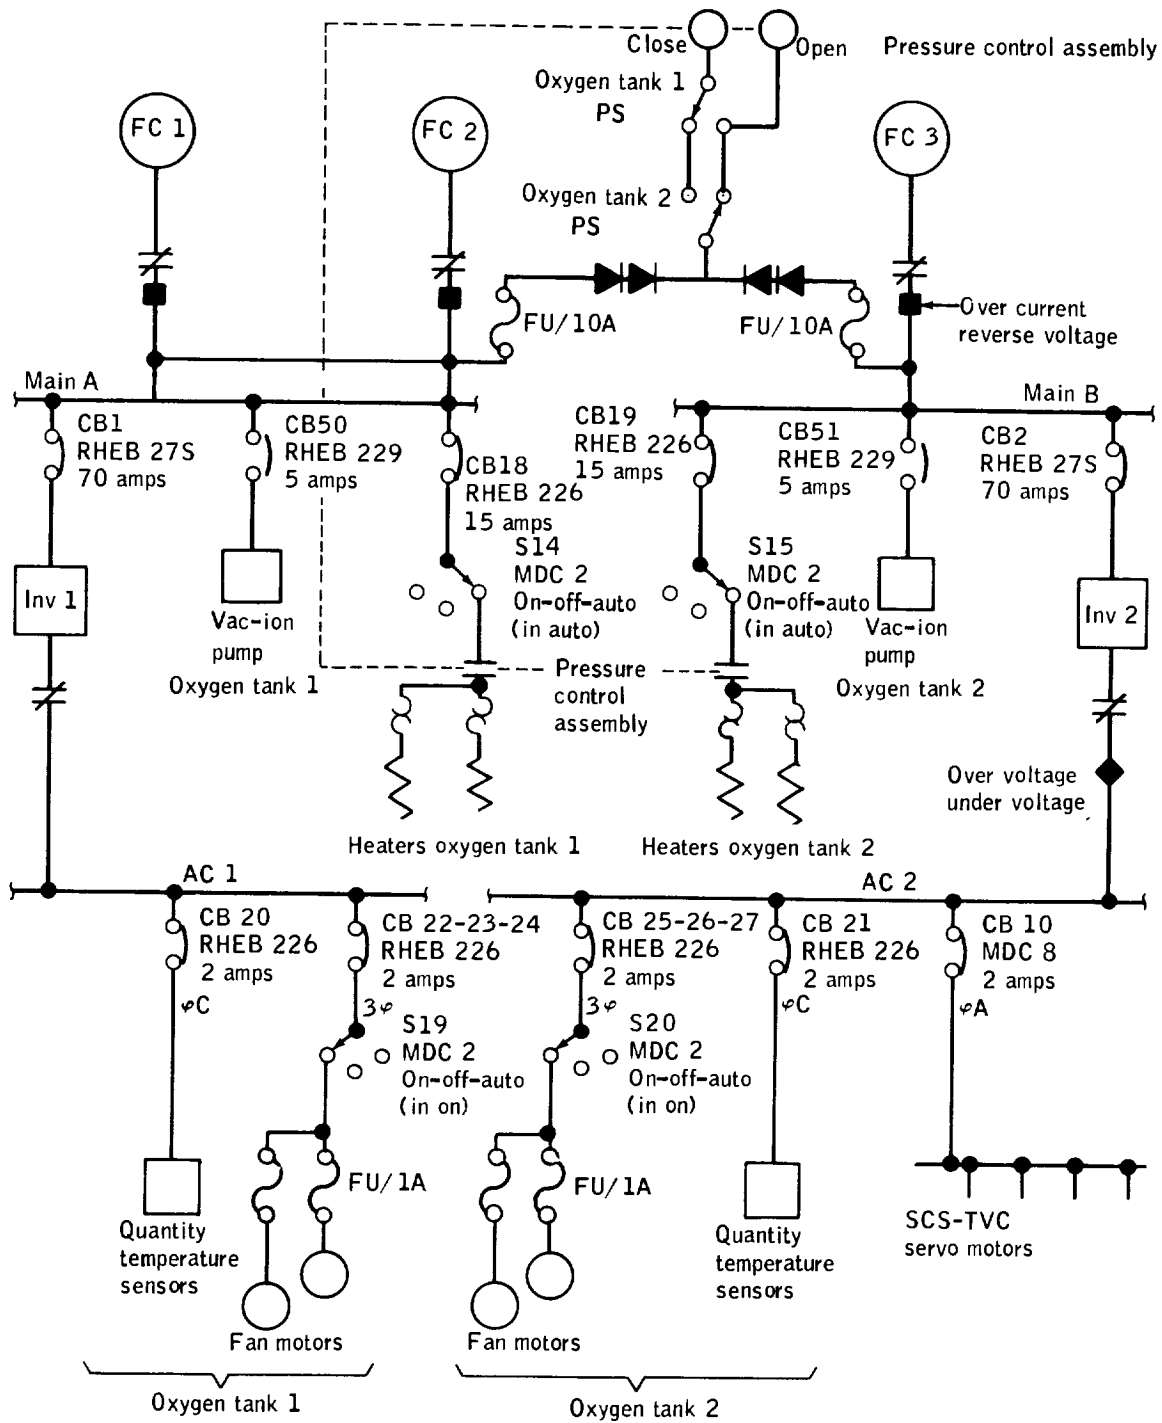
Figure D3-5.- Electrical schematic of relevant portions of electrical power system at 55:53:21.

The electrical power system, in general, provides multiple power busses with switching options for selecting an operating configuration. At 55:53:21, the electrical system was configured in accordance with reference 1, as shown in figure D3-5, with fuel cells 1 and 2 connected to main bus A and fuel cell 3 connected to main bus B. Inverter 1 was connected to main bus A and powering ac bus 1. Inverter 2 was connected to main bus B and powering ac bus 2. Inverter 3 was not connected. Battery busses A and B were not connected to main bus A or B. The switches controlling heater operation for both oxygen tanks were in the "automatic" position, controlling heater operation through the pressure control assembly. Pressures in the oxygen tanks were at levels which did not demand operation of the heaters. Temperature and quantity sensors on oxygen tank no. 2 were energized from ac bus 2. The quantity gage

had remained off-scale high from 46:40:06, indicating a probable short circuit either on the leads or the probe assembly. Operation of the fan motors in the oxygen tanks was accomplished throughout the mission using manual control in lieu of the automatic operation afforded by the logic of the pressure control assembly. A routine operation of the fans was requested by the ground at 55:52:58 and acknowledged by the crew at 55:53:06. Energizing of the fans in oxygen tank no. 1 is confirmed by a drop in voltage of ac bus 1 and an increase in total fuel cell current at 55:53:18. Energizing of the fans in oxygen tank no. 2 is confirmed by a drop in voltage of ac bus 2 and an increase in total fuel cell current at 55:53:20. Data substantiating operation and operation times are presented in Appendix B.

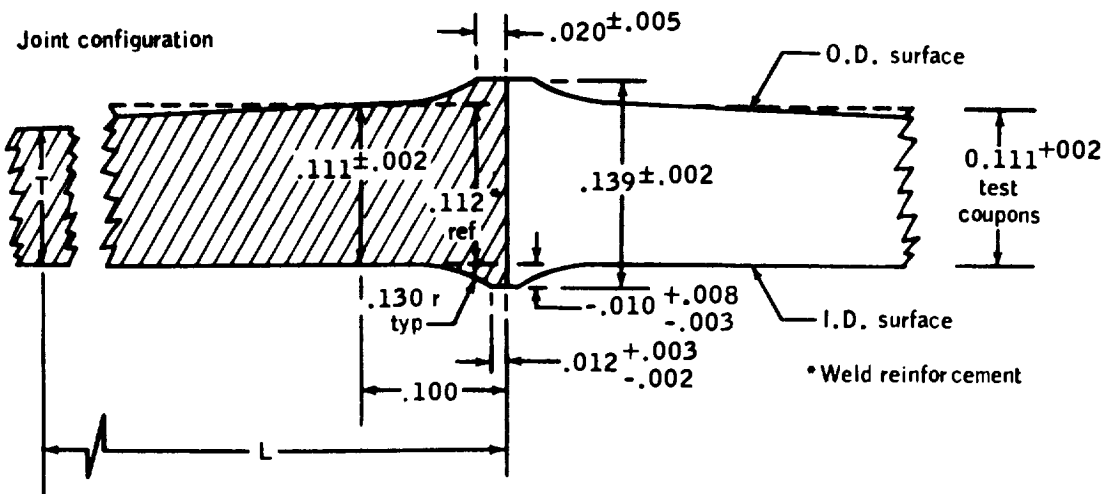
Figure D3-7.- Girth weld joint configuration and schedule.

A total of 39 data packages on oxygen pressure vessels were reviewed and it was ascertained that only 12 vessels had had weld discrepancies. Table D3-1 describes the weld discrepancies and their disposition. Neither of the two Apollo 13 oxygen tanks flown (S/N 10024XTA0008 and S/N 10024XTA0009) appear on this list. There were no recorded weld discrepancies during the manufacture of these tanks.

- Notes: (1) 0.002" gap, 0.003" offset (max typ)  
 (2) No weld repairs allowed  
 (3) Typical weld sequence shown on attached sketch

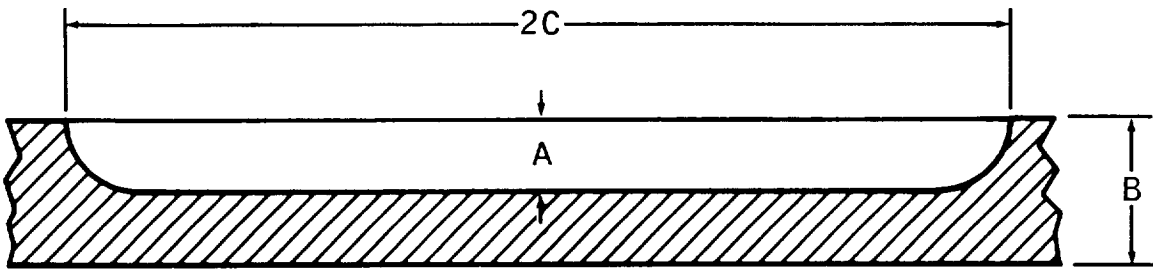
Figure D3-9.- Ligament model for ductile fracture of pressure vessel.

Area of lack of fusion produces  
an effective crack of depth  $A$   
& length  $2C$  in tank wall of  
thickness  $B$ .  $2C \gg A$

equatorial weld. It is postulated that the ligament will fail when its stress reaches the tensile strength of the material. Calculations show that the ligament stress  $\sigma_l$  is related to the average wall stress

where  $F_{tu}$  is the ultimate tensile strength. Failure will occur by tearing of the ligament accompanied by rapid decompression of the tank. It should be appreciated that this is a rather crude model of ductile fracture, and will probably overestimate the failure stresses in a spherical vessel. However, it should be useful in assessing the effectiveness of the proof tests in light of subsequent service, because of the very large margins between proof and operating pressures.

The ratio of tank pressures necessary to cause ligament failure for a given relative flaw size  $A/B$  at two temperatures will be equal to the ratio of the tensile strength of the material at these temperatures. On this basis, the maximum flaw size that could exist before CDDT is established by the last high pressure helium proof specified as 1260  $\begin{smallmatrix} +50 \\ -0 \end{smallmatrix}$  psi at ambient temperature (1276 psi for oxygen tank no. 2). From equation (1), the corresponding value of  $A/B$  for the weld metal is 0.55, based on a weld tensile strength of 158 ksi at room temperature, a weld land thickness of about 0.111 inch, and a nominal weld land stress of 71 ksi.

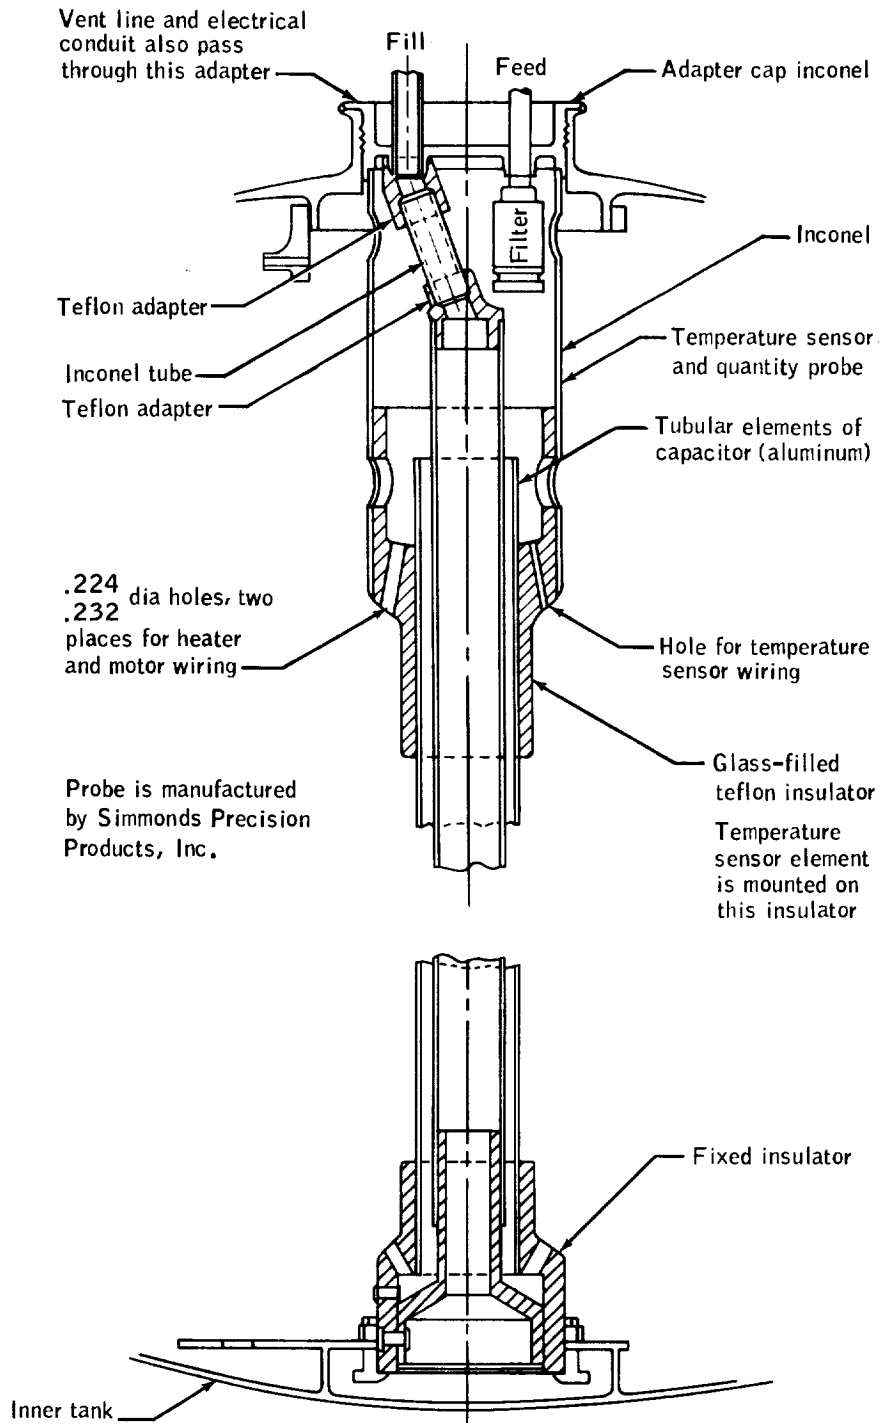
Figure D3-12.- Quantity gage.

The quantity gage capacitor (fig. D3-12) consists of two concentric aluminum tubes which are adequately mounted and supported. The inner tube of the capacitor constitutes the extension of the fill line. The outer tube is perforated to insure access of the oxygen to the space between the capacitor plates. The relative position of the two plates is maintained by insulating Teflon separators. Shorting of the capacitor at the plates within the tank requires bridging of the gap between the tubes by a conductive material. Shorting could also be induced by the contact of bare lead wires resulting from insulation damage. The power input to the quantity gage is regulated and limited by the high impedance source of the signal conditioner. The spark that could be

generated is at the 7- to 10-millijoule level. The evidence provided by the data can be construed to indicate that the effects of the probe failure during flight were limited to data loss.

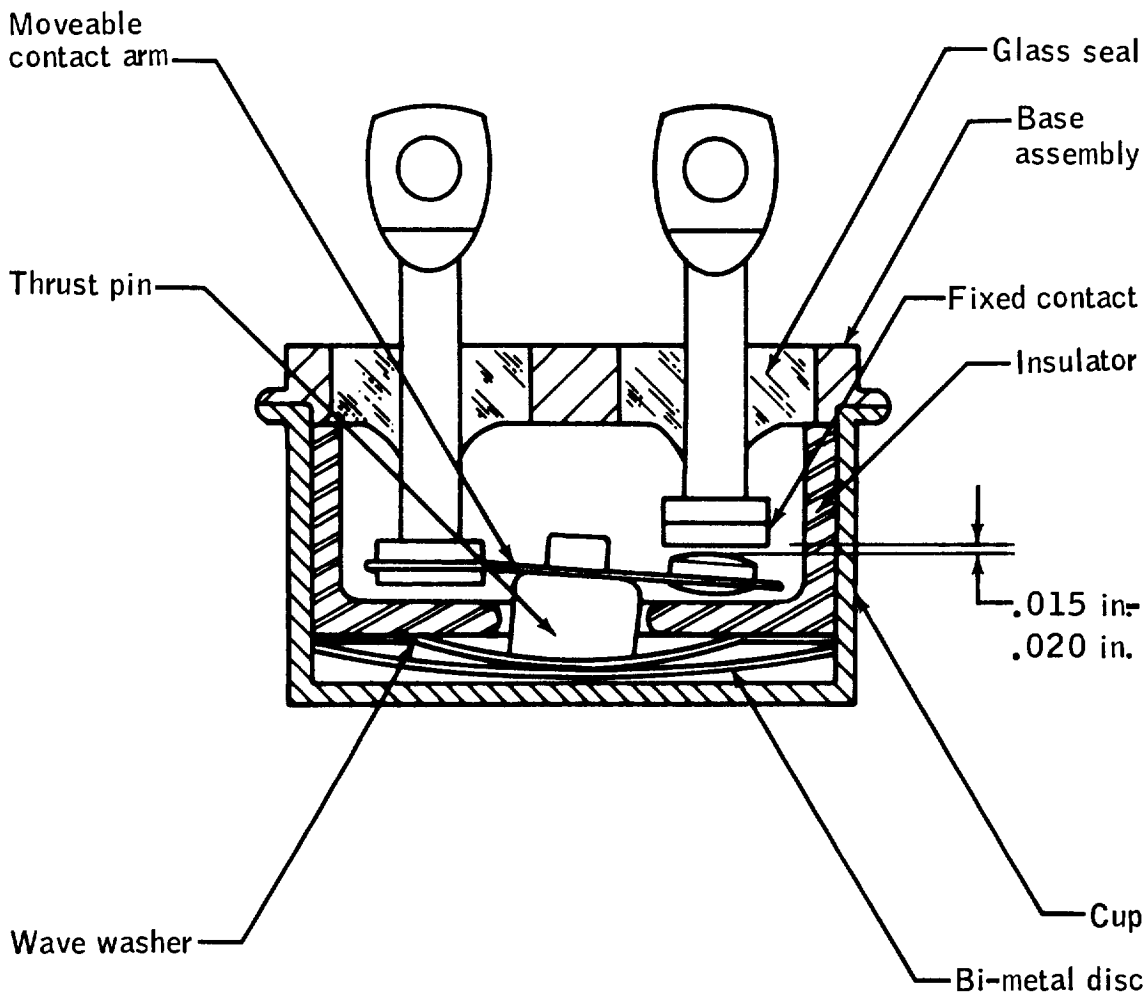
Figure D3-14.- Cross section of thermostat.

All qualification and acceptance tests identified were primarily concerned with the repeatability of the thermostat actuation at the specified temperatures. No qualification or acceptance tests have been identified which would verify the ability of the thermostats to open the heater circuit when energized at 65 V dc.

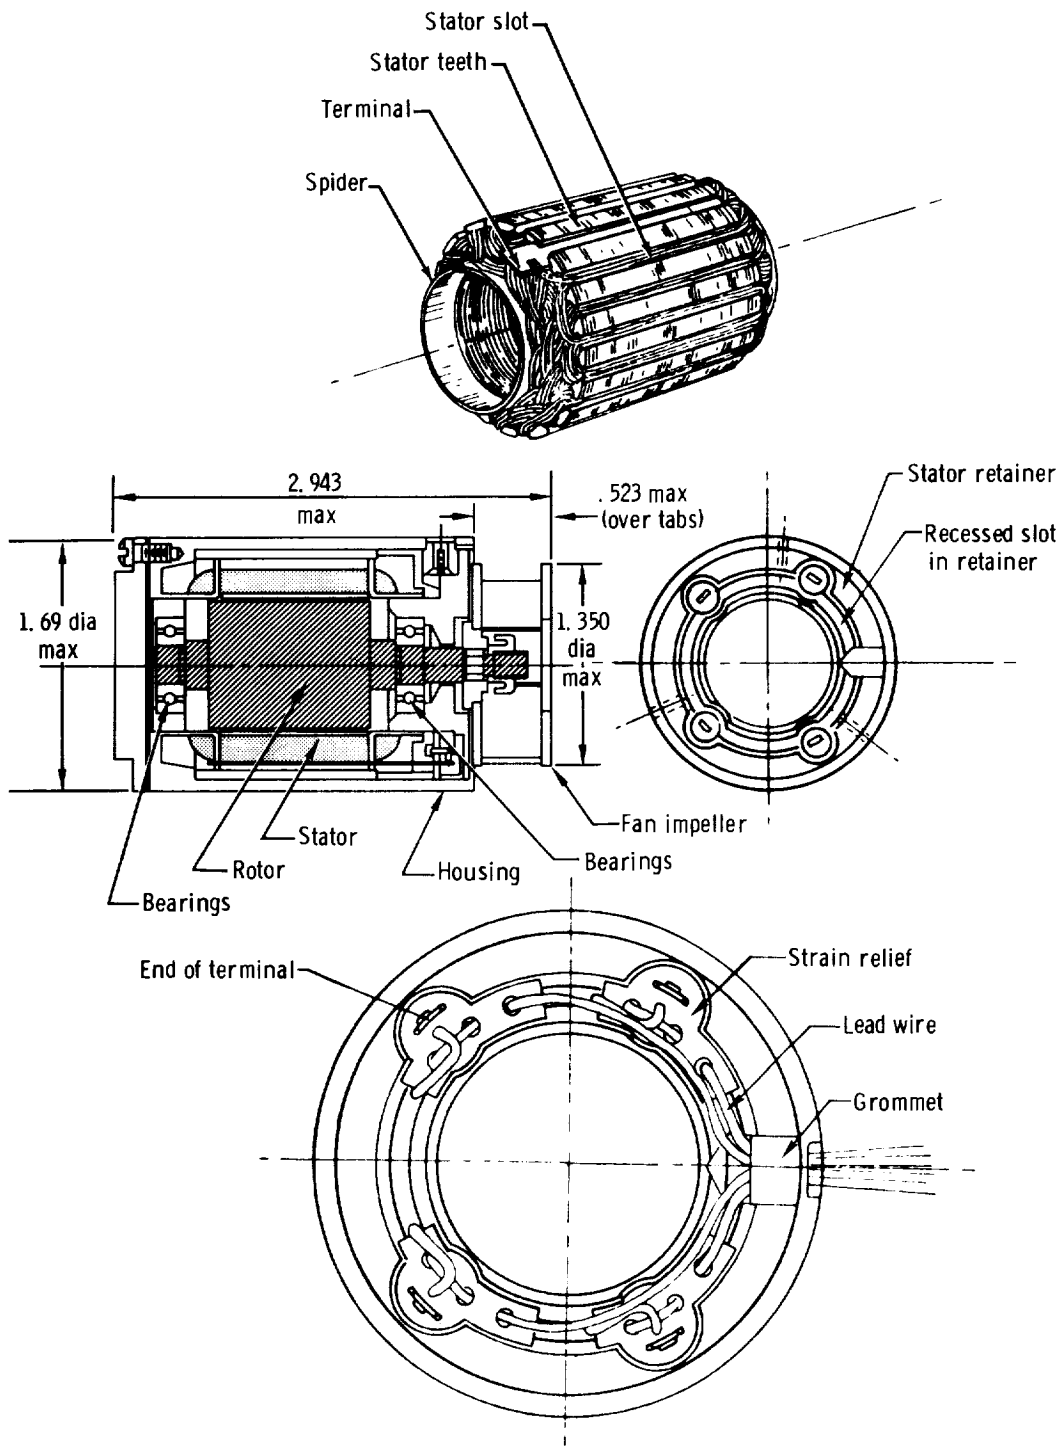
Figure D3-15.- Oxygen fan motor.

The stator windings are fabricated with number 36 American Wire Gage (AWG) wire, using a Teflon-coated ceramic insulation. The ceramic insulation is brittle and subject to breakage if proper tension is not used in fabricating windings or if sharp bends are made at the winding

end turns. Acceptance testing of the wire is conducted on the first 100 feet of each reel. The wire is considered acceptable if no more than 10 breaks in insulation are exhibited in the sample when pulled through mercury at 25 feet per minute. The rejection rate for stator winding faults for motors processed early in the production run was substantial. Improved yield was achieved only by rigid adherence to the winding tension process control used in fabricating the windings, proper assembly techniques, and frequent in-process dielectric testing. Phase-to-phase short circuits or shorted turns within a single phase are more likely than phase-to-ground faults. A limited amount of insulation is provided between windings and ground. Phase-to-phase insulation is limited to the end turns. Considerable improvement was accomplished in the acceptance rate of motors built after the fabrication control techniques were developed (Appendix C). No problem was exhibited in the testing of the two motors finally installed for flight in oxygen tank S/N XTAA0008.

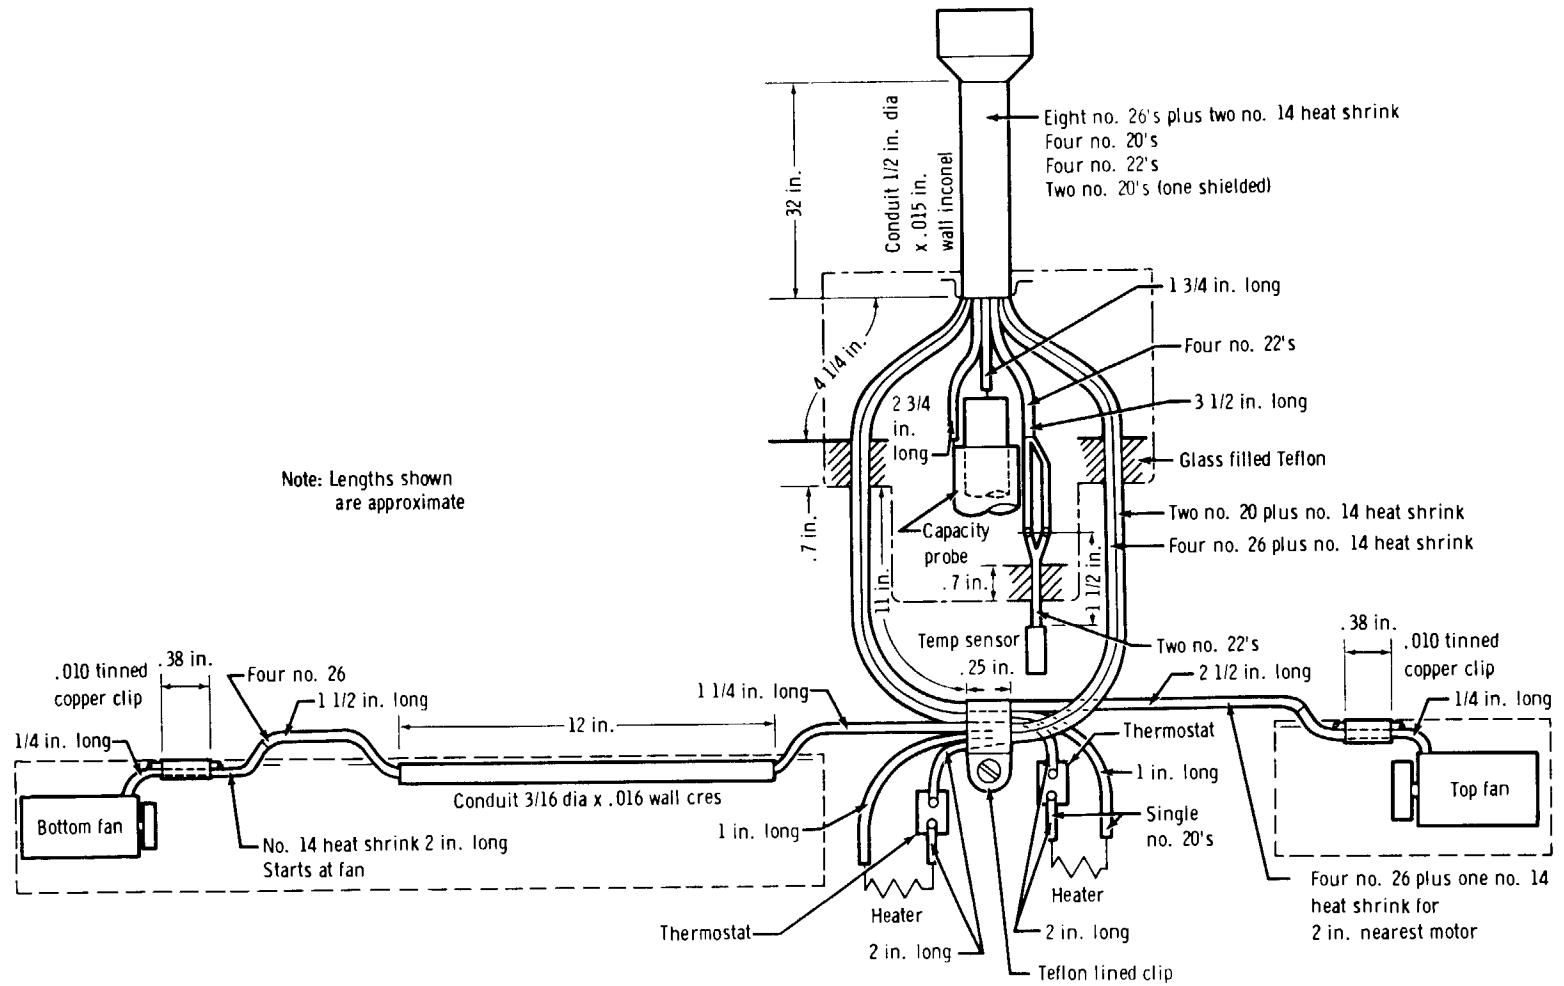
Figure D3-16.- Oxygen tank wiring distribution.

The mechanical design of the tank with respect to provisions for wiring is considered deficient. Damage to the wiring may be either insulation damage or conductor damage, portions of which cannot be inspected or adequately tested during or after assembly.

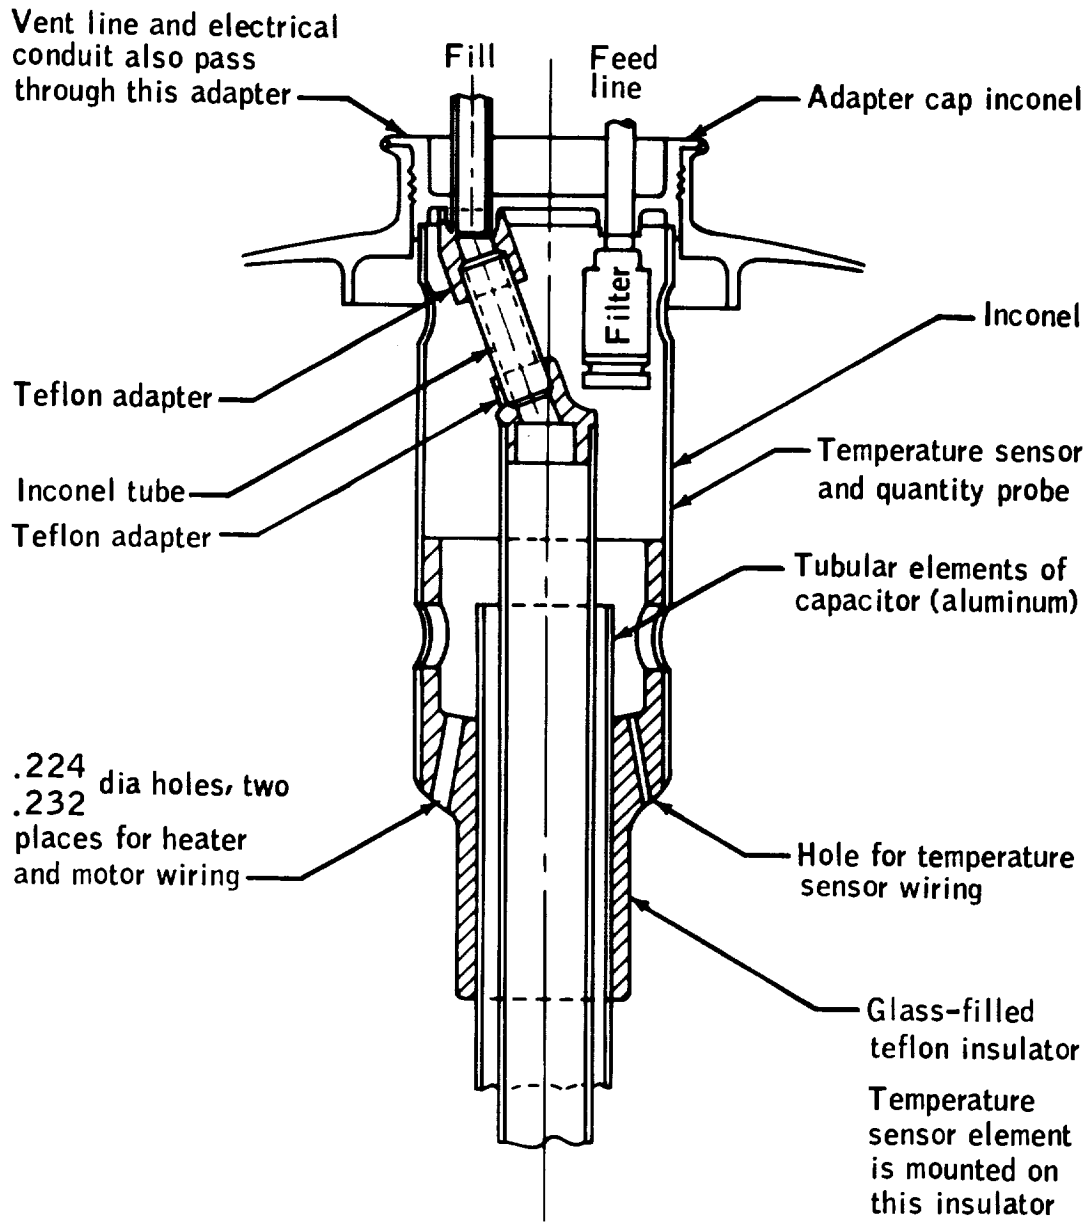
Figure D3-18.- Arrangement of head end of tank.

The head ends of the tank and the temperature sensor and quantity probe are shown in figure D3-18. One of the more significant features of the design is the arrangement of the connections in the fill line which routes the cryogenic fluid to the bottom of the tank, via the inner element of the quantity gage capacitor, and which permit the fluid to flow from the bottom of the tank during ground detanking. The manufacturing drawings of the elements of this connection, two Teflon adapters and an Inconel tube, allow a tolerance stack which is excessive. One combined worst case results in a connection which cannot reach from the fill tube connection in the tank head to the center element of the quantity gage capacitor. The other results in a connection length which prevents assembly of the probe to the adapter in the head of the tank. These are shown in figure D3-19. The tolerances on concentricity between the inner element of the capacitor and the outer shell of the probe are not known and are omitted from this figure. Inclusion would show an even worse situation than shown.

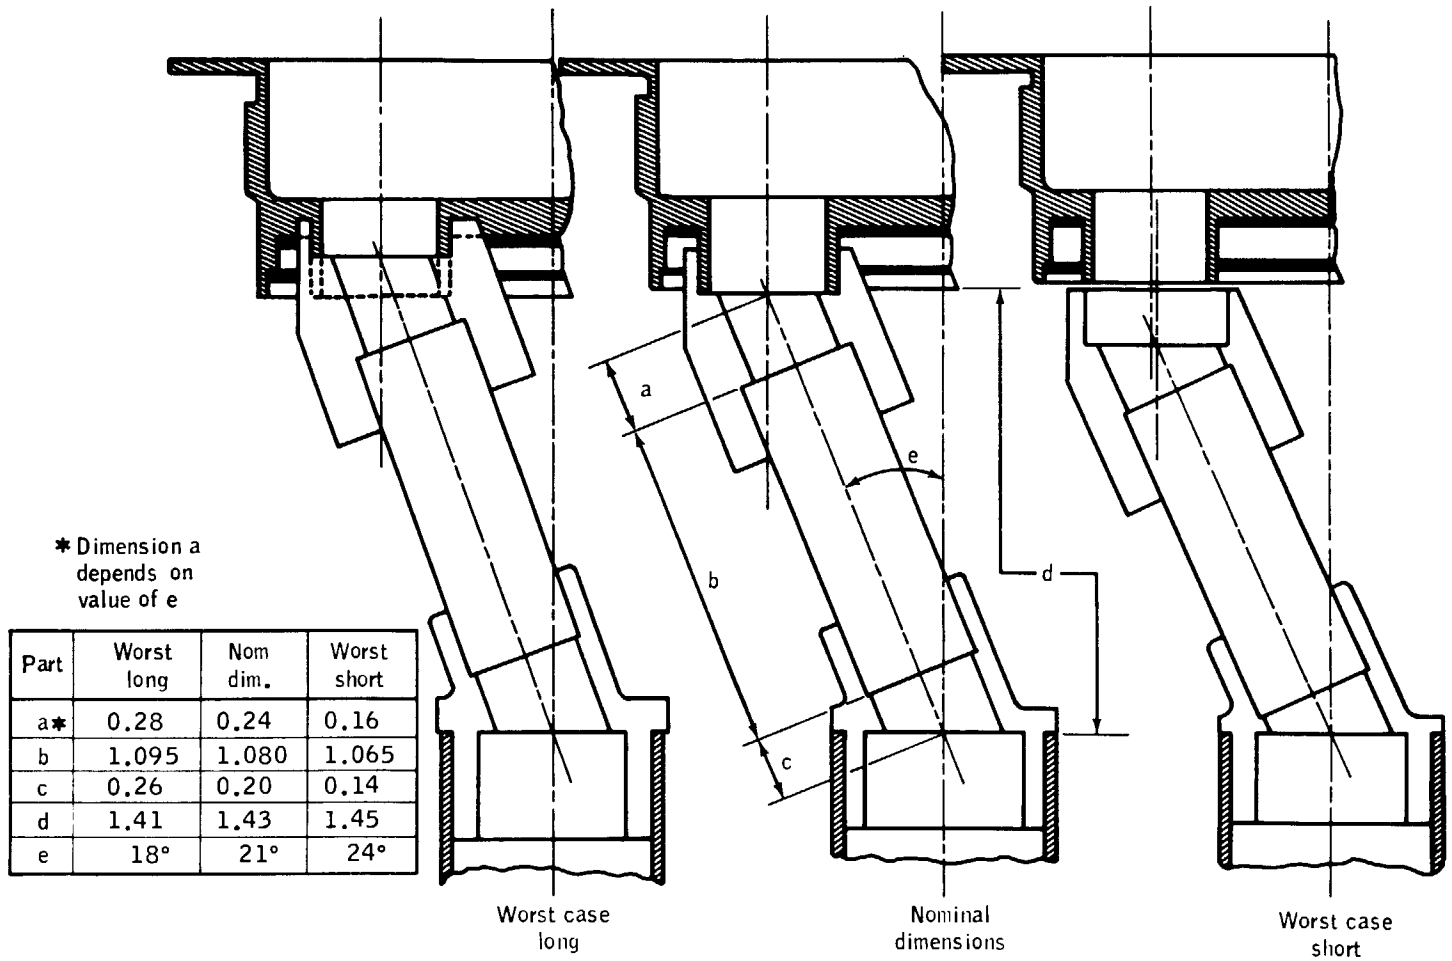
Figure D3-19.- Possible variations in fill line connection.

The experience with the oxygen tank no. 2 in Apollo 13 (apparently normal detanking at Beech, but normal detanking not possible at KSC) suggests that the components used in the fill line connection were close to a worst-case short situation. Tests conducted recently at Beech show that near normal detanking is possible when considerable leakage is present at the joints in the connection, and that a substantial displacement of the top Teflon adapter relative to the fill line in the tank adapter cap is necessary to reproduce the KSC situation.

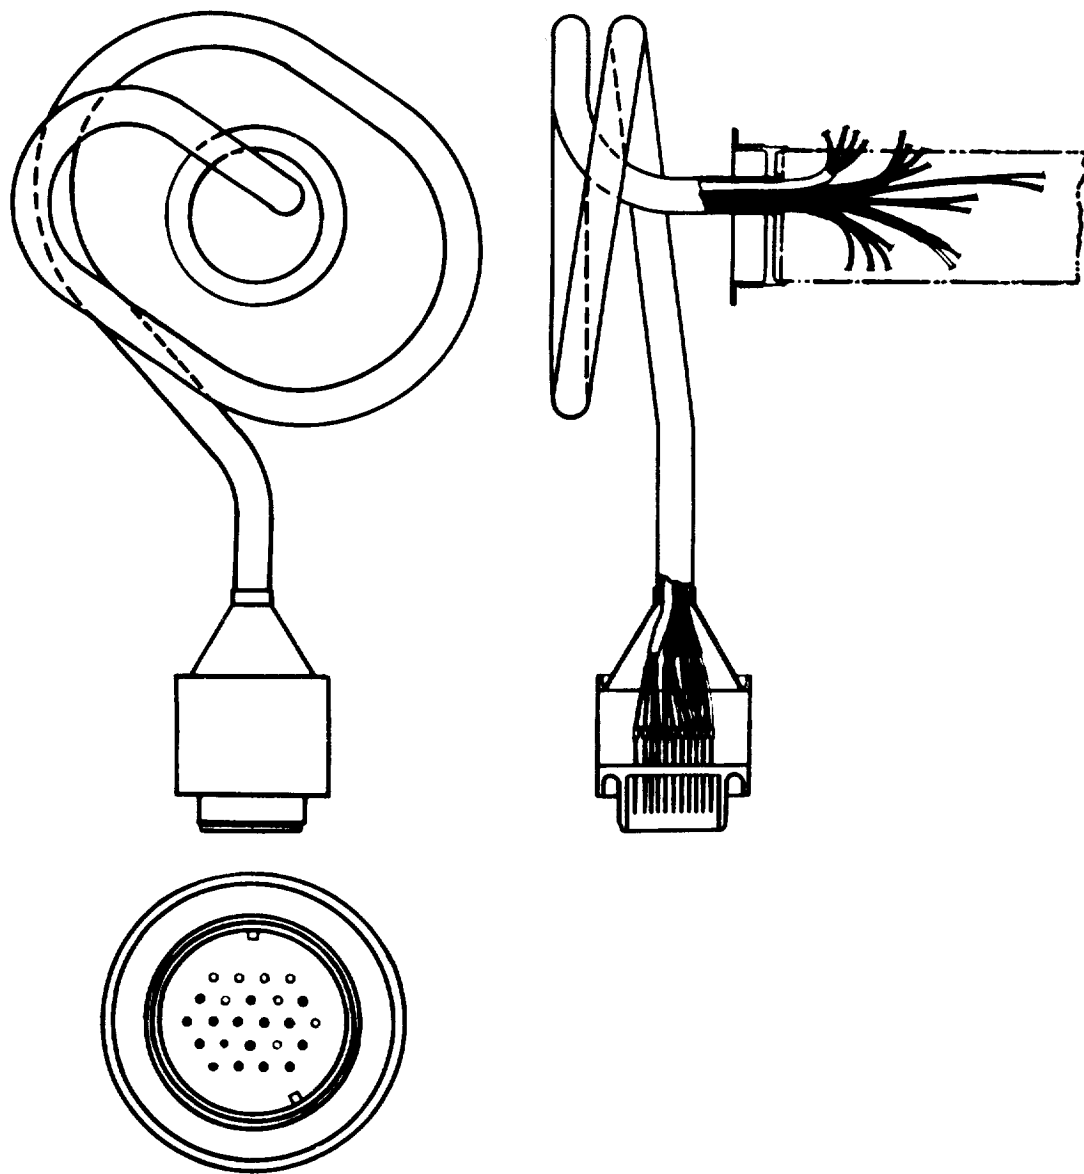
Figure D3-23.- Arrangement of electrical conduit.

A total of 18 wires pass through the electrical conduit, eight AWG no. 26's, four AWG no. 22's, and six AWG no. 20's. The conduit is shown in figure D3-23. At the start of the investigation some members of the Panel felt that the unorthodox detanking procedure used at KSC could have resulted in unacceptably high temperatures in this electrical conduit due to resistive heating of the heater wires. This possibility is discussed in a later section.

The design of this portion of the tank results in a configuration in which it is not possible to perform visual inspection of wiring after assembly. In consequence, the possibility of damage, in many cases undetectable by normal quality assurance procedures, is significant.
