NASA TM X-2290

**SOLDER-CIRCUITRY SEPARATION
PROBLEMS ASSOCIATED WITH
PLATED PRINTED CIRCUIT BOARDS**

by A. M. Pasciak

George C. Marshall Space Flight Center

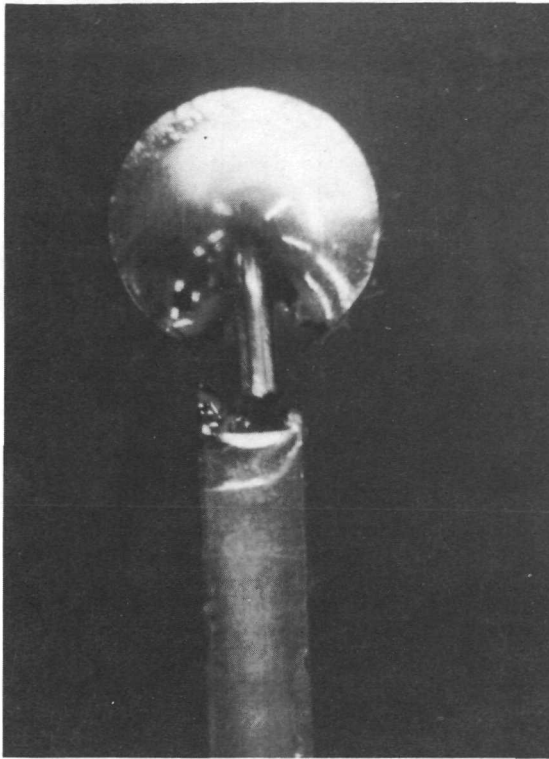
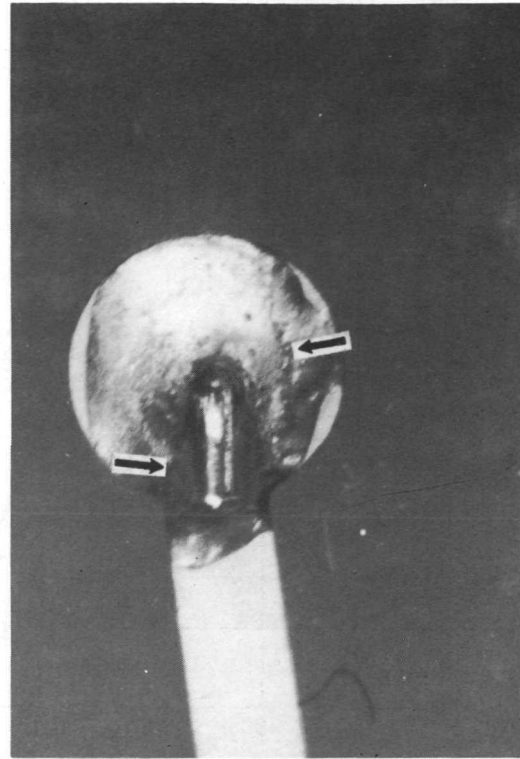
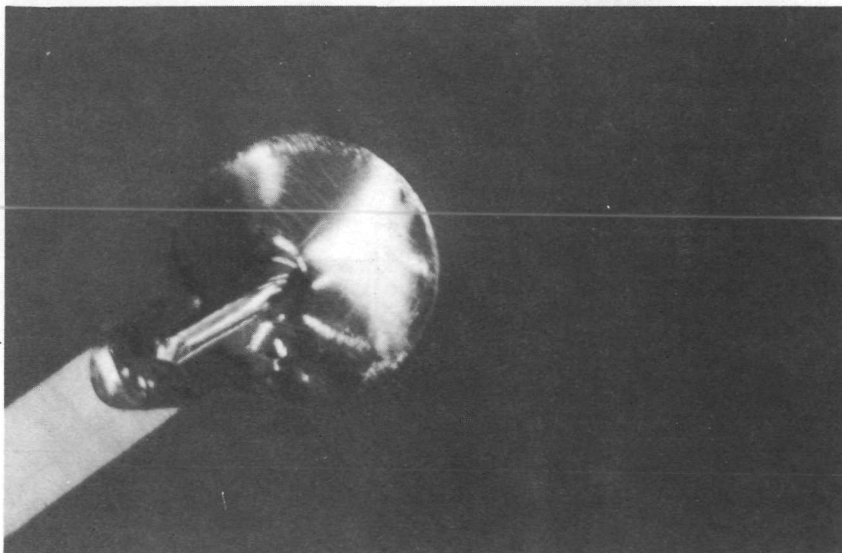
Visual inspection of the completed boards revealed the connections on bare and erased gold boards to be free of voids and porosity. They were shiny and filleted to a low dihedral angle. The connections on the gold-plated boards were grainy, dull grey, and porous. The solder masses generally exhibited irregular solidification lines giving the overall connection a "fried egg effect." A view of a solder connection of each board condition is shown in Figure 26. Note the similarity in the lustre and smoothness of the bare copper and erased gold connections. The gold plated connection exhibits dull appearance and porosity in the solder and solidification lines. This is a normal appearance when soldering directly to the gold plated surfaces. The solder-over-gold connections were not reworked because the gold plating effects were being evaluated.

Group A -- bare copper

Group B -- gold-plated

Group C -- erased gold plating

Figure 26. Overall view of soldered connection of each test board group.
(10X magnification)

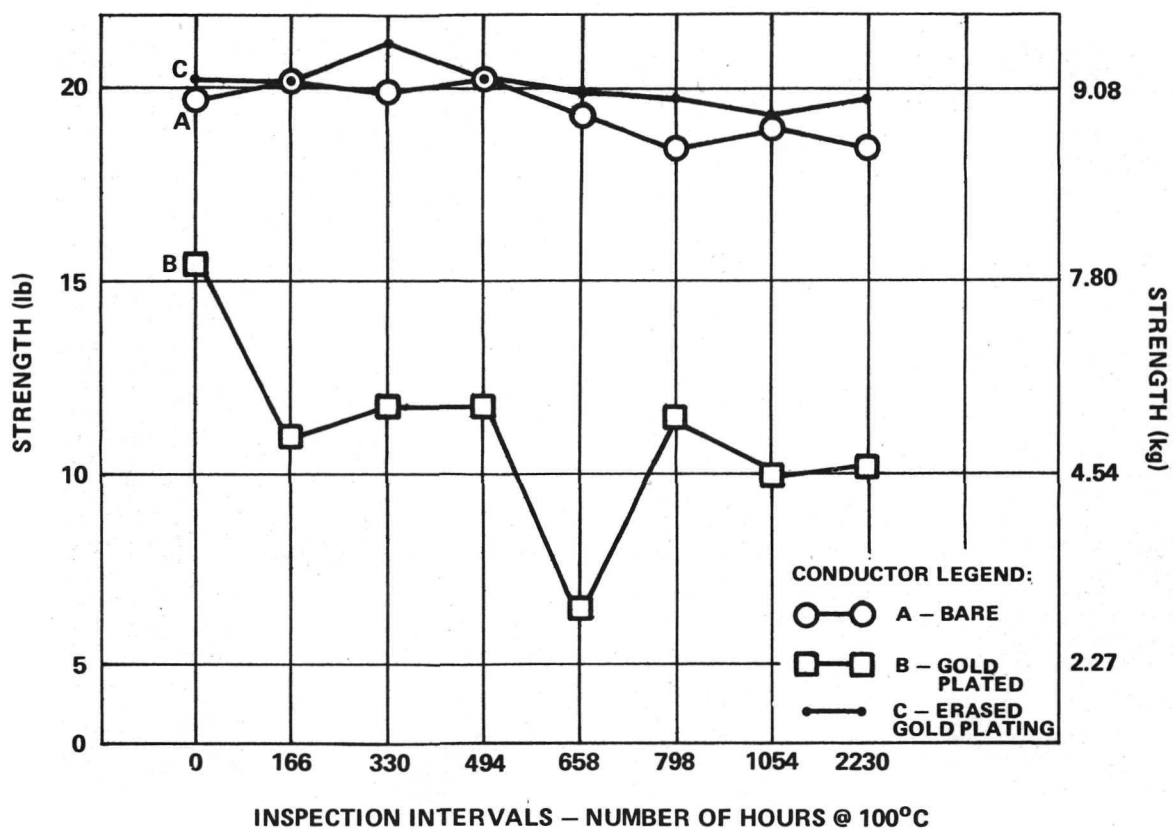
Thermal aging of the solder-to-gold connections showed a significant strength degradation after only 166 hours of exposure to 100°C temperature. Progressively erratic and weaker strengths were experienced until termination of this test. The connections of both the bare copper and erased gold remained approximately constant in strength. A comparison of the average strengths within each group is shown in Figure 27. The ability of a system to perform reliably in its selected environment may be dependent upon the continued level of interconnection strengths. The minimum push strength within each group is shown in Figure 28. Note the relatively weak connections in group B of approximately 0.91 kg as compared with groups A and C of 4.99 kg.

Note: Push tests results for the A and C groups do not reflect the maximum strengths of the solder-circuitry bond because in many instances the leads bent or the pads lifted.

Figure 27. Average strength push test results.

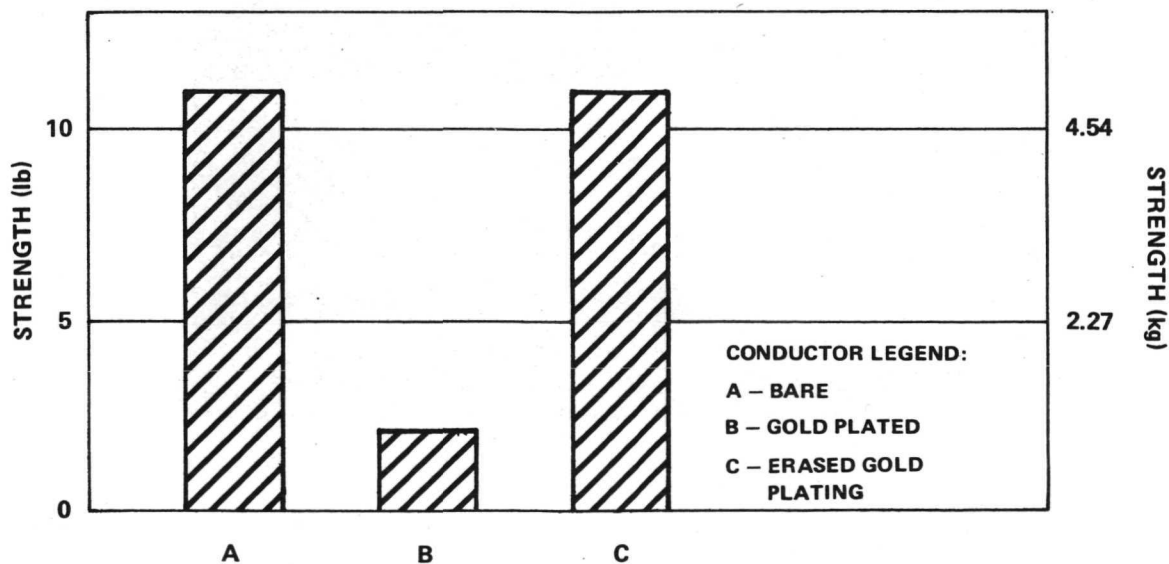
These connection strengths were compiled using the mechanical push tests. At no time did the solder separate from pads in groups A and C. Either the lead pushed out of the solder or, as in the majority of the cases, the pad lifted with the lead and solder. However, in the B group, partial solder separations occurred after 166 hours in thermal test. These separations displayed a darkened pad surface where the solder had separated. The solder remaining on the pads displayed a coarse and grainy structure. An example of this is shown in Figure 29. Another connection that separated after 658 hours in thermal test (Fig. 30) evidences bare copper on a portion of the pad. The first solder separation visually detected under the full length of the clinched lead was after 1054 hours in test. This connection is shown in Figure 31. Note that some solder is bonded to the side of the pad. This is because the unwanted copper on the board was etched after it was gold plated, leaving the sides with bare laminate copper which retained the solder during the thermal test. Similar separations were observed after the final inspection at 2230 hours in test, except that more of the bare copper on the pads was visible at this time.

Figure 28. Minimum push strengths.

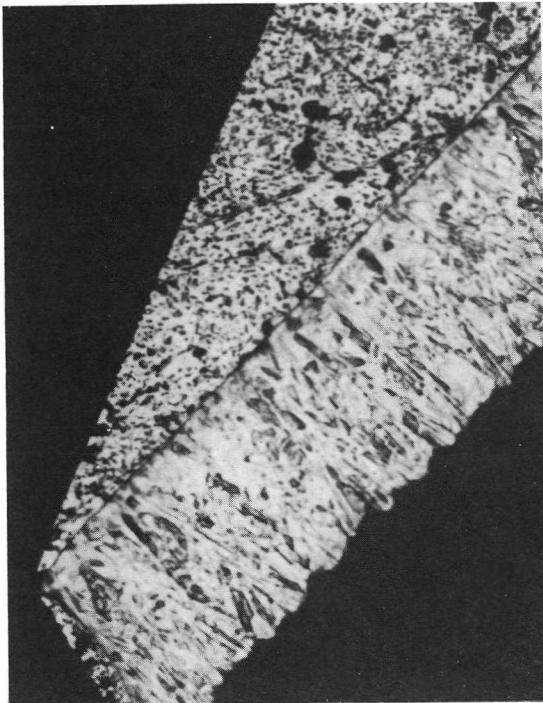
Group A connection

Metallographic examinations were performed on selected specimens at each of the evaluation intervals. However, only those photomicrographs that are significant when changes were observed are presented. This investigation has shown that prior to the temperature test all connections displayed good solder adhesion or bond to the solder pads. These are shown in Figure 32. In the gold-plated connection the solder appears to be bonded in part to the gold plating. Note the large void caused by outgassing of organics where the gold plating terminates. Voids were generally evidenced on all solder-to-gold connections that were cross sectioned. The bare copper and erased gold connections were similar in solder structure and copper-tin intermetallics and displayed complete and acceptable bonding characteristics.

Figure 32. Metallographic views of soldered connections of test board groups prior to tests. (400X magnification)

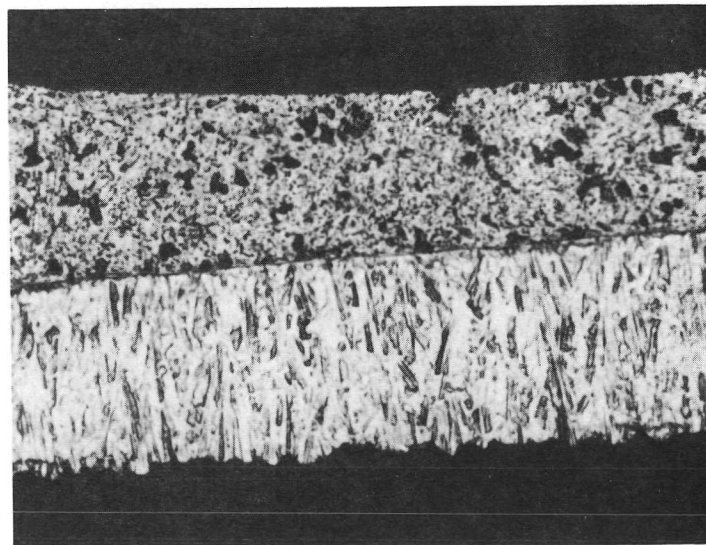
Group C connection (similar in structure to Group A.)
