# SPACE-STORABLE OXIDIZER VALVE

FINAL REPORT  
NOVEMBER 1970

McDonnell Douglas Astronautics Company—West  
McDonnell Douglas Corporation  
5301 Bolsa Avenue  
Huntington Beach, California 92647  
for

NASA Lewis Research Center  
Cleveland, Ohio  
R.E. Grey, Project Manager  
Liquid Rocket Technology Branch  
NATIONAL AERONAUTICS AND SPACE ADMINISTRATION

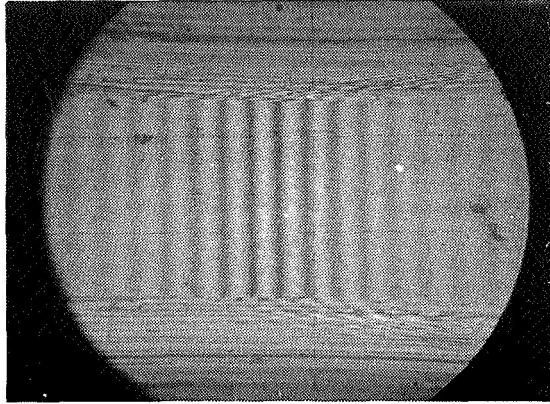
**Figure 3-1. Photomicrograph of Typical Seat-Seal Section (100X)**

The unplated A286 poppet seat used in the -1 configuration had the sealing surface lapped to a finish less than  $1\mu$  in. ( $2.54 \times 10^{-8}$  m) arithmetic average (AA). The photomicrograph of a typical section of seal is shown in Figure 3-1. The lapping technique used on this valve employed a hand-held lap moved in a circular pattern. This method of lapping produces a high-quality multidirectional lay, but not the specified circular lay. The differences between a multidirectional lay made in this manner and a theoretically circular lay were discussed with the Parker Hannifin Lapping Department personnel. Due to the anticipated difficulty in maintaining the required surface finish while lapping with a truly circular motion, a decision was made to approve the multidirectional finish for acceptance testing. The final inspection of the seal was conducted just prior to the assembly of the valve to ensure that no damage had occurred to the seat due to cleaning and handling of the part. This last inspection showed no scratches or other damage which would hinder proper valve sealing. The bumper height was 0.0002 to 0.00025 in. ( $5.08 \times 10^{-6}$  to  $6.35 \times 10^{-6}$  m) ( $0.0003 \pm 0.0001$  in. [ $7.62 \times 10^{-6} \pm 2.54 \times 10^{-6}$  m] specified). The spring rate of the bellows portion of the seat was measured and found to be 5,880 lbf/in. ( $10.30 \times 10^5$  N/m), which is well within the  $5500 \pm 500$  lbf/in. ( $9.62 \times 10^5 \pm 0.88 \times 10^5$  N/m) specified. Since this value was near the upper end of the specified range, it tended to compensate for the undersized seat diameter discussed in Section 3.2.1.4. The poppet seat for the -501 valve had the same spring rate as the -1 valve part. This poppet seat was given a light surface lapping prior to gold plating because the surface was scratched, was not flat, and did not provide the proper bumper height. The seat was lapped to an acceptable flatness and surface finish before the gold plating was completed. A second lapping operation was completed after the gold-plating process. This second lapping was to eliminate slight irregularities of the gold plating with the removal of a minimum amount of material.

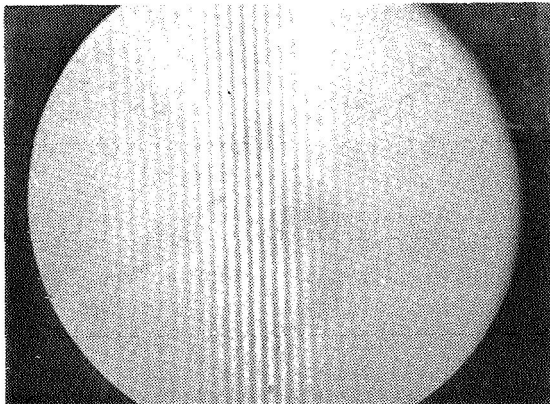
**Figure 3-2. Photomicrograph of Inconel 718 Sample Piece (100X)**

The shape of the poppet assembly prevented its installation into the optical device used to determine surface finish. Therefore, the poppet sealing surface was not completely inspected. Instead, a sample of the same dimensions and material as the poppet was lapped, using the same technique used on the valve poppet. The sample was then inspected and found acceptable. The photomicrograph of the Inconel 718 sample piece is shown in Figure 3-2. Based on the acceptable condition of the sample, the two poppets were accepted for testing.

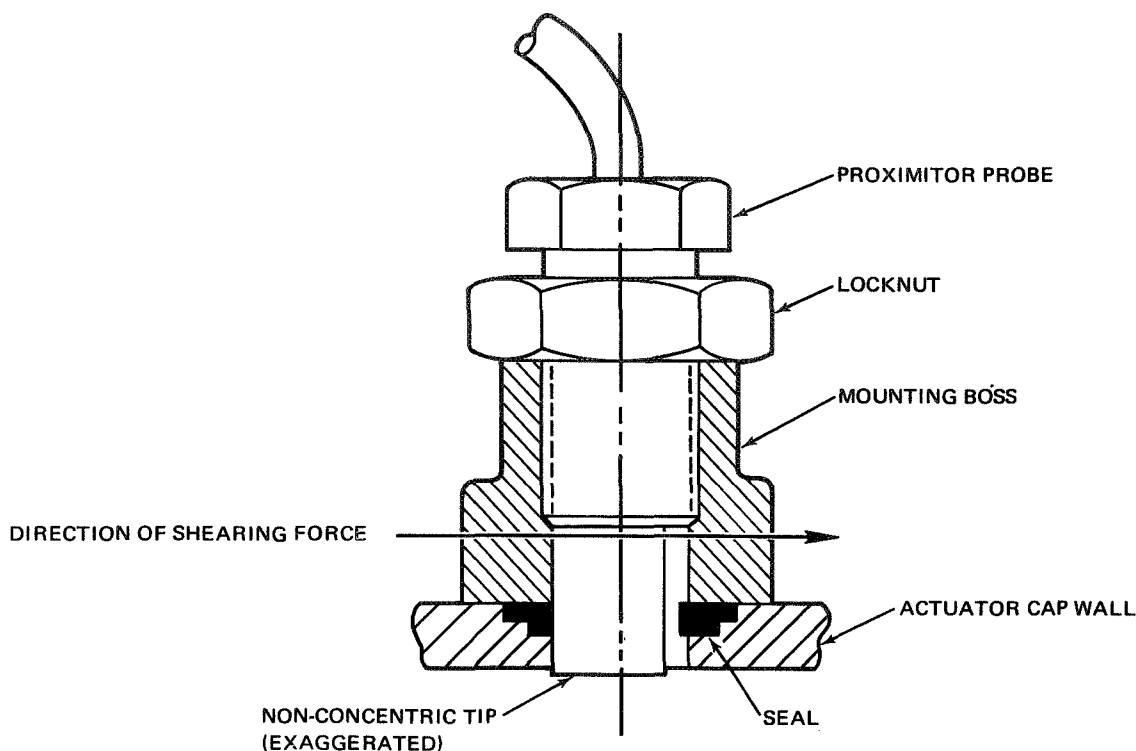
Figure 3-5. Proximito-Seal Installation

A second assembly difficulty was encountered when the proximator-type position indicators were installed. The position indicators in these valves utilize the outer surface of the variable reluctance detection coil as the sealing interface. This arrangement functions satisfactorily, provided the coil tip and the proximator mounting threads are concentric. This concentricity callout was inadvertently omitted on the original purchase order, and two of the first four proximators delivered were unacceptable for testing. The importance of the concentricity of the coil is illustrated in Figure 3-5. The lack of concentricity was discovered during the actuator leakage tests conducted as part of the valve acceptance tests. Excessive leakage occurred around one of the proximator seals, and it was found that excessive side loads on the proximator coil had broken the coil mounting joint. The defective units were returned to the supplier for replacement.

After removing all safety wires, disassembly began with the actuator portion of the valve. All breakaway torque values were within specification. Visual inspection of the removed proximitors showed an obvious nonconcentricity between the sensing tip and the mounting threads (Figure 3-5). This condition can result in excessive leakage and/or proximitor tip breakage, but is easily avoided by specifying the desired concentricity when ordering new parts. At this time, several correctly-specified spare units were on order. A small quantity of Teflon dust was observed in the actuator cap. This had been produced by friction between the actuator piston and Omniseal, and is considered normal. An imprint of the actuator piston face inside the end of the actuator cap and light impact marks on the piston face were probably produced during the 250-psig ( $1.73 \times 10^6$  pascals) GHe proof tests, and are also normal. Disassembly of the valve actuator disclosed a potential problem which can easily be eliminated by a minor revision to the assembly procedure. The cotter-key hole in the threaded portion of the poppet shaft should be aligned with its axis perpendicular to a plane passing through the position indicators. If it is not, the cotter key that retains the indicator nut can damage or interfere with the proximitor tips when the poppet moves. The alignment of the cotter-key hole is determined by the clocking of the bellows adapter to the main valve body when the poppet assembly is installed. During the original assembly of the -501 valve, the bellows adapter was misclocked by one bolt hole, resulting in a 45-degree ( $7.85 \times 10^{-1}$  rad) error in cotter-key position. As a result, the bent end of the cotter key narrowly missed one of the proximitor tips during prior operation.

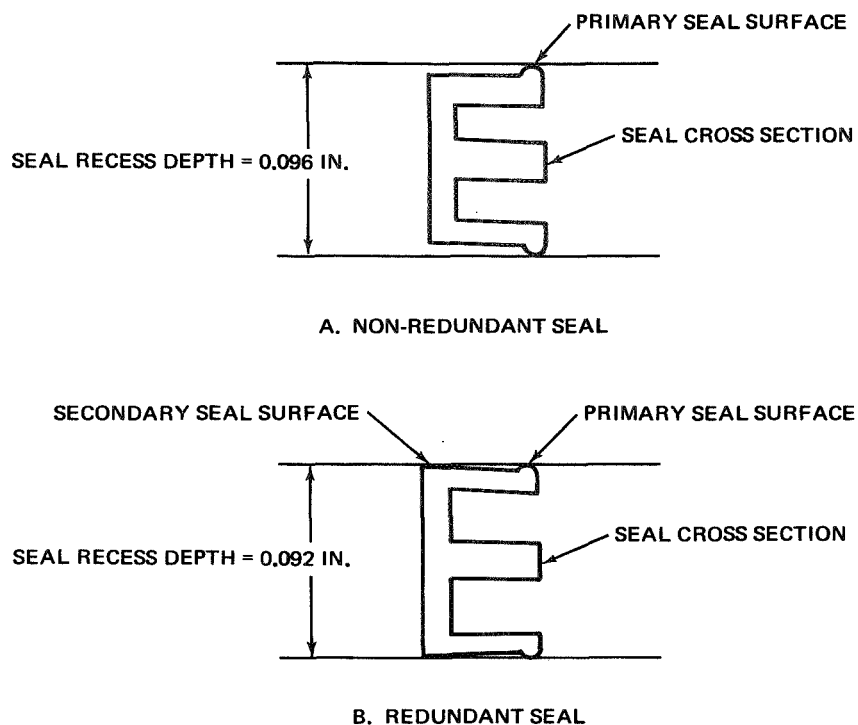
Figure 3-10. Effect of Loading on Static Seal Deflection

The seals are designed to seal properly by loading the primary seal area to a level of 2,500 to 5,000 psi ( $1.73 \times 10^7$  to  $3.45 \times 10^7$  pascals). This arrangement is shown in Figure 3-10A. To obtain this loading, a groove depth of 0.096 in. ( $2.44 \times 10^{-3}$ m) was specified by the seal supplier, and this value was used by Parker Hannifin in the design of the valves. All measurements made by MDAC-West indicated that the Parker Hannifin parts were properly machined to these dimensions. However, for critical applications, a redundant seal surface can be obtained by allowing the seal to compress as shown in Figure 3-10B. Although not required for normal liquid service, a redundant seal surface is recommended for sealing GHe at 250 psig ( $1.73 \times 10^6$  pascals), a test condition used routinely in evaluating valve poppet-seat leakage.

After leakage was detected at the inlet test adapter connection, the adapter was cryoshocked (i.e., submerged in LN<sub>2</sub>) to relieve residual welding stresses, and then remachined to provide the specified 0.096-in. ( $2.44 \times 10^{-3}$ m) groove depth. Leakage was still encountered after this rework, so a second rework was accomplished to reduce the groove depth to 0.092 in. ( $2.34 \times 10^{-3}$ m). This provided an acceptable seal.

The outlet test adapter was then installed, and it was also found to leak. Unfortunately, this adapter contained a flexible bellows between the two flanges, so it could not be remachined on the available machine tools. Furthermore, the lightweight flanges were designed so that a pilot surface bottoms with a mating surface to control the groove depth (to prevent seal breakage from over-compression). Thus, over-torquing of the flange bolts has no effect on the seal compression, once the pilot bottoms. A special lapping tool was made, and the required 0.004 in. ( $0.10 \times 10^{-3}$ m) was hand lapped from the pilot surface of the outlet test adapter flange. With the resultant 0.092-in. ( $2.34 \times 10^{-3}$ m) groove depth, the outlet test adapter also sealed properly at 250 psig ( $1.73 \times 10^6$  pascals) when tested with GHe.
