TEST AND EVALUATION OF THE

SURVEYOR III TELEVISION CAMERA

RETURNED FROM THE

MOON BY APOLLO XII

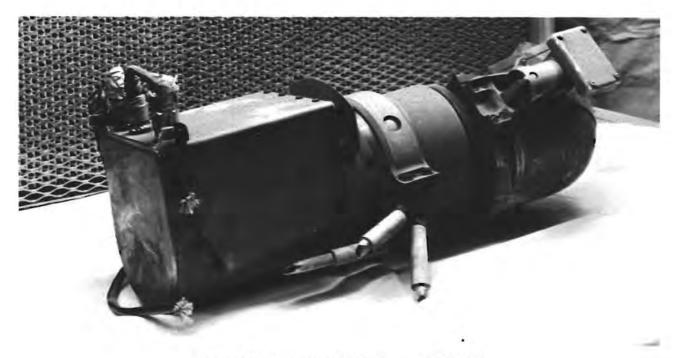
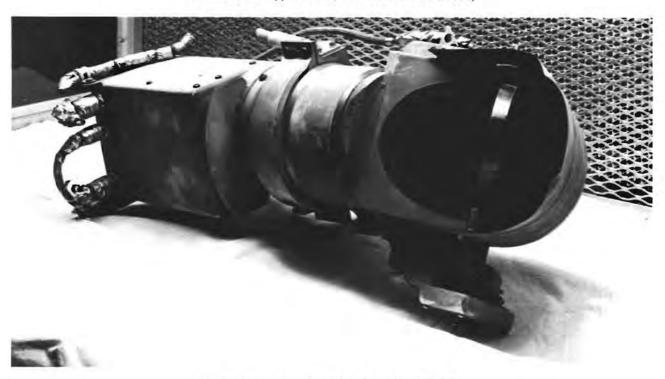
Figure 3-3. Returned Surveyor III TV Camera

Upon return of the camera to LRL, the plastic bag was removed in the laminar flow bench. The appearance of the camera immediately after removal of the bag is shown in the frontispiece and Figure 3-3*. The external surfaces of the camera were discolored and contaminated, presumably with lunar dust. The mirror was open with a view angle down and to the right. The filter wheel was in the "clear" position.

The four external connectors were still mated to the camera. A section of the severed cable, approximately 7 inches long, was attached to one of the three bottom connectors, and a longer section of approximately 15 inches was attached to the upper mirror assembly connector. A separate section of the severed TV cable, approximately 8 inches long, was still attached by a cable clamp to the bottom side of the camera. These cable sections are clearly seen on Figure 3-3b.

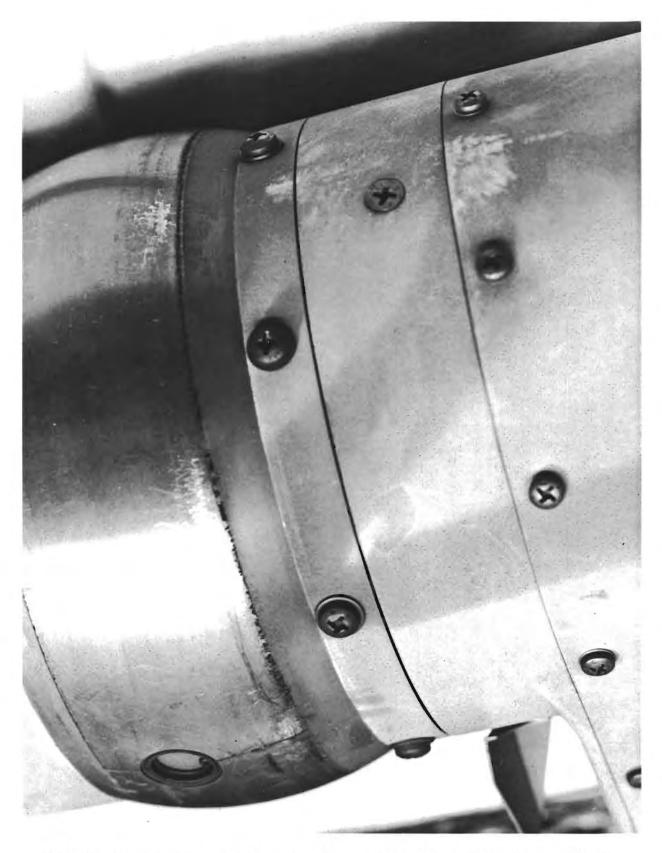
Figure 3-4. Area Under Support Collar Immediately Upon Its Removal in LRL (NASA Photo S-70-21138)

There were some unusual light and dark patterns evidenced on some of the exterior surfaces. These patterns did not appear to correlate with solar illumination of coating degradation. There were sharply defined dark (shadow) areas under a wire on the mirror elevation drive mechanism and on the lower shroud under the spacecraft camera mount support struts. Figures 3-4 and 3-5* illustrate this effect.

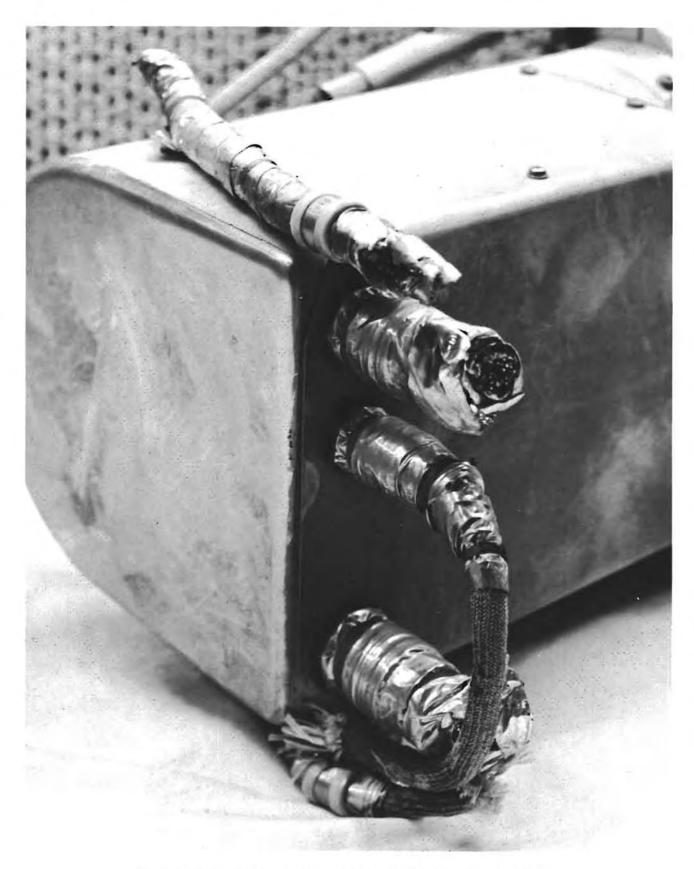
Figure 3-10. External Connectors on Lower Shroud (NASA Photo S-70-21146)

The external connectors on the lower shroud, which were unmated next, are shown in Figure 3-10*. These connectors employ a snap-on lock mechanism, and the force required to unmate them, ranging from 10 to 21-1/2 pounds, compares to the original requirement of less than 25 pounds.

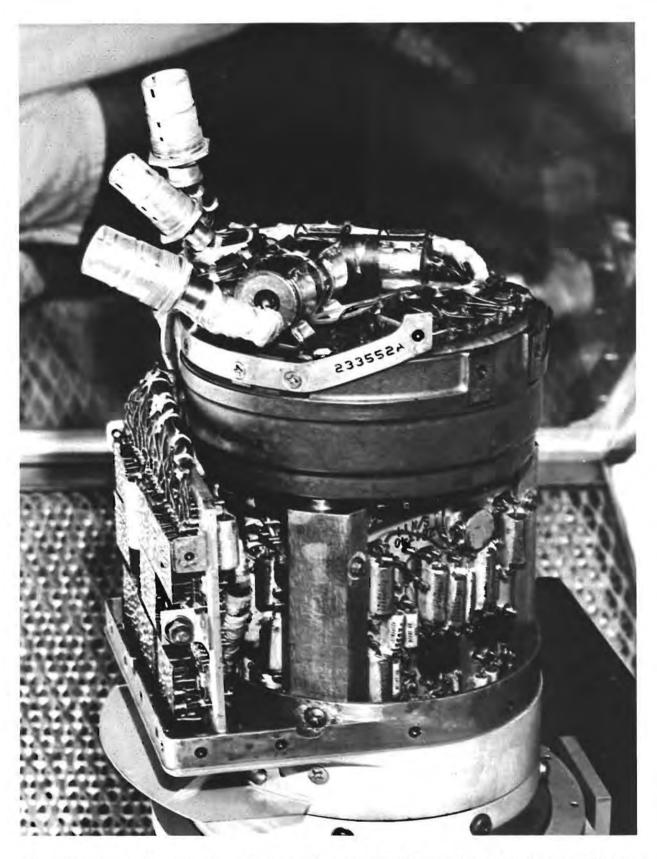
Figure 3-15. Exposed Lower Portion of TV Camera Upon Removal of Lower Shroud (NASA Photo S-70-21130)

Numerous photographs were taken of the exposed electronics of the TV camera after the removal of the lower shroud. The general appearance of the exposed chassis is indicated in Figure 3-15*. Many additional photographs are available in the Surveyor files, in particular, NASA photographs S-70-21131, S-70-21132, and S-70-21133.

Visual examination and photographic documentation of the exposed interior of the camera were performed. No breakage or degradation of materials was noted. The lower shroud was replaced on the camera with six spare screws. These were not tightened but merely used to hold the shroud in place. The connector bracket was not reinstalled.

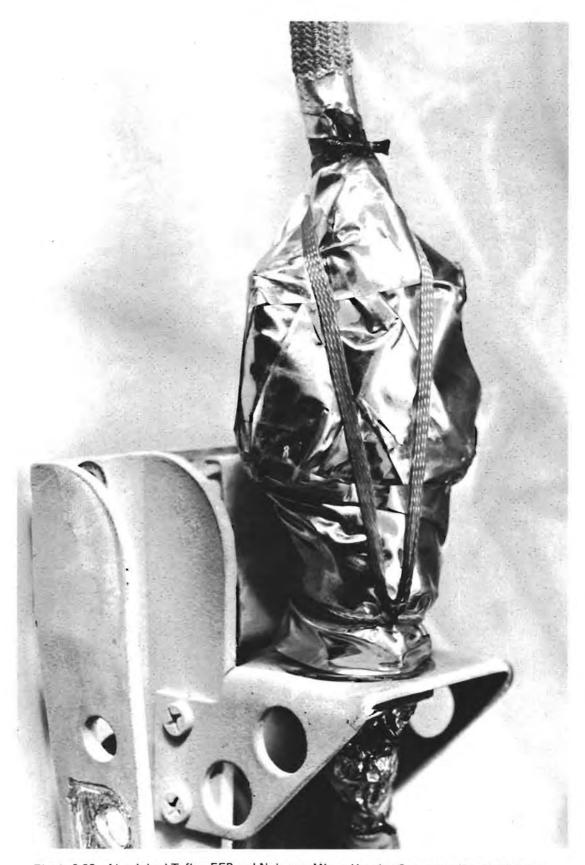
Figure 3-23. Aluminized Teflon FEP and Nylon on Mirror Housing Connector (Photo 70-5169)

The nylon cord seen in Figure 3-23* had the expected yellowish color, which, under microscopic examination, appeared to be only on the top surface of each individual strand. The color changes to a dark brown in the vicinity of the epoxy adhesive used to secure knots in the tie cord, indicating that some of the discoloration may be the result of the epoxy wicking along the cord and discoloring. The epoxy itself was dark brown. Physically, the nylon was in good condition; no adverse effects of the lunar exposure were noted.

Aluminized teflon FEP, teflon side out, was used as a radiative temperature control coating on the mirror housing connector, as well as on cables (Figure 3-23). The surface exposed to the lunar environment exhibited color changes and was dust-coated. The aluminum coating on the inside was faulty. On areas of the teflon that were overwrapped, no visual color change was noted.

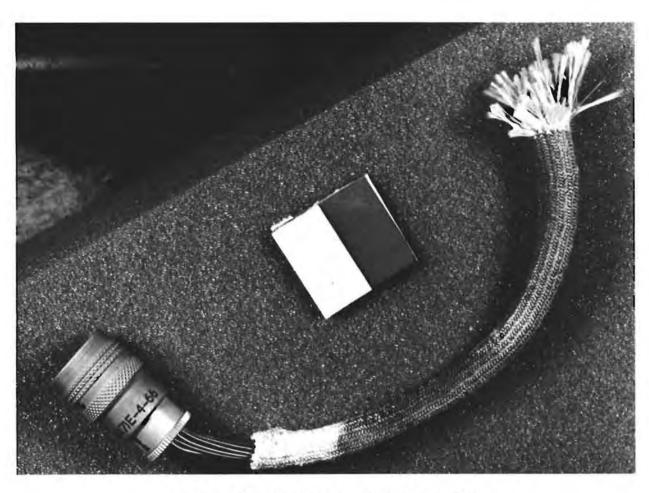
Figure 3-24. Glass Fiber Cable Insulation (Photo 70-5499)

The cable going from the mirror housing to the lower shroud was insulated with a glass fiber braid. The cable can be seen in the frontispiece and in detail in Figure 3-24*. This cable was heavily discolored in the area exposed directly to the external lunar environment, but was generally clean and white where protected by the teflon wrap. As with the nylon, the discoloration appeared to be only on the top surface of each strand when examined microscopically.

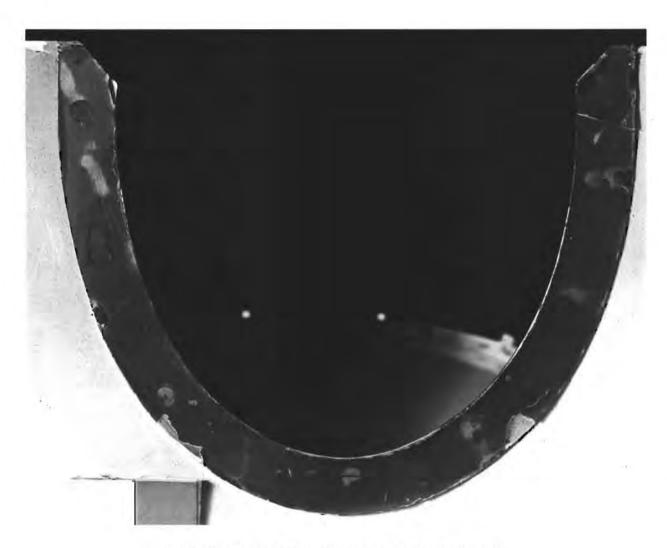
Figure 3-25. Teflon TFE on Mirror Assembly (Photo 70-5640)

The horseshoe-shaped area on the mirror housing directly below the mirror, as seen in the frontispiece*, was intended as a seal when the mirror is in a closed position. It consisted of 2 mil thick teflon TFE bonded down with an epoxy adhesive. Figure 3-25* shows this area in detail. The teflon had turned a dark brown from its original white color and had turned up along the edges in some areas. No cracking was seen on the surface. The discoloration is believed to be attributable to the epoxy bonding. Absence of teflon in several places in Figure 3-25 was caused by removal of samples later in the program for special tests and science investigations.

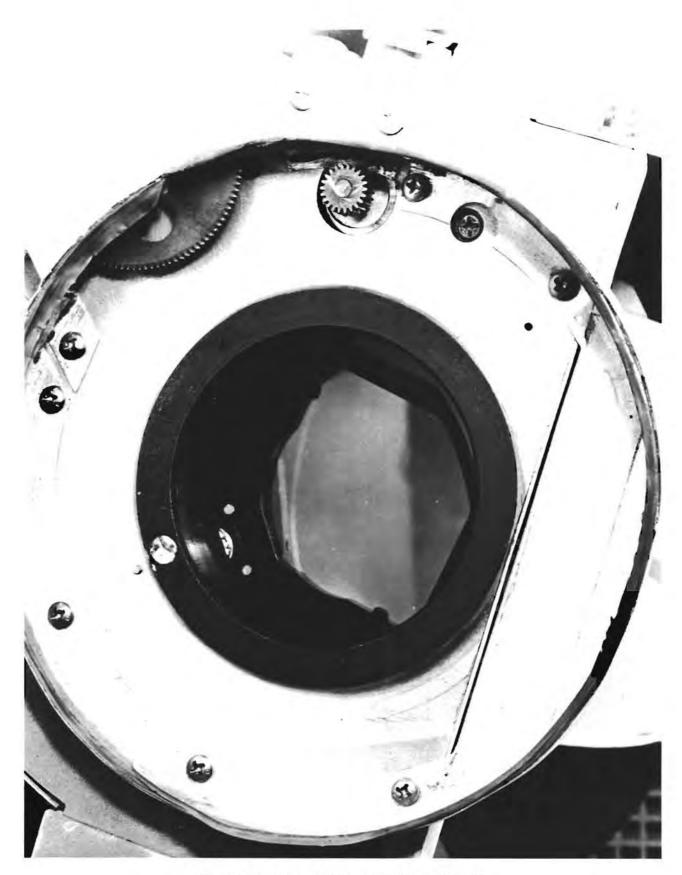
Figure 3-26. Teflon TFE Skirt Seal (Photo 70-4430)

Teflon TFE was also employed in the skirt, which is on the surface about which the mirror assembly rotates when stepped in azimuth. This area is visible in the frontispiece, and is shown in more detail in Figure 3-26*. Approximately one-half of the TFE teflon was bonded down. Discoloration was noted but not to the same extent as on the mirror housing. On the side of the camera facing the lunar module, the teflon was tucked under, allowing lunar material to enter. The teflon was also partially curled up along the edge. A more detailed investigation was instituted as part of the failure analysis task; additional data on this discolored and curled-up teflon TFE are presented in Section 12.

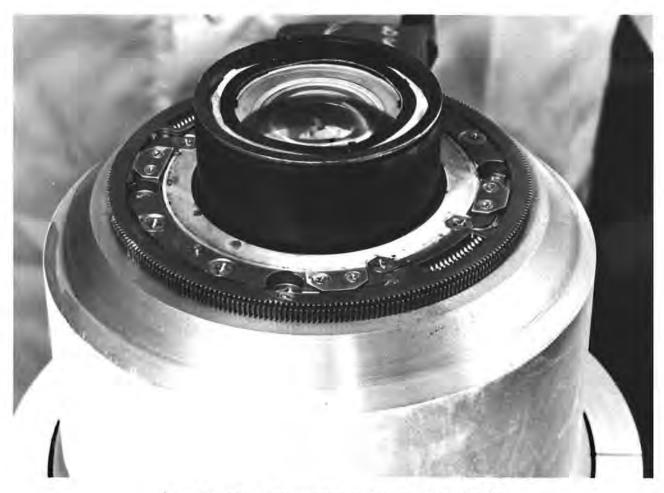
Figure 4-1. Azimuth Drive Ring Gear Assembly (Photo 70-4434)

The mounting screws were removed with a torque screwdriver, with a follow-up indicator gauge to measure the removal torques. The torques required to remove these eight mounting screws were measured and ranged from 8 to 11.8 in-lb, compared with the original requirement of 10 to 12 in-lb; thus, the results were nominal, as previously demonstrated at LRL.

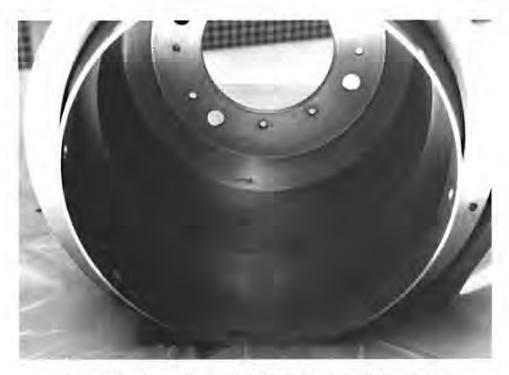
Figure 4-2. Bottom View of Upper Shroud of Camera (Photo 4R14061)

The torques required to remove these eight mounting screws, as measured with the torque screwdriver, ranged from 7 to 8 in-lb, compared with the original requirement of 10 to 12 in-lb; thus, the results were nominal. Figure 4-2 is a photograph of the upper shroud after removal, showing the flange under the ring gear and the holes for some of the mounting screws.

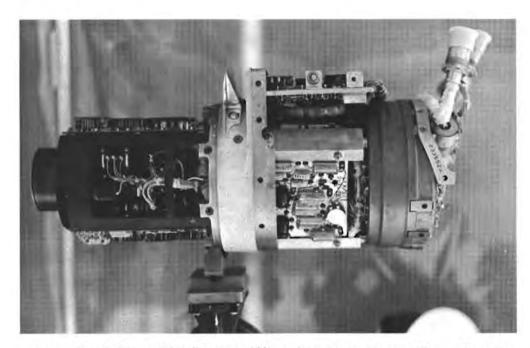
Figure 4-6. TV Camera After Removal of Mirror Assembly and Shroud (Photo 4R14058)

Figure 4-6 shows the appearance of the main TV camera structure after the removal of the mirror assembly and the shrouds, and prior to its disassembly. Another view of this assembly is also shown in Figure 2-3 (Section 2). The top of Figure 4-6 shows the lens support structure, the bottom portion the ECU. Figure 4-7 shows the camera main deck structure, which was the only remaining part after completion of the disassembly operations described in this section. The main deck structure is visible in the middle of Figure 4-6.

No problems were encountered during removal of the various camera assemblies. No evidence of cold welding was noted during removal of the mounting hardware. Table 4-6 indicates the observed torque values of the mounting hardware for the various subassemblies.

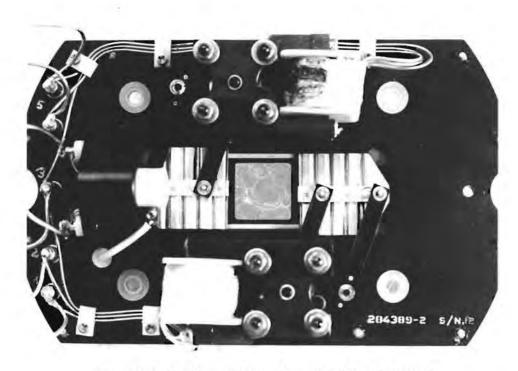
Figure 4-10. Top View of Shutter Assembly (Photo 4R15016)

Two anomalies were noted during the tests. A transistor in the shutter drive circuit was found open and burned out, along with one of the solenoids on the shutter assembly. This anomaly is discussed in more detail in Section 12. The second anomaly was an apparent change in the vidicon temperature readout circuit, as noted in Table 4-4. Further discussion of this anomaly is also presented in Section 12. This anomaly was thought to be attributable to changed characteristics of a transistor in the vidicon temperature differential amplifier circuit. Both the burned out silicon transistor and the suspected readout transistor are contained in the cordwood module, and it was not necessary to replace them to conduct the functional performance tests.

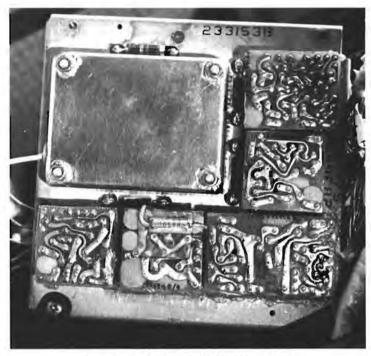
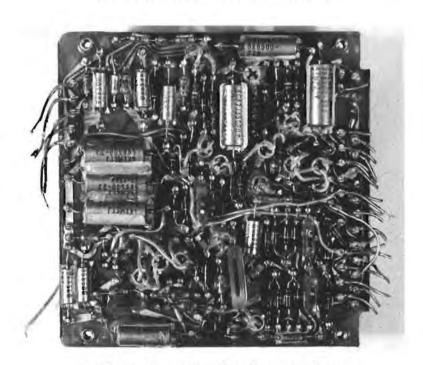
b) Etched Circuit Board Side (Photo 4R15697) Figure 4-12. Chassis A5

The failed capacitor could not be replaced since it was a selected low-leakage component during original assembly and a suitable replacement was not available. Furthermore, replacement of this component might have stressed adjacent circuit board areas. The capacitor was subsequently subjected to a detailed failure analysis to determine the specific causes of failure. Results of this analysis are discussed in Section 12.

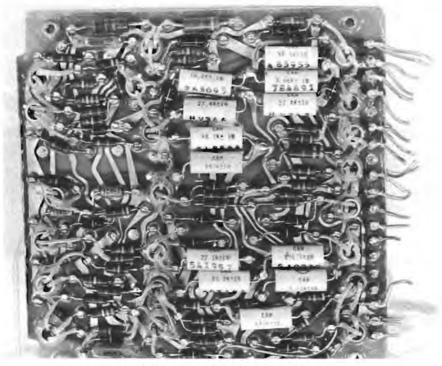
a) Chassis A3 (Photo 4R15117)

Microscopic examination and passive tests of chassis A-1, A-2, A-3, A-10 (star mode), and ECU revealed no major anomalies except for a number of cracked resistor and diode envelopes and one open diode on chassis A-3. These are discussed in further detail in Sections 7 and 12.

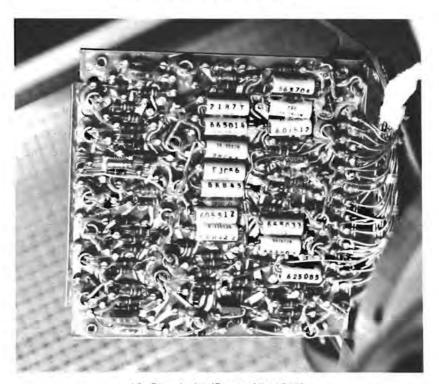
b) Chassis A4 (Photo 4R14649)

Upon application of power to the A-4 chassis, a check of the various outputs revealed that only the vertical sweep circuit and the vidicon biasing network were operational. All other circuits were inoperable; this was traced to two failures identified at that point of the test program. The first failure was of an alloy transistor (Q14) in the vertical blanking circuit. The second failure was of an open metal film resistor (R36) in the horizontal sweep generator circuit.

Chassis tests conducted after replacement of the two failed components produced the results shown in Table 4-1. All 18 parameters on chassis A-4 were well within specifications, and there was no indication of changes induced by the operation and residence of the TV camera on the lunar surface for 2-1/2 years.

It was decided to replace these failed components without disturbing other chassis elements. Fortunately, this could be readily accomplished. The two failed components were not subjected to failure analysis because they are no longer used in circuit applications. This is discussed in Section 12.

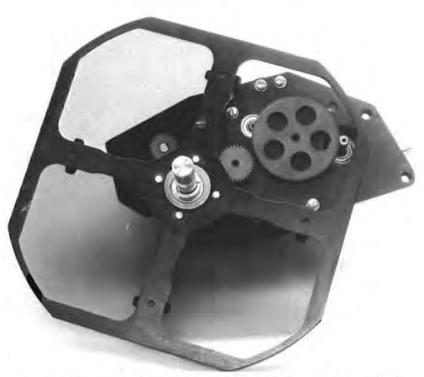
b) After Dismantling, Showing Wheel Frame and Gears (Photo A10779)

The top plate was removed next, and all gears were scribed to identify their mating positions. Figure 5-4b shows the filter wheel subassembly at this stage of the dismantling. The filter wheel frame and shaft were removed next. This operation required some manual forcing to loosen the hardened paint which had been applied to the shaft during manufacture as an antireflection measure. Last to be removed were the filter wheel gears. One of the filter wheel gears revealed a symmetrical scratch pattern on its surface caused by a broken safety wire. Results of analysis of this anomaly are presented in Section 12, where a photograph of this scratched gear is presented.

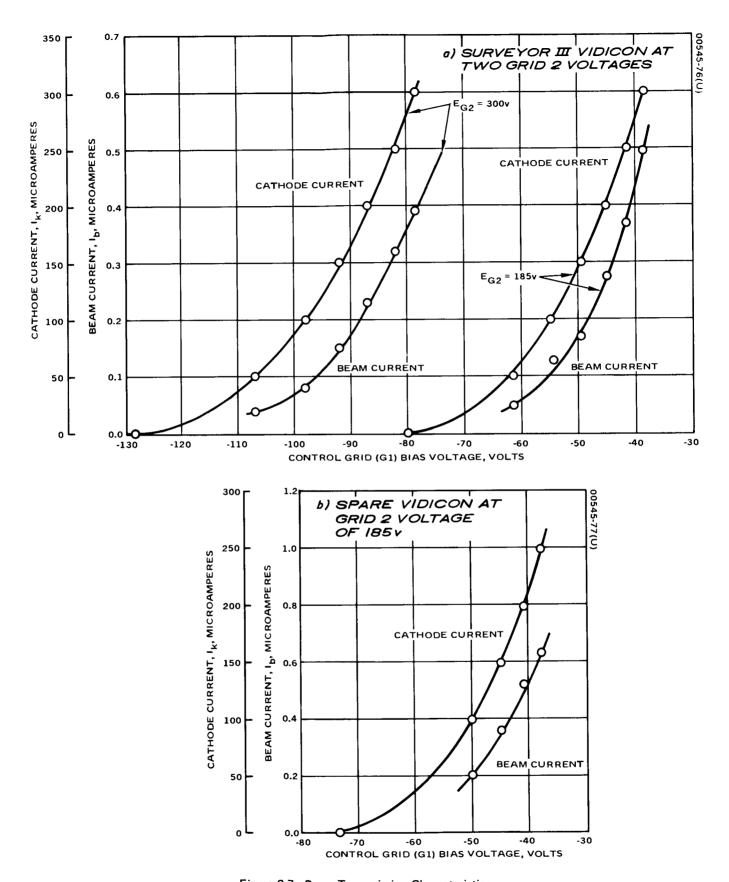
Results of the measurement of the beam transmission characteristics are shown in Figure 6-7a for the Surveyor III vidicon. This test was performed at two values of grid 2 voltage: at the nominal operating value of 185 volts and at 300 volts. Figure 6-7b shows results obtained for comparison on a spare vidicon at the grid 2 voltage of 185 volts. The result for the flight vidicon can be interpreted as nominal. Its cathode current was somewhat higher than that of the spare vidicon although its beam current was less by about 40 percent. As discussed in Reference 18, however, this is representative of vidicons which have been operated for prolonged periods of time.

The grid cutoff was also obtained from the beam transmission measurements. At the nominal grid 2 voltage of 185 volts, the value of control grid cutoff, corresponding to the cathode current of 1 microampere, is seen on Figure 6-7a to be -80 volts. This is nominal.

Figure 6-7. Beam Transmission Characteristics

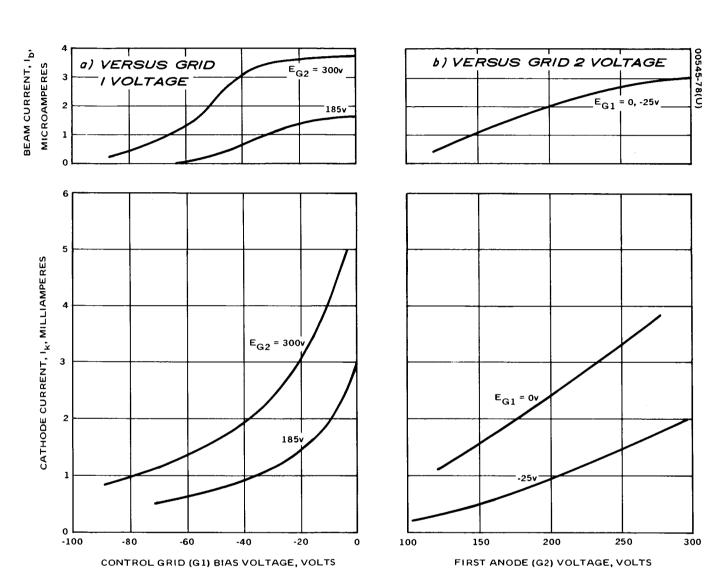
Grid transfer characteristics of the flight vidicon are plotted in Figure 6-8. Figure 6-8a shows the control grid transfer characteristic at two values of voltage applied to the first anode, grid 2. Figure 6-8b shows the first anode transfer characteristics at two values of control grid bias. Results are nominal.

Figure 6-8. Surveyor III Vidicon Transfer Characteristics: Cathode and Beam Currents

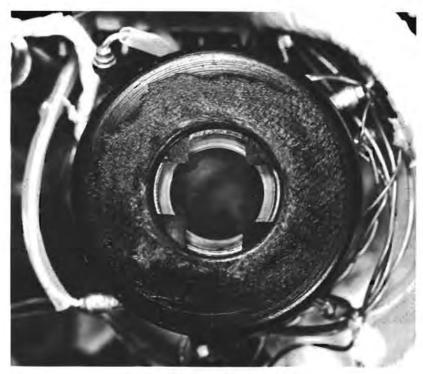
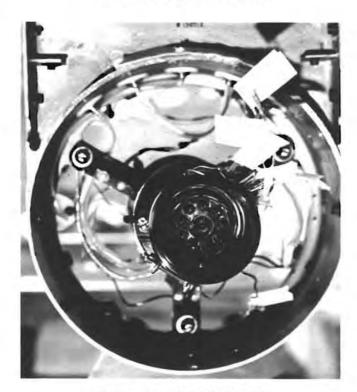
Figure 6-9. Vidicon Prior to Removal From Camera

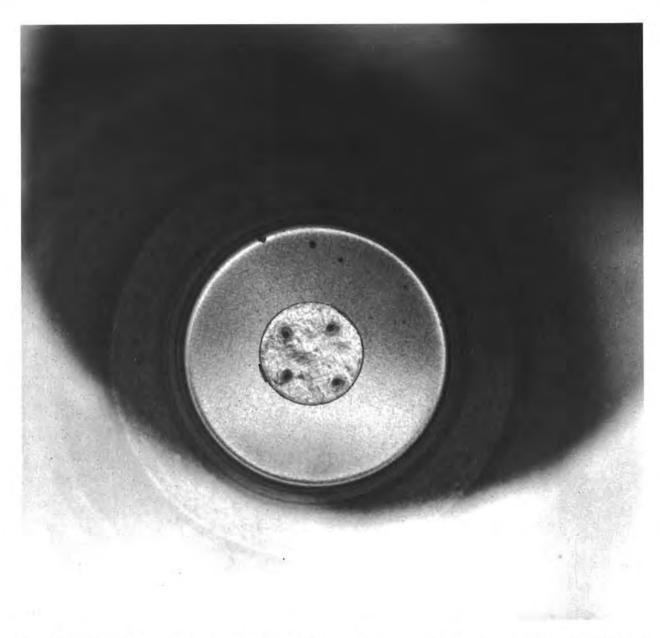
Figure 6-10. Front View of Transparent Faceplate of Surveyor III Vidicon, Showing Cathode in Rear (Photo 70-4863)

Absence of the photoconductor and tearing of the grid 5 mesh were confirmed. Figure 10*, taken at this time, shows the complete transparency of the faceplate. The cathode region in the rear can be seen clearly through the front of the vidicon. The presence of a small remaining piece of the photoconductor near the dark corner reference mark of the faceplate was confirmed. This piece was previously noted (Figure 6-5).

A number of pieces, presumed to have come from the grid 5 mesh, were noted. A large piece of grid 5 mesh, 1/8 by 1/8 inch, was seen wedged between the faceplate and the grid 5 ring assembly. Many small particles were also observed around this piece of the mesh. A larger piece, estimated to be about 3/16 by 1/4 by 1/2 inch, was found to be loose at the bottom of the tube. The size and shape of this piece appear to approximately the same as that of the hole in the grid 5 mesh. It was presumed that this was, indeed, the main torn section of the grid 5 mesh. In addition, there appeared to be a smaller piece, 1/8 by 1/8 inch, loose at the bottom of the tube.

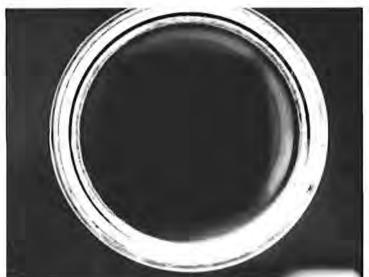
The results of the exposure of the spare vidicon to this temperature revealed a striking similarity with the apparent failure of the Surveyor III vidicon evident in Figure 6-10. Evidence of the evaporation of the photoconductor around the periphery of the faceplate was noted after 96 hours of exposure. Evaporation continued to be progressively greater as the length of exposure continued. After 118 hours, evidence of some photoconductor loss was seen over the entire surface of the faceplate, and a major portion of the outer edge area had evaporated completely. This can be seen on the original color photograph of the black and white Figure 6-12 — one of the many taken in this experiment.

Figure 6-12. Appearance of Faceplate Photoconductor of a Spare Vidicon After 118 Hours Exposure in Thermal Simulation Test (Photo 00545-84)

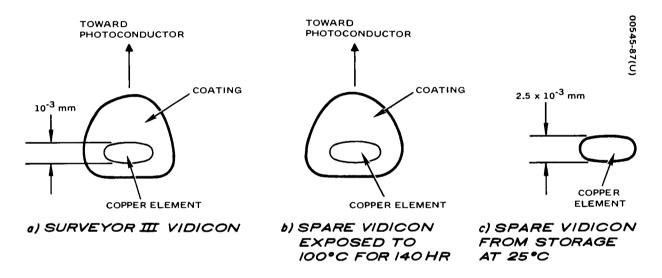
Results of the microscopic examinations are evident from the appearance of the three samples shown in Figure 6-15. The sizes are magnified, but the three samples are sketched so that the approximate relative dimensions are indicated. The grid elements of samples a and b are virtually identical in appearance. They both, however, differ considerably from the original vidicon grid wire of sample c in the following ways: the cross section of the copper portion of the elements of both damaged grids was much smaller, a thick layer of coating was present, and the thickest part of this coating was in both samples a and b on the side facing the vidicon faceplate. The thickness of the copper elements of samples a and b was of the order of 1 micron. The corresponding thickness of the original mesh elements, as indicated in Figure 6-15, was 2.5 microns.

Figure 6-15. Results of Microscopic Examination of Pieces of Grid 5 Mesh

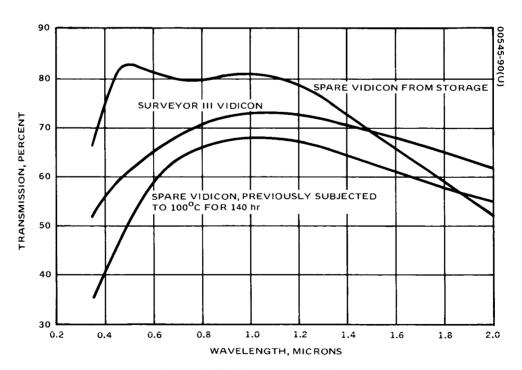
Figure 6-16. Optical Transmission Measurements of Nesa Coatings: Surveyor III Vidicon and Two Spare Vidicons

It is apparent from Figure 6-16 that the thermal exposure resulted in a significant degradation of the transmission of the coating of the spare vidicon over the entire spectrum relative to the vidicon from storage. Reduction in the order of 10 to 15 percent was noted in the infrared region and as much as 30 percent in the visible region. The Nesa coating of the Surveyor vidicon was also degraded relative to the vidicon from storage but not as much as the thermally exposed spare vidicon. The above observation should be qualified somewhat by recognition that the coatings may also have differed somewhat originally.

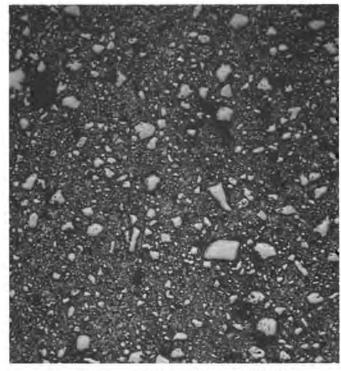
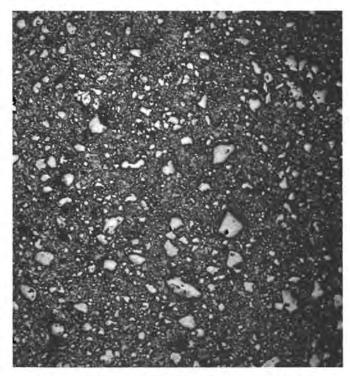
Internal examination was conducted on a 510 ohm and on a 1.5 megohm carbon composition resistor, respectively, as well as on new similar resistors for comparison. No evidence of voids, cavities, or unusual changes in grain structure were observed. As an example, Figure 7-3 shows photographs taken with 200X magnification of a section of the 1.5 megohm resistor from the Surveyor camera and from the control sample, respectively. No differences in appearance are noted. These results correlate with the absence of discrepancies in functional measurements.

Figure 7-3. Metallographic Section of 1.5 Megohm Carbon Composition Resistors (200X Magnification)

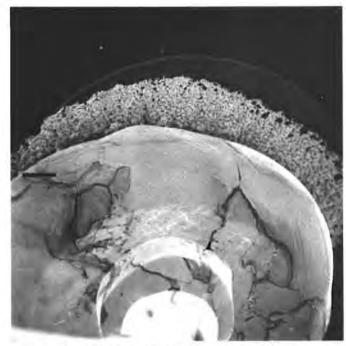
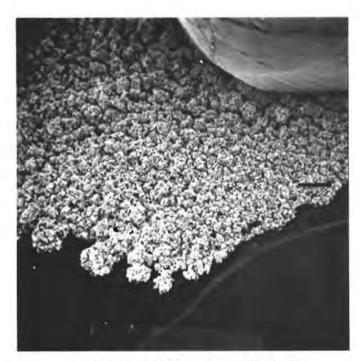
Because of the apparent differences in results of present and original measurements and because of the out-of-specification value for the noise figure on one of the transistors, this transistor was subjected to detailed diagnostic tests. The transistor was opened and examined internally with a scanning electron microscope. A substantial intermetallic gold-aluminum growth was found around the ball bonds. The findings are presented in Figure 7-14. The top SEM photograph was taken at a magnification of 1190X. The bottom SEM photograph was obtained at a magnification of 2390X and shows this intermetallic growth in some detail. It is believed that this phenomenon accounts for the high noise figure. This intermetallic growth frequently develops under normal shelf storage conditions as long as the proper materials and the high temperature environments are present. It cannot be attributable to the low temperature lunar environment. It should be noted that future designs employ aluminum-to-aluminum bonds for this reason.

Figure 7-14. SEM Photographs of Intermetallic Growth Bonds on Low Noise Transistor

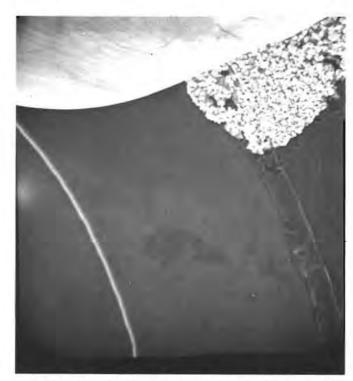
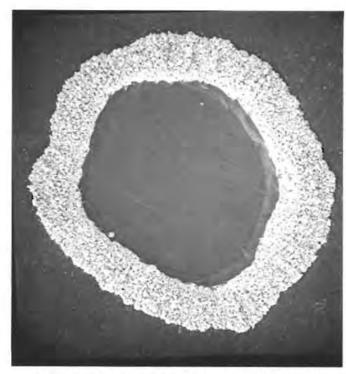
Figure 7-15. SEM Photograph of Base Lead of Transistors

a) Base Lead of General-Purpose Amplifier PNP Transistor, Type 2N722 (1000X Magnification) (Photo 00545-110)

b) High Voltage NPN Transistor, Type 2N871 (500X Magnification) (Photo 00545-111)

Two examples of these SEM photographs are shown in Figure 7-15. Figure 7-15a is an SEM photograph taken at a magnification of 1000X of the base of the general-purpose PNP amplifier transistor. The intermetallic growth is seen here at the base lead, stopping at the oxide step. Figure 7-15b is an SEM photograph at a magnification of 500X of the emitter pad of the high frequency transistor. Substantial intermetallic growth can be seen, as well as striations of the silicon. These are believed to have been caused by the formation of aluminum silicide created during the thermal compression bonding. This material subsequently cracked, forming the striations.

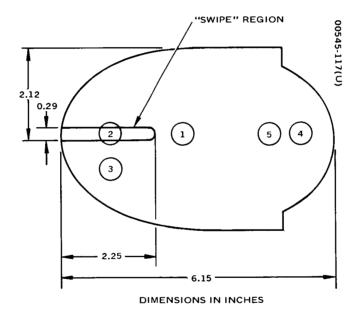
Figure 9-2. TV Mirror Regions Measured for Reflectance

Figure 9-2 shows the five regions of the mirror for which reflectance measurements were conducted. Region 2 was in the area that had been wiped by one of the astronauts on the moon before the removal of the camera. Regions 1 and 3 were representative of areas with most of the contamination. Region 4 was representative of an area that was reasonably

well protected and exhibited much less scattering when viewed at large angles of reflection. Region 5 was in the center of the previously noted discoloration band and represented the transition area between the relatively clean and dusty portions of the mirror.

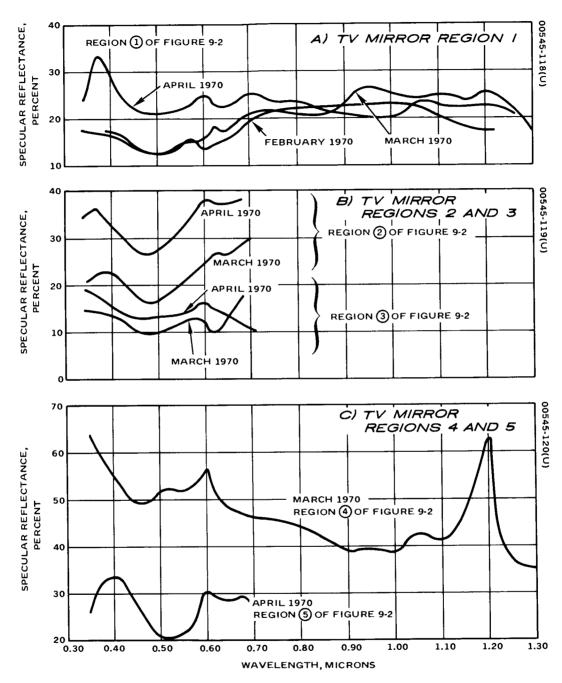
Figure 9-3. Results of Specular Reflectance Measurements

The results of the specular reflectance measurements are plotted in Figures 9-3a, b, and c for regions 1, 2, and 3, and 4 and 5, respectively. The initial measurement on the TV camera was conducted only on region 1. The second measurements on the mirror assembly were conducted on regions 1, 2, and 3. The final measurements on the disassembled mirror were conducted on all five regions, including regions 4 and 5 in the lower portions of the mirror, previously inaccessible.

It is evident from Figures 9-3a and b that reflectance increased with time. This was particularly true for the most heavily contaminated region 1 and for the disturbed area on the "wipe" in region 2. The increase in reflectance in the visible part of the spectrum between the time that the mirror was on the camera, and the measurement taken after its removal was on the order of 10 percent. This increase is probably the result of loss during storage and in handling of some of the original dust.

Characteristic absorption bands are evident on the figure. The most dominant absorption region at 0.49 micron can be seen on all three curves, and additional absorption maxima at 0.9, 1.0, and 1.3 microns are noticeable in region 4 in Figure 9-3c.

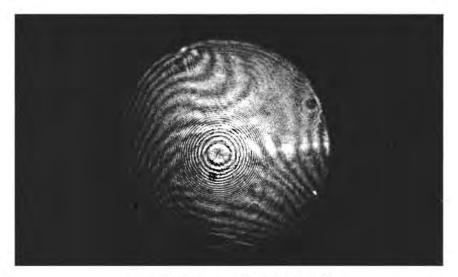
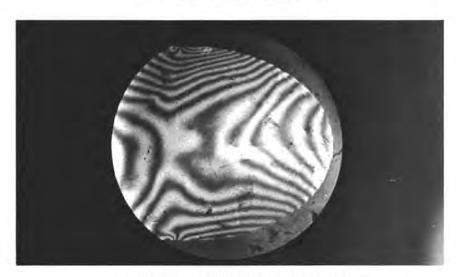
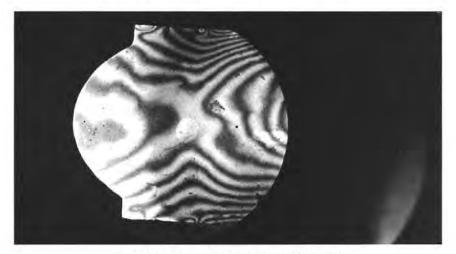
c) Left Region of Mirror (Photo 4R15369)
Figure 9-6. Interference Patterns During Flatness Measurements of TV Mirror

Figure 9-6 shows three of the interference patterns recorded. Figure 9-6a is of the central region of the mirror, and Figures 9-6b and c of the right and left regions, respectively. The right region on Figure 9-6b corresponds to the area of the swipe made by the astronaut. Results were indicative of the saddle-shaped surface. The irregular pattern obtained in Figure 9-6a shows approximately seven to eight fringes of irregularity across the surface. These figures are quite similar to the patterns seen in the earlier examination of the mirror on the mirror assembly, as noted above.

Studies of these patterns indicated that they were attributable to the deformation of the mirror blank in the original manufacture, as mentioned in Section 9.2.1. Absence of original data did not permit a quantitative comparison. However, it was concluded that no evidence could be gleaned from the results obtained that would suggest any changes resulting from lunar exposure.

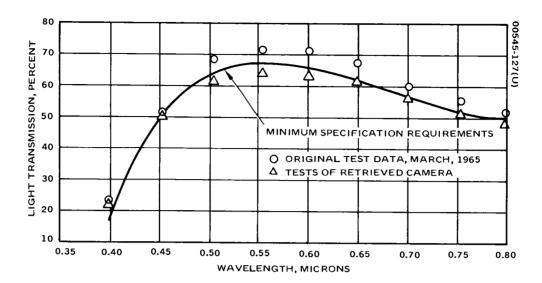
Figure 9-8. Results of Lens Transmission Measurements

It is seen that a slight decrease in optical transmission occurred although the new values are still close to specification requirements. The loss relative to this March 1965 data was on the order of 5 percent of transmission, that is, on the order of 8 percent of original values. Departure from the specification requirement occurred only in the 0.5 to 0.6 micron region; maximum deviation was about 4 percent.

The observed loss in transmission is likely the result of the dust, film, and contamination, discussed above, particularly the film on the beamsplitter. It should be noted that the greatest decrease in the optical transmission relative to the original data was at the shorter wavelengths.

This is consistent with the postulate that the effect was caused by deposits of small dust particles. The shielded location of the lens would be expected to preclude significant radiation damage. This would also result in the greatest decrease of optical transmission at shorter wavelengths.

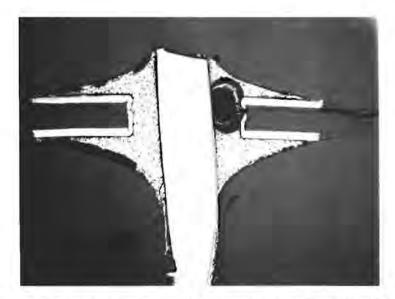
Figure 10-4. Void in Solder Joint of Cordwood Module (Photo 00545-173)

Figures 10-4 and 10-5 are typical examples of the extensive photographic analysis that was carried out. Figure 10-4 illustrates a void noted in the solder joint of a cordwood module. Figures 10-5a and b show cross sections of typical solder joints mated to the circuit boards by a resistor and a diode lead, respectively, taken at a magnification of 50X. Figure 10-5c shows a cross section of the solder joint between a stranded wire and the bifurcated terminal at a magnification of 30X and illustrates an incomplete filling of the plated-through hole with solder.

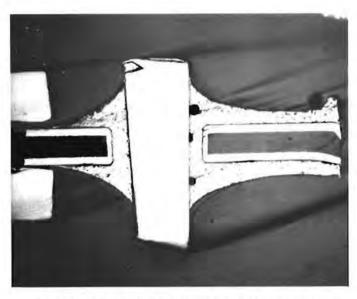
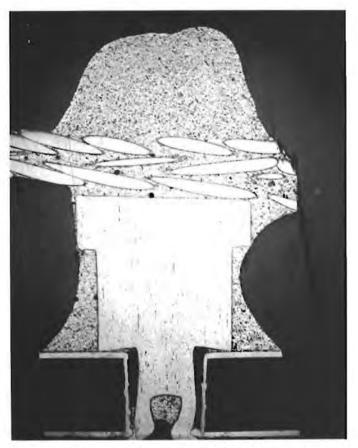
b) Diode Lead to Circuit Board (50X Magnification) (Photo 00545-175)

c) Stranded Wire to Bifurcated Terminal (30X Magnification) (Photo 00545-176)

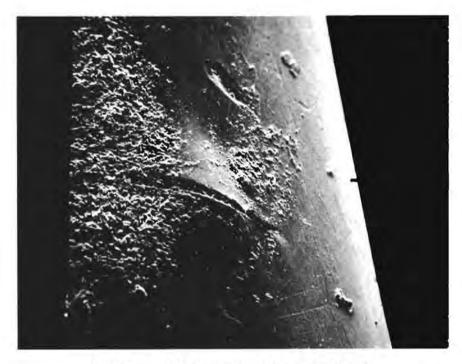
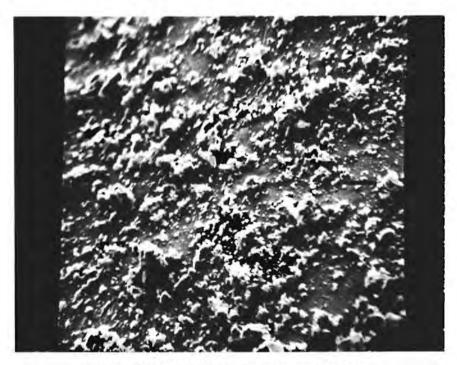
Figure 10-12. SEM Photographs of Polyimide-Coated ML Wire

The appearance of the polyimide coating of the ML wires was normal except for a slight frosty appearance on wires which had been exposed to the environment. Figure 10-12a is an SEM photograph of one of these wires. The apparent deformation in the center is attributed to the extrusion process used in manufacture to coat the wire. The area on the right is clear while the area on the left illustrates the frosty appearance. Figure 10-12b is an SEM photograph of this frosty area at high magnification. Study of the appearance of the debris suggested that it is very likely lunar material.

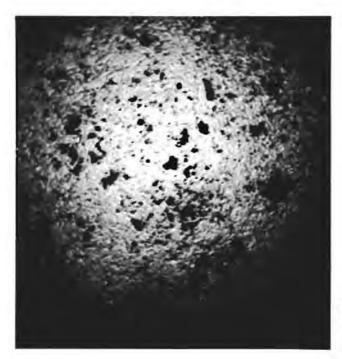
Figure 10-15. Photomicrograph of Ball Surface From TV Mirror Support Bearing (250X Magnification) (Photo 00545-189)

The lubricant used on the bearing was Lubeco 905, a bonded solid lubricant containing molybdenum disulfide, graphite, and lead sulfide. The bearing was observed to rotate freely. The races and bent wire retainers showed good adhesion. The balls appeared to have a multitude of microscopic pits as shown in Figure 10-15. The coating on the balls seemed to be poor, but no evidence of corrosion was noted. Apparently, the lubricant had been wiped off the faces of the bearings prior to oven cure.

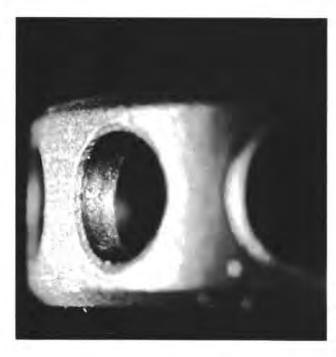
Figure 10-16. Elevation Drive Outer Bearing (20X Magnification) (Photo 00545-190)

The mirror elevation drive outer bearing was a Bar-temp bearing, utilizing a Duroid 5813 ball retainer. This material is a fiberglass-reinforced teflon containing 15 percent molybdenum disulfide. As evident from Figure 10-16, only a very slight amount of wear was noted on the retainer.

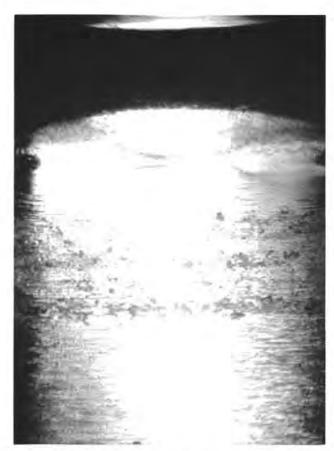
Figure 10-17. Film of Transferred Lubricant on Outer Bearing of Elevation Drive (50X Magnification) (Photo 00545-191)

Figure 10-18. Interference Rings on Outer Bearing of Elevation Drive (200X Magnification) (Photo 00545-192)

Figure 10-17 shows that some of the retainer material transferred to the races in rather uniform rows; this material was transferred by the balls. On closer inspection, these rows appeared to be discrete particles mashed so flat that interference fringes can be seen on the edges. This is shown in the closeup photomicrograph of the outer bearing, Figure 10-18, magnified 200X. A minute amount of lubricant was retained by the balls, whose photomicrograph closely resembles that of Figure 10-15. Its surface exhibited microscopic and rather uniform surface roughness, resembling pitting, but showed no evidence of corrosion.

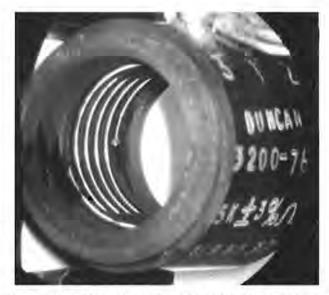
Figure 10-23. Helical Winding of Focal Length Potentiometer (Photo 00545-197)

A visual examination was conducted of the surfaces of the helical winding and of the wiper contact. The inside diameter of the helical spiral, shown in Figure 10-23, was thoroughly inspected with a long focal length microscope (Technoscope) to observe the appearance of the wear track. The potentiometer wiper contact was examined similarly.

If niobium disclenide had been present on the windings, some of it would have transferred to the wiper contact during operation. No such evidence was uncovered in examining the wiper. Blue sheen in the reflected

light observed in viewing the contact was believed to have been caused by the trapped DAP powder or to be the result of a frictional burn rather than of any niobium diselenide film.

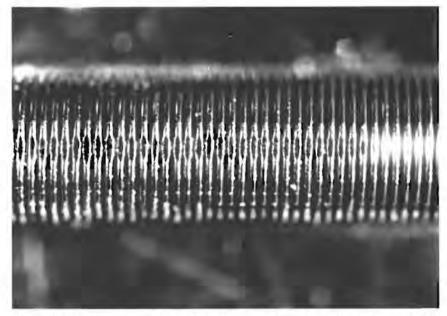
Figure 10-27. Appearance of Surveyor III Focal Length Potentiometer Wire After the Friction Test (40X Magnification) (Photo 00545-201)

Figure 10-27 shows the appearance of the surface of the originally worn wire element after the friction test. Comparision with the appearance of this worn surface after lunar operations but before the friction test, shown in Figure 10-24, indicated that a further degradation had taken place. The original wear track was now found damaged to the point of flattening the tops of the 1 mil resistance wire.

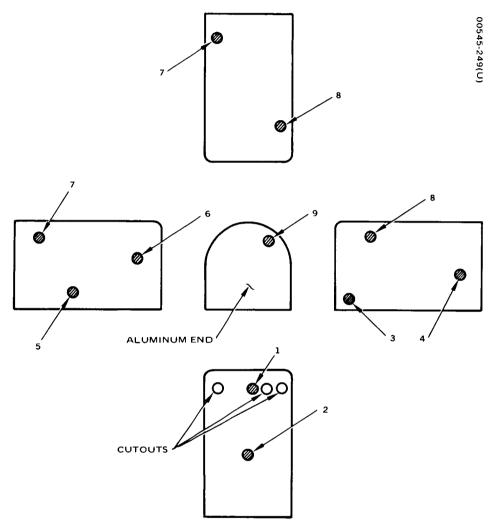
The reflectance of the lower shroud of the television camera was measured at seven locations (Figure 11-1). Throughout this subsection, these numbered positions are referred to as "TRW positions". Positions 5, 6, and 7 were on the side of the shroud facing the landing site of the lunar module. Positions 1 and 2 corresponded to the front of the shroud, which faced the lunar northeast.

A decrease in reflectance over original values at 1.5 microns was found on most surfaces. This was not seen on TRW position 1 of Figure 11-1. This location was protected from the lunar environment by a bracket, whose photographs are shown in Appendix J (Figures J-19 and J-20). Laboratory studies have shown that neither ultraviolet nor solar wind protons will cause a reflectance decrease at 1.5 microns for this clay-silicate inorganic paint. Thus, the reflectance drop is attributed to lunar dust. Organic contaminants were ruled out as discussed later. The variance in the magnitude of the reflectance at 1.5 microns is a measure of the amount of lunar material present on the surface. Table 11-1 summarizes the significant results obtained. An expression relating dust coverage to the reflectance is presented in Section 11.4.2.

Figure 11-1. Lower Shroud of Surveyor III Camera, Showing TRW Measurement Positions

With the exception of one small area designated in Figure 11-1 as TRW position 3, described below, all exposed surfaces of the camera had a coating of fine lunar material. The amount of this coating varied from area to area: the "dirtiest" area was estimated to be about four to five times more heavily coated than the "cleanest" area. The various sources of lunar dust are listed in Table 11-5. These variations in the degree of cleanliness may thus be attributed to the quantity of dust imparted from the various sources to the differences in the adhesion of the dust to camera surfaces and to the various mechanisms of removal of the dust: prior to camera retrieval, during return, and during subsequent handling. In addition, there was some variation in surface roughness of the paint; the rougher areas tended to hold more material during deposition and during disturbances in handling.

A small area on the side away from LM, designated as TRW position 3 in Figure 11-1, appeared to be free of dust. This area was beneath the cable running from the front, along the left side of the camera.* The absence of dust may be due to "shadowing" of the surface from the incident dust or caused by a removal mechanism not fully understood.

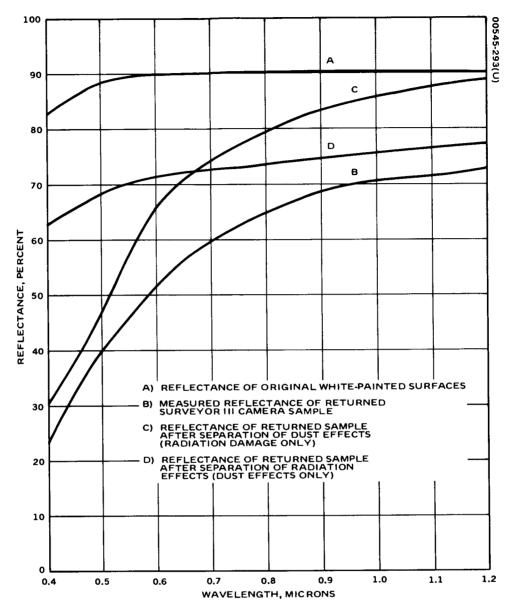
It should be noted that the same evidence is apparent from the measurements discussed in Appendix J. 4.1. In particular, results obtained for the two samples, shown in Figures J-10c and J-10f, should be compared with the results shown in Figure 11-3. Figure J-10c applies to the samples whose reflectance degradation is predominantly attributable to radiation,

Figure 11-3. Separated Radiation and Dust Effects on Spectral Reflectance. White inorganic painted surfaces of Surveyor III camera

while Figure J-10f applies to a sample primarily degraded by lunar dust. Comparison of Figure J-10c and Figure 11-3c illustrates the photo bleaching effect described in Section 11.4.1.

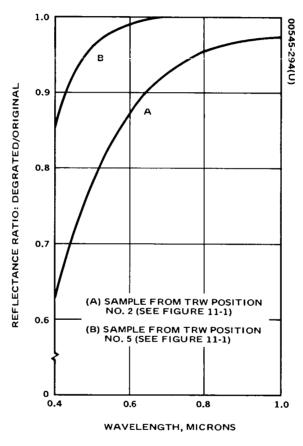
As reported above, it was reasonably possible to isolate by measurement and analysis the contributions of the lunar dust coverage from the total reflectance from the painted surfaces. This made it possible to separately analyze the patterns of discoloration and damage attributable to solar radiation only. As illustrated in Figure 11-4, it was then verified that the discoloration in the paint attributable to radiation effects is indeed proportional to the degree of solar exposure. The two locations on the lower shroud of the camera, positions 2 and 5 in Figure 11-4, correspond to areas of near-maximum and near-minimum solar exposure, respectively.

Figure 11-4. Effect of Radiation on Spectral Reflectance of White Inorganic Painted Surfaces of Surveyor III Camera (Contributions of Lunar Dust Removed Analytically)

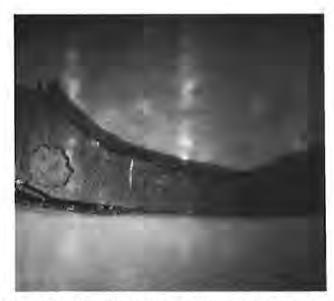
Figure 12-2. Segment of Shroud in Contact With Connector J2 (3X Magnification) (Photo 00545-203)

welding. It was observed at the time of dismantling that the connector nut was loose, suggesting that a considerable amount of motion with associated abrasion of the protective coating may have occurred during launch and possibly during operation of the camera on the moon; forces were imparted to the total camera and its cabling as the mirror assembly was rotated. This made it possible to postulate cold welding as a mechanism of failure since the thin iridite coating (less than 0.1 mil) originally applied over the connector could easily have worn off or been scuffed off during repeated insertion. The bare aluminum surfaces would be more susceptible to cold welding.

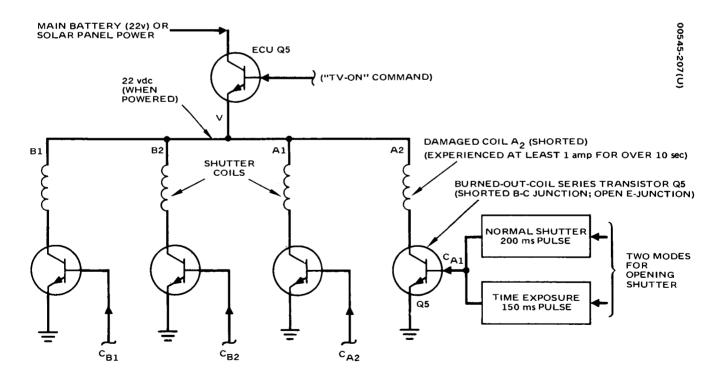
The shutter contains two solenoids, A and B, each comprised of two bifilar windings. The four coils, designated A1, A2, B1, and B2, are driven from a common voltage source marked as point V in Figure 12-6. Each coil is individually triggered by actuation of a similar series

Figure 12-6. Simplified Schematic of Shutter Coils and Drive Circuits

The two effects were opening of the shutter (event 3 in Figure 12-7) and eventual burning of the insulation of coil A2 and shorting of its windings (event 4). A necessary condition for these events, as evident from Figure 12-6, was, in addition to the collector-emitter short of transistor Q5, the continuing presence of the applied voltage at point V in Figure 12-6. Damage to coil A2, as discussed in Section 5.5, resulted in reduction of its winding resistance from an original value of 33 ohms to the final measured value of 0.2 ohm. This caused an increase in current through Q5, which, in turn, eventually burned out the emitter lead of the Q5 transistor, leaving it in the open condition found (event 5 in Figure 12-7). Thus, the Q5 transistor initially shorted and later opened (failures 1 and 3 in Figure 12-7).

The evidence of failure was that the insulation was burned on one of the windings and both coils of the windings were damaged. One of the coils had a resistance of 24 ohms, compared to the original value of 33 ohms, showing some degradation due to shorted windings. The other coil, corresponding to coil A2 in Figure 12-6, was virtually completely shorted. It measured 0.2 ohm, compared to 33 ohms nominal.

The presence of voltage of appreciable duration across the shutter coil drive circuit (point V in Figure 12-6) after the first lunar night was established to be the second necessary condition for the failure of the solenoid coil and subsequent events. A review of mission records confirmed that no anomalous effects were noted at the end of the first lunar day and that the shutter had been properly closed for the lunar night. The effort to explain the existence of the coil voltage entailed analysis of the available evidence summarized earlier, additional tests of the returned chassis and components, a review of operational commands sent to the spacecraft after the first lunar night, and a study of the electrical subsystems of the spacecraft for possible alternate modes of failure which, in conjunction with the commands transmitted, might provide a plausible explanation.
