TEST AND EVALUATION OF THE

SURVEYOR III TELEVISION CAMERA

RETURNED FROM THE

MOON BY APOLLO XII

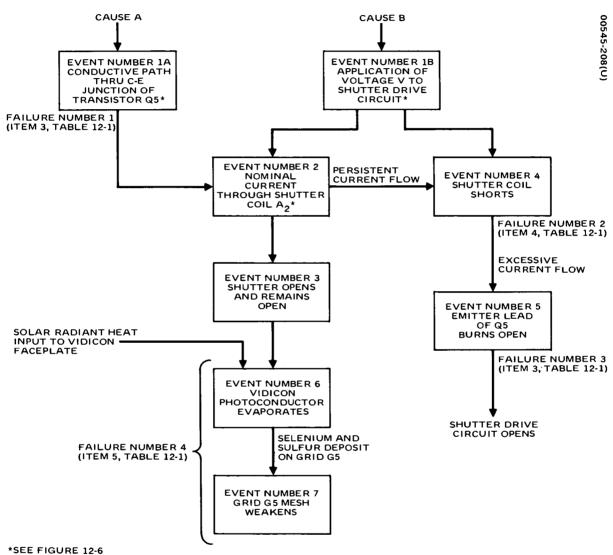
It became immediately obvious from the preliminary analysis that all subsequent failures occurred because the current flow through coil A2 was of unduly long duration either because the activating pulses had persisted too long, maintaining transistor Q5 in the ON state, or because its conductive emitter-to-collector path was permanently maintained as a result of an internal failure. As discussed later, the former possibility was subsequently discounted. As a result of this long-duration current through coil A2, two effects occurred, causing the remaining interrelated failures to occur. This is illustrated in the logic block diagram of Figure 12-7.

The two effects were opening of the shutter (event 3 in Figure 12-7) and eventual burning of the insulation of coil A2 and shorting of its windings (event 4). A necessary condition for these events, as evident from Figure 12-6, was, in addition to the collector-emitter short of transistor Q5, the continuing presence of the applied voltage at point V in Figure 12-6. Damage to coil A2, as discussed in Section 5.5, resulted in reduction of its winding resistance from an original value of 33 ohms to the final measured value of 0.2 ohm. This caused an increase in current through Q5, which, in turn, eventually burned out the emitter lead of the Q5 transistor, leaving it in the open condition found (event 5 in Figure 12-7). Thus, the Q5 transistor initially shorted and later opened (failures 1 and 3 in Figure 12-7).

Figure 12-7. Logic Block Diagram Showing Relationship and Sequence of Failures of Shutter Drive Transistor, Shutter Coil, and Vidicon Photoconductor and Grid

the faceplate caused the photoconductor to evaporate (event 6, Figure 12-7). Subsequent deposition of sulfur and selenium from the photoconductor onto its grid 5 caused a physical/chemical change and a weakening of the copper mesh (event 7, Figure 12-7). The grid eventually shattered — either on the moon or during subsequent handling.

review of design features of the television, power, communication, and command subsystems of the Surveyor III spacecraft, led to the development of a failure logic tree and study of the many possible modes of failure. This analysis stressed the occurrences of the two original events, noted as events 1A and 1B in Figure 12-7, which would explain the subsequent occurrences.

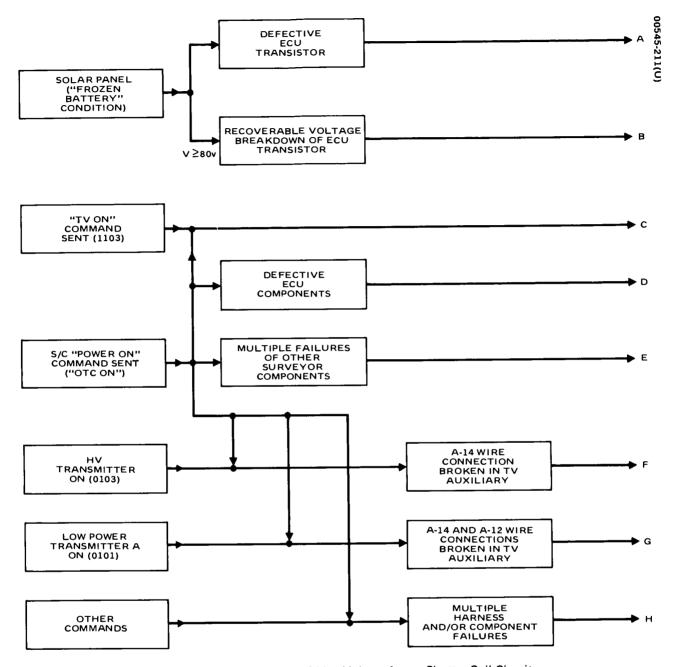
Figure 12-10. Possible Causes of Line Voltage Across Shutter Coil Circuit

accomplishing this entail the transmission of a separate command, whose code was 1103, shown as TV ON command in Figure 12-10. This command, then, in conjunction with the OTC ON command, is designated in Figure 12-10 as a possible path C. Extensive search of mission records revealed no trace of this command.
