NASA CR-1897

**DESIGN AND APPLICATION OF  
POLYCARBONATE CAPACITORS IN  
AEROSPACE AC POWER SYSTEMS**

*by J. F. Gosda, A. C. Elles, and R. R. Bailey*

TRW

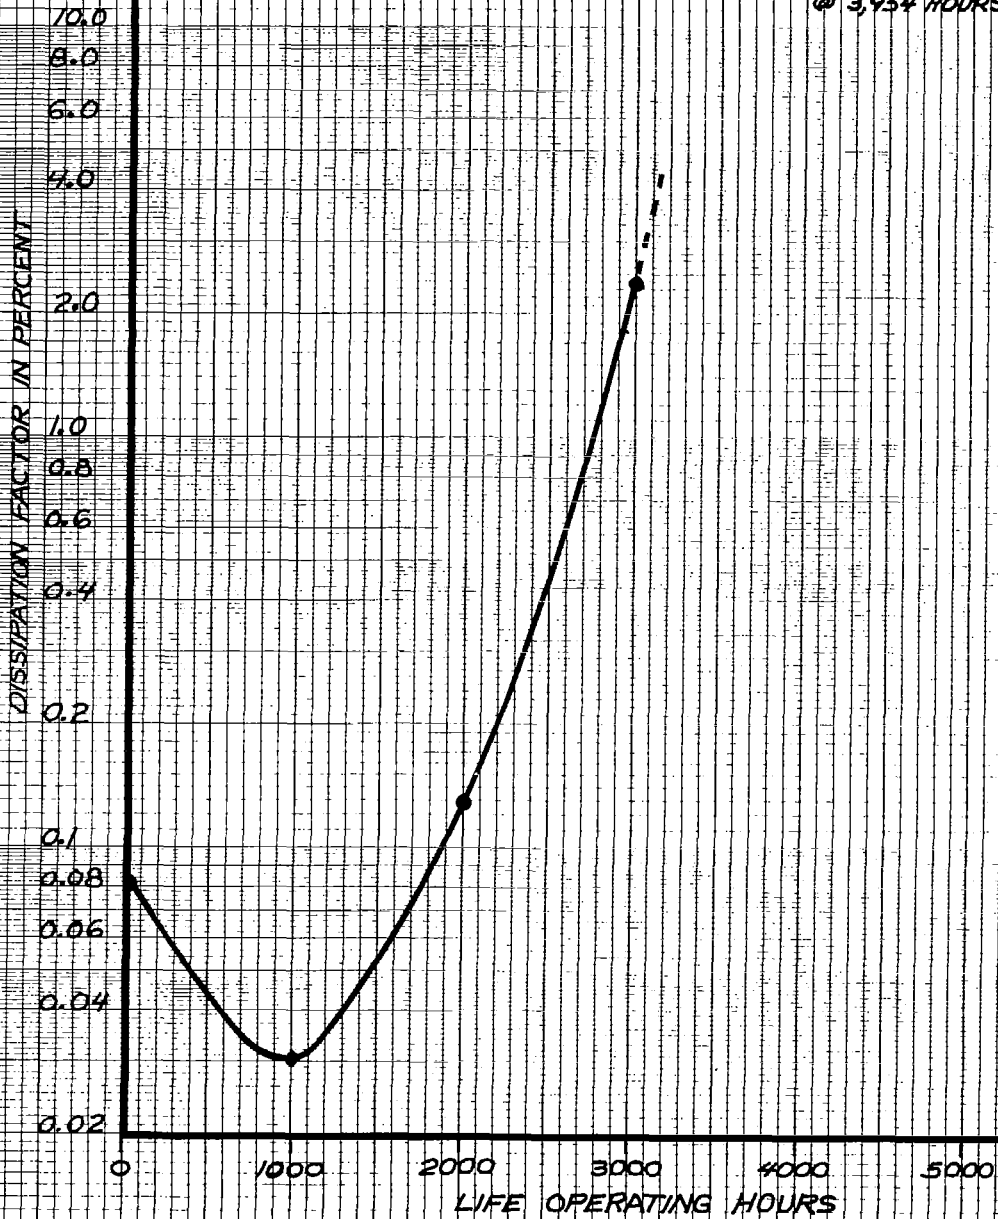
FIGURE 22

- a. Design B-1 See performance curves in Figures 21, 22, and 23, photograph Figure 24 and refer to Failure Analysis 41 in Appendix B. The increase in DF with time is apparent when reviewing the curve of Figure 22. This was caused by a deteriorating termination which resulted in excess heat at the termination and led to eventual failure.

DISSIPATION FACTOR  
OF  
SERIAL NO. 42XB06  
DURING  
400-HZ AC LIFE TESTING @ 125°C  
DESIGN B-1 1.0  $\mu$ F

UNIT SHORTED  
@ 3,954 HOURS

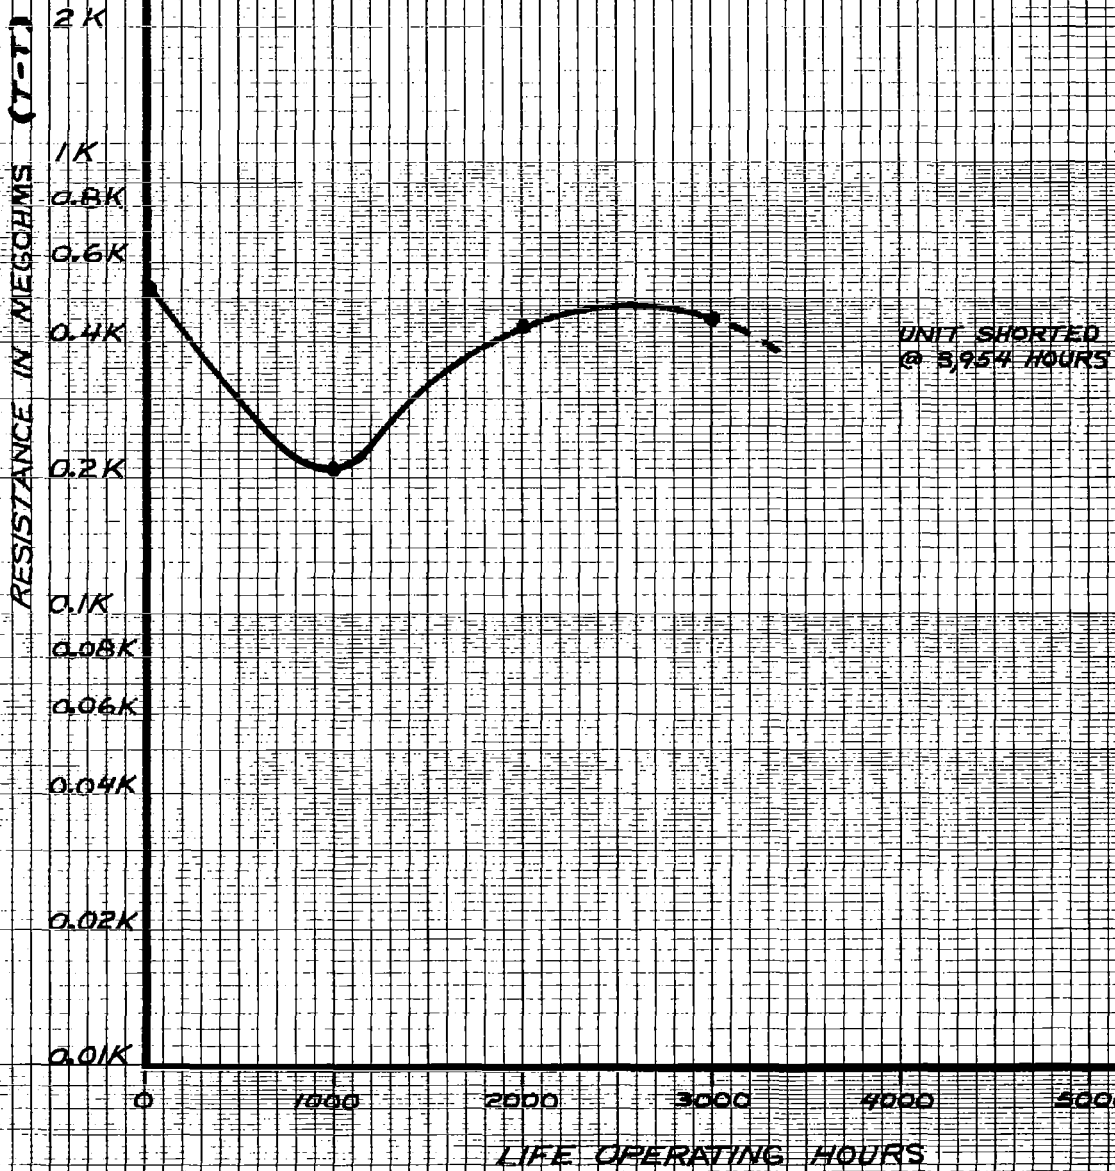
FIGURE 23

INSULATION RESISTANCE CHARACTERISTICS  
OF  
SERIAL NO. 42X806  
DURING  
400-HZ AC LIFE TESTING @125°C  
DESIGN B-1 1.0  $\mu$ F

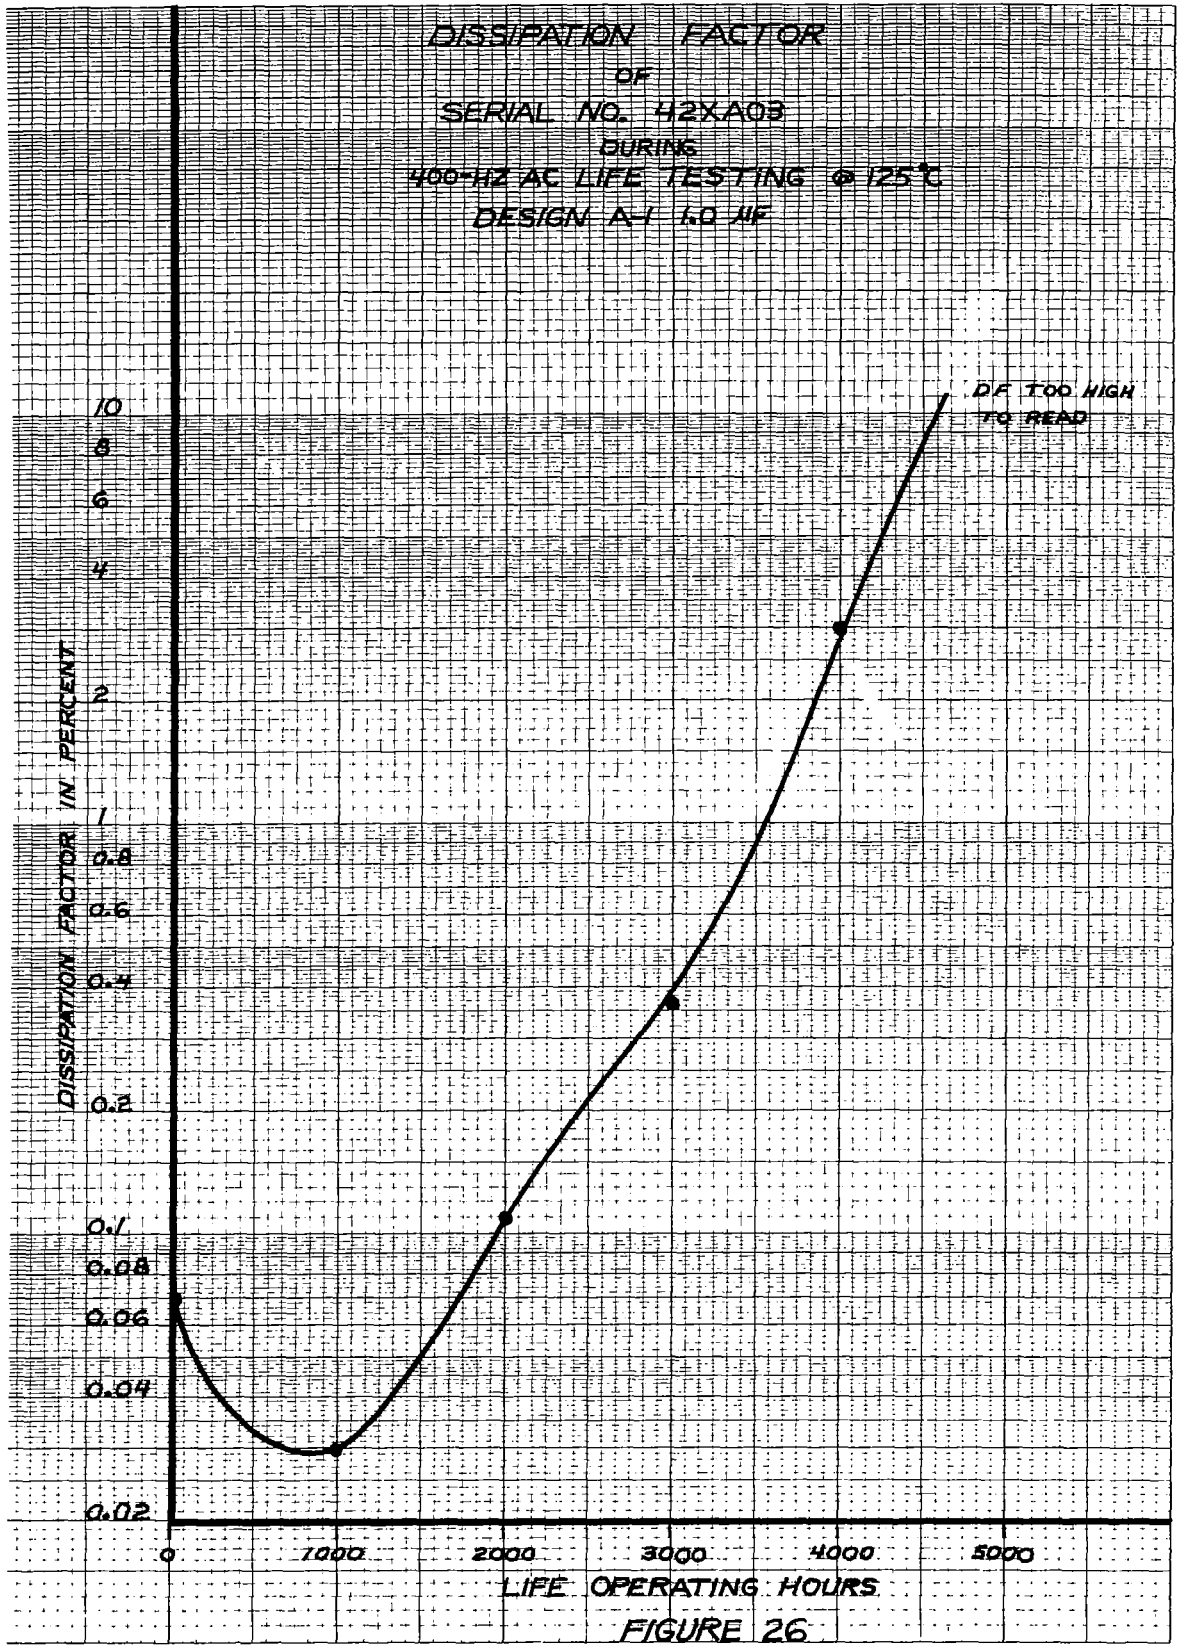
FIGURE 26

- b. Design A-1 See performance curves in Figures 25, 26, and 27, photograph Figure 28 and Failure Analysis 48 in Appendix B. A review of Figure 26 illustrates a continually increasing DF after 1000 hours on test. The part was considered a failure due to exceeding the 0.5% maximum DF allowable and though it made it through 5000 hours without shorting, would have eventually failed. Reason for the curious and short lived low DF at the 1000-hour point in time could have been due to some physical changes in progress due to the termination problem which gave a temporary improvement in DF.

DISSIPATION FACTOR  
OF  
SERIAL NO. 42XA03  
DURING  
400-HZ AC LIFE TESTING @ 125°C  
DESIGN A-1 6.0 HF

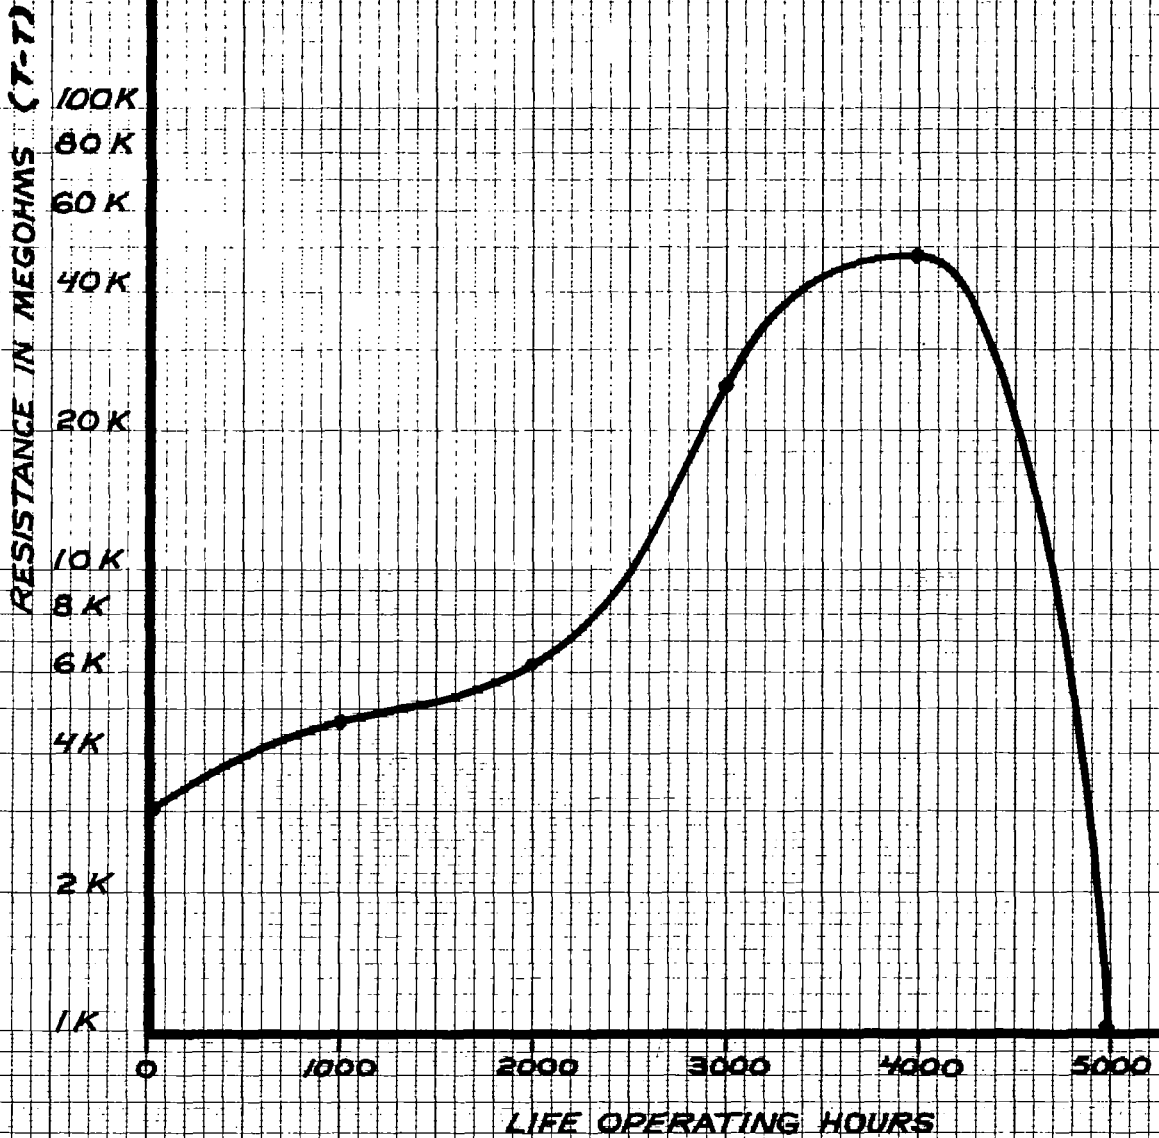
FIGURE 27

INSULATION RESISTANCE CHARACTERISTICS

OF  
SERIAL NO. 42XA03

DURING  
400-HZ AC LIFE TESTING @ 125°C  
DESIGN A-1 1.0 μF

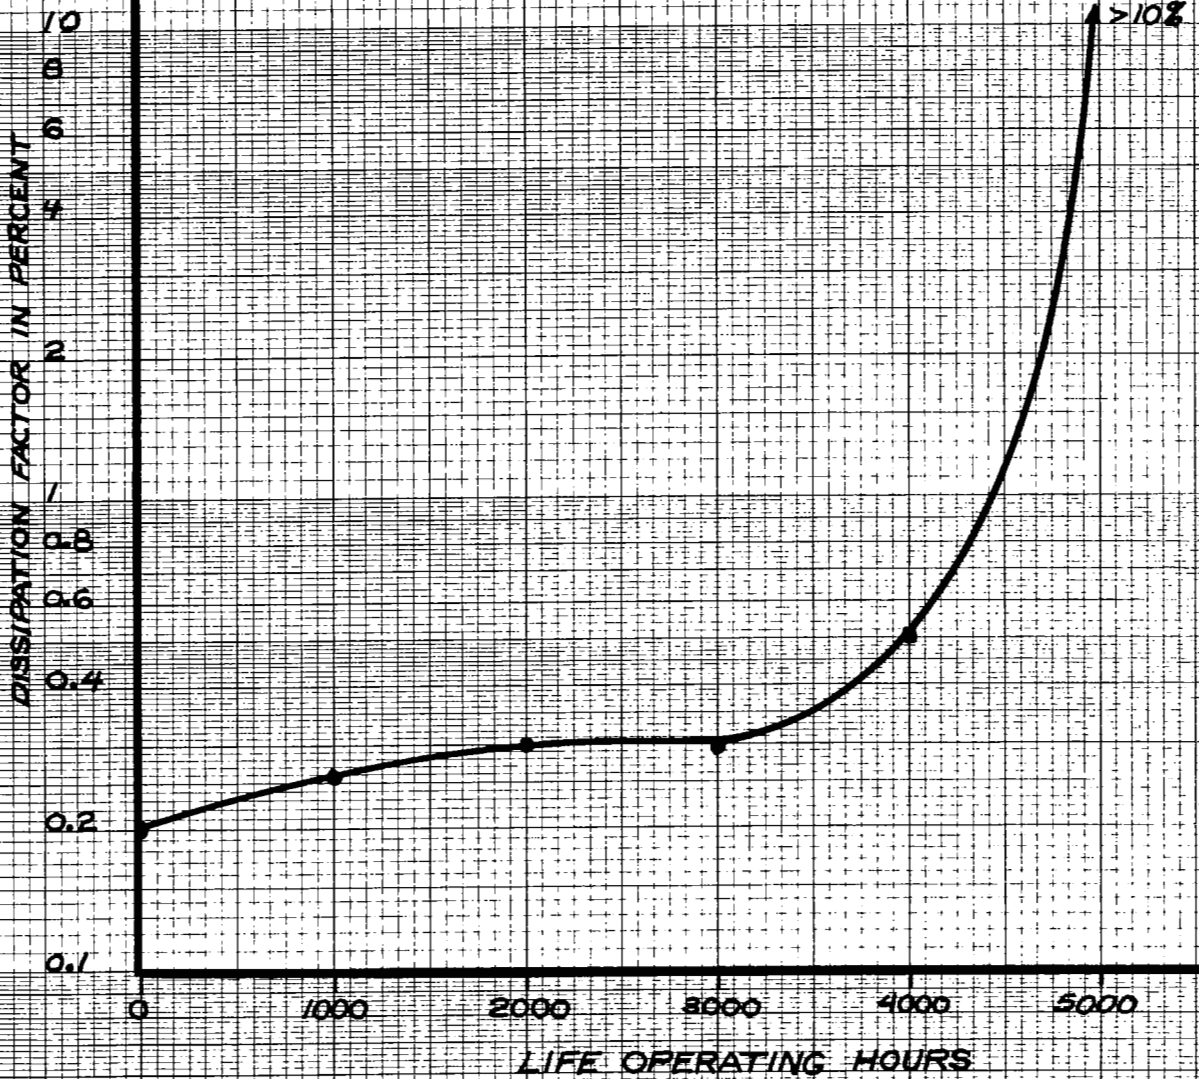
FIGURE 30

- c. Design A-2 See performance curves in Figures 29, 30, and 31, photograph Figure 32 and Failure Analysis 46 in Appendix B. This capacitor was still operating at the end of the 5000 hour test but is considered a failure since the 0.5% maximum DF was exceeded. As evidenced by Figure 30, the DF was increasing with time and the resulting heat losses would have caused failure.

DISSIPATION FACTOR  
OF  
SERIAL NO. 41FA12  
DURING  
400-HZ AC LIFE TESTING @ 125°C  
DESIGN A-2 1.0 μF

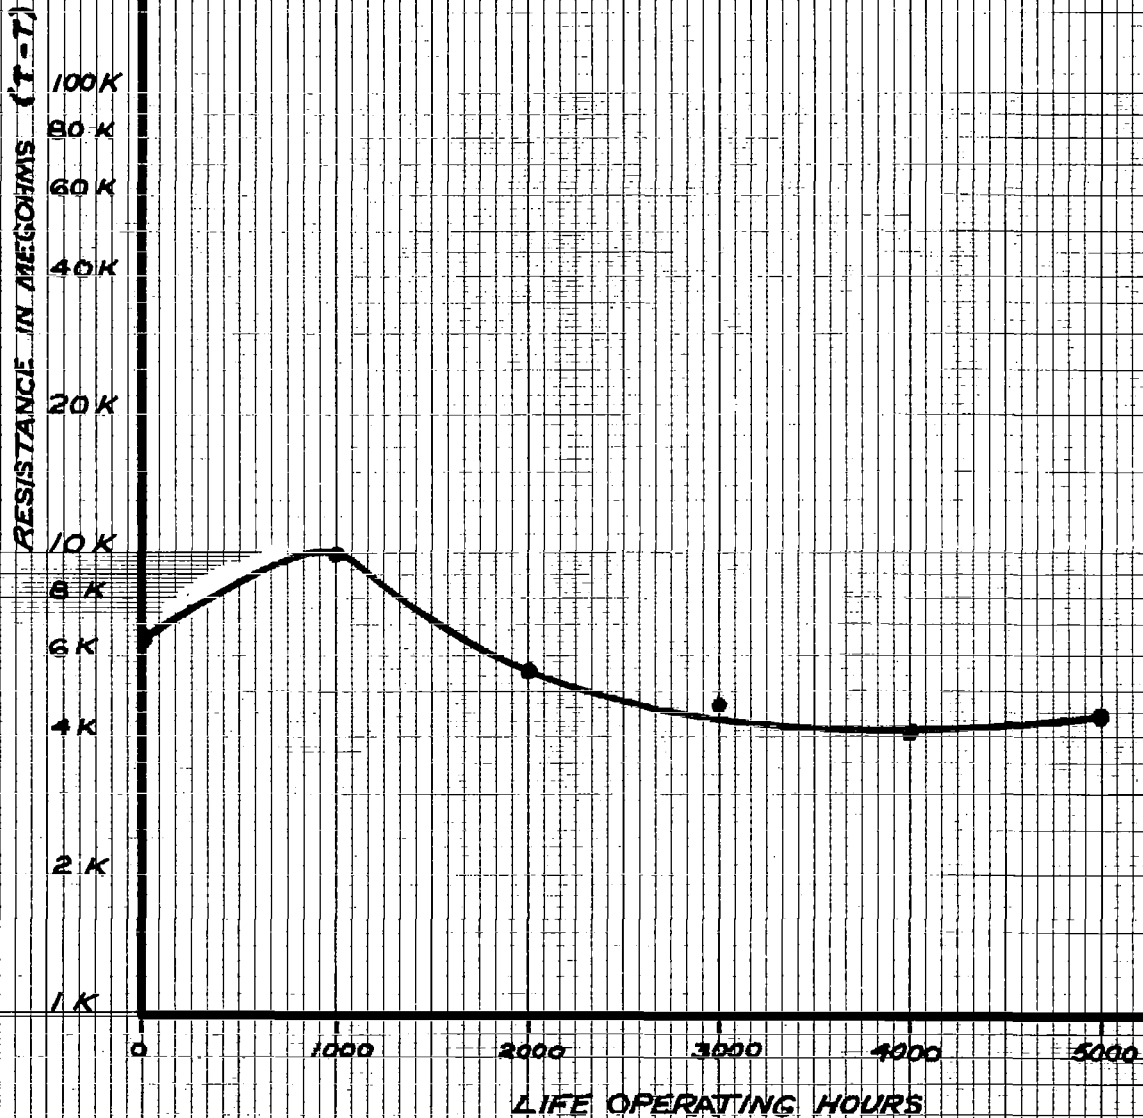
FIGURE 31

INSULATION RESISTANCE CHARACTERISTICS  
OF  
SERIAL NO. 41FA12  
DURING  
400-HZ AC LIFE TESTING @ 125°C  
DESIGN A-2 1.0  $\mu$ F

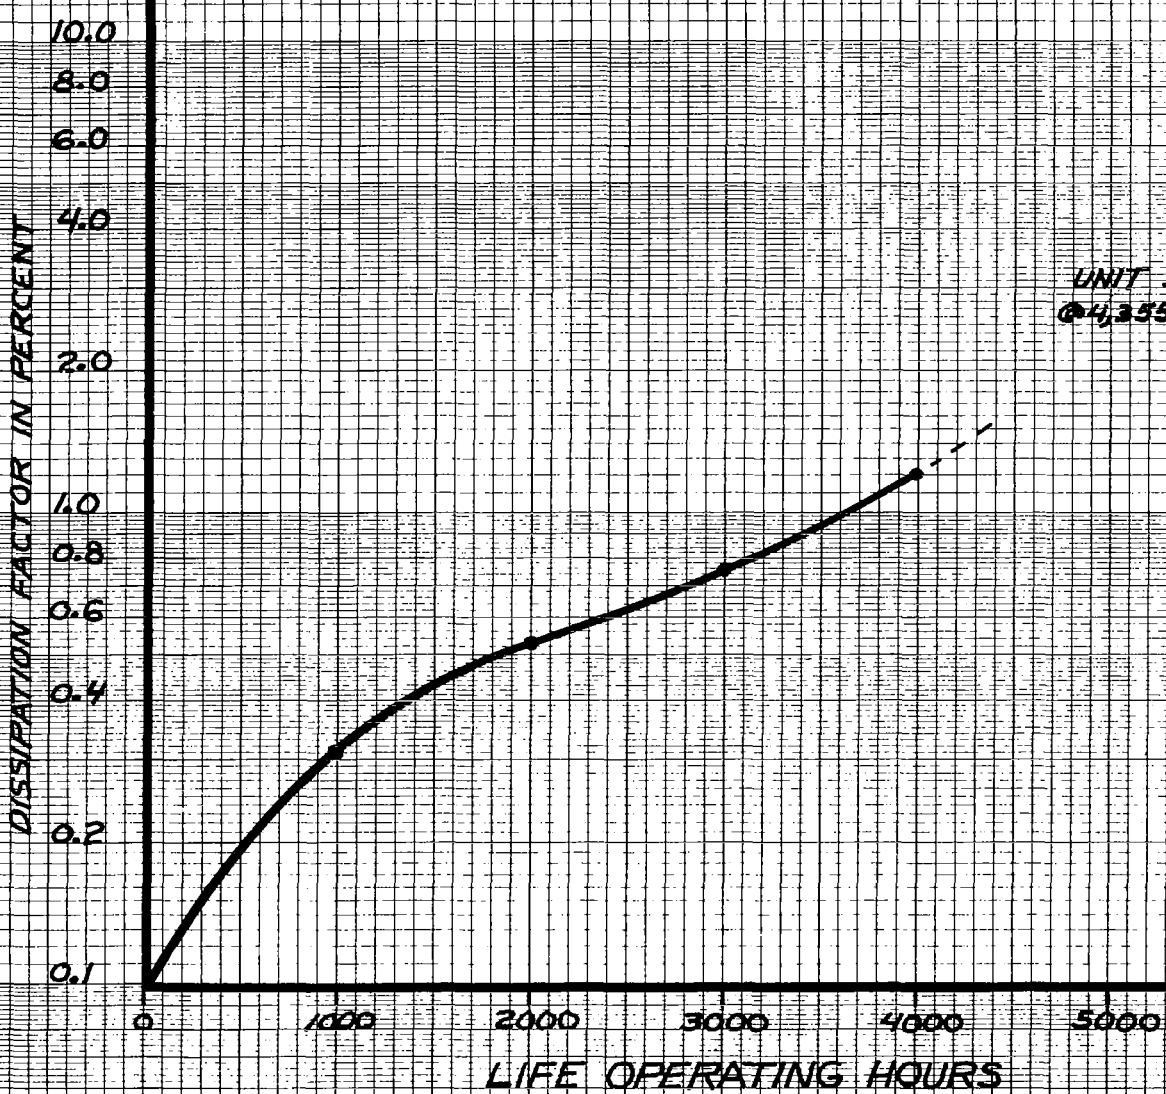
FIGURE 34

DISSIPATION FACTOR  
OF  
SERIAL NO. 43XA02  
DURING  
400-HZ AC LIFE TESTING @ 125°C  
DESIGN A-1 1.0 μF

UNIT SHORTED  
@ 4,355 HOURS

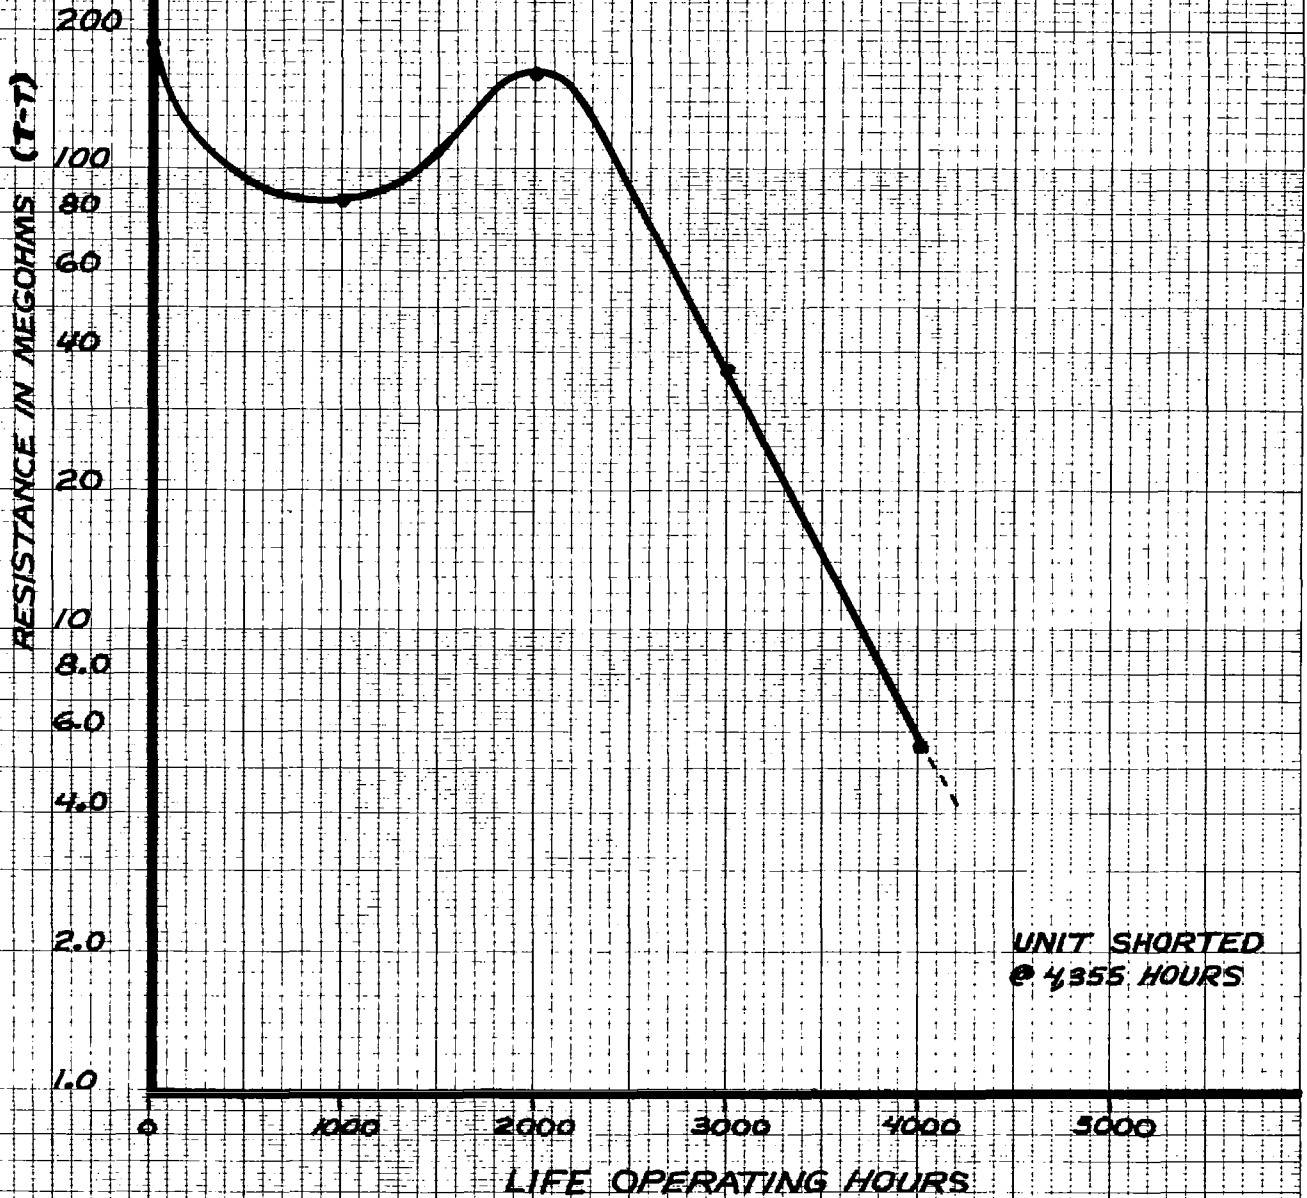
FIGURE 35

INSULATION RESISTANCE CHARACTERISTICS  
OF  
SERIAL NO. 43XA02  
DURING  
400-HZ AC LIFE TESTING @ 125°C  
DESIGN A-1 1.0 μF
