17. DEVELOPMENT OF IMPROVED CERAMIC COATINGS TO INCREASE

THE LIFE OF XLR99 THRUST CHAMBER (L)

By Lawrence N. Hjelm
Aeronautical Systems Division, U.S. Air Force

ABSTRACT

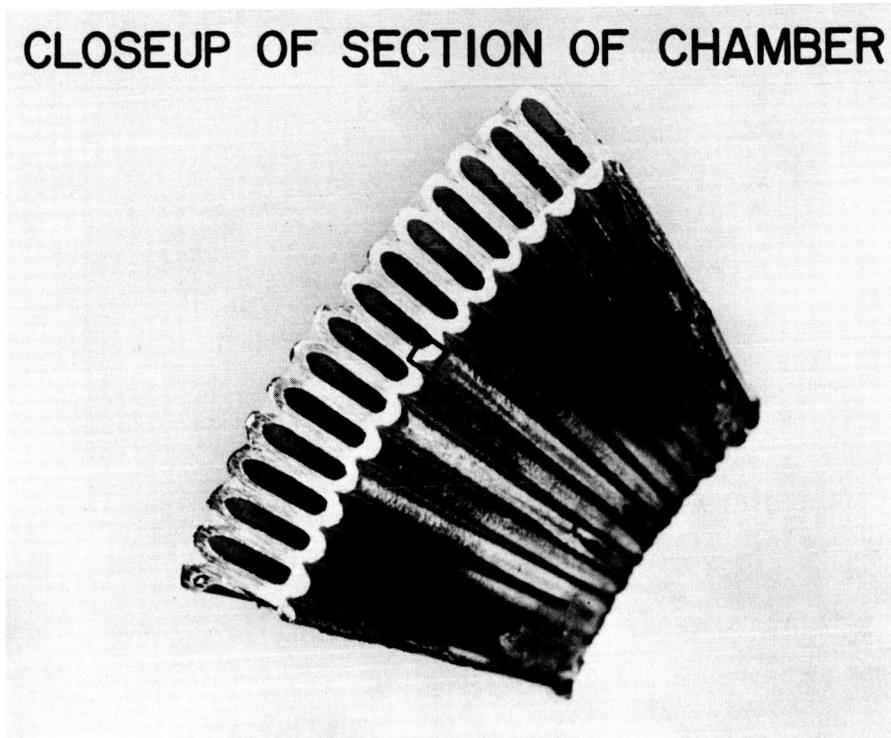
Figure 2

CLOSEUP OF SECTION OF CHAMBER

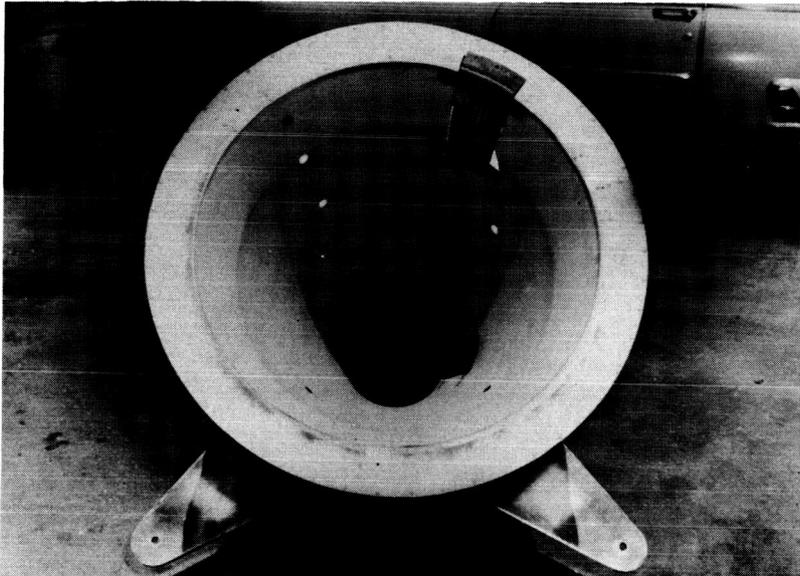
Figure 10

A mock-up of the combustion chamber illustrated in figure 10 was used to determine deposition rates for the spraying process so that the desired coating thickness could be obtained on the actual hardware. The mock-up was constructed of aluminum with panels cut from an old chamber inserted at three positions. This assembly is coated in the same manner as an engine and chamber, and coating thicknesses were measured. The coating thicknesses on the smooth surface are compared with those on the corrugated panels. Proper spraying parameters can then be determined for coating a combustion chamber.

MOCK-UP OF COMBUSTION CHAMBER

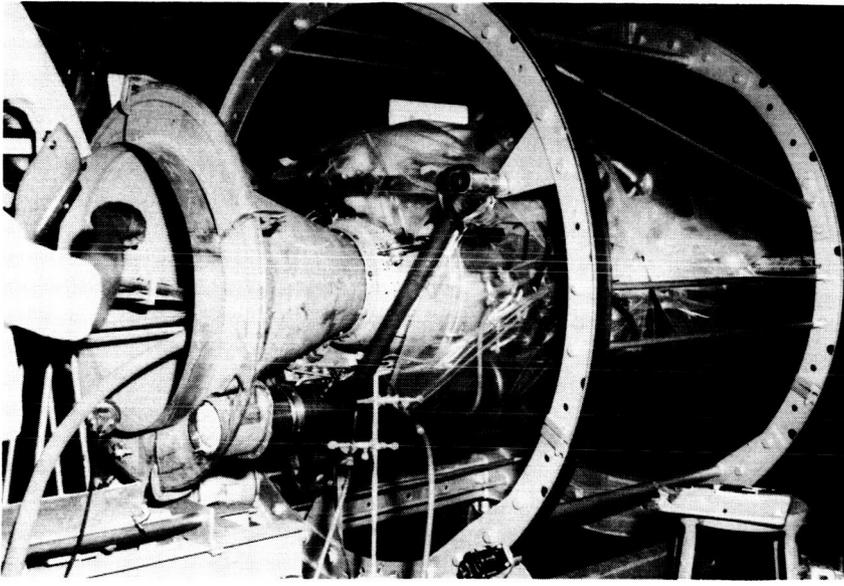
Figure 11

A special fixture was built at NASA Flight Research Center for coating a fully assembled engine. This fixture and the coating operation on the first test engine are shown in figure 11. This figure shows the

COATING OPERATION - SIDE VIEW

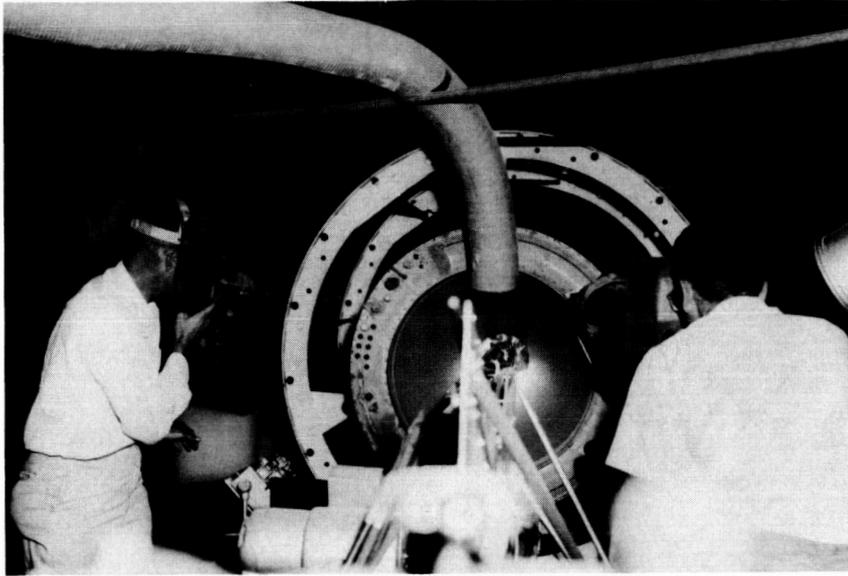
engine mounted in rings so that it can be rotated. Figure 12 is a rear view of this operation.

COATING OPERATION - REAR VIEW
