NASA TECHNICAL NOTE

NASA TN D-6721  
c.1

# APOLLO EXPERIENCE REPORT - WINDOW CONTAMINATION

*by L. J. Leger and R. W. Bricker*  
*Manned Spacecraft Center*  
*Houston, Texas 77058*

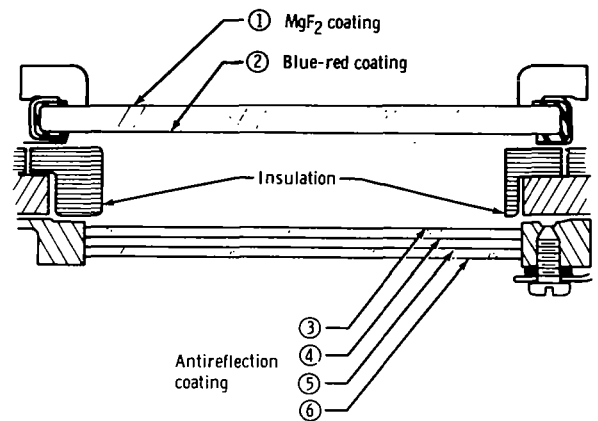
Figure 5. - Command module window-surface notation used in contamination locations.

Because of the high temperatures that are encountered during entry, insulation is necessary between the heat shield and the pressure-vessel structure. This insulation, as shown in figure 5, extends to the edge of the aluminum window frame and consists of four 1/2-inch layers of silicone-resin-impregnated glass fibers bonded with silicone rubber RTV-511 (General Electric). The exterior of this composite, silica fibers and silicone rubber, is coated with an additional layer of RTV-511. Any area of the insulation that is exposed to astronaut view is sealed in a layer of aluminum foil reinforced with glass cloth and is overcoated with black silicone rubber 92-018 (Dow Corning) for antiglare purposes.

Soon after earth-orbital insertion, a film appeared on surfaces 2 and 3 of the hatch and side windows of the Apollo 7 and 8 command modules. This contamination continued to accumulate during flight and resulted in a heavy film in some locations and droplet formation in other locations. A photograph, taken with a camera focused on the hatch window during the Apollo 7 mission, is shown in figure 7. During the night pass of the spacecraft in earth orbit and during other similar cold-window conditions, the contamination seemed to crystallize and become opaque, particularly on the hatch window.

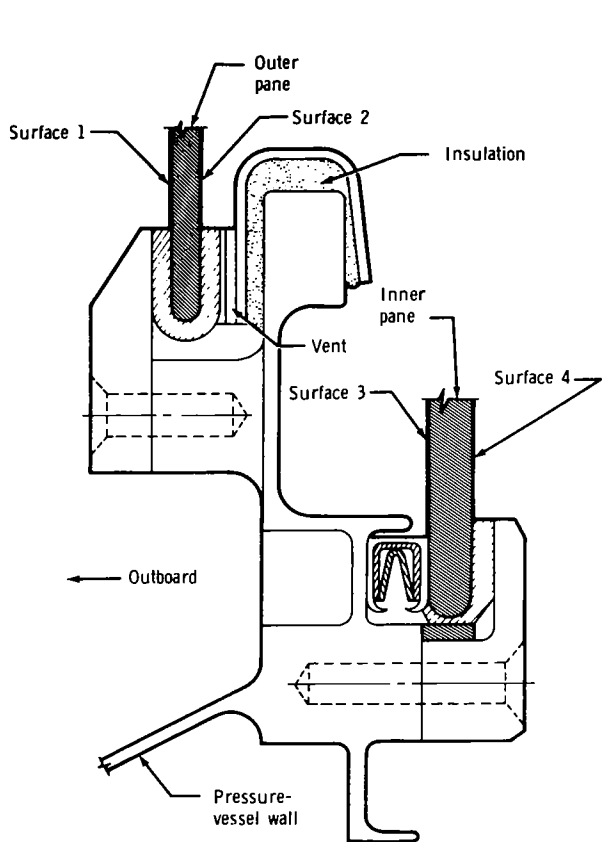
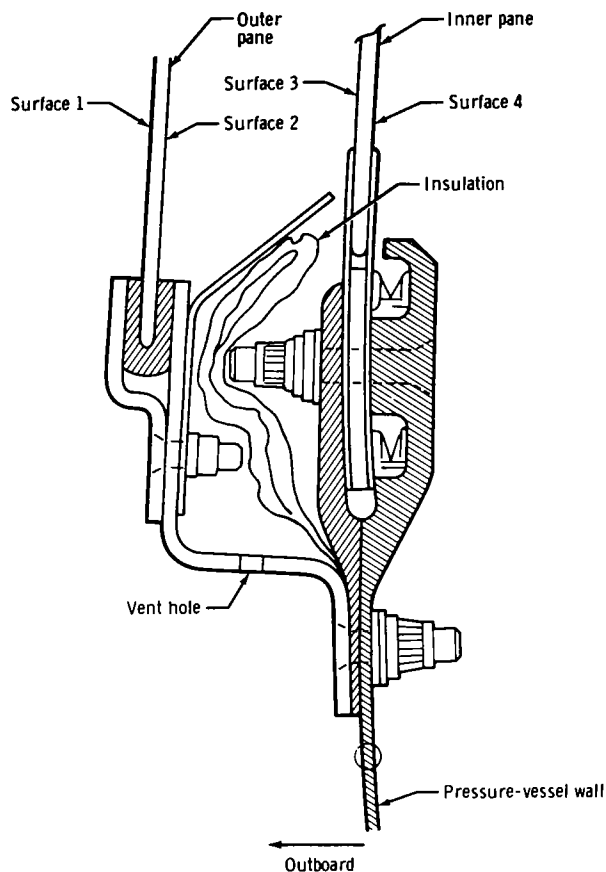
Figure 15. - Cross section of LM forward windows. Figure 16. - Cross section of LM docking window.

All three outer panes are sealed into the vehicle structure by the use of a heat-molded rubber (Dow Corning Silastic 675-24-480), as shown in figures 15 and 16. The thermal-insulation blanket that protects the window frame is held in place by an epoxy/fiber-glass retainer ring. The forward-window pressure seal is made by pressing, with a Teflon and Silastic-jacketed metal spring, the inner pane against a silicone-rubber seat. The docking-window pressure seal is made by adhesively bonding the inner pane directly to a Kovar metal frame. Because the LM does not have to survive

The relatively contamination-free condition of these windows might seem surprising because it was indicated earlier that the weight loss of the materials that were used in construction was rather large in some instances. However, if table II and figures 15 and 16 are examined, it is clear that the materials that sustain large weight losses are used in very limited amounts and, in general, are not exposed to the area between the panes. There is one exception: the fiber-glass retainer that involves an epoxy as the matrix material. The weight loss for this material was 0.65 percent. Because no contamination problem was encountered, the amount of condensable outgassing products from the epoxy was assumed to be very low.
