MSC-07230

APOLLO 16 MISSION REPORT

MANNED SPACECRAFT CENTER

AUGUST 1972

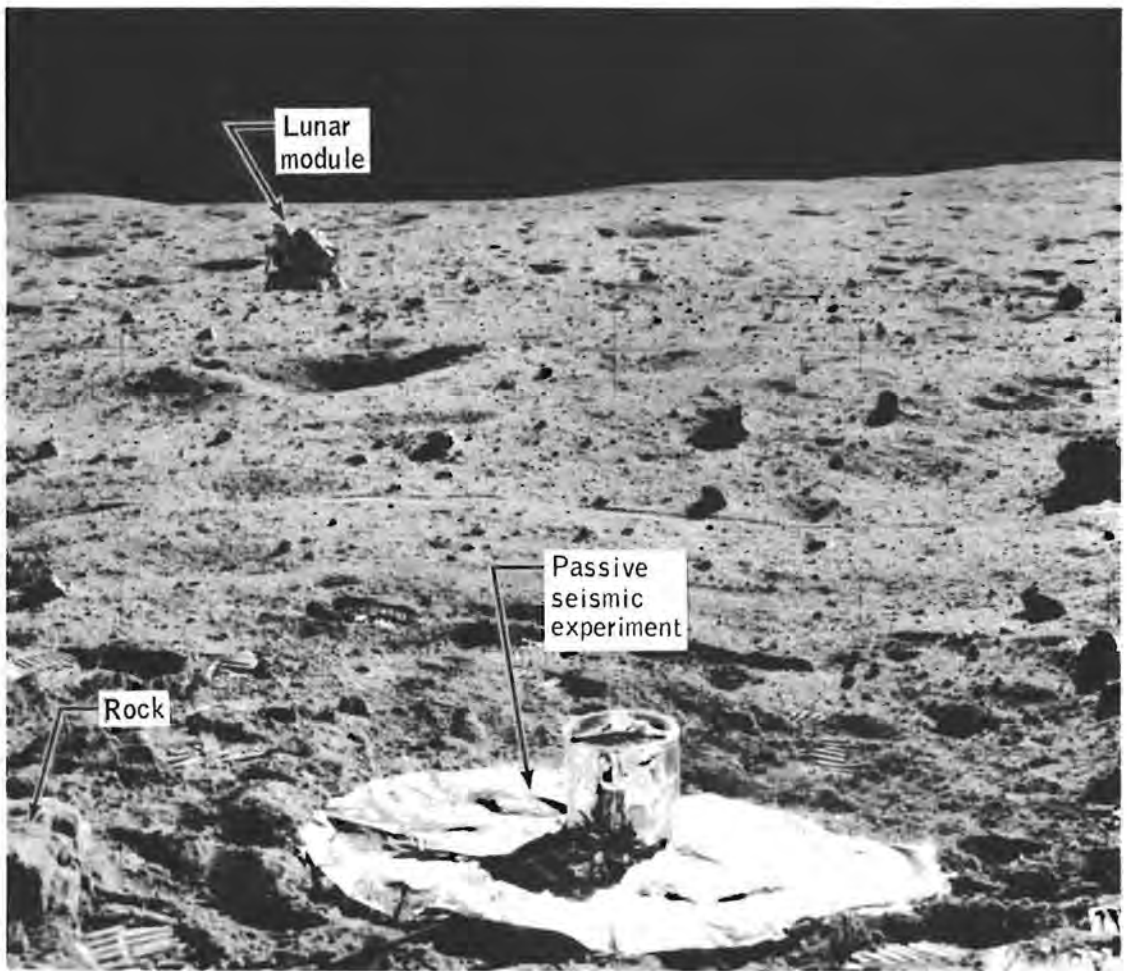
Figure 4-5.- Passive seismic experiment

The passive seismic experiment (S-031) was deployed as planned. All elements of the experiment have functioned normally with the exception of the thermal control system. Two days after activation, the temperature increased markedly beyond the controller set point and eventually exceeded the range of the sensor, 61.4° C. The temperature stabilized at night to 52.2° C. Photographs of the instrument show the shroud skirt to be raised at several places (fig. 4-5); further, dust was inadvertently kicked onto the skirt after the photographs were taken. These factors are believed to be responsible for the abnormal temperatures. The temperatures are not expected to affect instrument life or seismic data, but will degrade the tidal data.

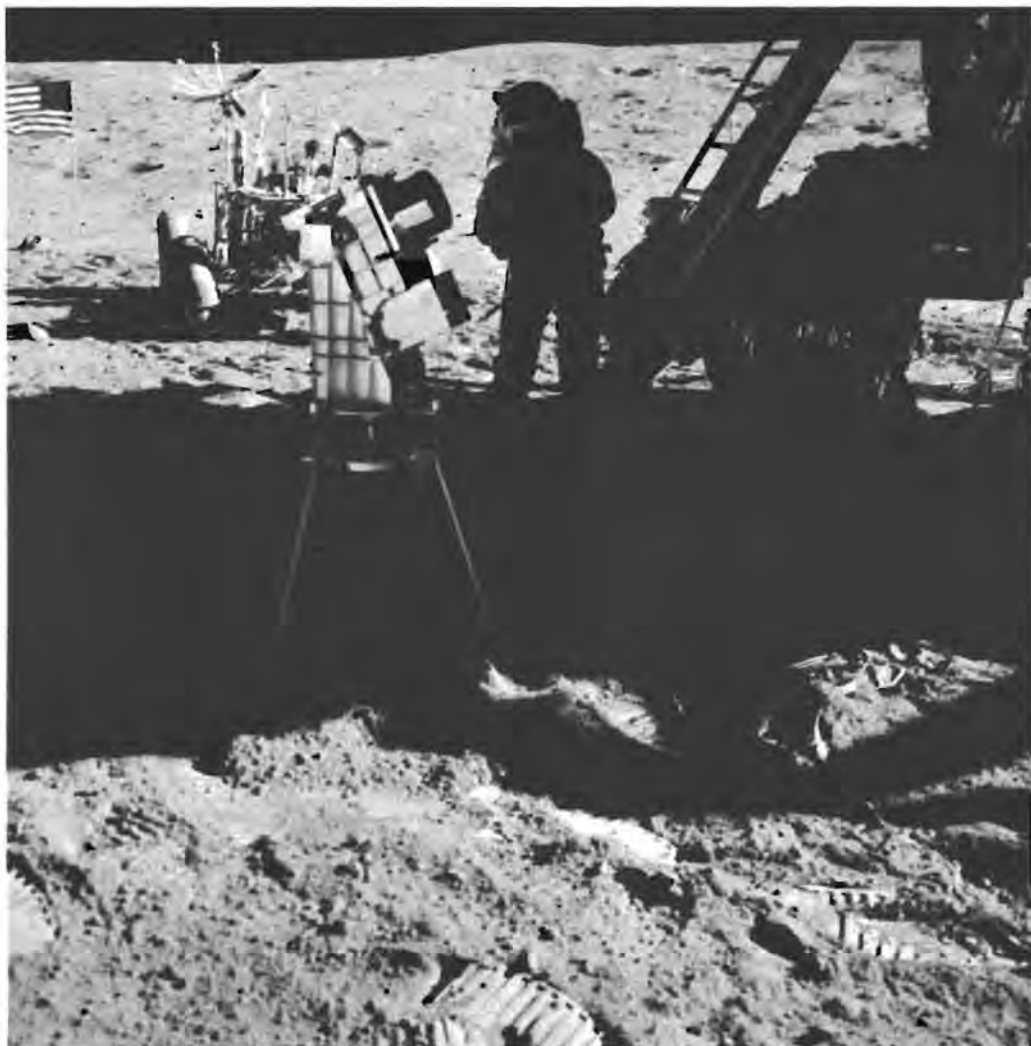
Figure 4-8.- Far ultraviolet camera/spectroscope experiment,

The far ultraviolet camera/spectroscope (S-201) was deployed approximately 2 meters southwest of the down-sun footpad of the lunar module with the camera in the shade and the battery in sunlight (fig. 4-8). Because of the landing delay and the consequently high sun angle, it was necessary to move the camera into the shade during the second and third extravehicular activities. Difficulty was experienced in adjustment of the azimuth ring. The condition degraded with each adjustment. Section 14.4.9 contains a discussion of this anomaly.

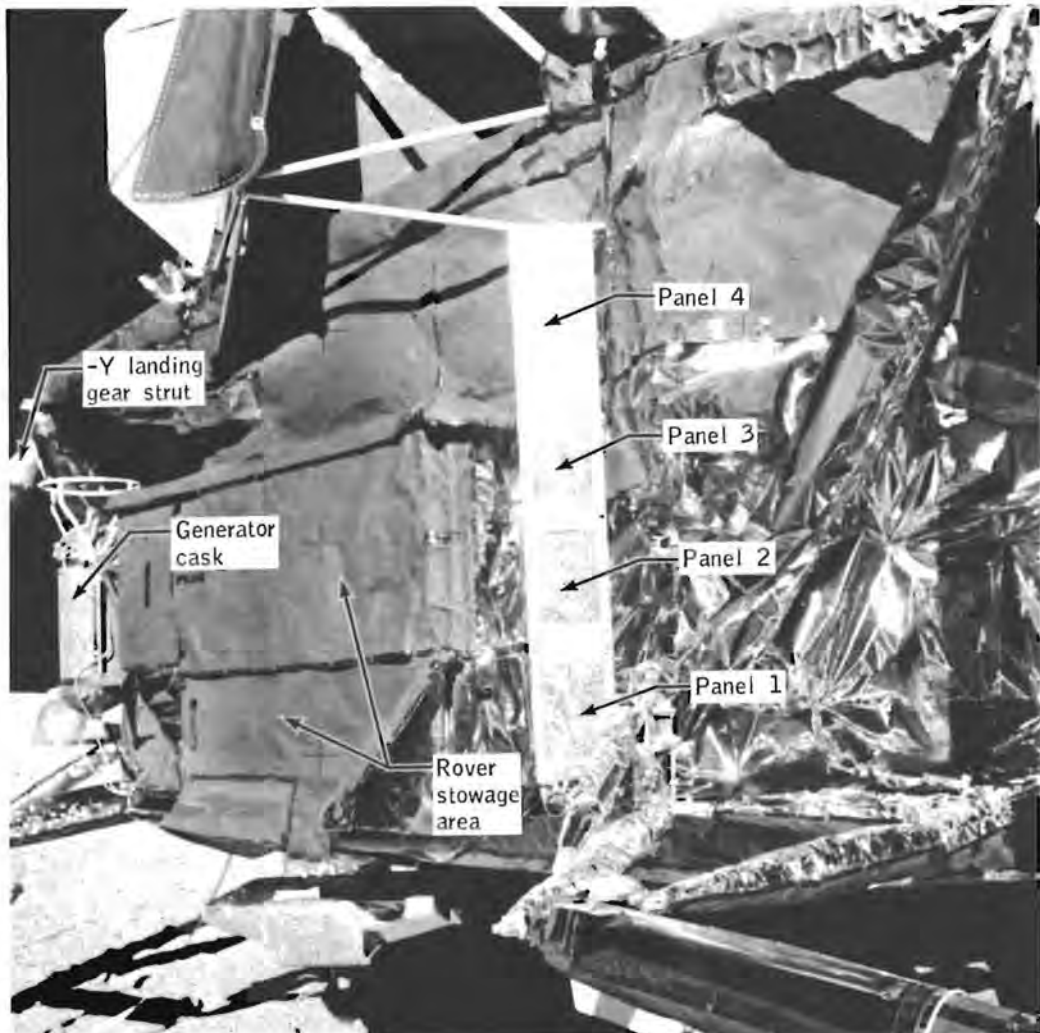
Figure 4-11.- Cosmic ray detector experiment.

The panel array of the cosmic ray detector experiment (S-152) was exposed in its initial configuration upon jettisoning of the spacecraft-launch vehicle adapter panels. The hidden surface of panel 4 was partly exposed by the Commander early in the first extravehicular activity (fig. 4-11). The planned area of exposure for detecting particles at the lunar surface could not be obtained because the experiment mechanism jammed as described in section 14.4.4. The detector panel array was retrieved at

the end of the third extravehicular activity, folded in the proper configuration for transearth coast data collection, and returned for analysis. It was difficult to separate the panel assembly from the main frame at the end of the third extravehicular activity because of thermal expansion of the Teflon slides.

The plastic in all panels of the experiment was degraded by heating above the design limit of 54°C , at which temperature degradation begins. The high temperature was most likely caused by a film accumulating on the thermal control surface, in addition to lunar dust. Analysis of the film has not been completed.

As a result of the incomplete exposure of panel 4, the portion of the experiment designed to measure neutron flux was degraded, as were those designed to measure solar wind gas, and search for radon (Rn^{222}) and argon (Ar^{40}).

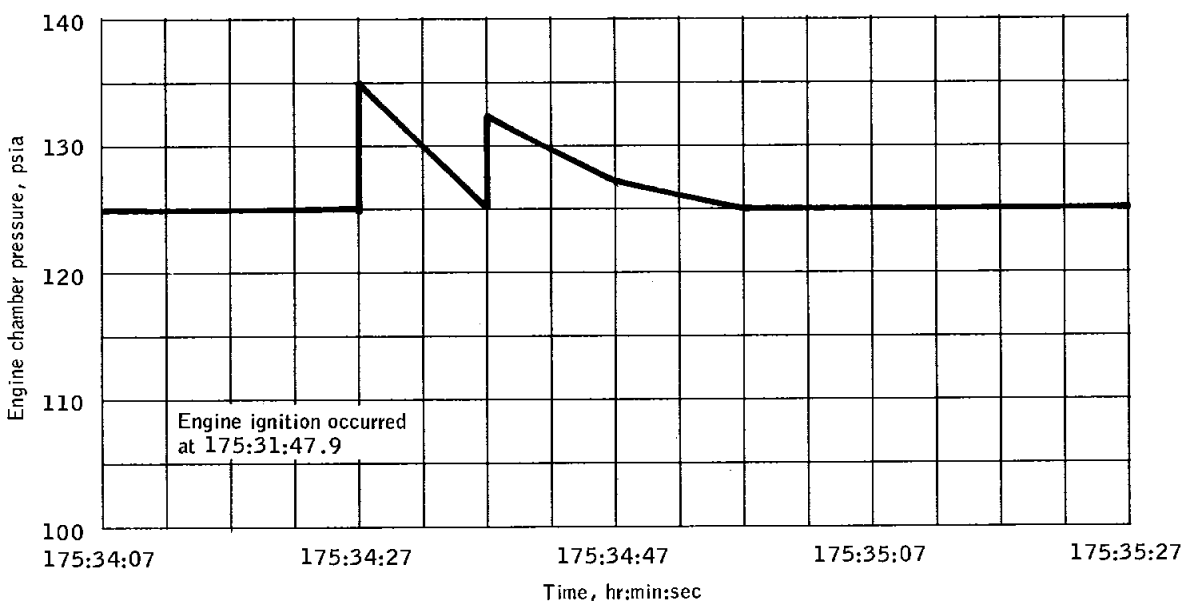
Figure 7-3.- Ascent propulsion system pressure fluctuations.

Two upward shifts in the engine chamber pressure were recorded during the ascent maneuver, as shown in figure 7-3. A review of all other available engine and acceleration data failed to substantiate the increased chamber pressure indication. The crew did not recall feeling additional acceleration or surges during the maneuver. This anomaly is discussed further in section 14.2.8.

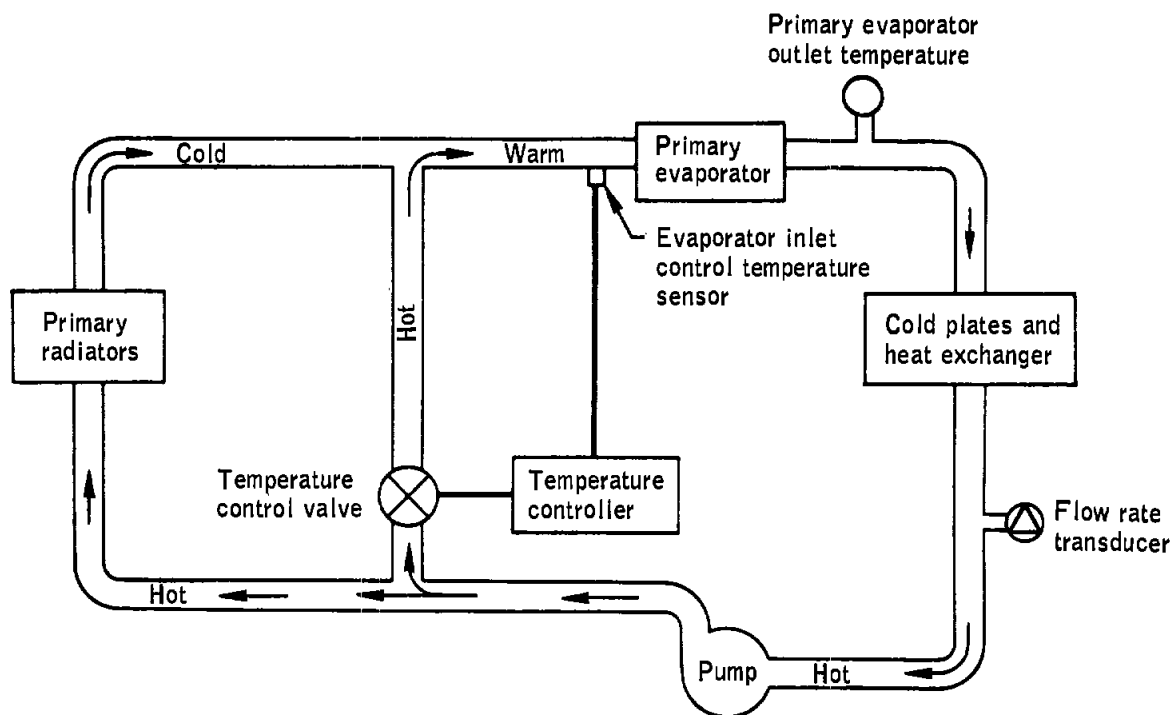
Figure 14-1.- Primary water/glycol coolant loop.

14.1.1 Water/Glycol Temperature Control Circuit Failed in the Automatic Mode

About 3 hours into the mission, the water/glycol temperature control circuit (fig. 14-1) malfunctioned in the automatic mode. The malfunction allowed an excessive amount of hot water/glycol to bypass the radiator causing the mixed water/glycol temperature to exceed the upper control

limit of 48° F. After remaining in this maximum bypass position for 5 minutes, the temperature control valve cycled regularly between maximum and minimum flow to the radiators for about 14 minutes before stopping again at maximum bypass. The control was changed to manual and back to automatic to restart the valve operation and, finally, left in manual at the desired valve position. Variations in the evaporator outlet temperature and total system flow rate for the period are shown in figure 14-2. Control valve operation is evident from the variation of system flow rate. Total flow rate increases as the flow control valve opens since the total system pressure drop decreases.

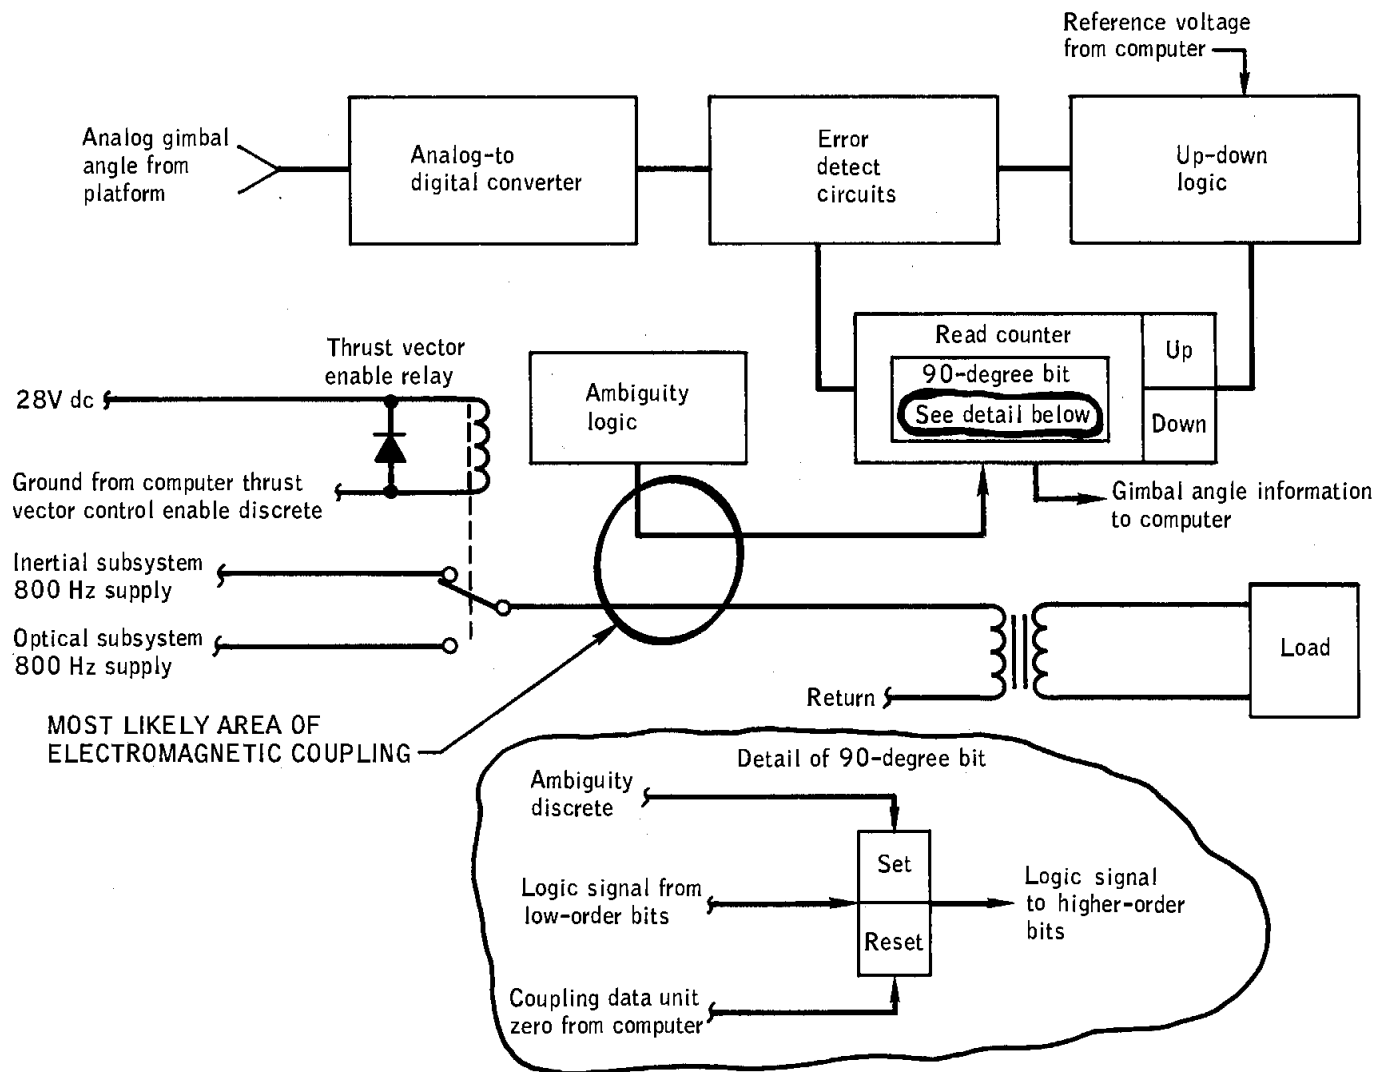
Figure 14-4.- Coupling data unit functional diagram.

The cause of the problem is contact bounce in the thrust vector enable relay (fig. 14-4). The relay switches between two 800-hertz excitation-voltage power sources which are applied to a transformer in the digital-to-analog converter portion of the coupling data unit. A relay without a coil spike suppression diode will transfer between contacts in about 0.5 millisecond with the transients caused by the power interruption and collapsing field of the transformer inconsequential. The addition of the suppression diode across the relay increases the dropout contact transfer time to about 6 milliseconds.

In either condition if the relay contact initially closes the circuit to the transformer (fig. 14-4) at the beginning of either half cycle of the 800-hertz wave form, the current taken by the transformer during the first 3/4 cycle of the 800-hertz excitation voltage will reach 4 to 5 times the steady-state level. If this higher-than-normal current is interrupted by the relay contact reopening, the transformer will feed back a voltage transient as high as 250 volts on the line to the relay. Both of these problems result in circuit-interruption (bounce) durations that would cause high voltage spikes; however, the bounce must occur, as stated previously, at the right time in the 800-hertz waveform.

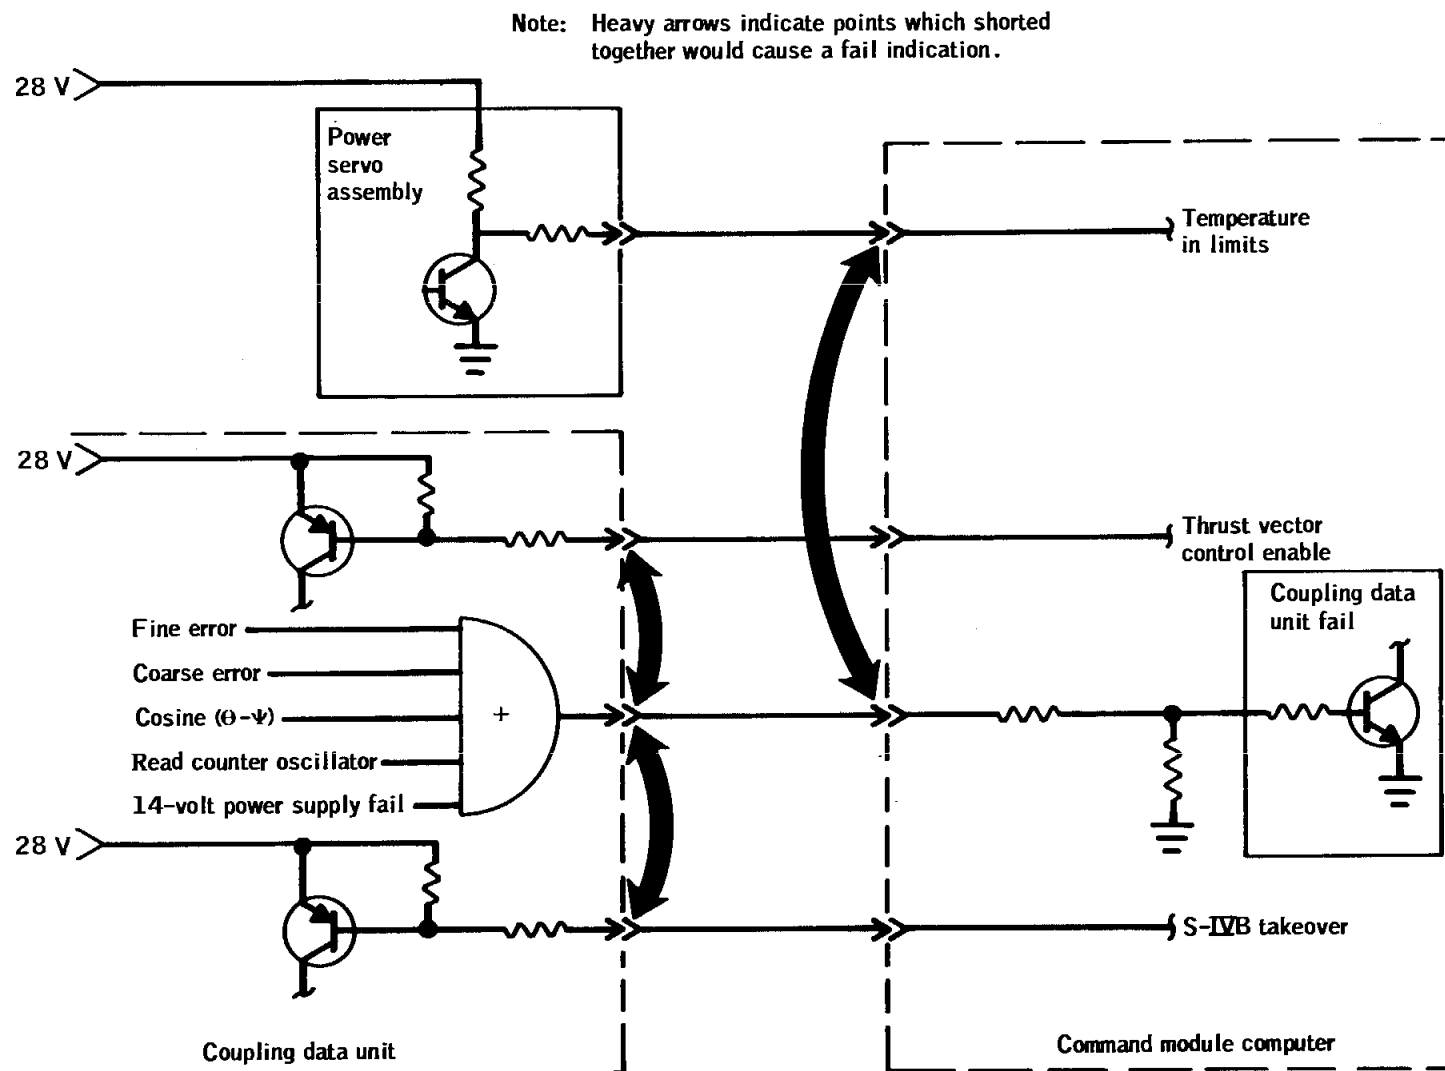
Figure 14-5.- Coupling data unit fail indication.

Data during each occurrence has been reviewed and no abnormalities were observed. If a real failure of the coupling data unit had occurred and lasted as long as 894 seconds, then some data indication should have been observed. For this reason, an intermittent short in the wiring harness or associated connectors shown in figure 14-5 is indicated. However, other possible causes may be an intermittent in the failure detection logic circuits or the input logic to the computer.

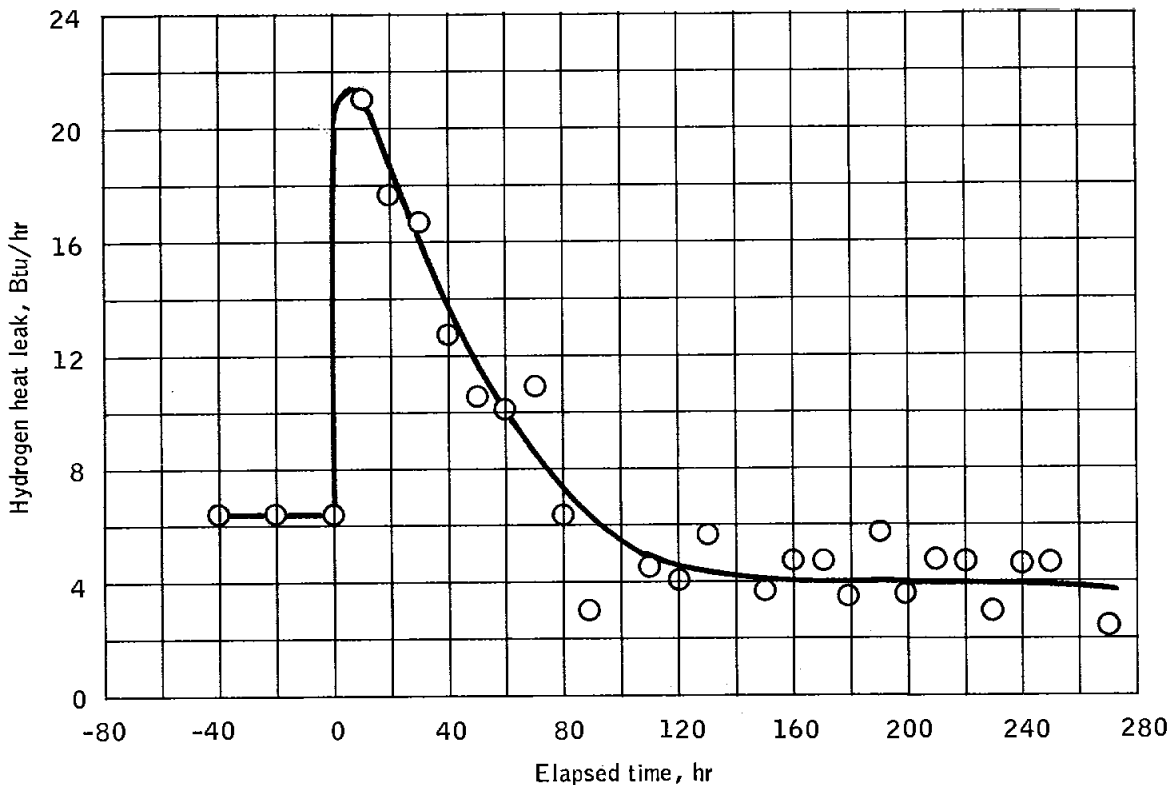
Figure 14-6.- Hydrogen tank heat leak data.

The heat leak into cryogenic hydrogen tank 3 was abnormal during the early hours of the mission. Analysis of the Kennedy Space Center data has shown that the heat leak of this tank was normal prior to lift-off. As shown in figure 14-6, the leak decreased from a high value of 15 to 20 Btu/hour to a normal 2 to 6 Btu/hour by 70 hours and remained normal thereafter. All other parameters were normal.

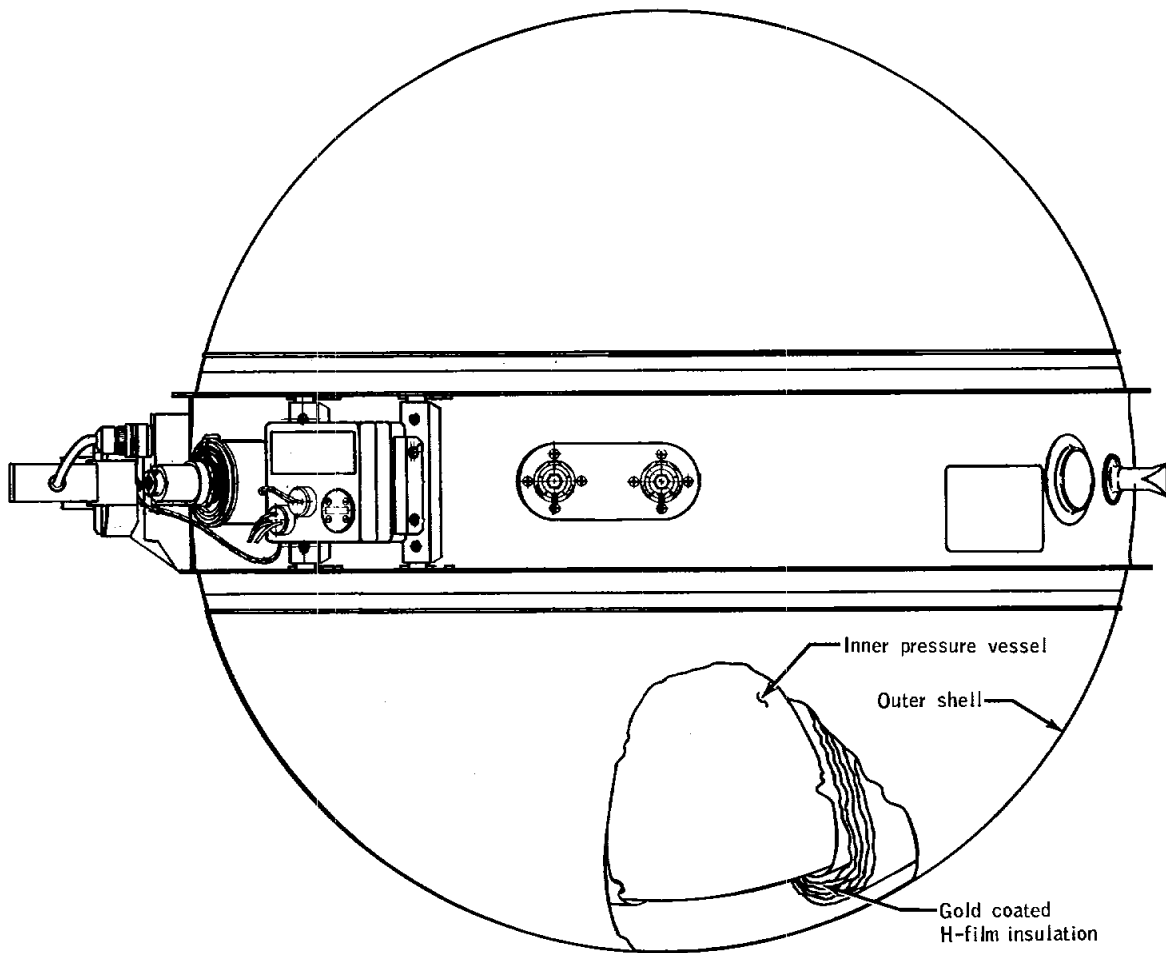
Figure 14-7.- Hydrogen tank.

The insulation for this tank consists of several layers of gold-coated H-film in a vacuum annulus that is formed between the inner pressure vessel and the outer shell (fig. 14-7). The primary insulation system is, however, the vacuum annulus. Degradation of this insulating vacuum will cause a significant increase in the heat leak into the tank as shown in figure 14-8. The analysis indicates that the high initial heat leak resulted from a degradation of this vacuum by approximately one decade (approximately 10^{-6} to 10^{-5} torr). This degradation could have been caused by any of three conditions.

- a. If thermal insulation layers rubbed together during the launch phase vibration, the condition could have caused the release of previously entrapped or absorbed gas molecules into the annulus (hereafter referred to as "insulation scrubbing").
- b. A hydrogen leak from the pressure vessel into the annulus.
- c. An ambient air leak into the annulus during launch.

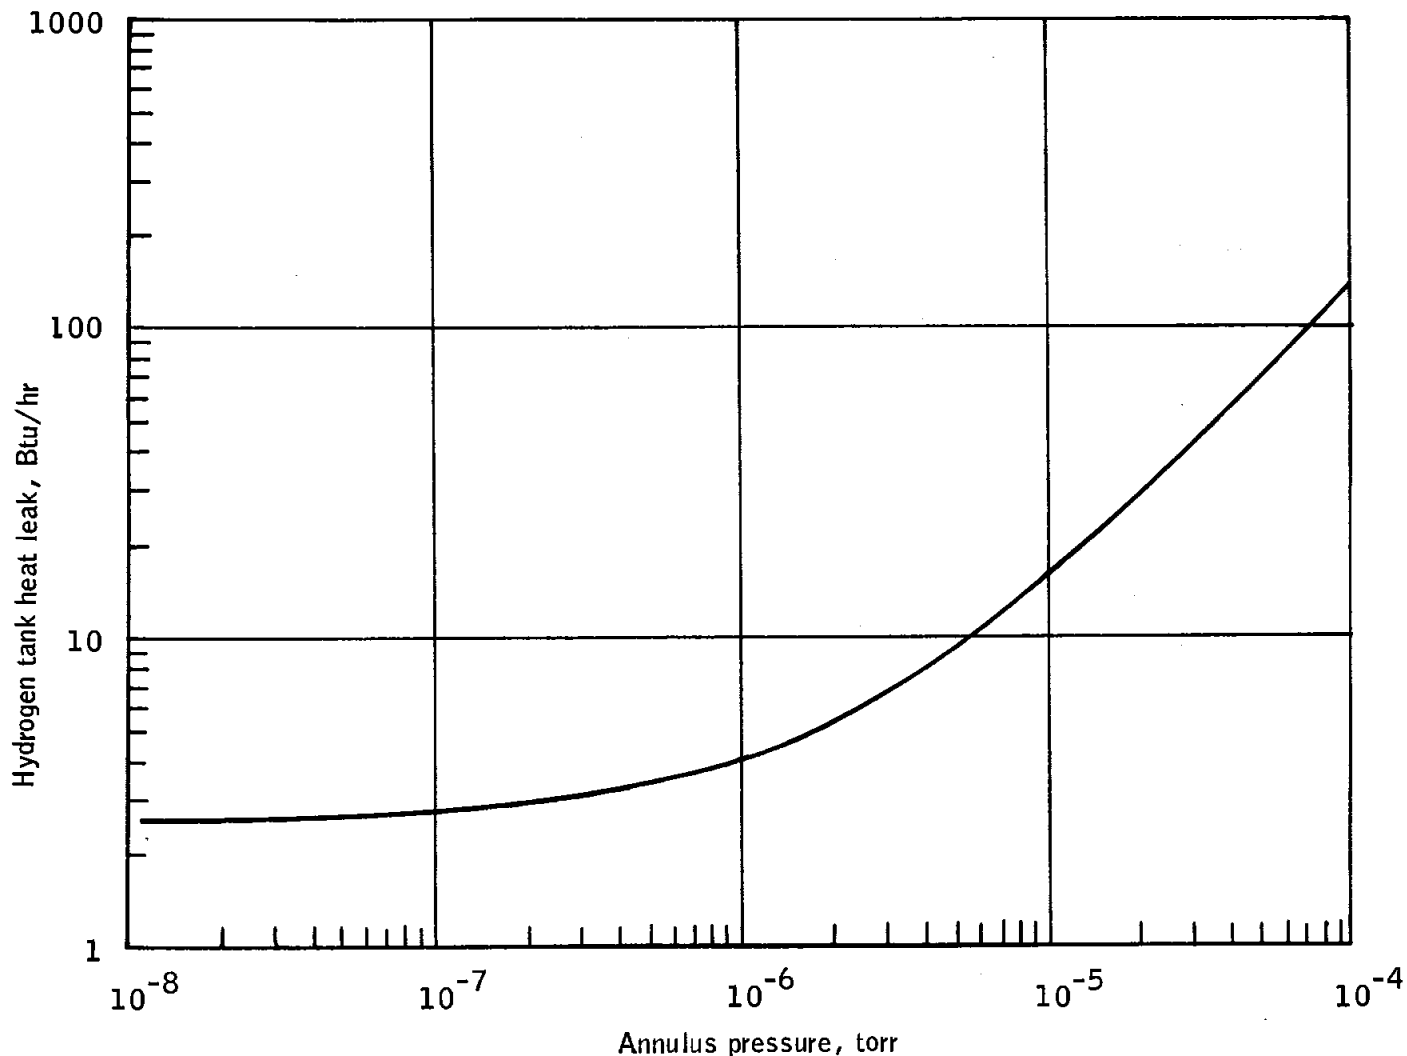
Figure 14-8.- Hydrogen tank heat leak as a function of annulus pressure.

Condition c.— An ambient air leak is the most probable cause of the high heat leak. Figure 14-8 shows that a pressure of 5×10^{-5} torr in the annulus would produce a heat leak of 21 Btu/hr, which is the average observed for the first 10 hours of the flight. The heat leak returned to a normal value of 6 Btu/hr by 80 hours, which corresponds to approximately 2×10^{-6} torr. Assuming that a small hole opened in the outer shell during the launch phase, the annulus pressure would quickly build up to that required to produce the observed heat leak. As the bay pressure continued to decrease and fall below that in the annulus, the annulus pressure would follow the decrease slowly and drop to a final value sufficient to provide the normal heat leak observed by 80 hours. Analysis shows that the area of the opening was at least 2.2×10^{-3} sq cm. For an opening of this size, iterative analysis places the formation of the crack or hole at approximately 2 1/2 minutes into the flight to produce the observed conditions.

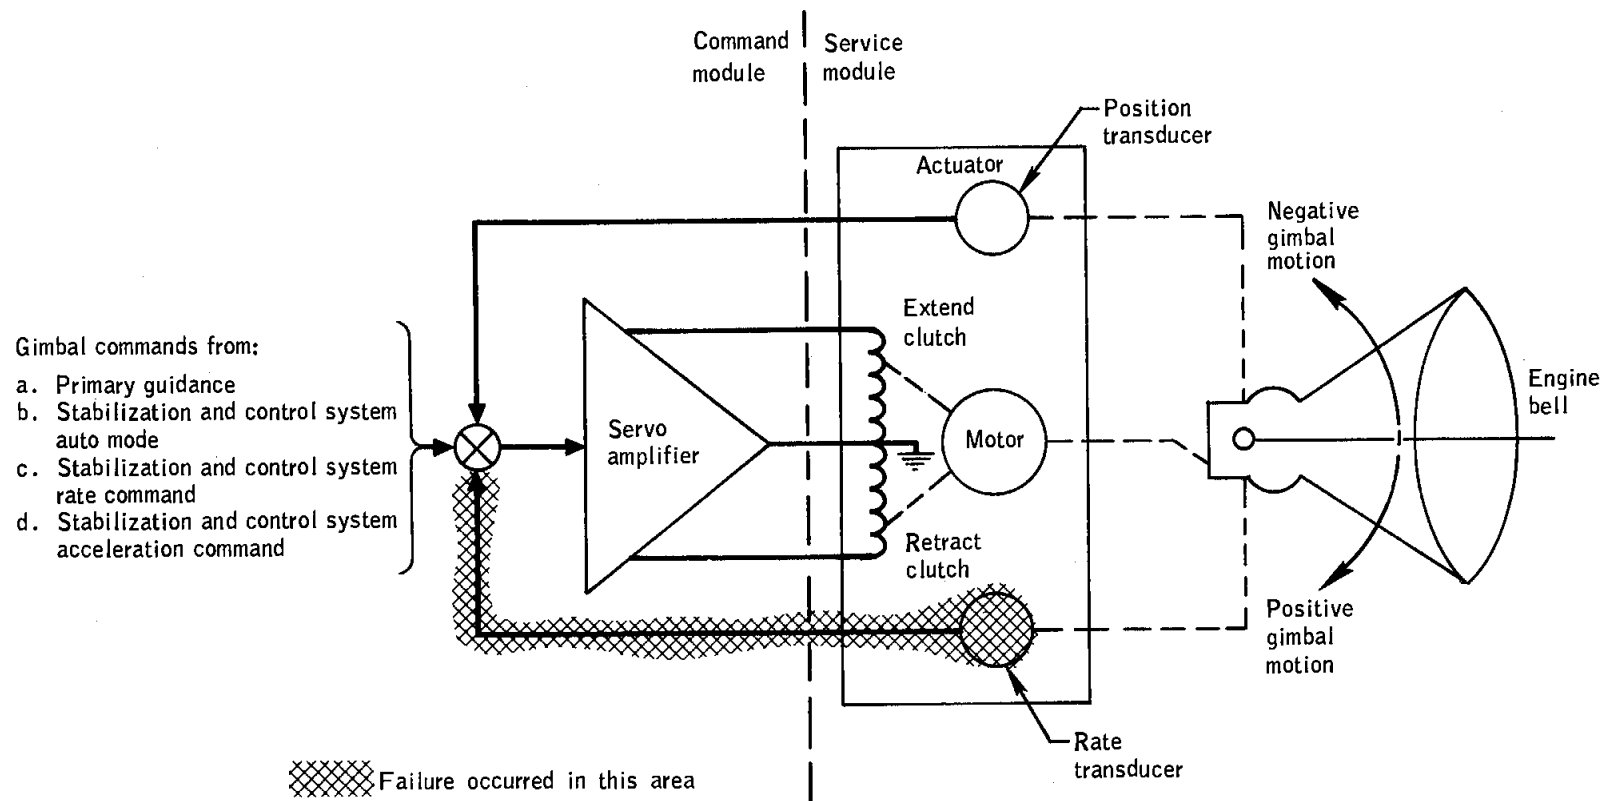
Figure 14-10.- Service propulsion system gimbal servo diagram.

During the pre-ignition checklist for the lunar orbit circularization maneuver, an oscillation was detected in the yaw axis of the secondary servo system for the service propulsion engine gimbal actuator. Figure 14-10 is a functional diagram of the servo loop. The oscillation was present in all modes of operation, but only when the secondary yaw servo loop was used. The oscillation was limited at ± 1.0 degree and at 2.4 hertz with the gimbal correctly following commands to different positions. Figure 14-11 shows one occasion that the oscillation did not occur when repositioning the engine which implies that the failure is electrical in nature.

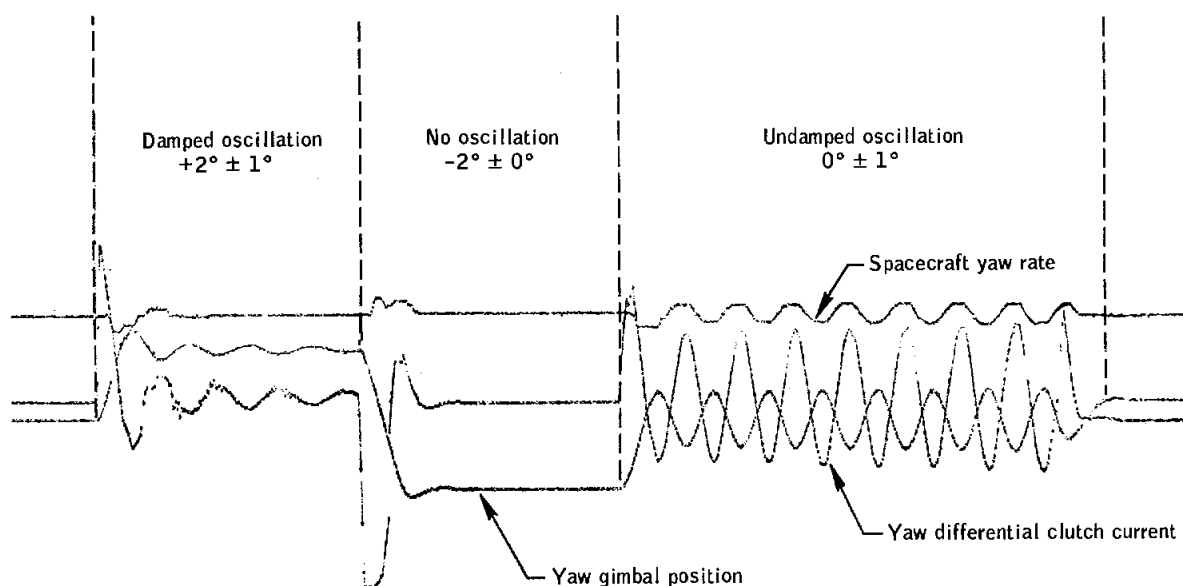
Figure 14-11.- Secondary yaw gimbal drive test
(primary guidance control).

Inflight results were matched by simulations of system performance with an open in the rate feedback loop of the yaw servo system. It was also demonstrated that the oscillations would have damped after ignition because of the side load forces exerted on the engine bell while thrusting. Therefore, the secondary yaw servo system was considered safe to use if the primary servo system were to fail and it became necessary to switch over to the secondary system.

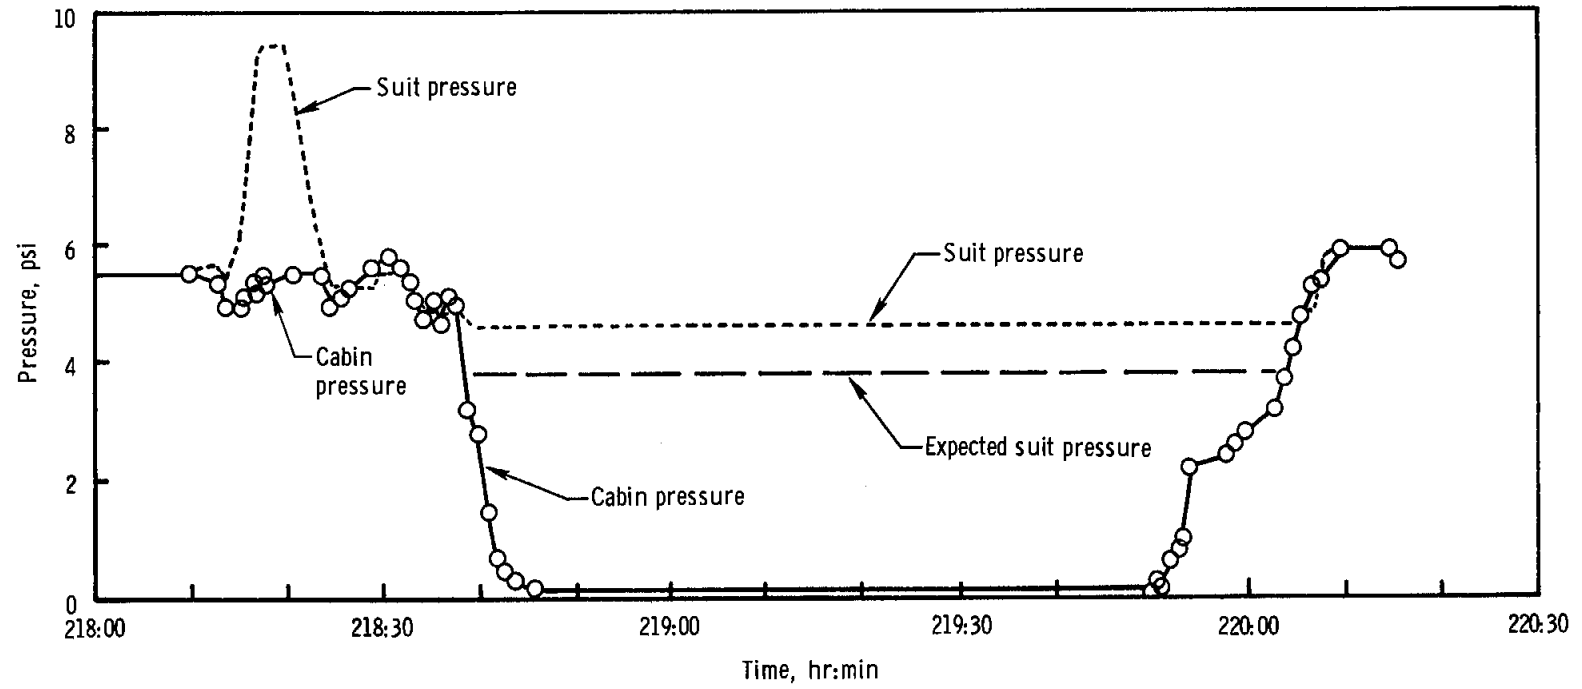
Figure 14-13.- Suit loop pressure data.

While the cabin was depressurized during the transearth extravehicular activity, the indicated environmental control system suit loop pressure transducer reading was 4.6 psia (fig. 14-13). Specification values for this regulated pressure are 3.5 to 4.0 psia and the control point determined from Kennedy Space Center altitude chamber testing was 3.8 psia. The Commander's and Lunar Module Pilot's suit cuff gage readings of 3.5 and 3.8 psia indicated that pressure regulation was satisfactory and that the transducer reading was erroneous.

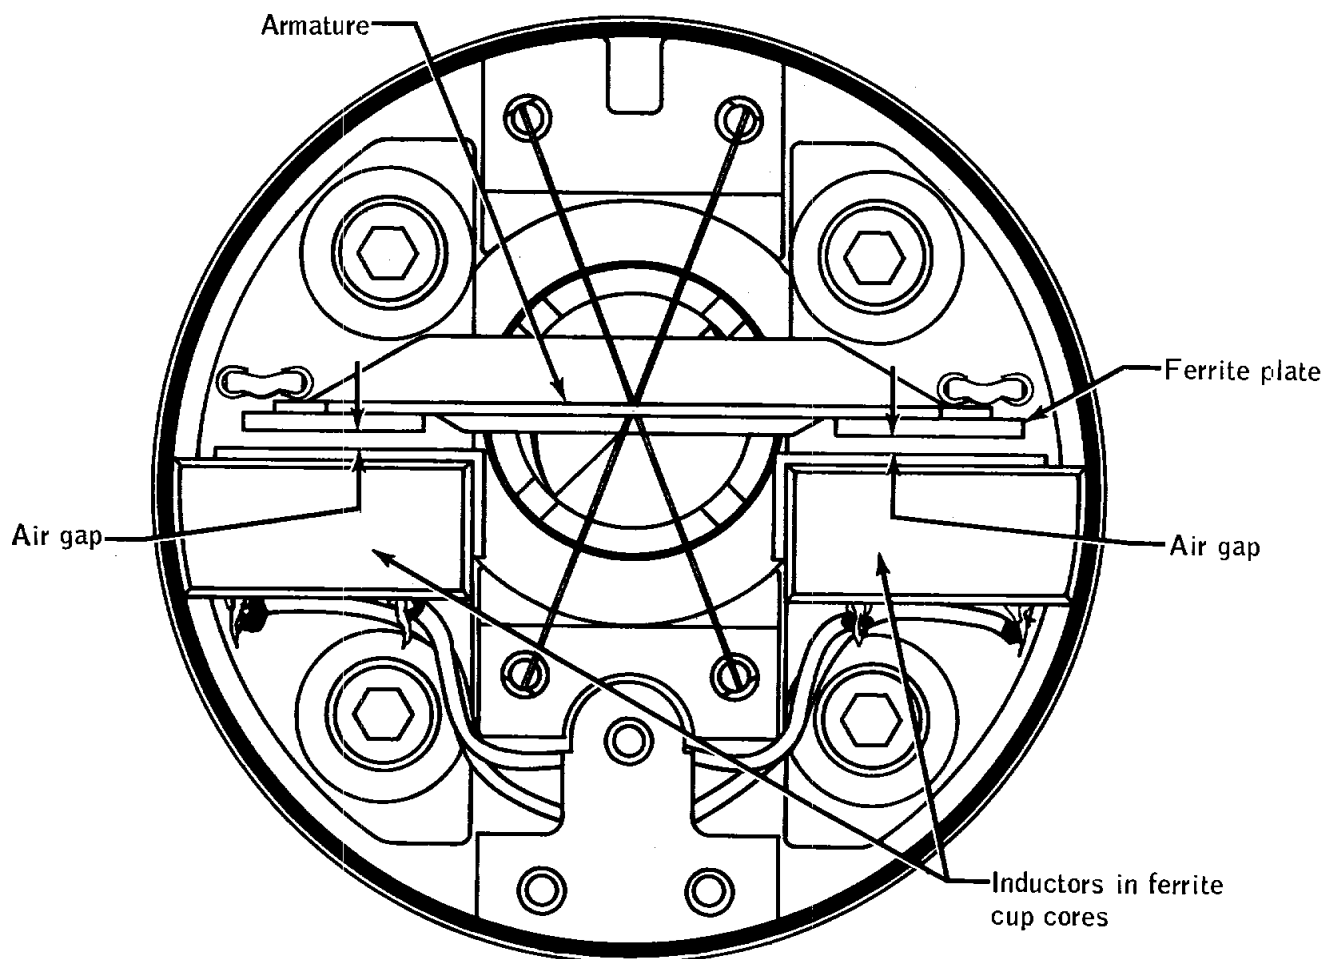
Figure 14-14.- Suit pressure transducer.

were conducted. The results were within tolerance. Teardown analysis revealed three particles of calcium aluminum silicate (lunar origin) ranging from 500 to 2000 microns in size in the sense cavity. If one of the lunar particles had been caught in the air gap (see fig. 14-14) of the variable reluctance element, the armature would transmit an incorrect signal. Normal readings were obtained when the cabin was repressurized and a suit pressure in excess of 4.6 psia was obtained. This could have freed any particle that might have been lodged in the air gap.

The corrective action for Apollo 17 and later spacecraft will be to add a 5-micron filter in the suit pressure sense line to protect the suit pressure transducer.

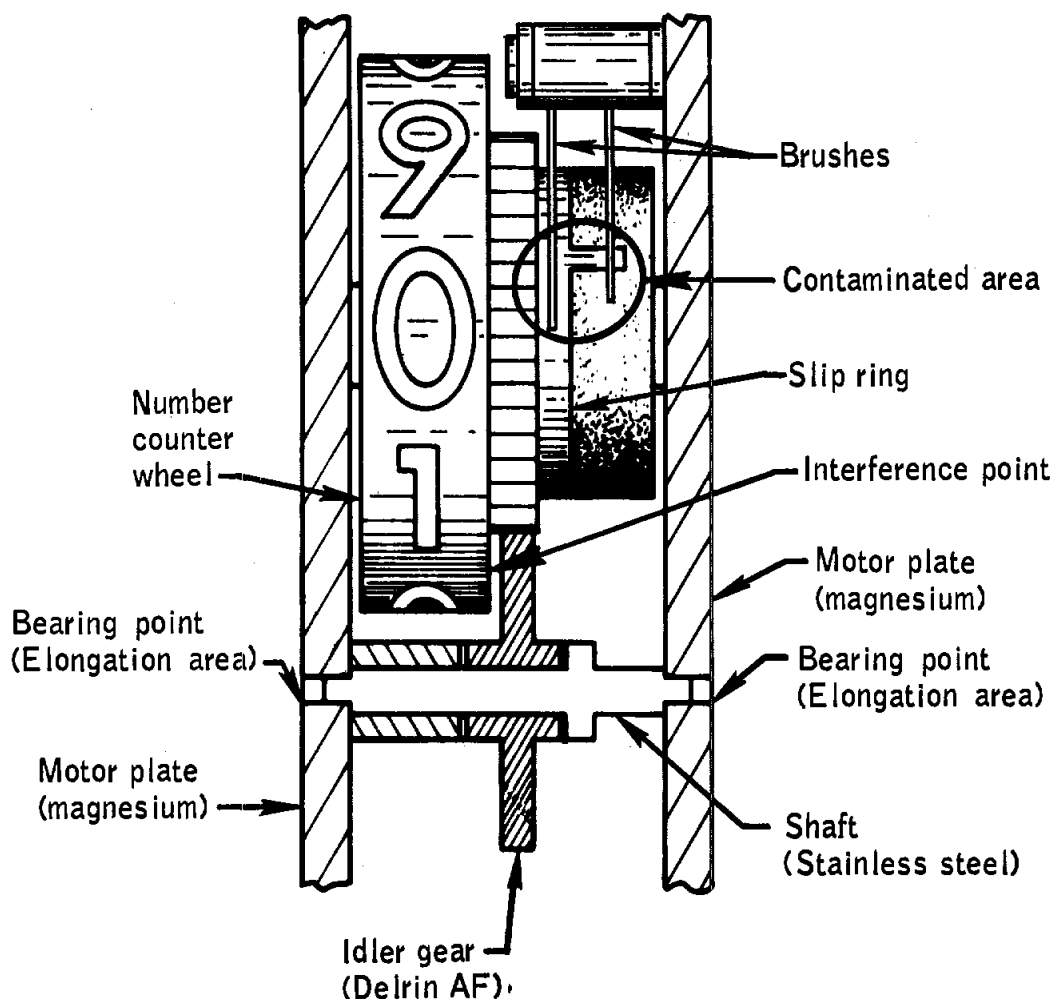
Figure 14-15.- Digital event timer seconds counter.

Inspection of the digital event timer showed that the bearing points in the magnesium motor plates had been elongated. The idler gear is free to rotate on the shaft (fig. 14-15); however, the design permits the stainless steel shaft to also rotate which would account for the wear in the motor plates. The elongated bearing points permitted the idler gear to rub against the number wheel. This interference rubbed paint off the number wheel and the paint particles prevented the slip rings and brushes from making good contact which affected proper counting of the seconds wheel.

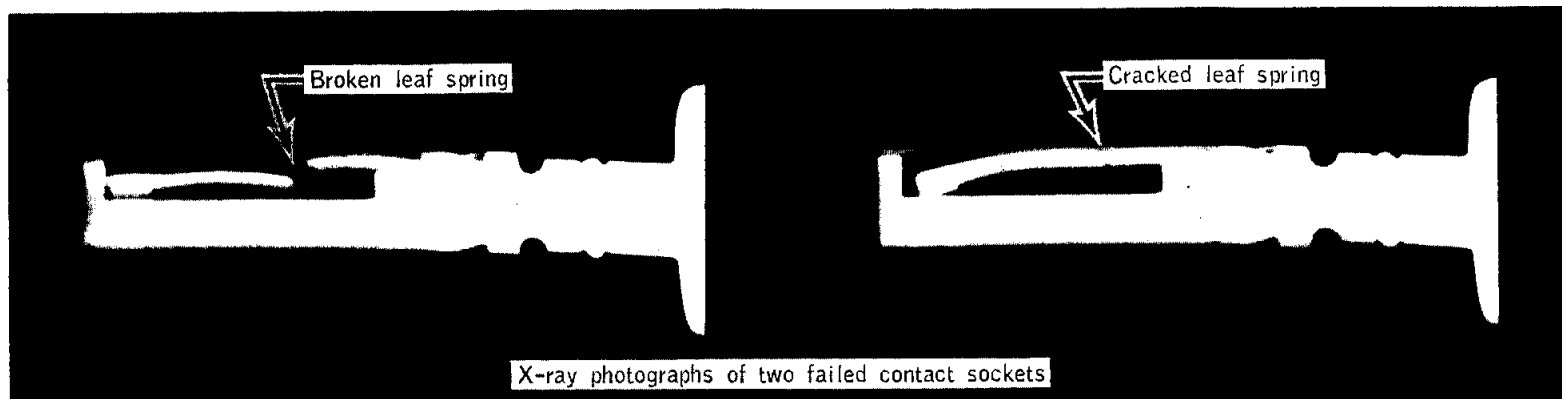
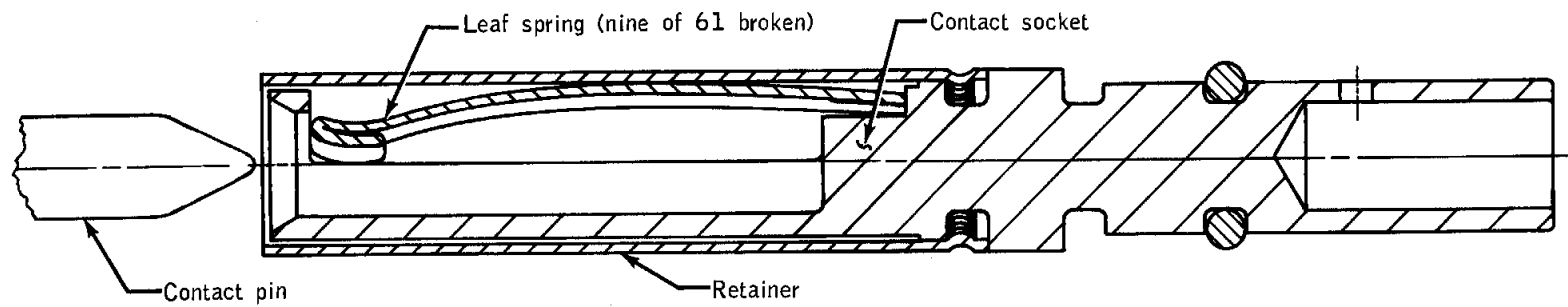
Figure 14-16.- Contact and leaf spring arrangement of optical unit connector.

The optical unit assembly was thoroughly soaked during recovery by salt water which caused extensive corrosion. The unit was cleaned, however, and tested. The intermittent flight condition was reproduced by wiggling the scanning telescope wiring harness in the optical unit assembly. An examination of the female connector on this harness revealed 9 of 61 contact springs (fig. 14-16) were cracked or broken. Also, several contact springs were found broken in a 91-pin connector in the optical unit assembly. The cause of the broken springs is being investigated.

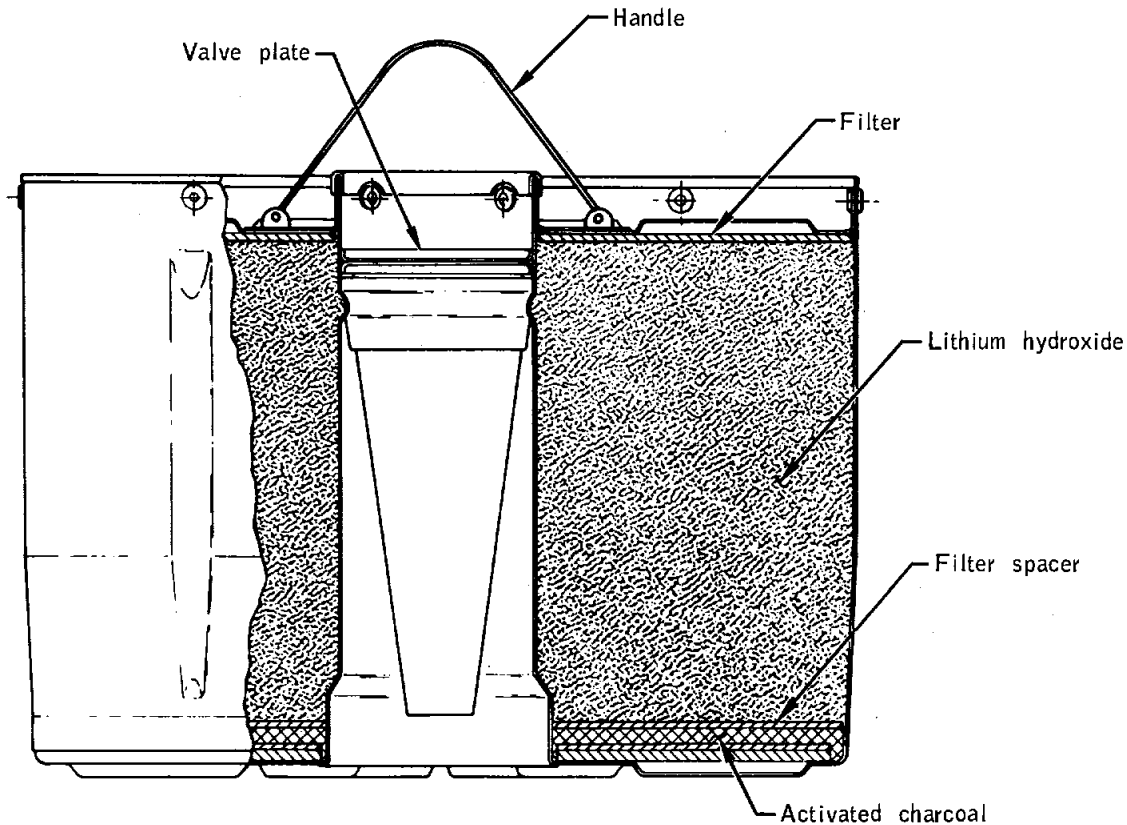
Figure 14-17.- Lithium hydroxide canister.

Although canister 10 was jettisoned with the lunar module, canister 12 was returned for inspection and analysis. Figure 14-17 shows a cross-section of the lithium hydroxide canister. The lithium hydroxide swells while it is being used, and to account for this swelling, the units are fit checked in the spacecraft with 0.030-inch shims on all sides. Additionally, the pull force required to remove the canister is checked with the shims in place. An analysis performed on five separate layers of the chemical bed indicated that approximately 32 percent of the lithium hydroxide had been used. In addition, the analysis showed the moisture content to be approximately 21 percent compared to a range of 5 to 10 percent found in canisters used during the solo period on previous flights.

A dimensional analysis showed both sides of the environmental control unit canister receptacle to be within specification, although postflight removal forces using the canisters indicated a tighter fit in side B (53-lb pull) than side A (22-lb pull). The preflight pull force for this canister was 18 pounds. Normally, pull forces for these canisters are 10 pounds or less.

The combination of the adverse environment and the initially tighter-fitting canister apparently accounted for the removal difficulty.

To prevent recurrence of this problem during the Apollo 17 mission, the prelaunch insertion and removal force specification during fit checks at the Kennedy Space Center will be changed from 30 pounds to 8 pounds for the canisters to be used during the solo activities. The maximum allowable force on the remaining canisters will be reduced to 15 pounds. In addition, flight procedures will be changed to insure that the suit flow control valves are positioned to cabin flow for solo operation.
