MSC-07230

APOLLO 16 MISSION REPORT

MANNED SPACECRAFT CENTER

AUGUST 1972

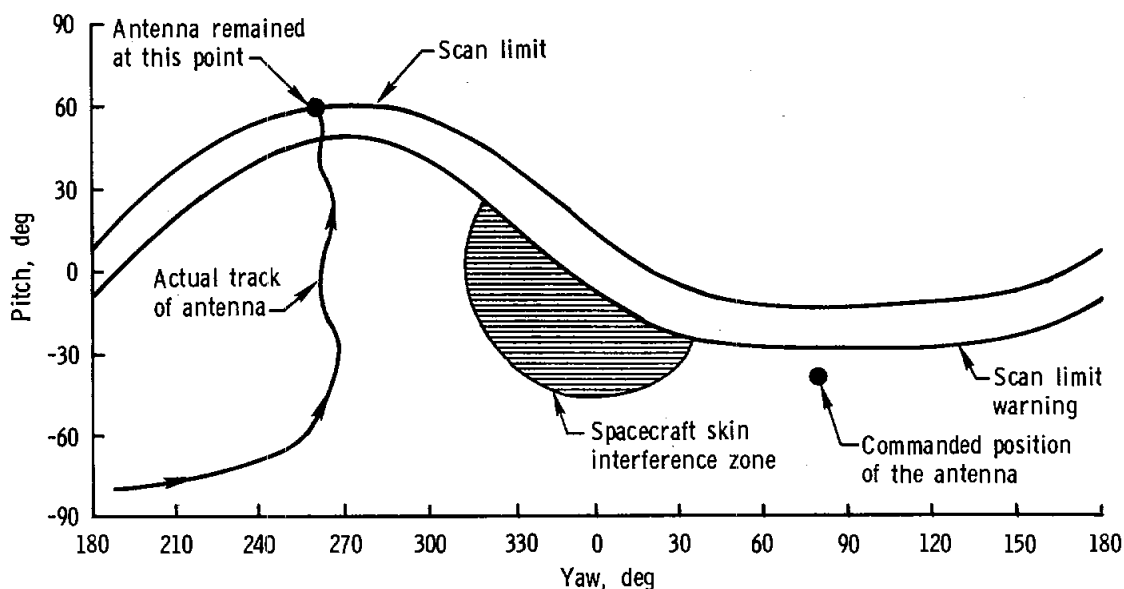
Figure 14-18.- High gain antenna scan limit.

the spacecraft were being maintained by ground-commanded switching between the high-gain antenna and omnidirectional antenna D. The initial indication of a problem occurred at about 234:04 when the high-gain antenna reached the scan limit and failed to drive to the position set on the manual controls. Figure 14-18 shows the path taken by the antenna prior to the anomaly, where it stopped, and the position to which it should have driven. The antenna remained at the position indicated until the crew awakened about 1 1/2 hours later and cycled the high gain antenna track mode switch from "reacquisition" to "manual" and then back to "reacquisition".

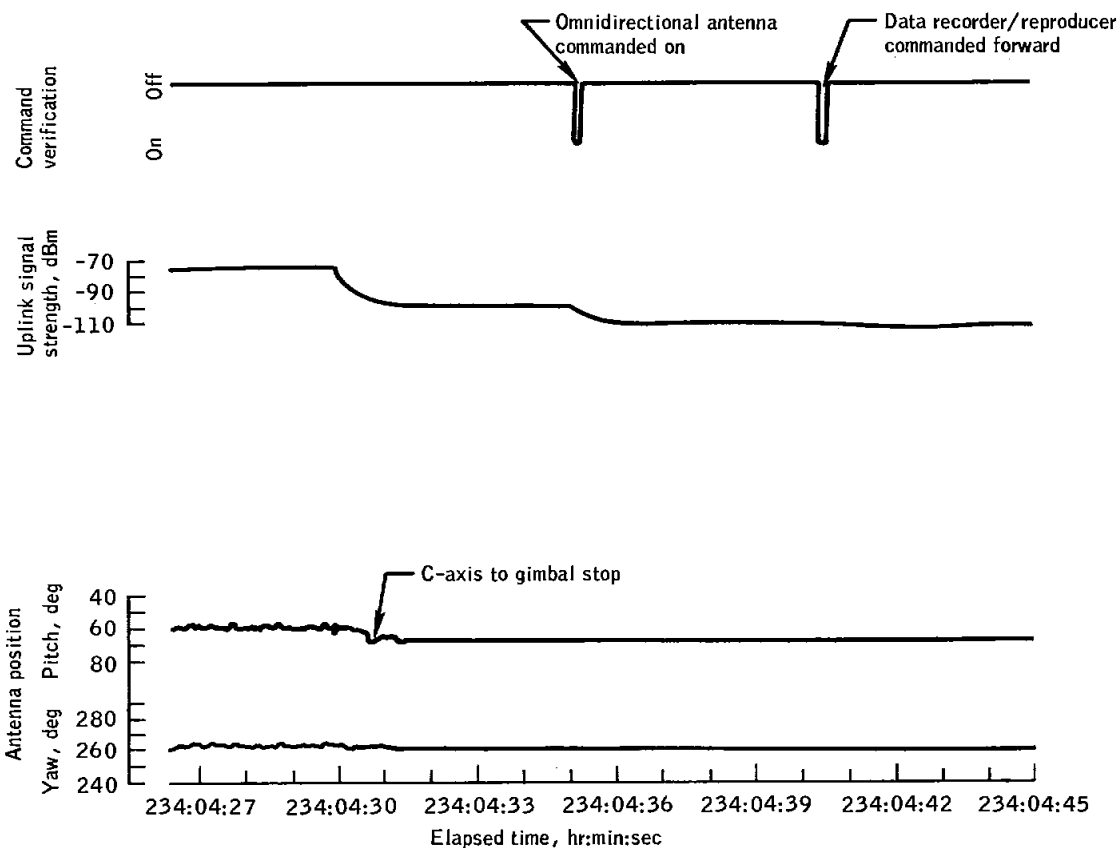
Figure 14-19.- High-gain antenna data at beginning of anomalous period.

Figure 14-19 shows the pitch and yaw positions and signal strengths in the time frame of the problem. This figure indicates normal high gain antenna operation up to and immediately following entry into the scan-limit region. The step decrease in both uplink and downlink signal strength was due to switching from narrow to wide beam. Such a beam switch results when the logic latchup circuit 2 latches (fig. 14-20). Logic latchup circuit 2 latches when logic latchup circuit 1 latches and logic latchup 1 latches when the antenna with the "reacquisition" track mode selected, tracks from the clear track area to the scan limit. Latching of logic latchup 1 also internally switches the antenna to manual track. For the

antenna position (pitch = 60 degrees and yaw = 258 degrees at the scan limit) and the commanded position (pitch = -44 degrees and yaw = 84 degrees), the C-axis error signal is large and it should drive the C-axis to the gimbal stop upon switching to "manual". The A-axis should also start rotating, but its response is very slow because it is essentially 180 degrees away from the commanded position. The A-axis manual error signal also has a false unstable null 180 degrees away from the true null. The rapid change in pitch shortly after the beam switching, shown in figure 14-19 (from approximately 59 deg to 71 deg) is verification that the C-axis drove to the stop as expected. Normally, the C-axis would remain against the gimbal stop until the A-axis rotated approximately 90 degrees and then would drive away from the stop to the commanded position.

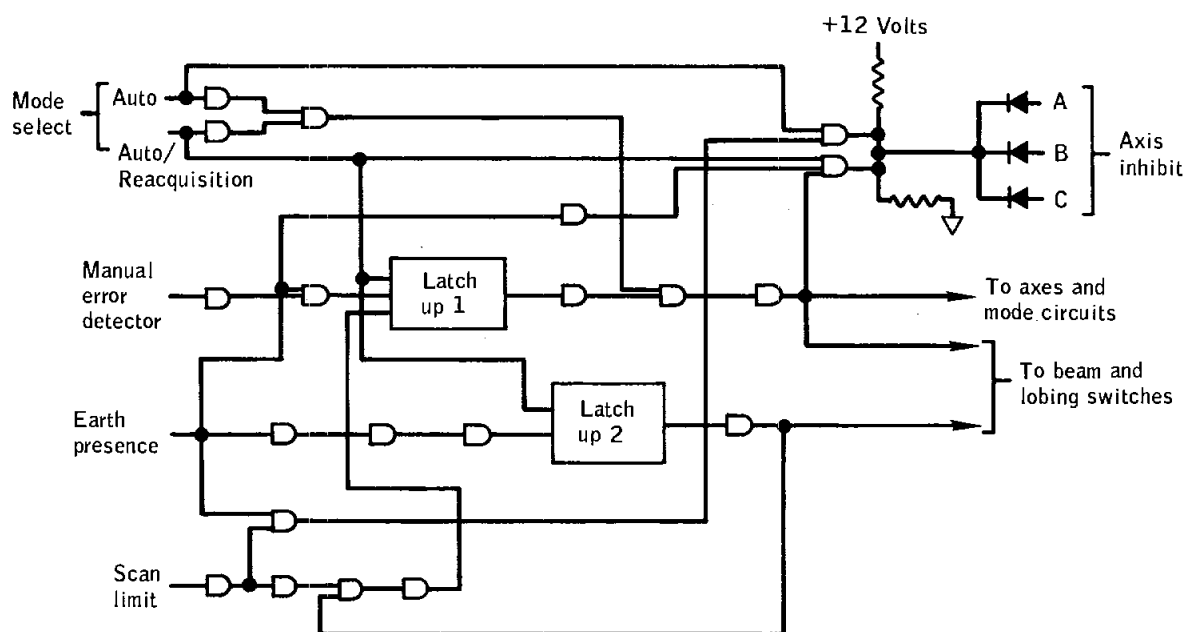
Figure 14-20.- High-gain antenna logic diagram.

no noise has been associated with the "inhibit" mode. Figure 14-20 shows that selecting the "automatic" mode and reaching the scan limit triggers an "inhibit" circuit.

Tests did indicate, however, that the anomaly could be the result of simultaneous selection of both the "reacquisition" and "automatic" track modes. In this case, an inhibit would result if the antenna entered, and remained inside the scan limit (fig. 14-20). Simultaneous selection of both "reacquisition" and "automatic" track would require a fault, or malfunction in the mode select switch, associated spacecraft wiring, or internally in the high-gain antenna electronics. Although the telemetry data indicate no voltage on the "automatic" select line, such a condition could occur and not be detected. The mode select switch and the associated wiring, however, were thoroughly checked, including disassembly and inspection of the switch, and no discrepancies were noted.

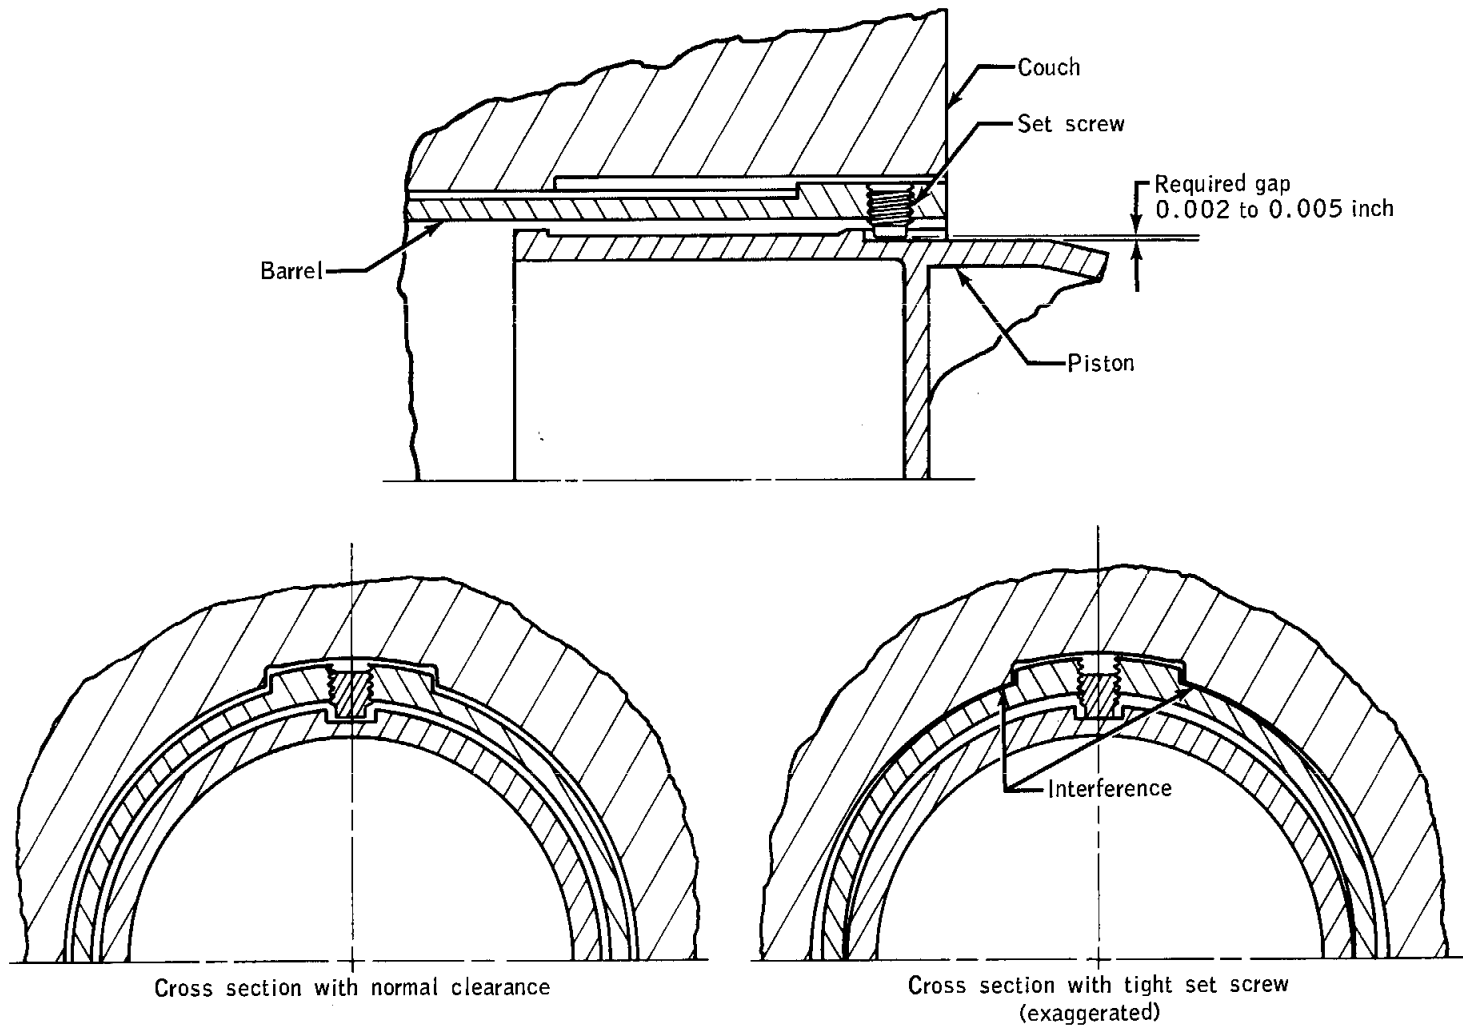
Figure 14-22.- Couch strut interference.

- a. Wear areas along the keys
- b. The strut barrel was 2.757 inches in diameter and should have been between 2.740 and 2.750 inches
- c. The set screws which provide a stop for the strut piston in the strut barrel were bottomed out against the piston.

The strut barrel was deformed by the set screws and caused the wear along the keys because the barrel became within tolerance as soon as the set screws were adjusted to the specified gap of 0.002 to 0.005 inch.

A similar condition was reported on the Apollo 17 spacecraft and corrected by adjusting the set screws. Engineering has been released to verify these dimensions prior to installation for future spacecraft.

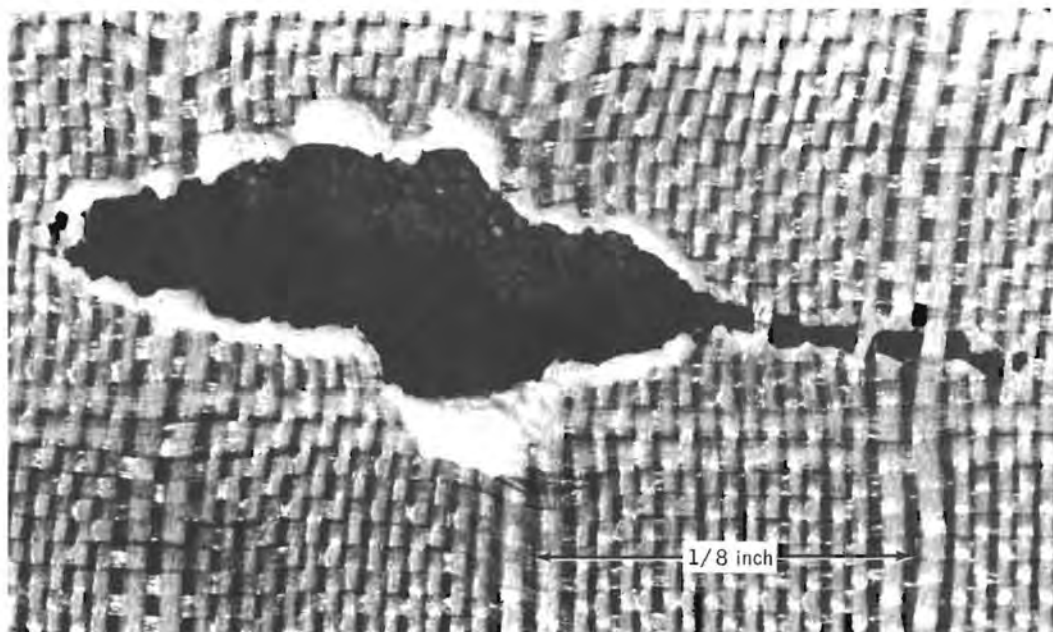
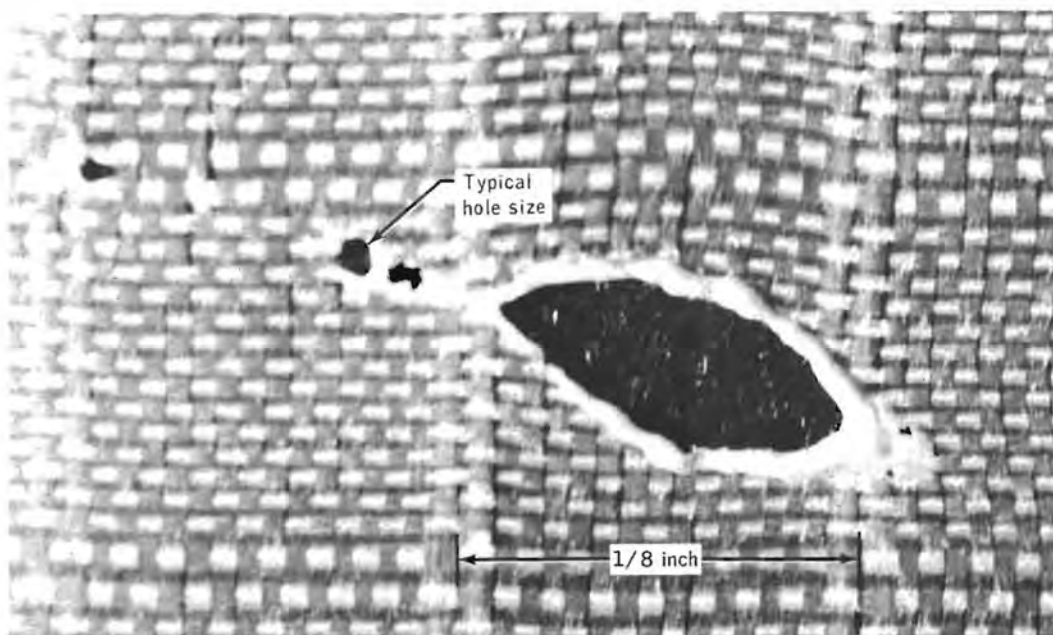
Figure 14-23.- Typical burn holes found in recovered parachutes.

Inspection of the canopy of one of the recovered main parachutes indicated numerous small burn holes which are similar to the burn holes observed on parachutes from previous missions (fig. 14-23). The cause of the earlier holes had been attributed to the reaction control system oxidizer.

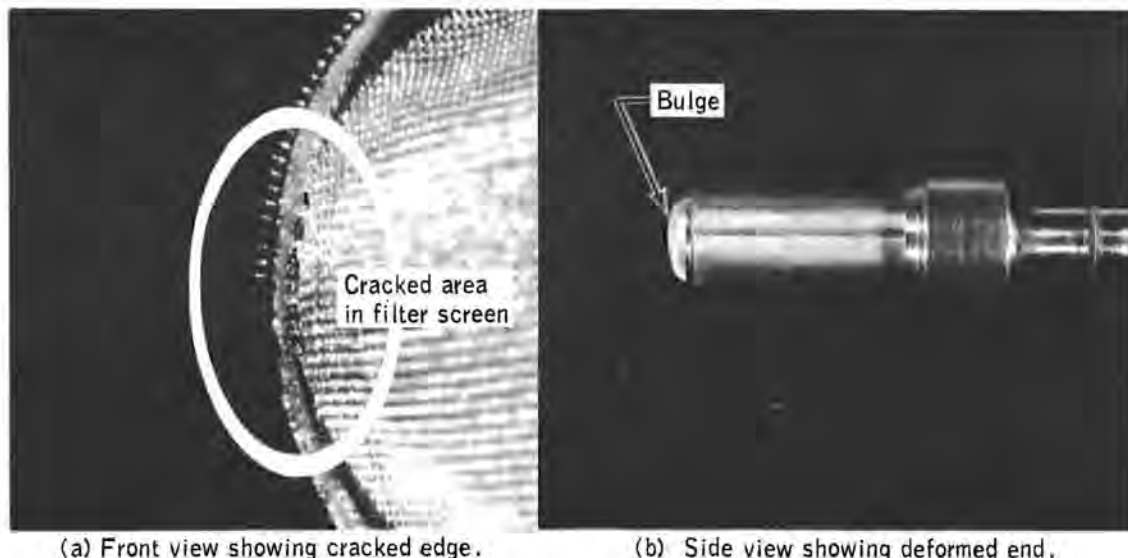
Figure 14-25.- Reaction control system regulator filter.

As a result of the Apollo 16 lunar module reaction control system regulator anomaly, the command module reaction control system regulators were removed for postflight testing and examination. A visual examination showed two of the regulator cylindrical-inlet-filter assemblies were deformed in the area of the end screen (fig. 14-25). On one filter, the end screen was bulged out about 0.060 inch. The visual examination also revealed that these two filters have either a wire separation or crack in the end screen near the peripheral weld area. Tests showed that the bubble point on the worst-case filter had increased to 100 microns (specification is 25 microns). The filters on the other two regulators were essentially normal, and testing on these two regulators showed completely normal characteristics.

The deformed filters are being evaluated. This evaluation includes retesting the filters for bubble point and performing a microscopic examination and a metallurgical examination in the areas of the wire separation. The objective of this investigation is to establish if the deformation is a normal condition resulting from system activation or if a unique condition occurred on Apollo 16.

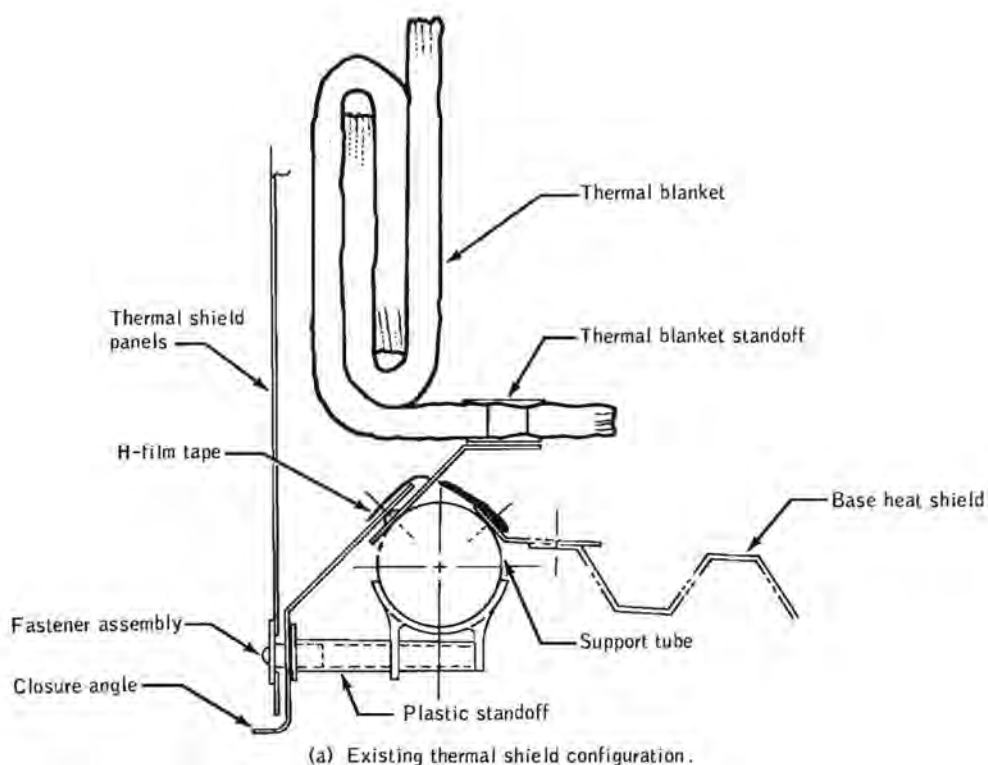
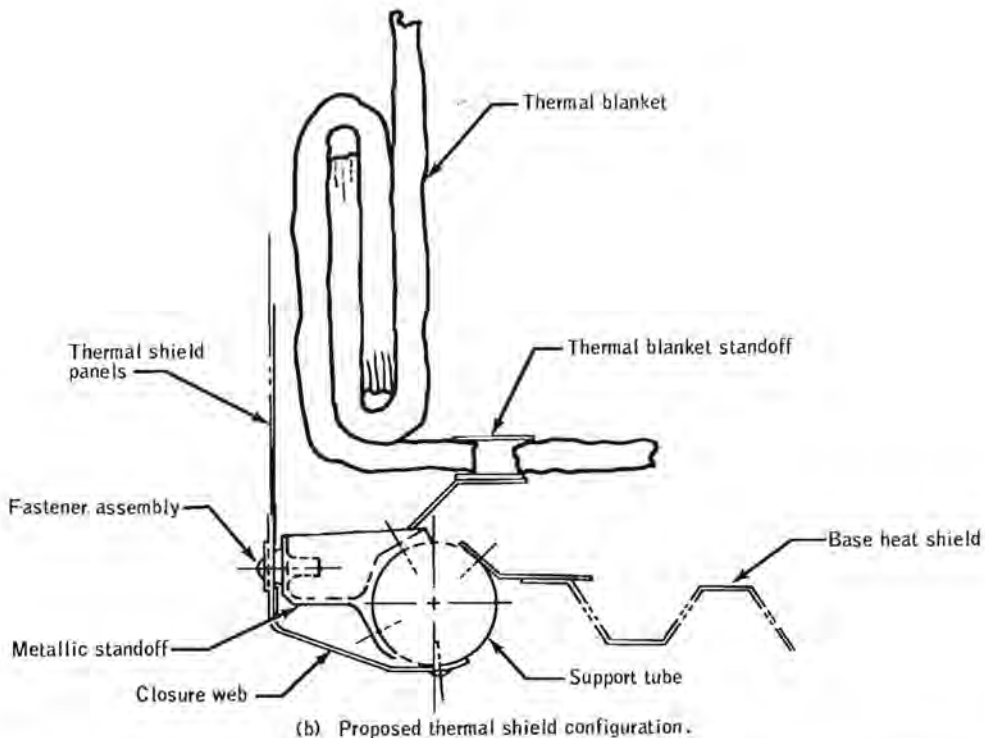
Figure 14-27.- Aft equipment rack thermal protection configuration.

The most probable cause of the failure was ascent engine exhaust entering the cavity behind these thermal shields. A cross section of the lower edge of the shields is shown in figure 14-27. Analysis shows that the thermal shield which extends below the support tube allows a pressure buildup on the closure shield which exceeds its capability. Once the closure shield failed, the exhaust entered the cavity behind the shield, resulting in a pressure buildup exceeding the capability of the vertical thermal shields. The detailed flight configuration in this area was not tested.

The corrective action will include a redesign of the thermal shield to eliminate the projection below the support tube, as shown in figure 14-27, and to provide additional venting to the blankets as well as additional standoffs.

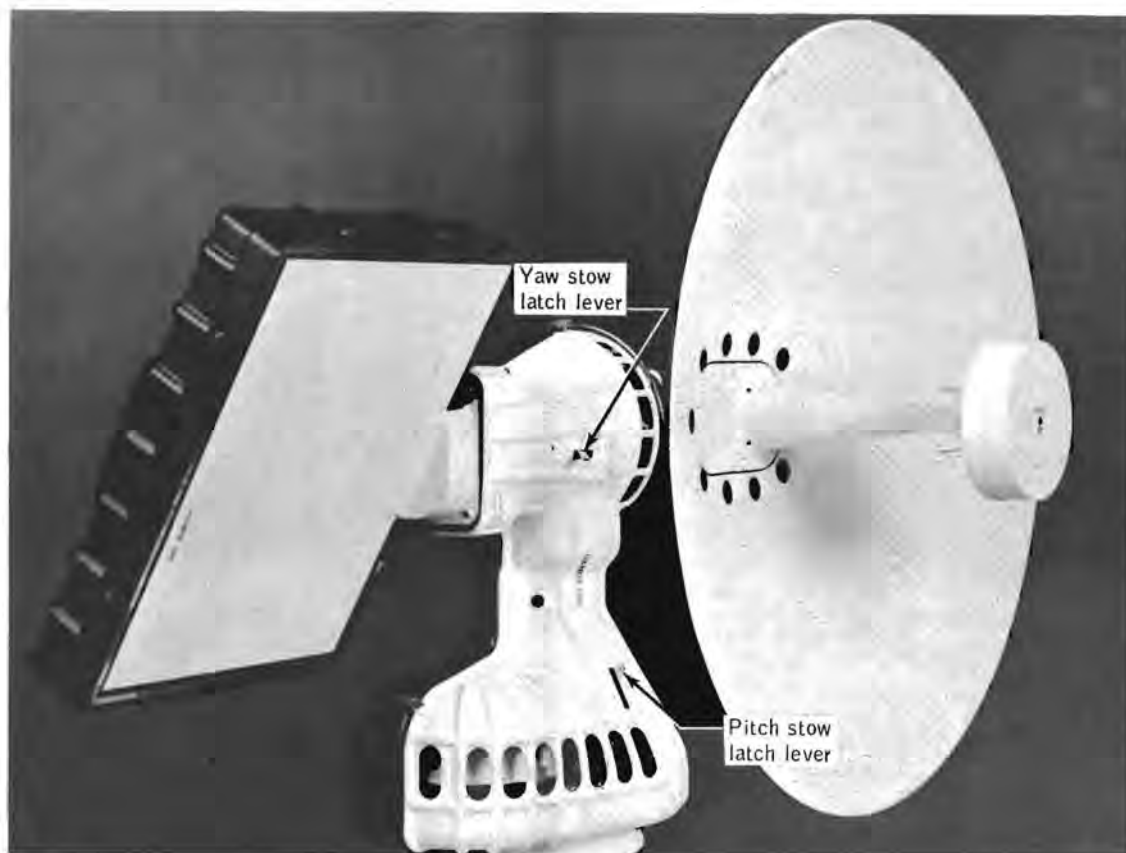
Figure 14-29.- Lunar module S-band steerable antenna.

The S-band steerable antenna (fig. 14-29) would not move in the yaw axis during initial activation. Several unsuccessful attempts were made to operate the unit using both the manual slew and auto track modes. Photographs and inflight test data show that the problem was caused by failure of the mechanical stow latch to release.

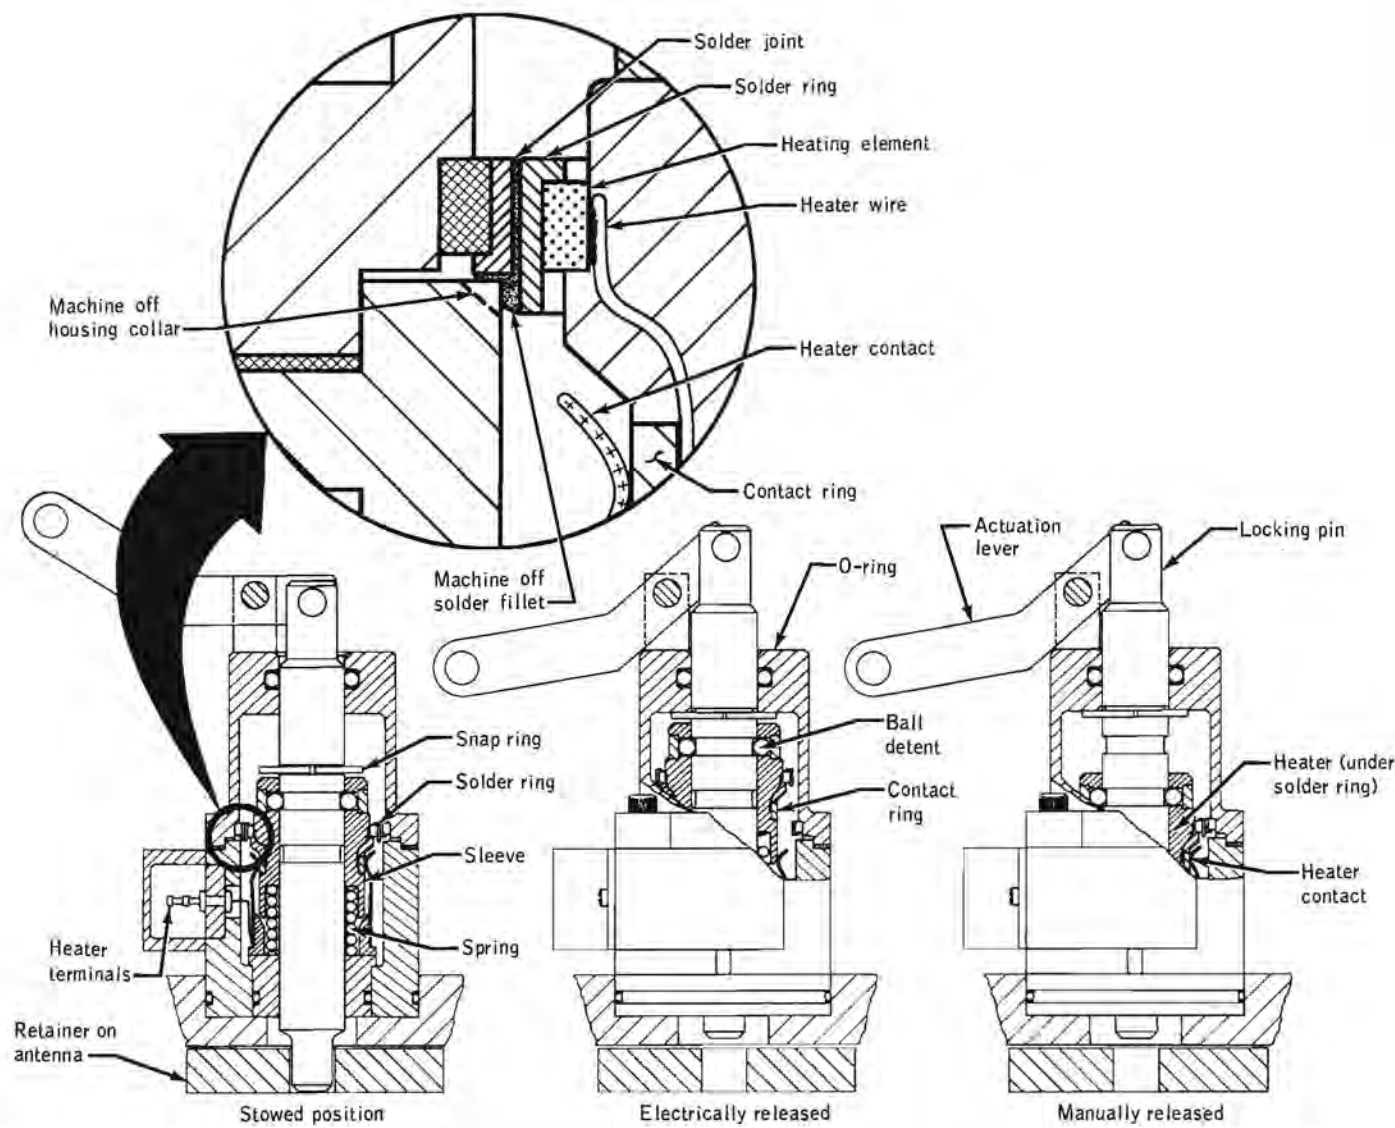
Figure 14-30.- Antenna stow latch mechanism.

Antenna photographs taken on the lunar surface and in lunar orbit prior to docking indicate that the lever for the yaw axis latch was still in the locked position. The crew noted a 2- to 3-degree movement of the yaw indicator during activation attempts. Ground tests have shown that the tolerances in the antenna retainer/locking mechanism will allow a slight movement of the antenna dish even though the pin is locked.

There are several areas in the electrical circuitry which could have caused the problem. One is that one contact in the safe/arm switch (figure 14-31) did not make. The second is that an open may have existed downstream of the safe/arm switch, either in the solder-melting element or in the wiring back through ground. A resistance measurement is made across the two parallel solder-melting elements prior to flight. About a 3-ohm increase in resistance was found at the last check. This change is equivalent to a possible 10-ohm increase in one of the elements which could have reduced the power dissipation below that required to melt the solder. Allowable tolerances on mechanical drawings and tests on sample latches have shown that it is possible for a solder fillet extending below the ring to make physical contact with the housing (fig. 14-30). The

contact allows the housing to act as a heat sink and, under marginal electrical conditions, draw off sufficient heat to prevent melting of the ring.

Several corrective actions are planned for Apollo 17 to cover all reasonable possibilities of failure. These include:

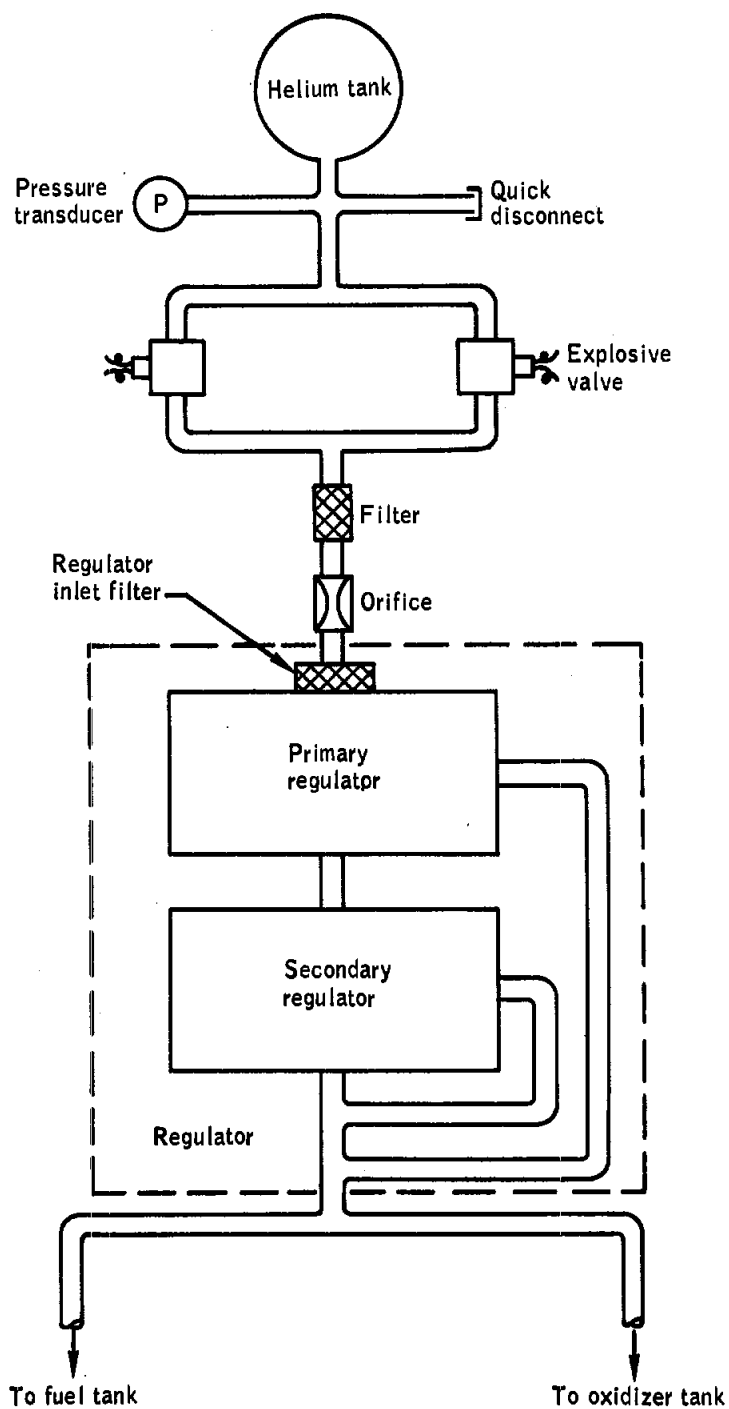
Figure 14-32.-- Reaction control system pressurization system.

During pressurization of the system at about 95 hours, the regulator outlet pressure in system A (fig. 14-32) increased above regulator lockup pressure. The normal pressurization is characterized by a sharp increase from the nominal pad pressure, in the interval of 1 to 2 seconds, to the normal regulator outlet pressure. The outlet pressure of system A, after reaching the normal value of 184 psia, continued to rise at approximately 10 psi/minute, a condition which clearly indicated the existence of internal leakage in the regulator assembly.

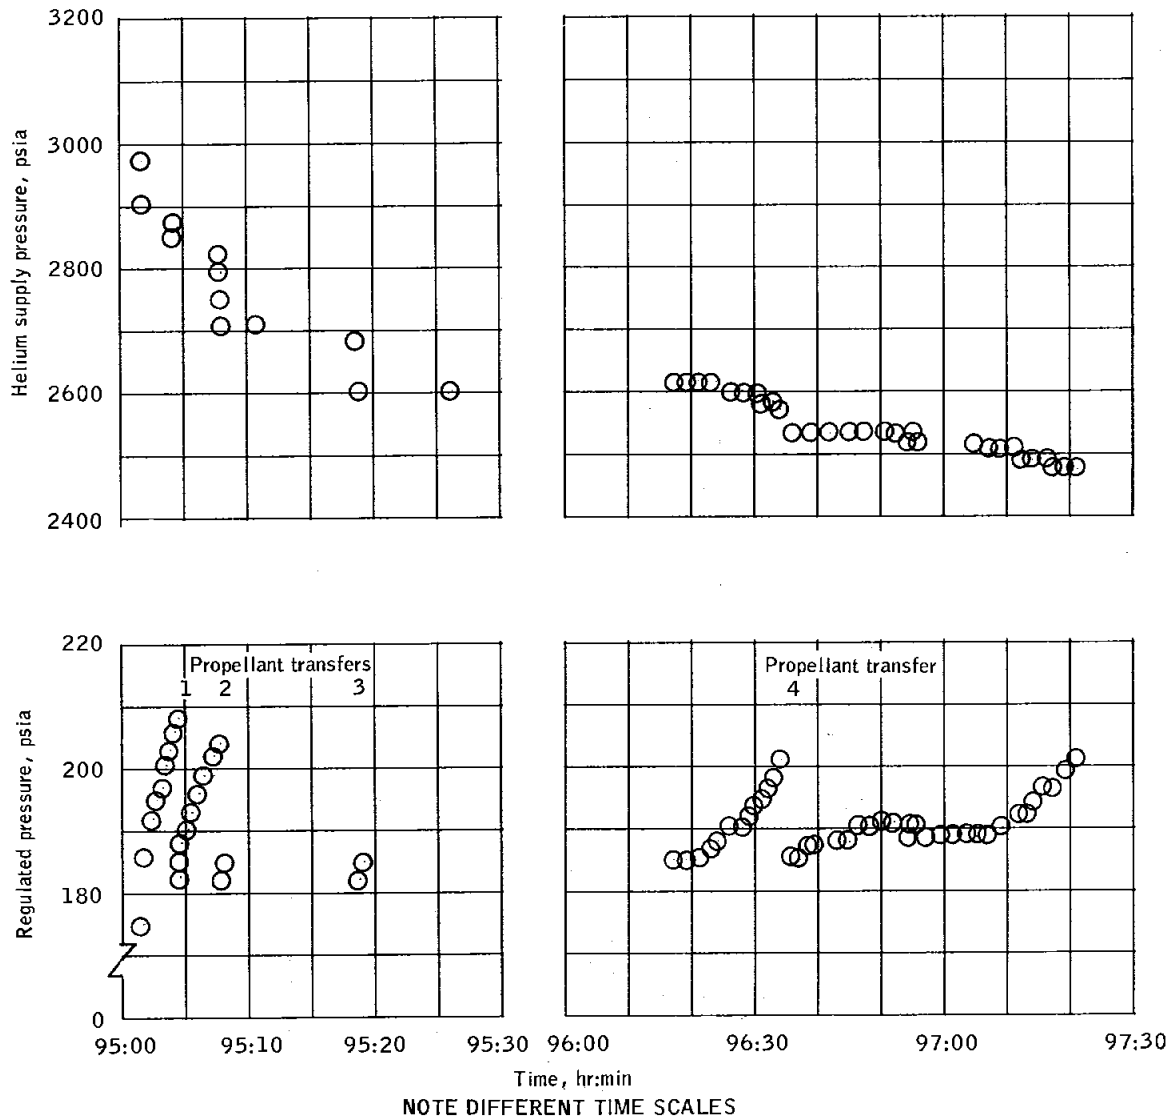
Figure 14-33.- Comparison of helium supply pressure and regulator outlet pressure following reaction control system pressurization.

Approximately 3 minutes after pressurization, the first of four propellant transfer operations was performed (fig. 14-33) to lower the ullage pressure and to create a larger pressurant volume in the propellant tanks, thereby obtaining a blowdown capability for expulsion of the remaining propellant in case of total loss of system A pressurization gas through the relief valves. The helium leakage continued throughout the mission, although the leakage rate varied from essentially zero to a maximum of about 1100 scc/min (figs. 14-34 and 14-35). The regulator outlet pressure eventually increased to about 237 psia at which time the relief valves of system A started to periodically relieve the pressure to about 232 psia.

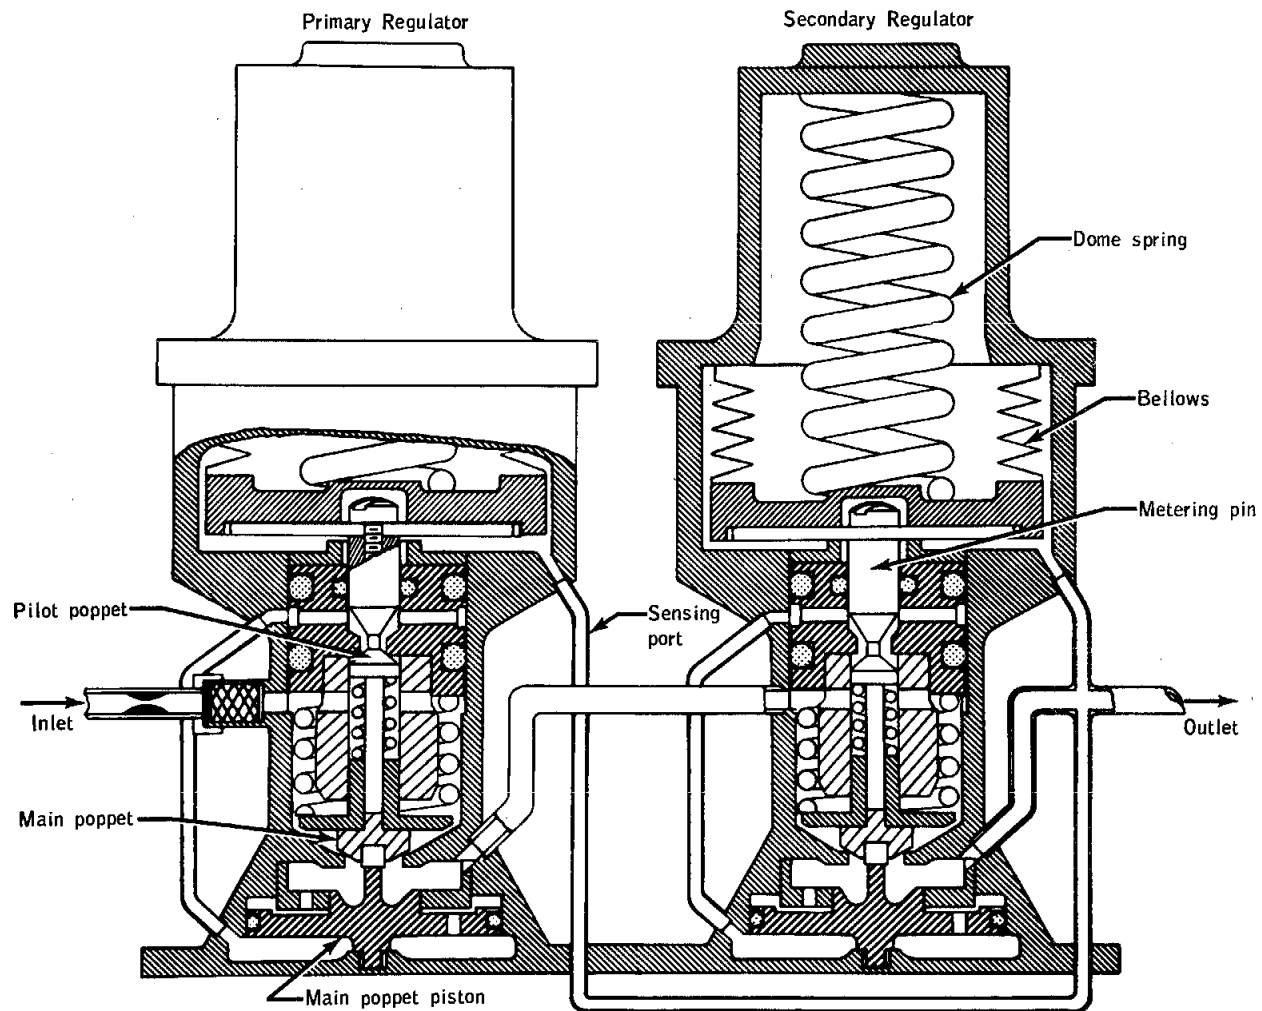
Figure 14-36.- Cross-section of reaction control regulator.

A series of tests was performed to determine lockup characteristics of nine spare regulators under small differential pressure conditions. The tests showed that a design deficiency in the secondary regulator does not exist, but did not eliminate the possibility of a weak poppet spring or sticky poppet in the Apollo 16 regulators since they were not tested under the same conditions. Further, the test demonstrated that the flight anomaly was the result of two discrepancies within the regulator assembly. A matrix of the possible leakage paths is shown in table 14-I. As can be seen from the matrix, there are 15 possible double-failure combinations which can result in the anomalous condition observed during the flight. Of these, the four involving only the poppets are considered probable since the leakage was variable. A variable leak path is usually caused by particulate contamination on a poppet seat. The particulate contamination could have been inside the regulator assembly during ground tests, but located in such a manner that it was not dislodged by the gas flow under 1-g conditions. In a weightless condition, the contamination could have moved and deposited between any of the poppets and their seats.

Because contamination during manufacture was considered to be a possibility, two regulator assemblies were disassembled and examined. Approximately 90 pieces of material over 100 microns in size (fibers and particles) were found in the first regulator assembly. Over 50 of these were found in the lubricant (Dri-lube 822) adhering to the poppets and poppet guide assembly of the primary regulator. The rest were in the sensing tubes and transfer tubes. The secondary regulator poppets were not checked. Contamination consisted of about 50 fibers (paper and nylon) and some metallic, plastic and unidentified hard particles. The cleanliness specification used by the manufacturer does not allow any particles in excess of 100 microns; however, a hard particle less than 100 microns in diameter, if located on a poppet seat, would cause that poppet to leak in excess of specification. The origin of the contamination could not be established. However, since the regulator was not tested after delivery, the contamination must have been built into the component. Examination of the second regulator assembly showed similar contamination.

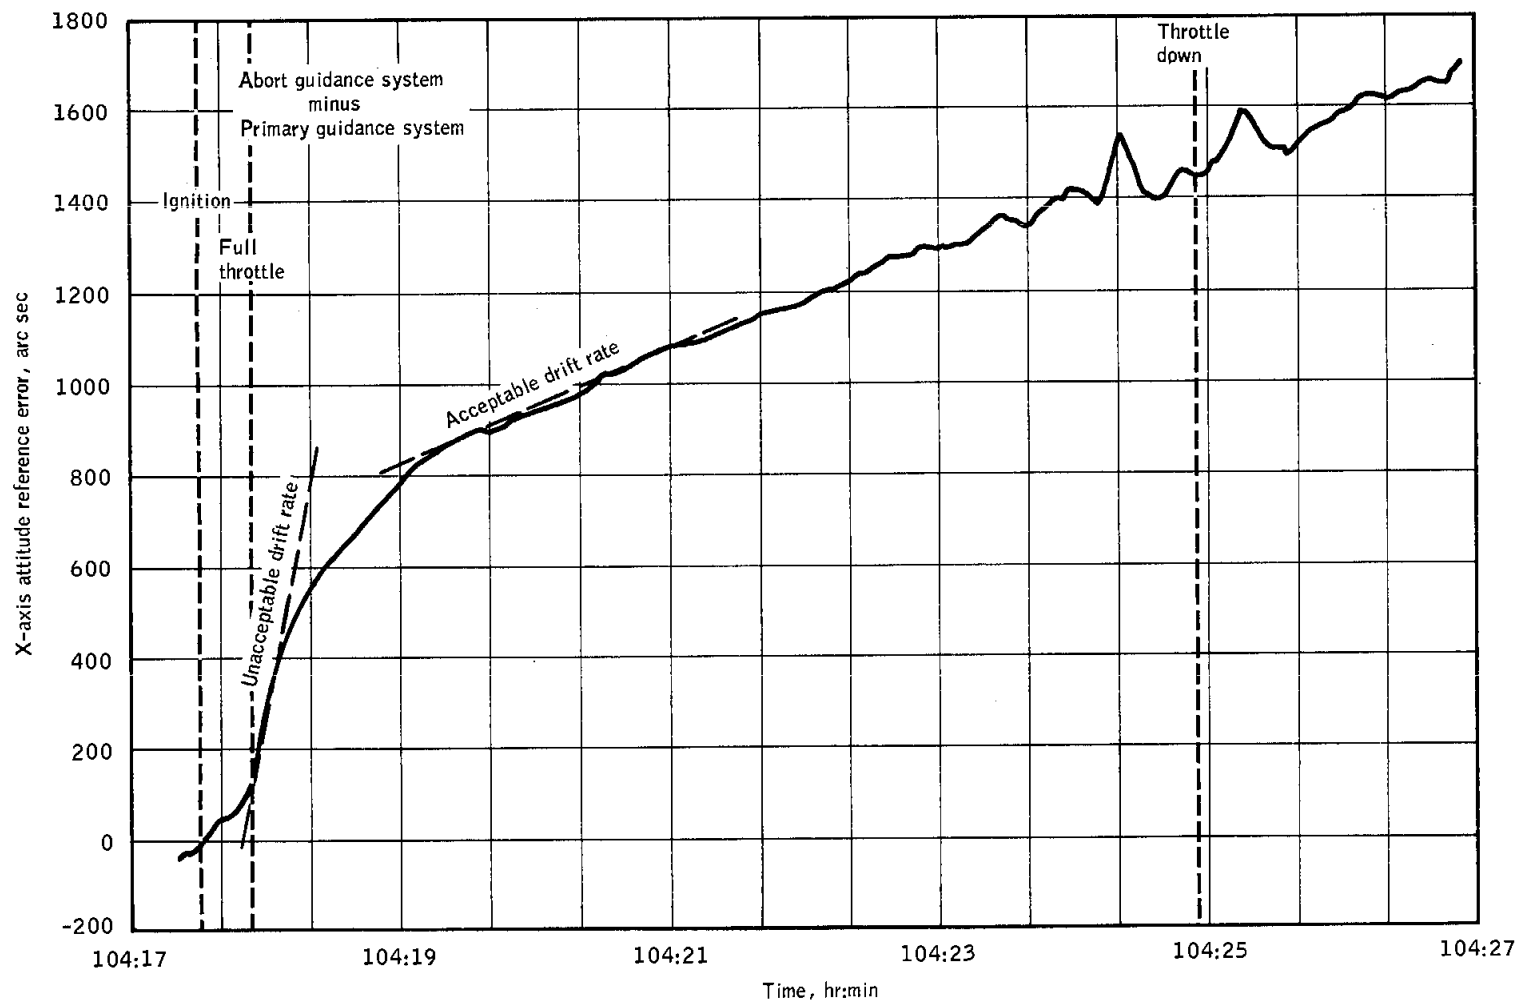
Figure 14-41.- Attitude reference error during descent.

Figure 14-41 is a time history of the difference between the abort guidance system and the primary guidance system X-axis attitude reference during descent. The rapid error buildup during the first 2 minutes indicates drift rates of up to 19 degrees per hour. No reason can be given for these high drift rates; however, a change in the X-axis gyro performance characteristics obviously took place. The steady drift rate of 2 degrees per hour during the last 8 minutes is believed to have been caused by a shift in a mass unbalance along the X gyro spin reference axis. Drift caused by this mass unbalance was also apparent in the data for the lunar surface calibration (due to gravity) and during ascent (due to the ascent engine thrust).

The roll axis misalignment is accounted for by the higher-than-normal drift rates during descent.

No indication of a problem existed before launch. Hardware malfunctions of the gyro and associated electronics have been hypothesized in an attempt to construct a model which would reproduce the error curve shown in figure 14-41. The worst-case electronics failure would only produce drift rates of 1 degree per hour compared to the 19 degrees per hour observed. Mechanical failures within the gyro which would duplicate flight results have a very low probability of occurrence. Therefore, the most likely cause is contamination or an air bubble in the fluid between the gyro float and case.

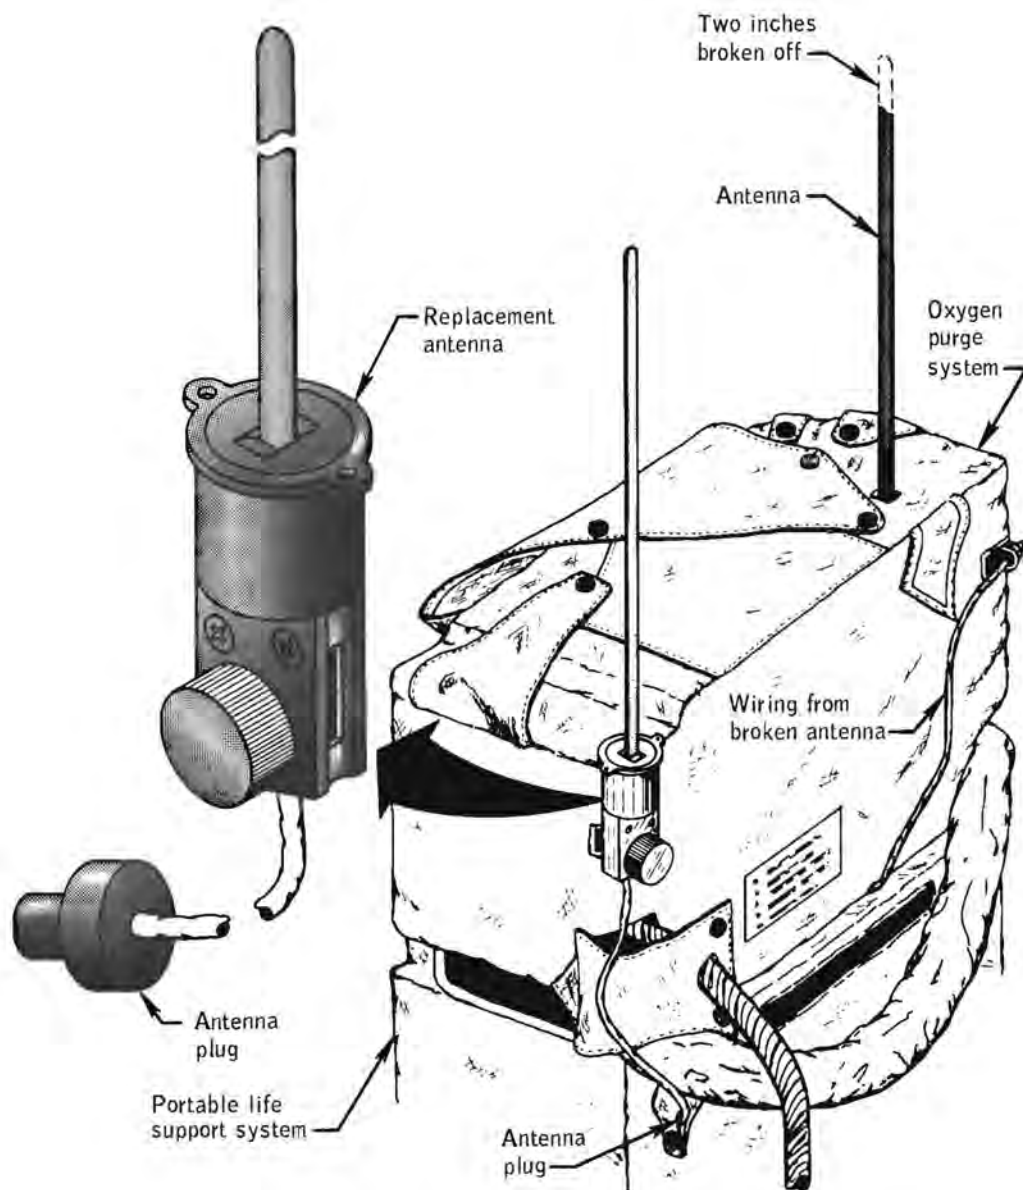
Figure 14-43.- Oxygen purge system antenna.

Following ingress after the second extravehicular activity, the crew reported that approximately 2 inches had been broken off the tip of the antenna on the Commander's oxygen purge system (fig. 14-43). The antenna had inadvertently been left unstowed while ingressing and it is believed that the antenna was broken when it struck the ascent propulsion system engine cover as the Commander was entering through the hatch.

One spare oxygen purge system antenna will be carried on Apollo 17 and will be stowed in the buddy secondary life support system bag on the lunar roving vehicle.

Installation of the spare antenna is accomplished by clamping the antenna adapter to the oxygen purge system right-hand D-ring and connecting the spare antenna coaxial connector in place of the broken antenna's connector (fig. 14-43).

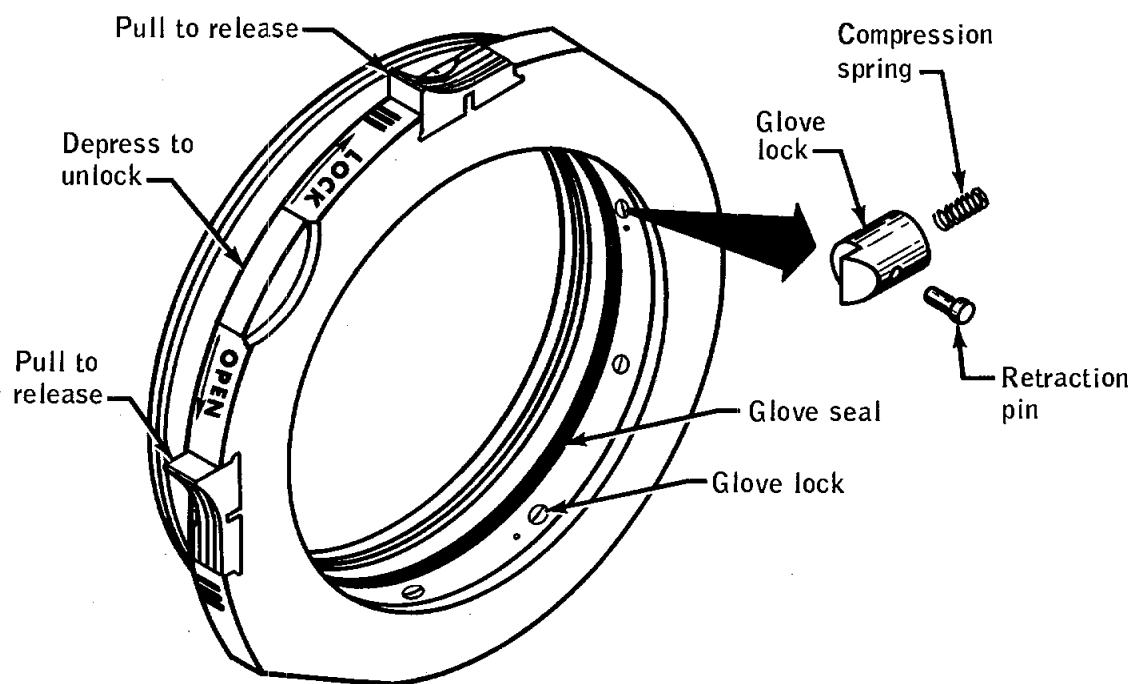
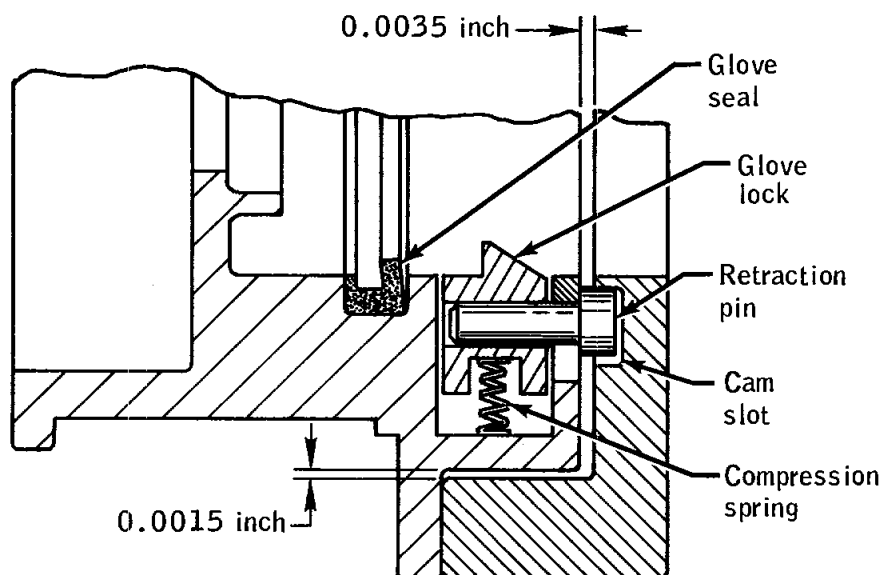
Figure 14-45.- Wrist disconnect.

Postflight inspection of the wrist disconnects showed that lunar dust in the clearance areas caused the problem. Rubber dust covers for the ring disconnects which will afford better protection from contamination will be added for Apollo 17.

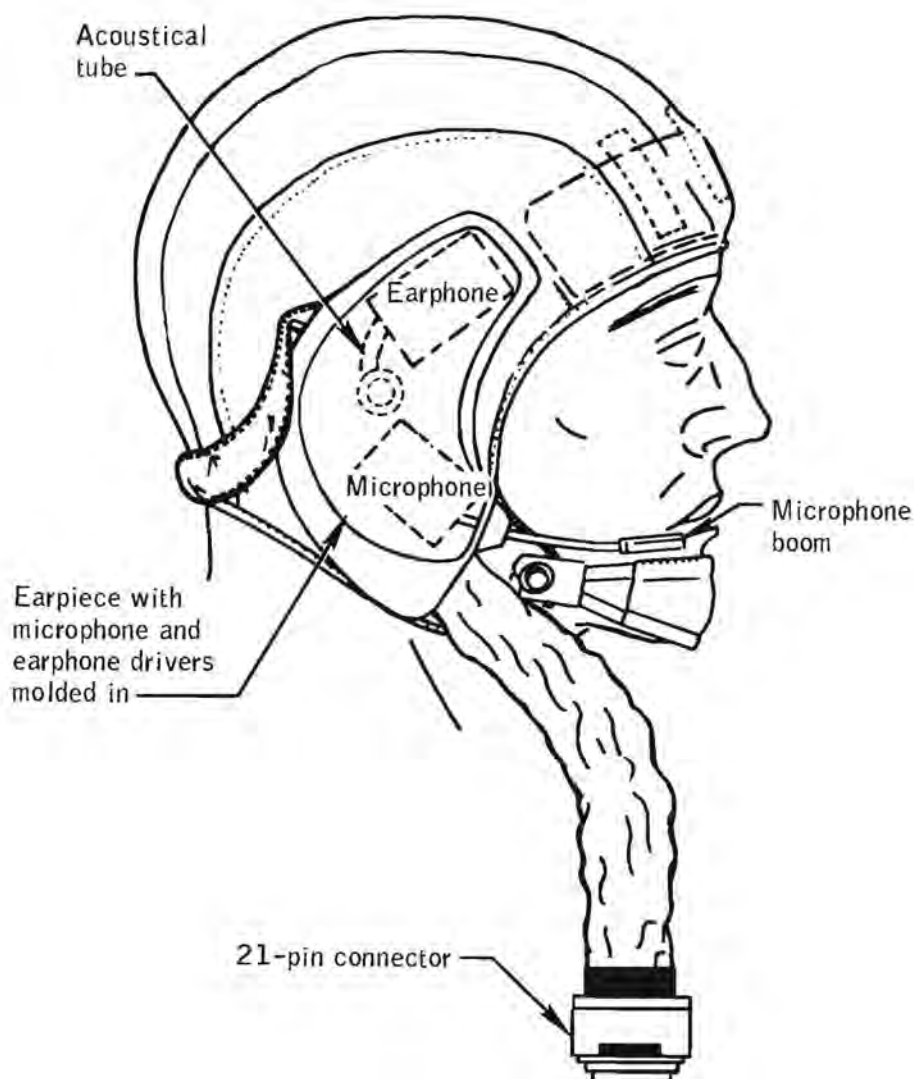
Figure 14-47.- Communications carrier.

During the transearth coast phase, the Lunar Module Pilot experienced intermittent operation of his communications carrier headset earphone circuit. This condition was cleared by flexing the constant wear garment harness near the 21-pin connector (fig. 14-47).
