MSC-07230

APOLLO 16 MISSION REPORT

MANNED SPACECRAFT CENTER

AUGUST 1972

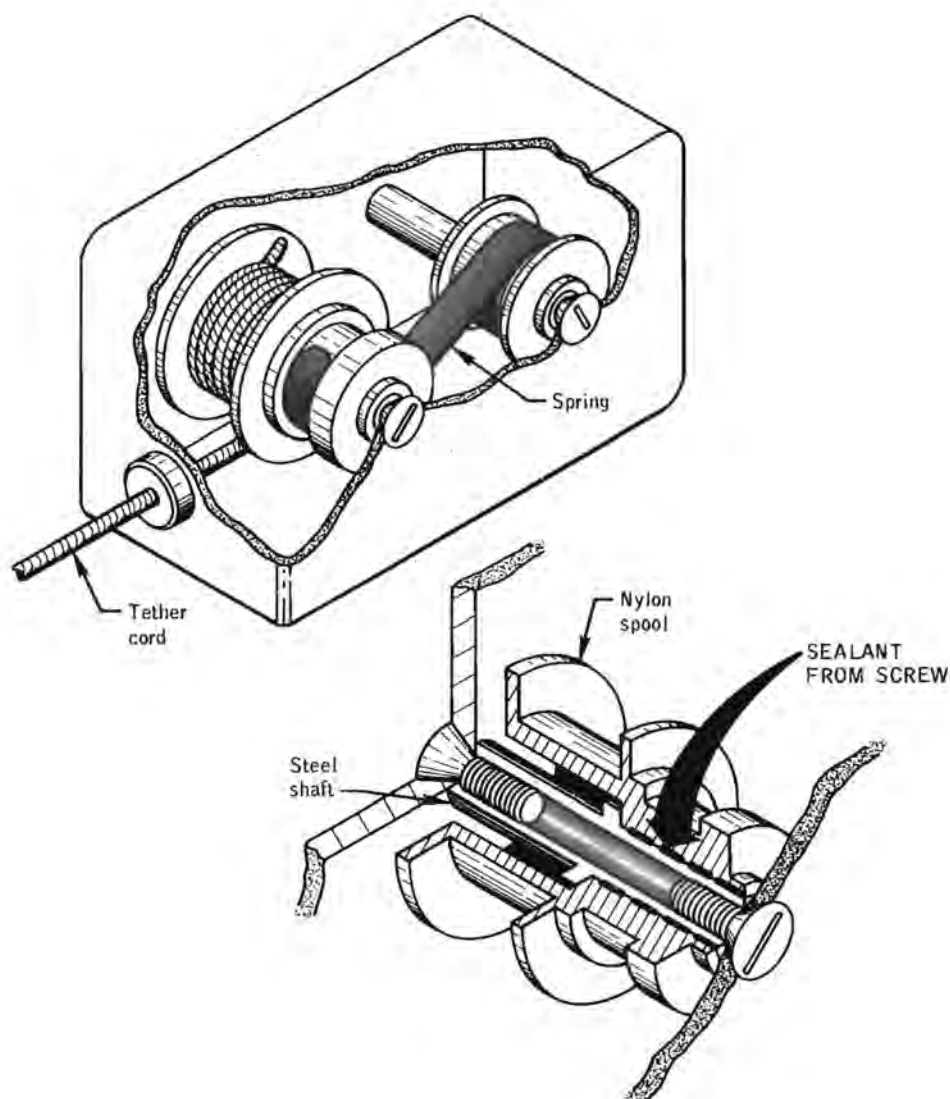
Figure 14-48.- Retractable tether.

Postflight inspection indicates that the tether is now operating; however, there is a noticeable increase in friction (fig. 14-48) during the retraction cycle. A thread sealant (loctite) was found on the spool shaft, which increased the friction.

Future units will be tested for friction buildup prior to flight.

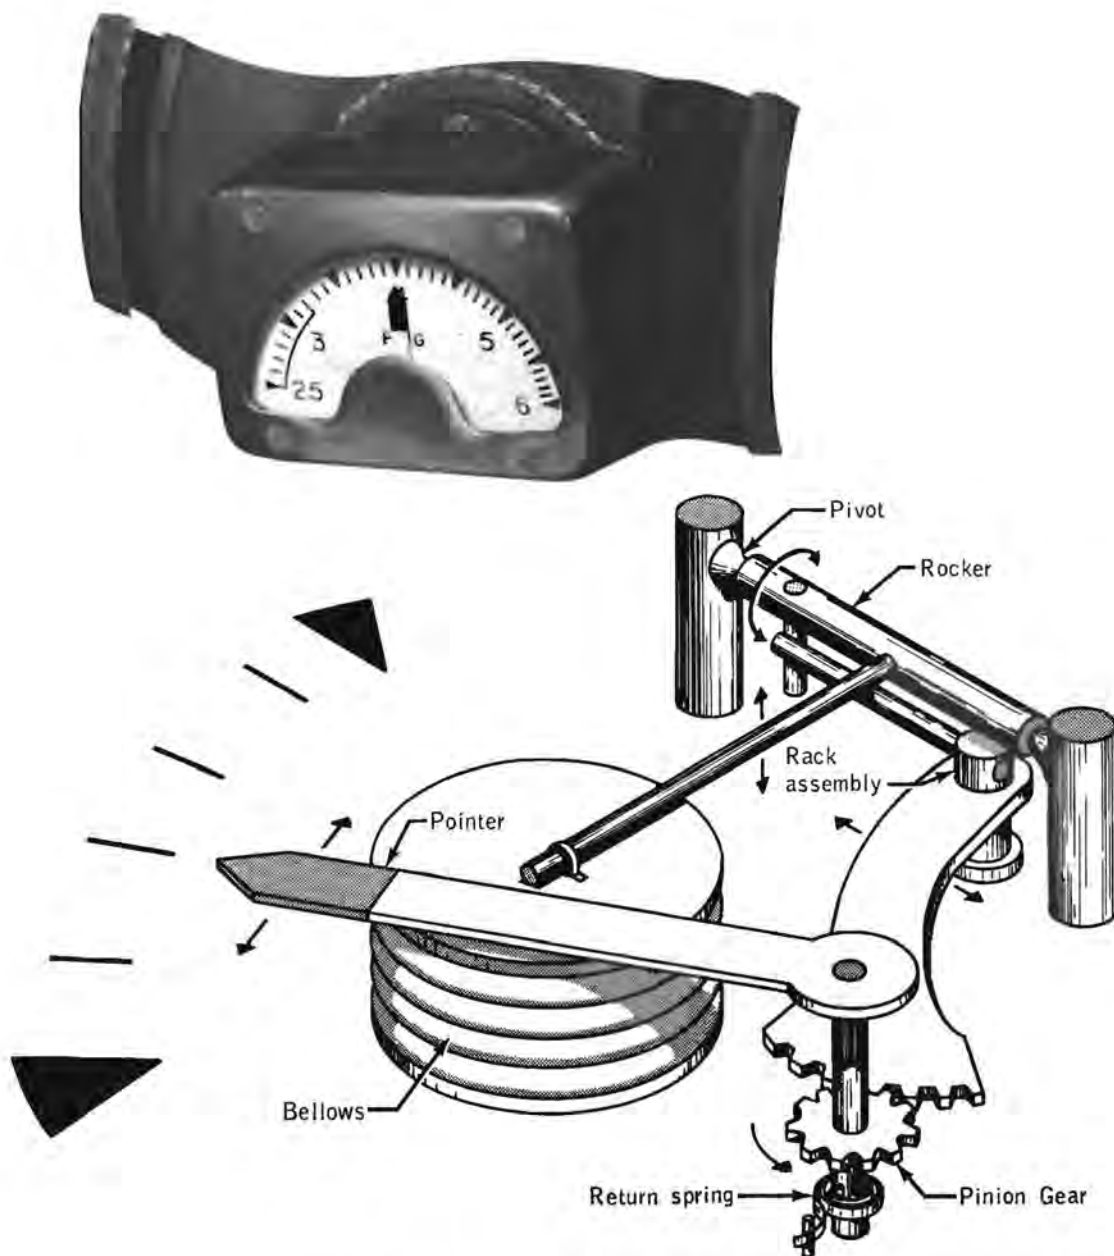
Figure 14-49.- Cuff gage mechanism.

The Commander reported that his cuff gage indicated a different pressure from that of the Lunar Module Pilot during the transearth extravehicular activity. The Commander's gage indicated approximately 3.5 psia, whereas the Lunar Module Pilot's gage indicated approximately 3.9 psia. The normal suit pressure should have been approximately 3.8 psia. During the previous suit integrity check, the cuff gages indicated approximately the same. The crew did not read the gages again after the reported problem.

During postflight testing at ambient and vacuum conditions, both the Commander's and the Lunar Module Pilot's gages read well within 0.1 psi of the 4.0 psi to which they were pressurized.

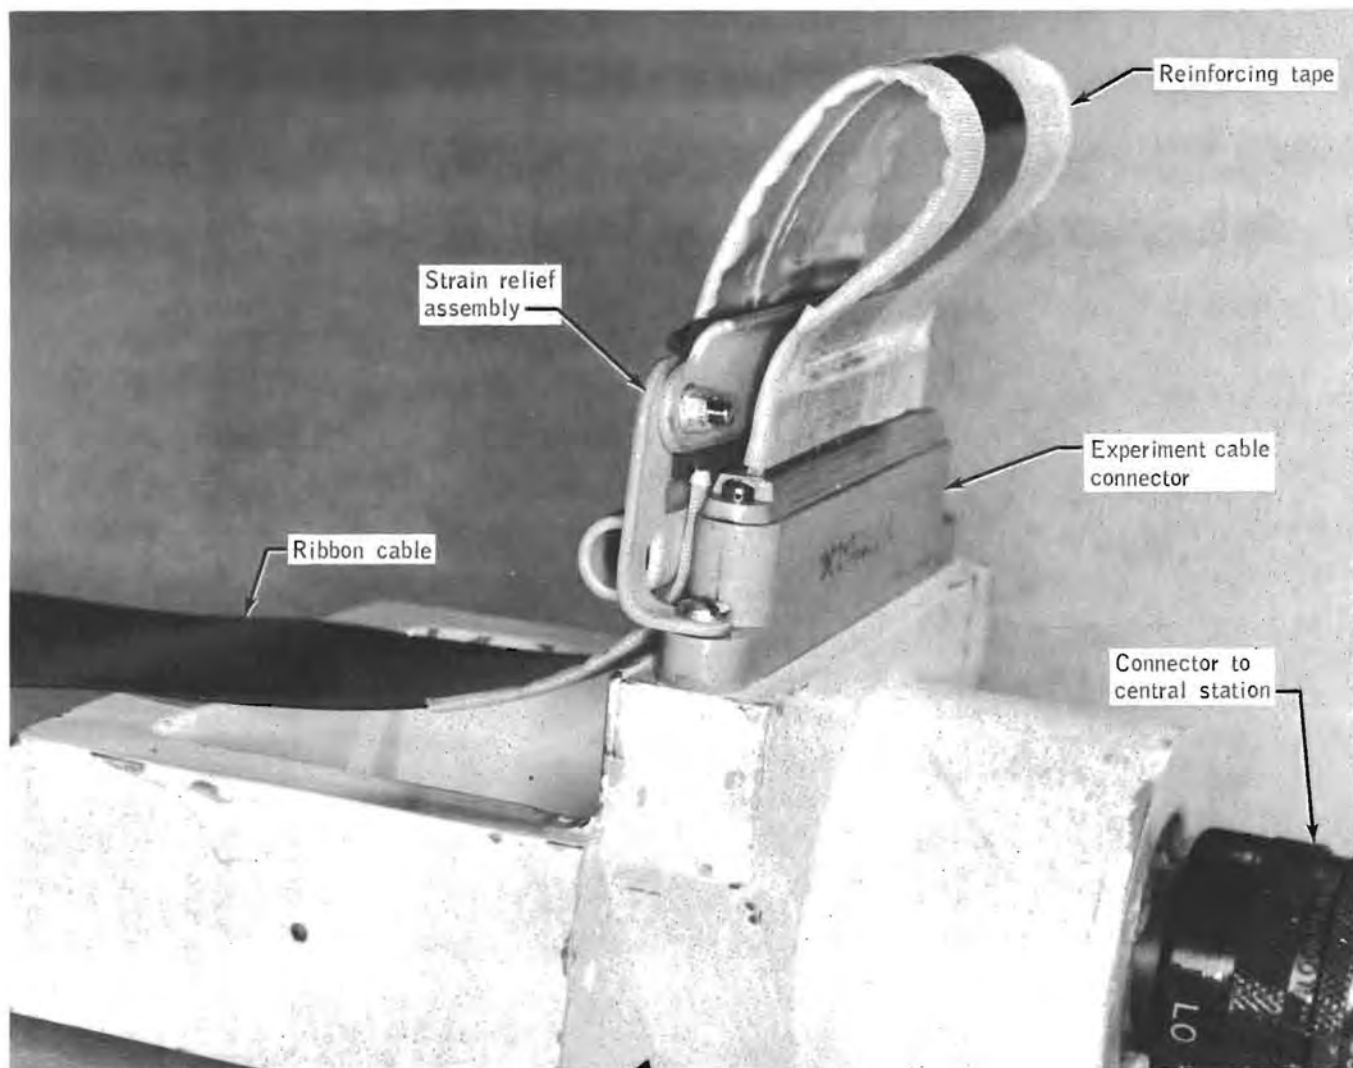
Pull tests performed on the cable/Astromate connector configuration indicate the strength at the cable/board interface was 31 pounds. A modified joint assembly (fig. 14-52) which provides for strain relief and has a pull strength of over 100 pounds will be used for the heat flow experiment connector and similar connectors on Apollo 17.

Figure 14-52.- Modified heat flow experiment connector assembly.

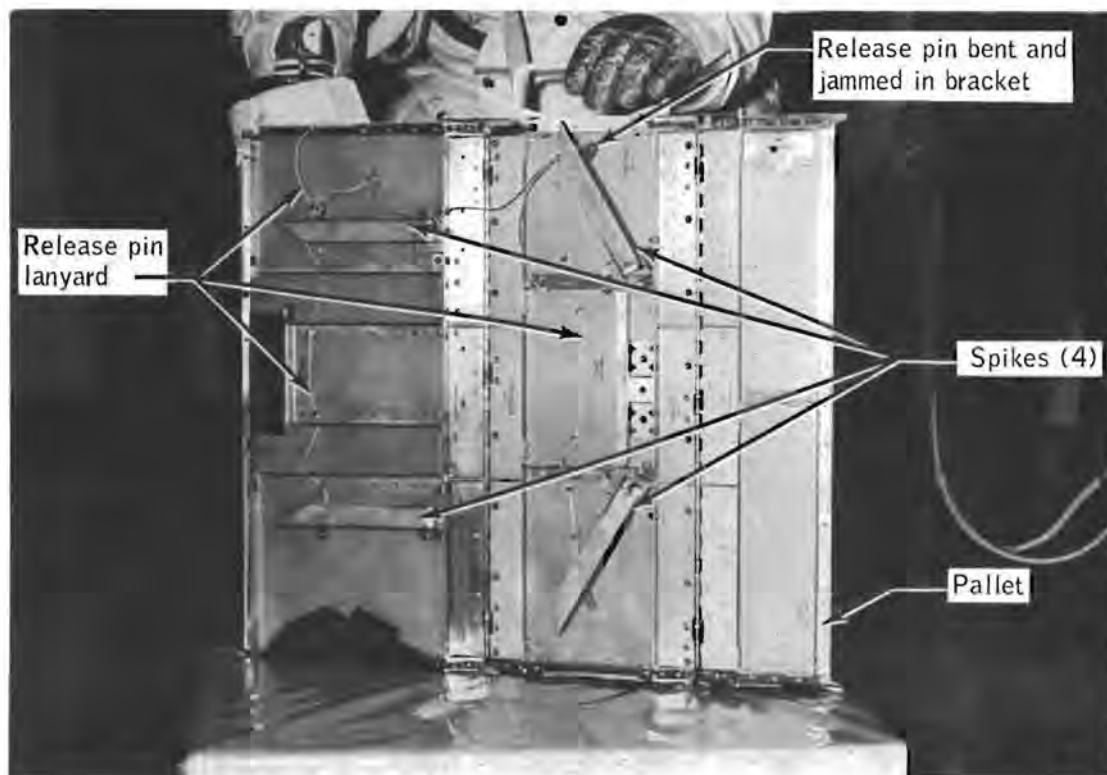
The mortar package pallet assembly includes four 7-inch long stakes (fig. 14-53) which deploy normal to the pallet when the release pins are removed. When the pallet is properly positioned, the stakes are pressed into the lunar surface to provide additional stability to the platform.

Figure 14-53.- Bottom view of active seismic experiment mortar package pallet.

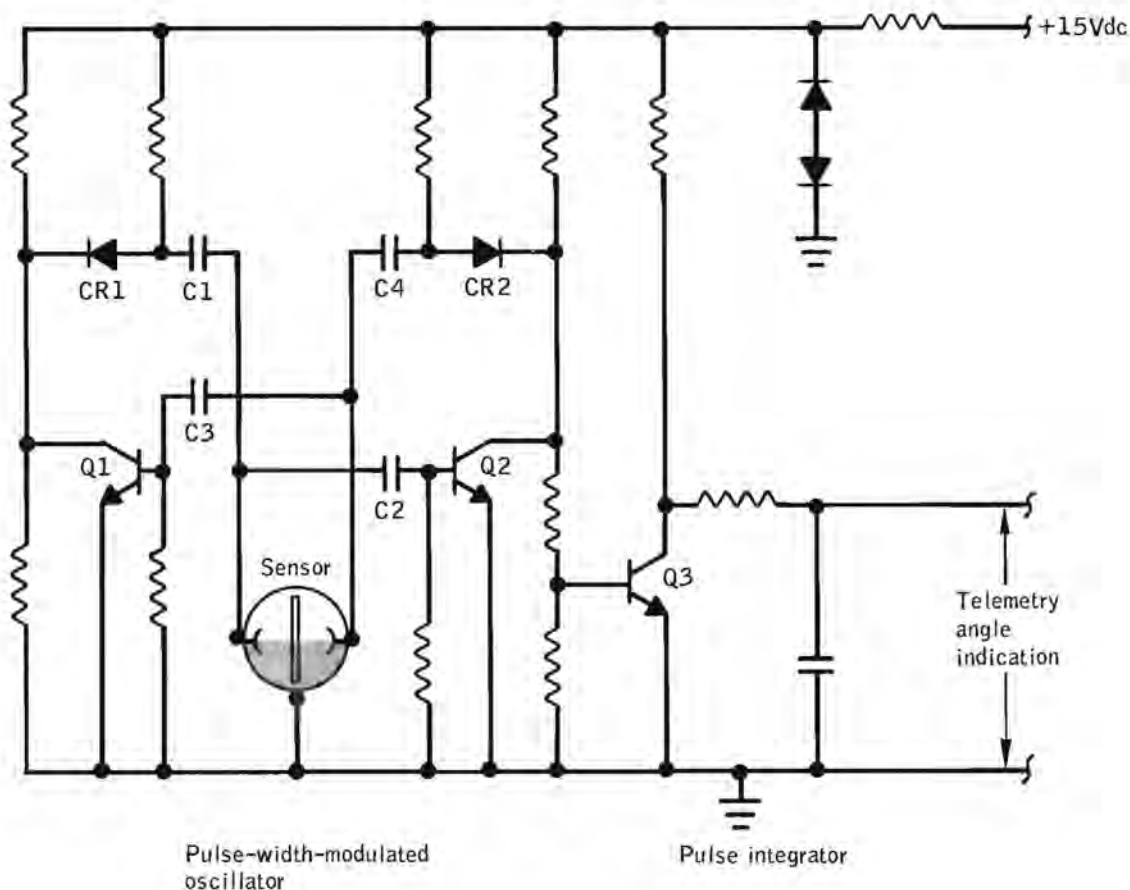
the bubble in the level indicator observed by the crew showed that the mortar package was less than 5° off the nominal in combined pitch and roll. The pitch angle sensor data indicated a pitch angle of minus 2.7° and photography confirms that the alignment was satisfactory. The off-scale reading therefore indicates a failure of the sensor circuit.

The sensor circuitry includes a free-running multivibrator, with the pulse-width ratio controlled by the sensor which functions as a potentiometer (fig. 14-54). Numerous failure possibilities in the circuit, such as open transistors, shorted capacitors, and open solder joints could have caused failure of the multivibrator and the off-scale high reading.

Note: An open in any component in the pulse-width-modulated oscillator (CR1, CR2, C1, C2, C3, C4, Q1 and Q2) is a single-point failure, or an open in the pulse integrator (Q3) is a single-point failure.

Figure 14-54.- Roll or pitch angle sensor electronics.

No corrective action is required as the experiment is not scheduled for another mission.

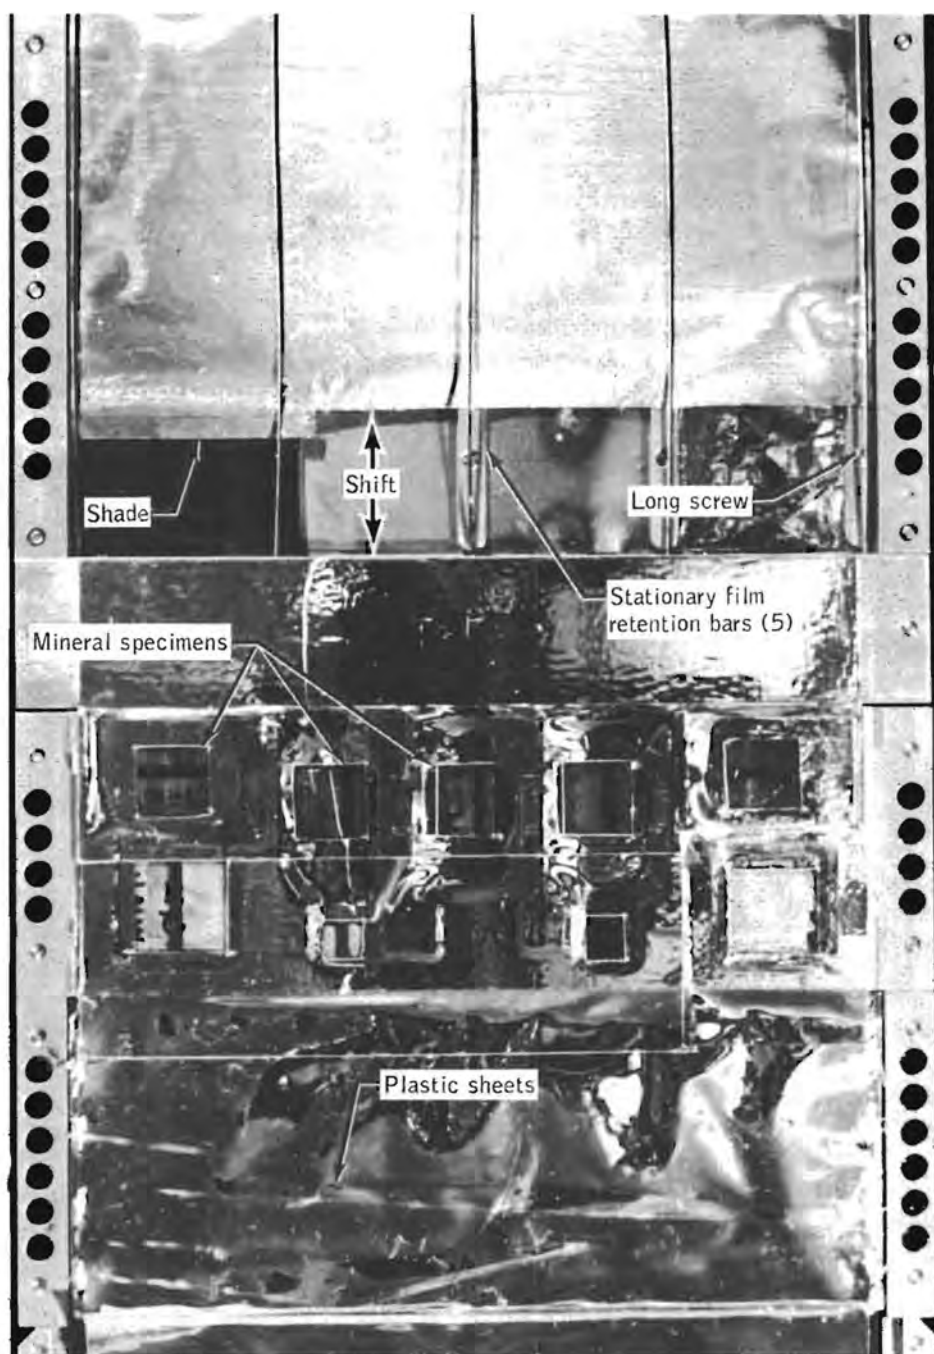
The Commander pulled the red-ring lanyard to shift the shade in panel 4. The shade moved only 1 inch instead of about 3.5 inches and the lanyard broke.

Figure 14-55.- Panel 4 with partially deployed shade.

Examination of the panel assembly has shown that the failure of the shifting mechanism was caused by a clamping of the target plate by two retention bar screws which projected past the backplate into the target plate, and effectively locked it in place (fig. 14-57).

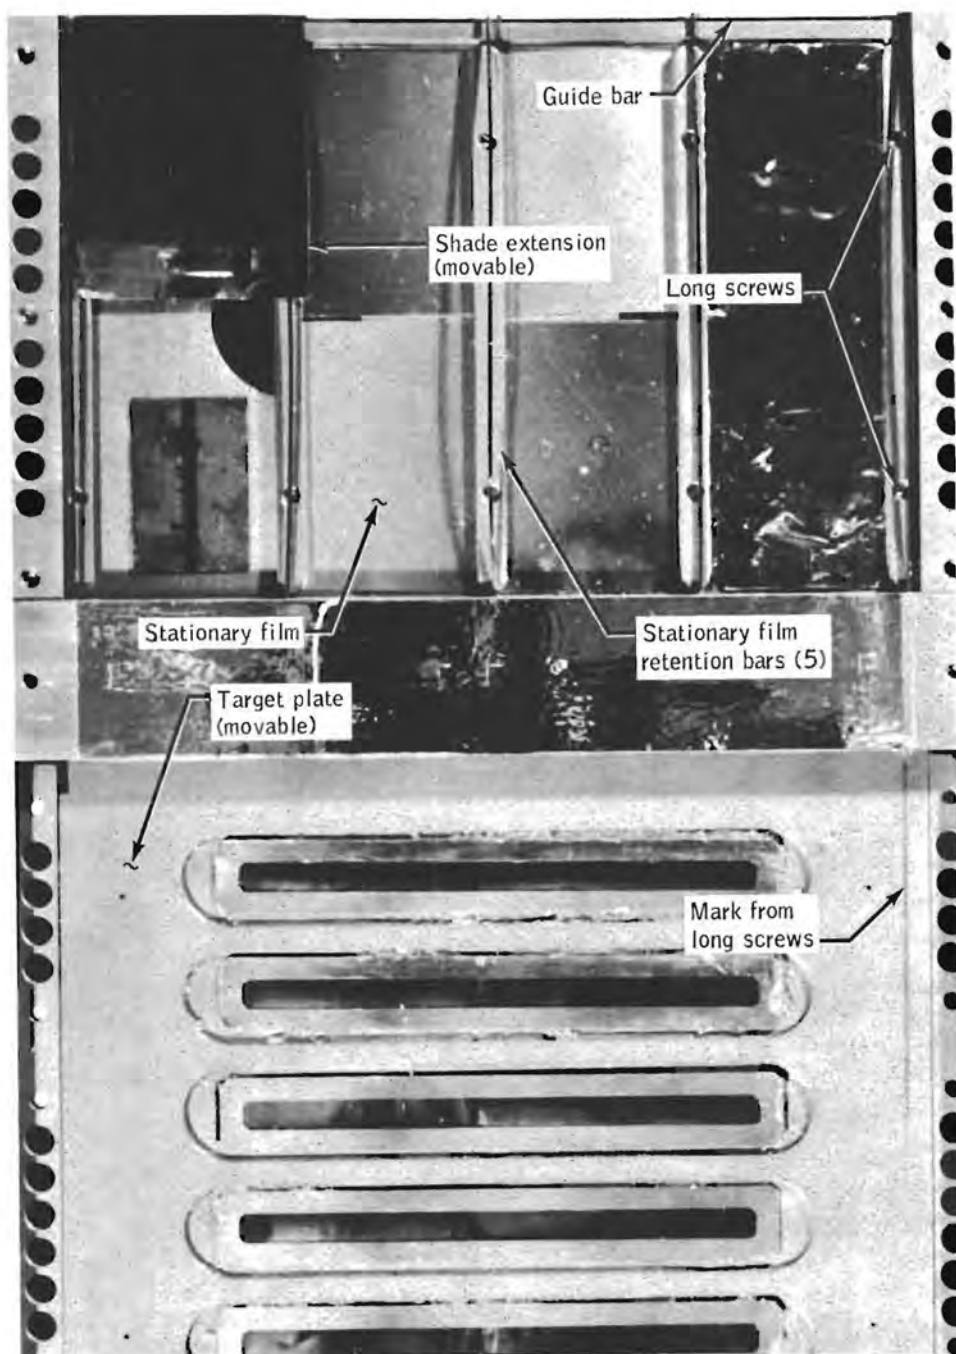
Figure 14-56 shows the panel 4 assembly with the target plate and shade fully deployed after having backed off the two projecting screws. Note the rub mark from the screws on the target plate.

Figure 14-56.- Panel 4 target plate and fully deployed shade.

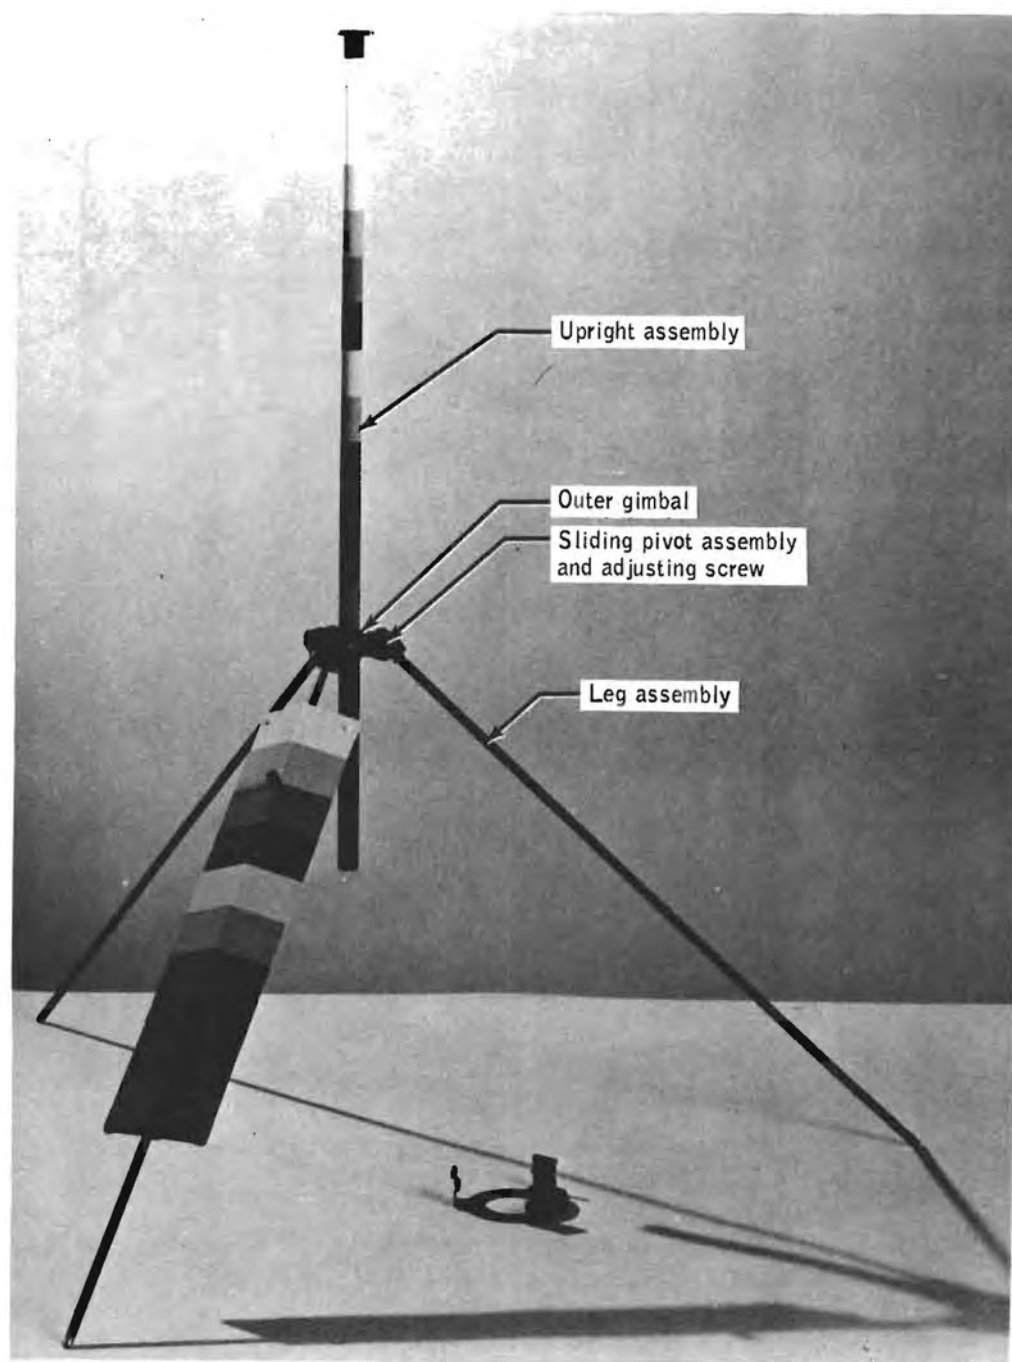
When the gnomon (fig. 14-58) was being unstowed from its stowage bag during the second extravehicular activity, the leg assembly remained in the bag, and the vertical staff came out separately. The leg assembly, because of its color scale, was used during the rest of the lunar surface photographic operations. The primary function of the complete gnomon is to indicate the local vertical in lunar surface geology photographs.

Figure 14-58.- Gnomon assembly.

Pivot pins for the Apollo 17 gnomon will be given the additional tempering required for greater toughness, and a thin film of oil will be applied for protection against corrosion. Ground tests have shown the

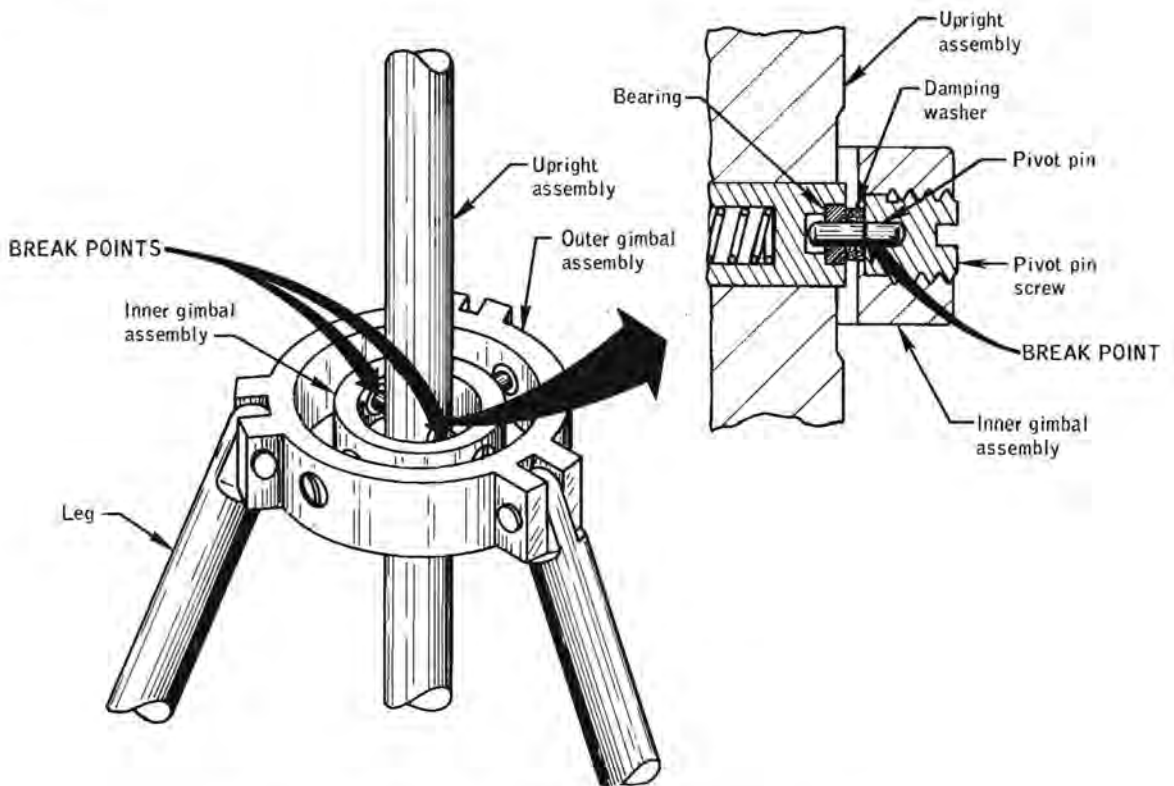
The staff can be separated from the leg assembly by backing out the gimbal pivot screws. However, all four screws must be backed out (fig. 14-59). There was no indication in the photographs of any screws backing out. During ground operations, a staff separated from the leg assembly by breaking the inner gimbal pivot pins. The break occurred where the 0.040-inch-diameter pivot pin is pressed into the pivot screw.

but has a tendency to be brittle without additional tempering. In addition, the combination with stainless steel can be conducive to stress corrosion. Either, or a combination, of the two conditions is considered as the most likely cause of the anomaly.

Figure 14-59.- Gnomon gimbal assembly

damping will be unaffected. Assembly of the pin in the screw will be delayed until as late as possible before launch so as to reduce the time for possible stress corrosion to occur.

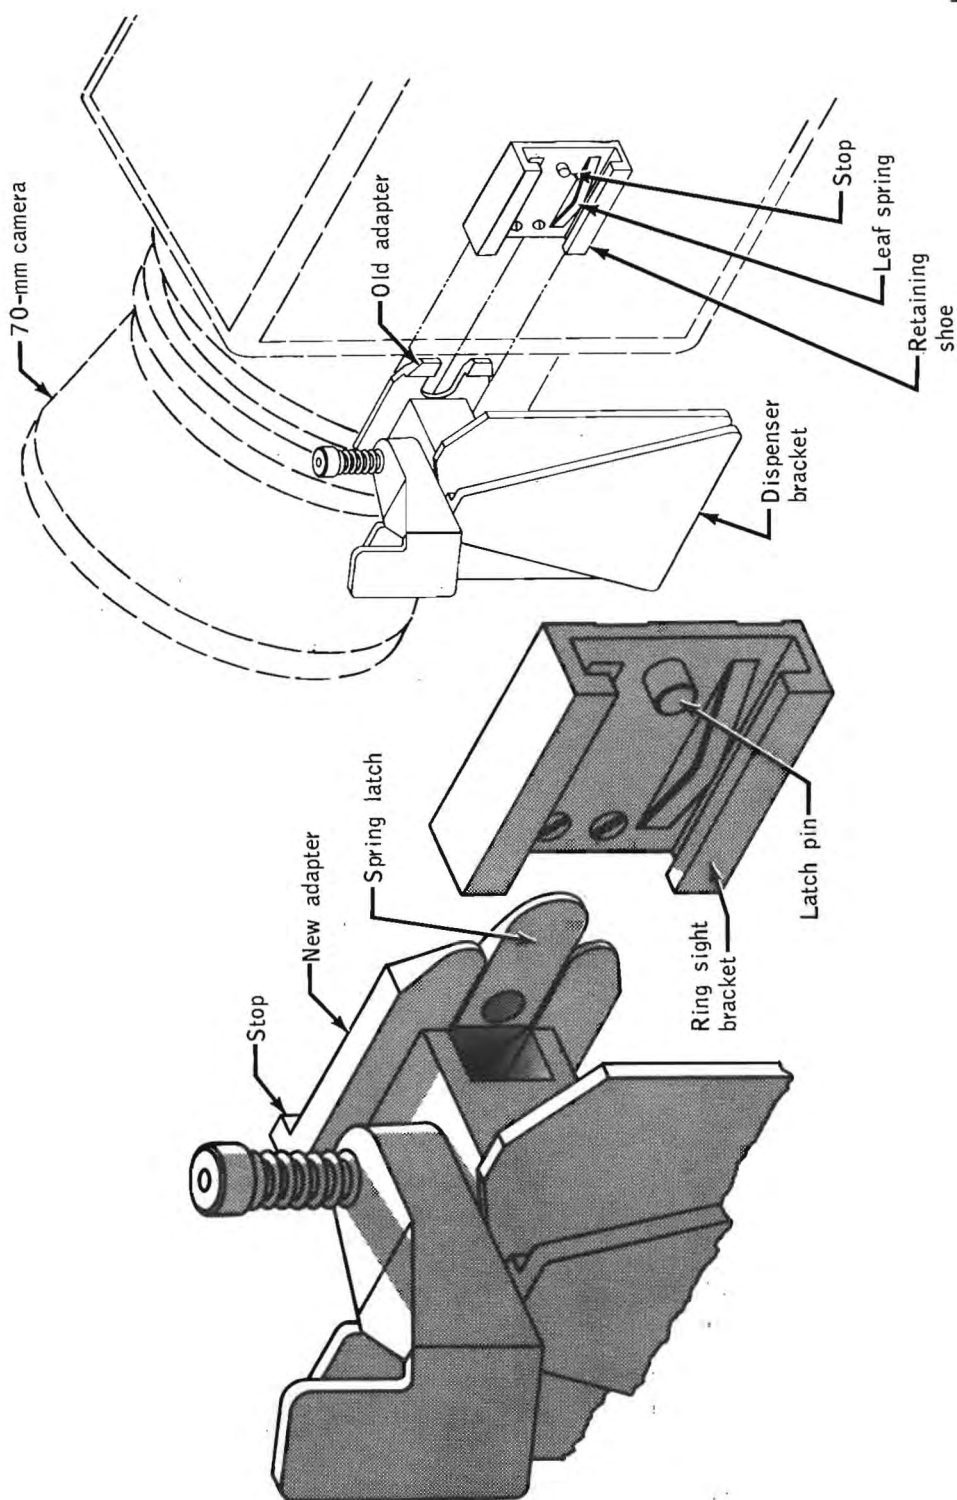
The dispenser is mounted on an adapter (fig. 14-60) which is inserted in the ring-sight tee-slot bracket on the camera. The adapter-to-tee slot interface is horizontal and depends on springs in the tee slot to hold the adapter in the latched position. This latching method is inadequate.

Figure 14-60.- Sample bag dispenser retention.

The adapter has been redesigned so as to provide a positive lock in the installed position as shown in figure 14-60.

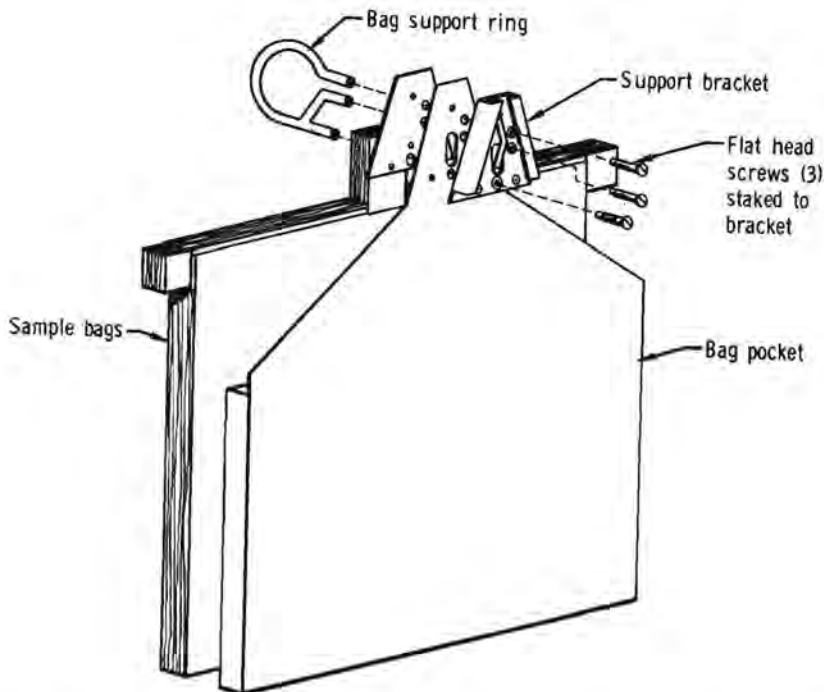
The three flat-headed stainless steel screws mate with threads in the aluminum ring (fig. 14-61). The heads are staked to the aluminum bracket plate. Thread sealant materials are not permitted because of the possibility of lunar sample contamination.

Figure 14-61.- Documented sample bag dispenser assembly.

The Apollo 17 dispensers will be re-inspected to assure proper staking of the screws and tightness of the threads in the aluminum ring.

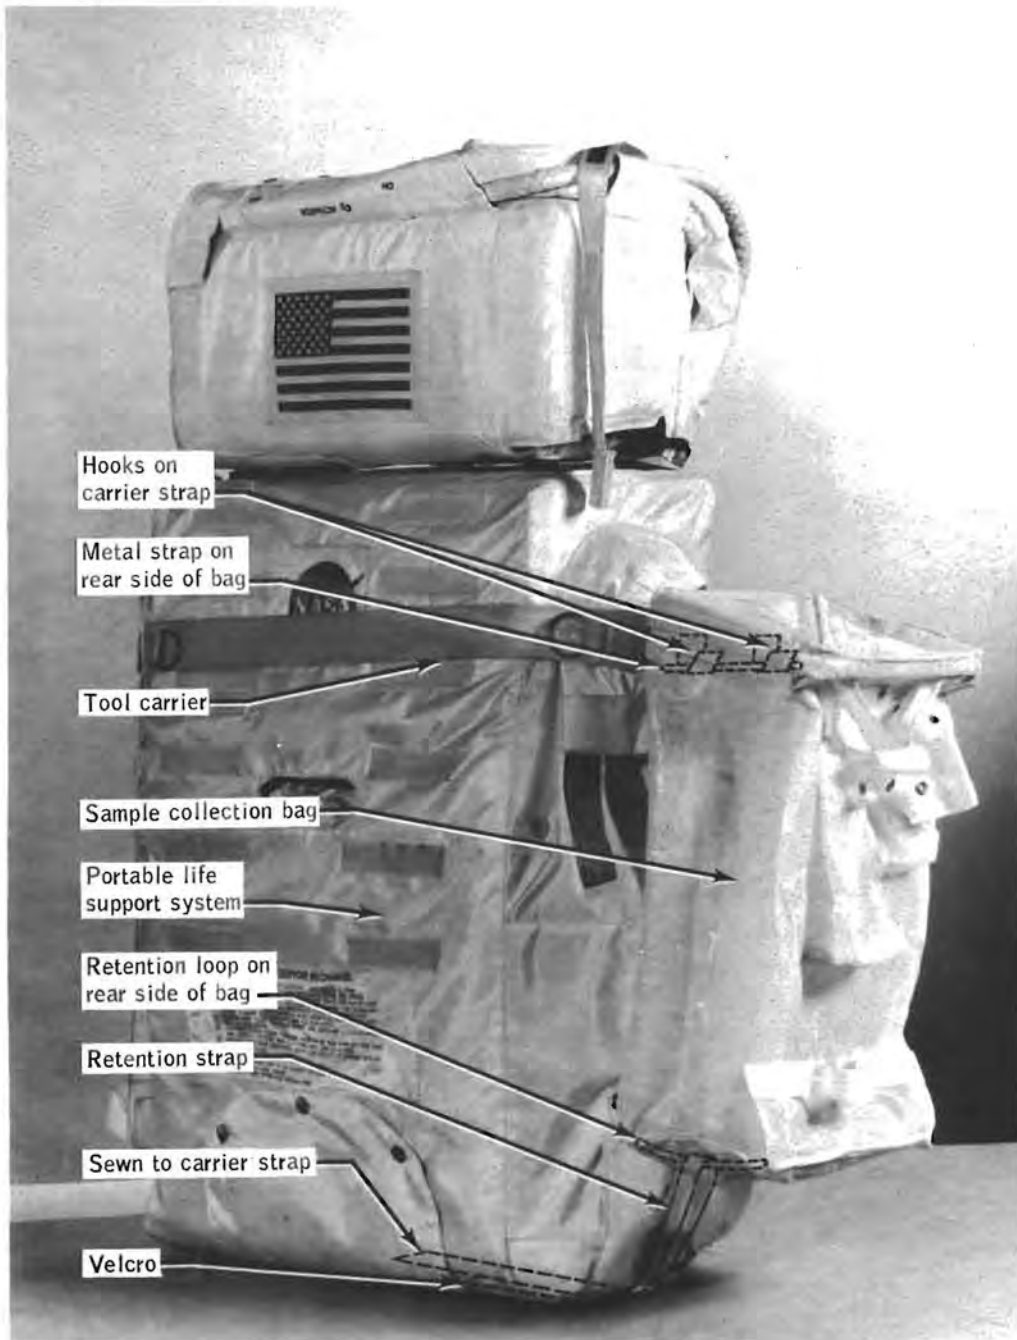
During lunar surface operations, the Commander's sample collection bag came loose from the portable life support system tool carrier several times and fell off once.

The sample collection bag essentially consists of a Teflon bag on a metal frame (fig. 14-62). The bag opening is covered by a Teflon lid on a hinged metal frame. Attached to the metal frame on one side of the bag, about 2 inches below the lid, is a 3/8-inch-wide stainless steel strap with offsets to accommodate the two hooks on the tool carrier. About 1 inch from the bottom of the same side is a 1-inch-wide Teflon band, sewn to the bag, with an offset loop approximately 1 inch by 5 inches to accommodate the Velcro strap from the bottom of the tool carrier. The Velcro strap, when tightened down, keeps the bag from floating or bouncing off the hooks. During the lunar roving vehicle operations, the Velcro strap sometimes loosened because of the entrapped lunar dust so that the bag could come off.

Figure 14-62.- Sample collection bag on portable life support system tool carrier.

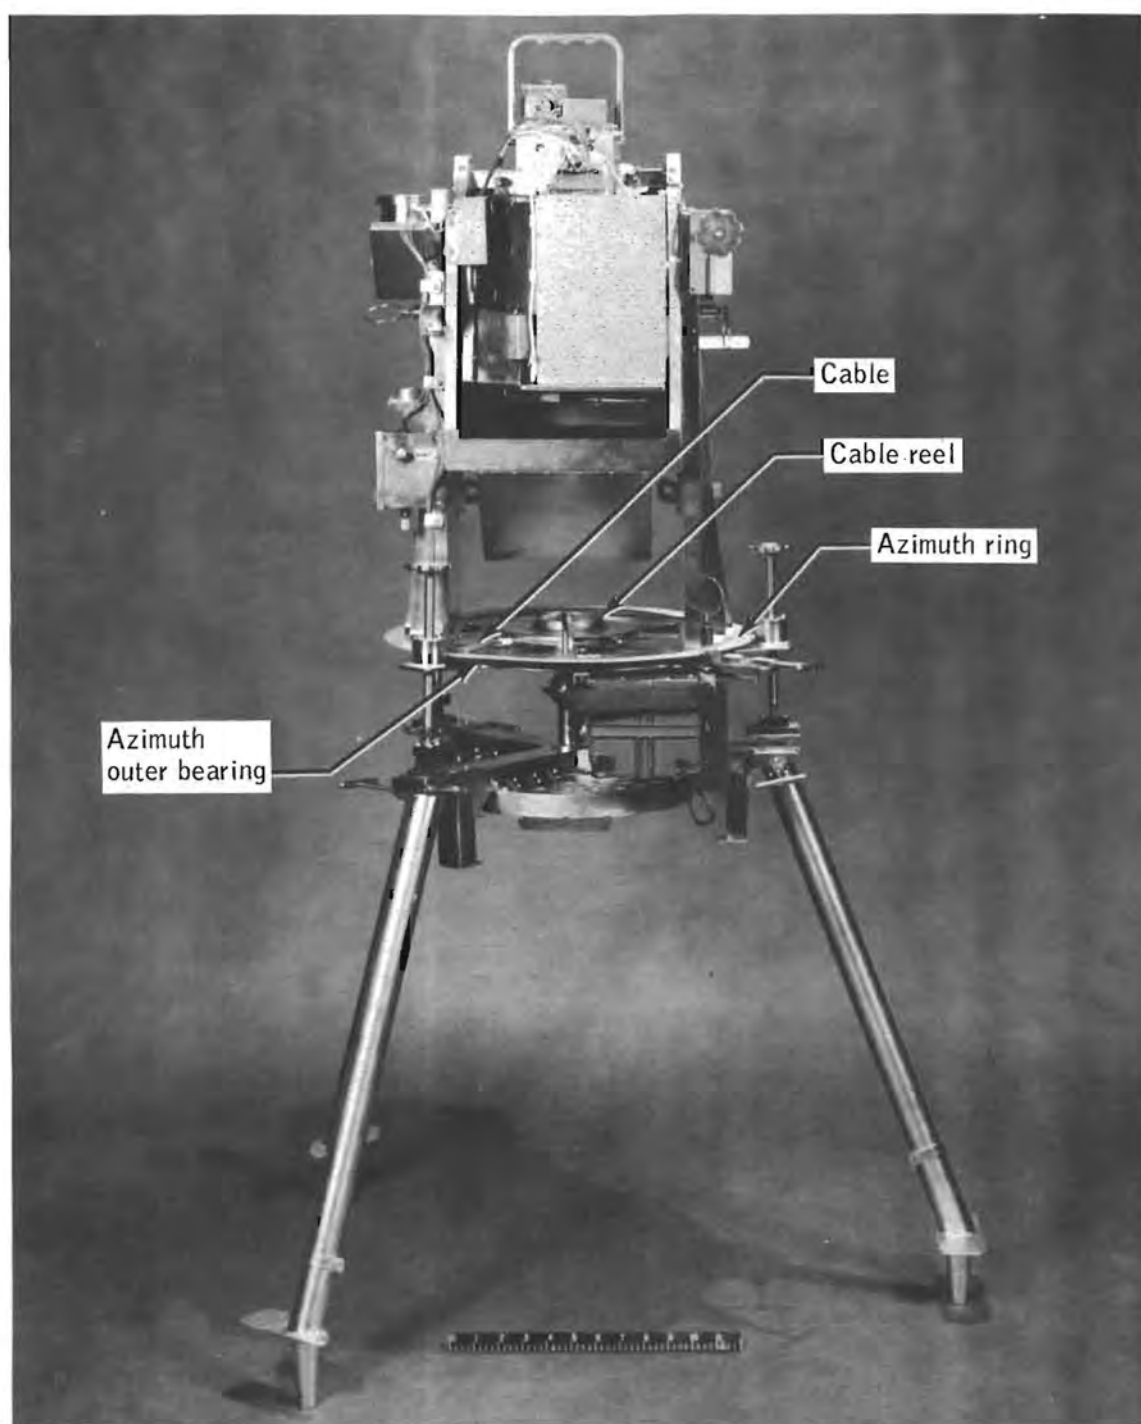
To adjust the azimuth to the proper dial reading, the camera is rotated on a 12.5-inch diameter ball-bearing ring (fig. 14-63). The bearing is not sealed; however, the crew did not observe any lunar dust on the bearing.

The azimuth ring bearing was packed with a waxy, low-outgassing grease which stiffens appreciably at temperature below 50° F. This grease is normally used as a sealant rather than a lubricant. The camera was intentionally kept in the shade to protect the film from high temperatures. As a result, the grease stiffened. The manual azimuth adjustment operation was not included in cold chamber tests with other operations of the camera.

Figure 14-63.- Far ultraviolet camera.

The difficulty was caused by the use of the wrong type of grease in the azimuth ring bearing.

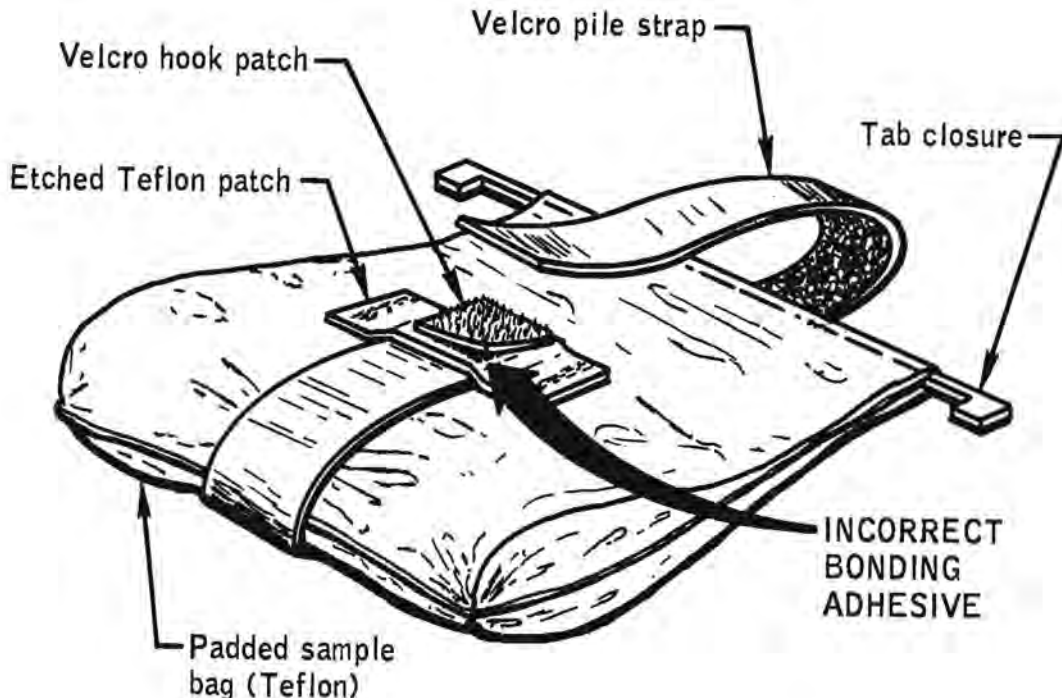
When the crew wrapped the Velcro strap around each of the padded sample bags to further secure them, the Velcro attachment patches came off the bags and the straps were ineffective.

Figure 14-64.- Padded sample bag.

is heat-sealed to the Teflon bag. A Velcro hook patch is bonded to the etched Teflon patch with a pressure-sensitive adhesive and provides the attach point for the other end of the strap. The peel strength of the pressure-sensitive bond was less than that of the Velcro pile-to-hook connections. Consequently, when the Velcro strap was adjusted to the proper tension, the hook patch came off the bag.

The problem resulted from using the improper bond material for the Velcro hook patch.

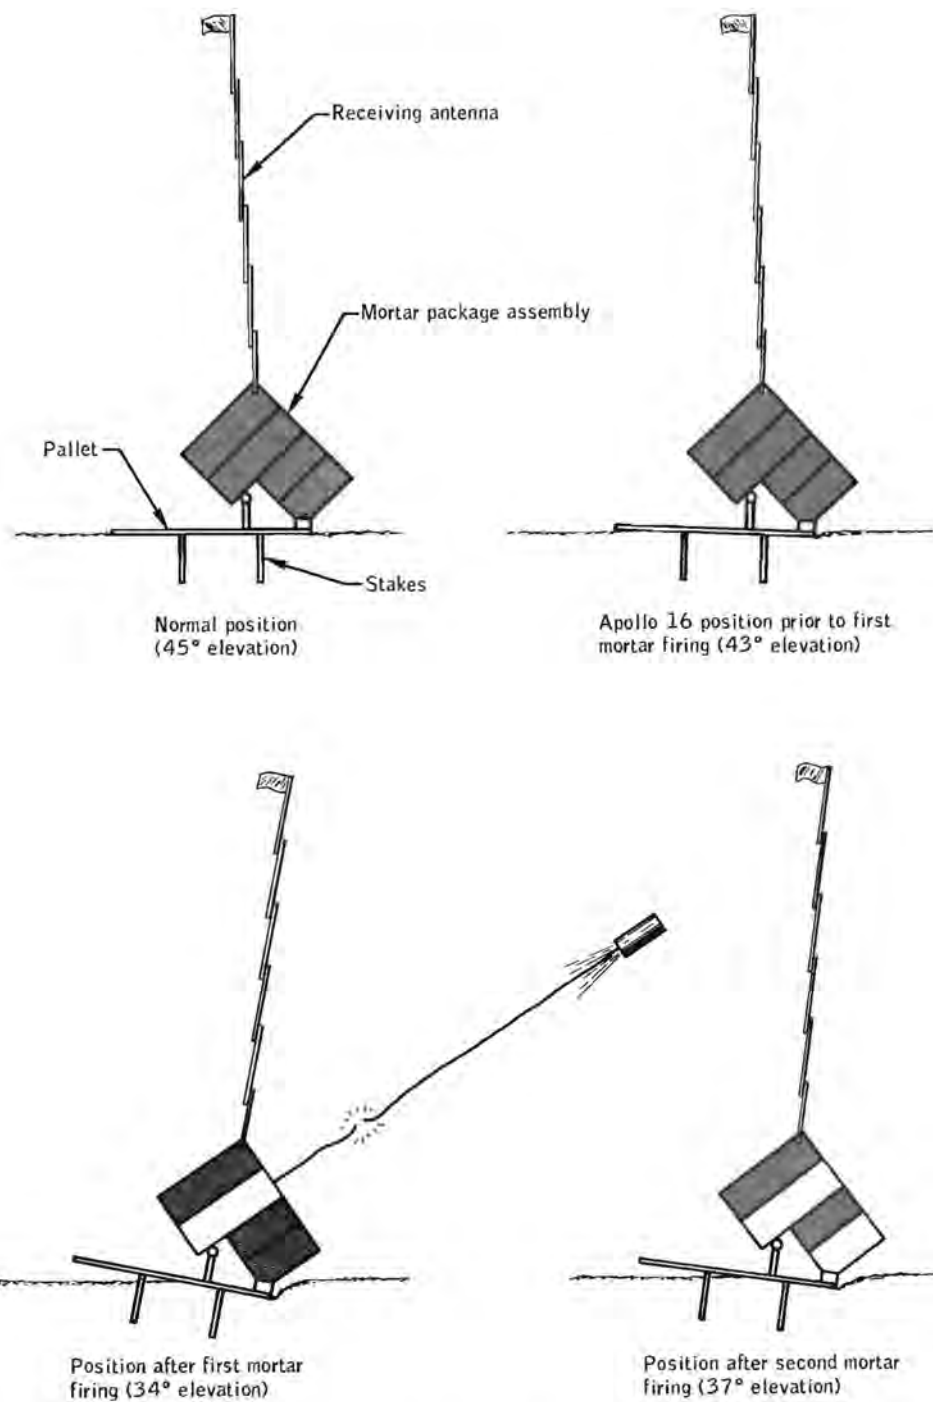
Immediately prior to launching the third grenade, the pitch sensor indicated that the mortar package assembly was pitched down about 8° from the nominal plus 45° elevation (fig. 14-65). Within 2 seconds after firing the mortar, the sensor indication was off-scale-high and has remained off-scale-high.

Figure 14-65.- Pitch movement of mortar package assembly.

Based on ground tests during which the assembly was rotated through 360° , an off-scale-high indication means either that the mortar package assembly is pitched up between 25° and 155° above the normal plus 45° elevation, or that the sensor has failed. There are two stable positions of the mortar package and pallet assembly between these two points: (1) pitched up 30° above normal (75° elevation), and (2) pitched up 135° above normal (180° elevation). The temperature profiles for the two temperature sensors on the mortar package assembly, when compared with the calculated temperature profiles for elevations of 45° and 75° , indicated that the mortar package assembly was not in the 75° elevation position. In the 180° elevation position, the receiving antenna would have been broken off or badly bent and lying on the ground. In this case, complete real-time event data would not have been received during the flight of the third grenade. However, complete real-time event data were received during the entire 19-second flight, indicating that the mortar package assembly was not in the 180° elevation position.

It is most likely that there is a failure in the pitch sensor circuit, and the orientation of the mortar package is unknown.

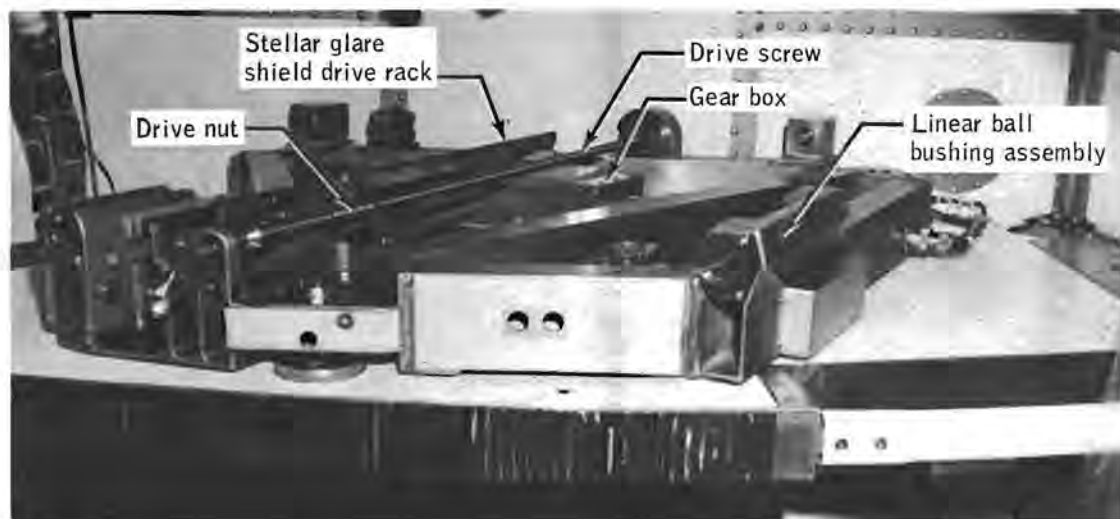
Preflight deployment operations had disclosed a chattering noise in the mechanism when the retraction was aided by the pull of the cable harness to the camera. An analysis of the drive train indicates that a state of dynamic instability may exist in a zero-g environment because of the resultant loss of the damping provided by the deployment rail friction. Simulated zero-g tests are being conducted by suspending the camera with a long cable in order to remove the weight from the rails while maintaining the inertial properties of the camera during the deployment.

Figure 14-66.- Mapping camera deployment mechanism.

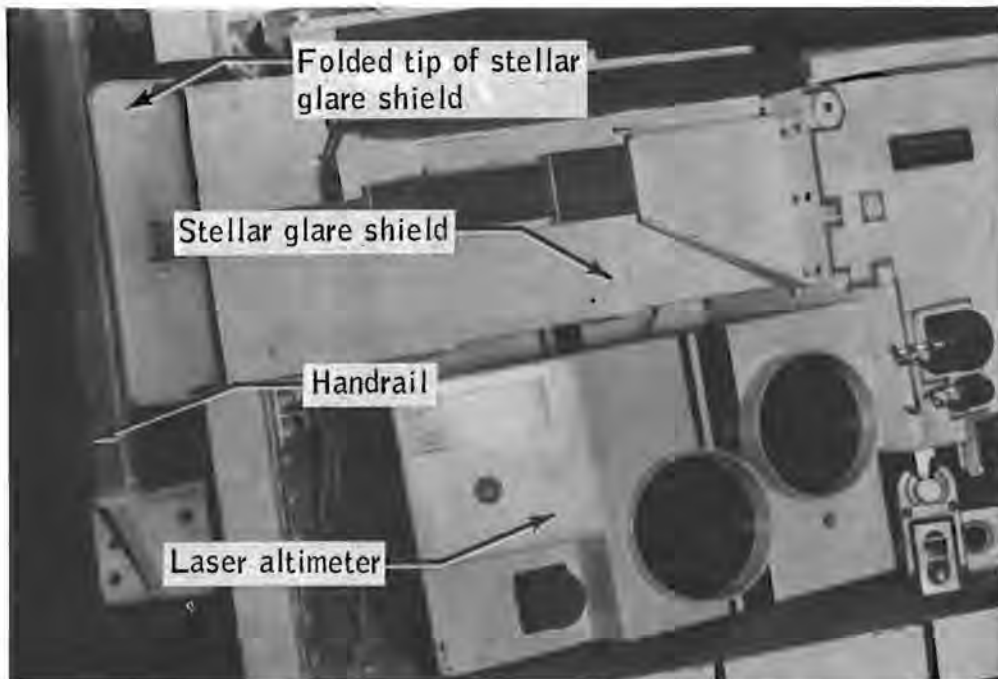
The Command Module Pilot observed that the glare shield for the stellar camera was jammed against the handrail paralleling the scientific instrument module bay (fig. 14-67) during the transearth extravehicular activity. In the 16-mm photography of the extravehicular activity, the outermost edge of the folding tip of the glare shield is visible above the handrail, in the fully-extended position as shown in figure 14-64.

Figure 14-67.- Mockup photograph of glare shield handrail.
