MSC-07230

APOLLO 16 MISSION REPORT

MANNED SPACECRAFT CENTER

AUGUST 1972

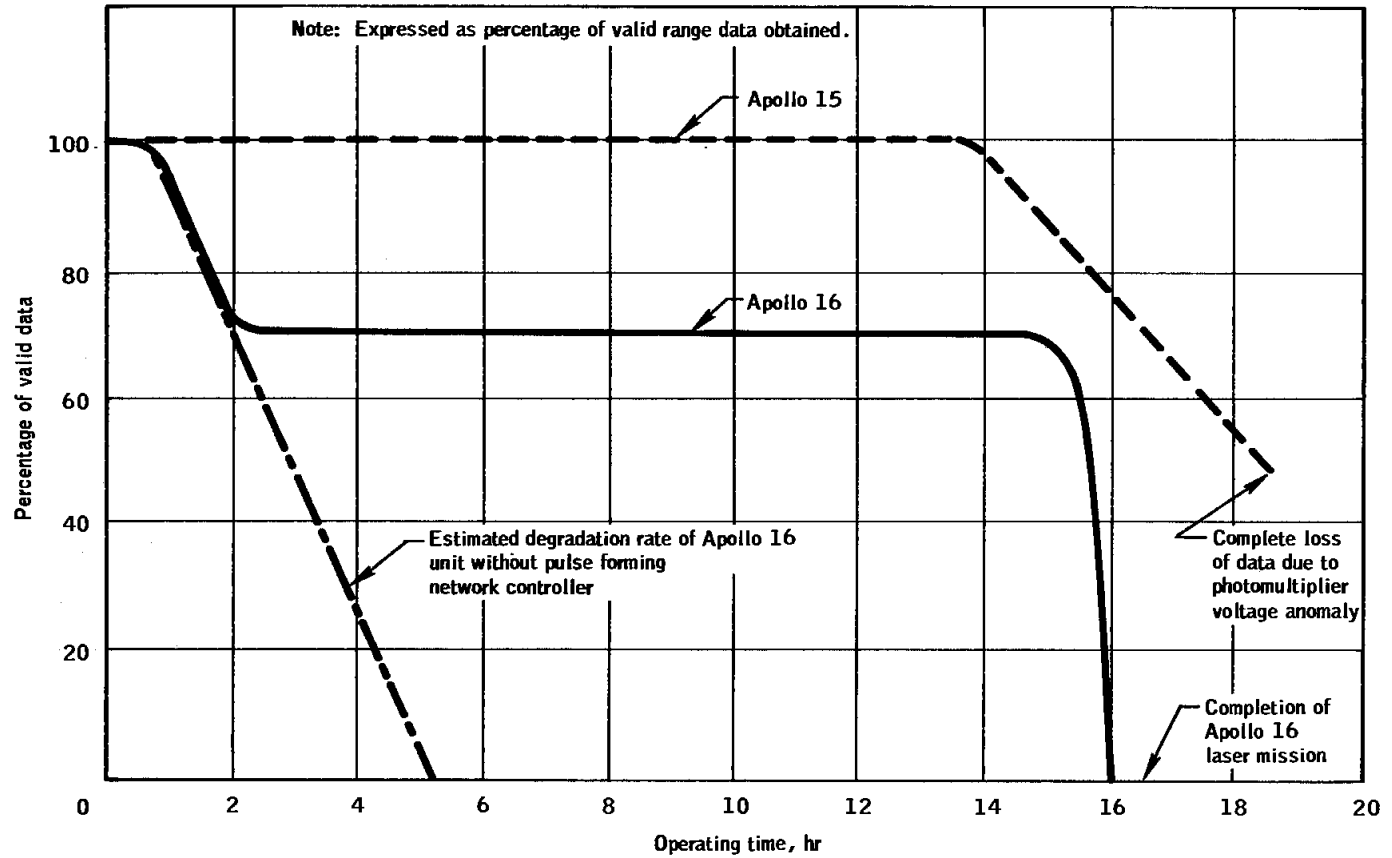
There were approximately 2400 laser operations (firings) during the mission. The laser output appeared to degrade more rapidly than during the Apollo 15 mission (fig. 14-68) but was compensated by the action of the pulse forming network voltage controller added for this purpose as a result of the Apollo 15 anomaly. The voltage controller consists of a laser power status sensor (photodiode) located inside the laser module and associated circuitry to increase the output of the pulse forming network power supply if the sensed laser power is lower than a pre-established threshold.

Figure 14-68.- Laser degradation versus operating time.

The plots of data validity versus operating time in figure 14-68 are approximate in that the effects of laser module temperature and lunar surface illumination have been averaged out. During the first 11 hours of laser operation during Apollo 15, the command and service module was in a highly eccentric orbit which, due to the range limitations of the laser altimeter, caused the loss of approximately 50 percent of the altitude data. Since the data loss was not due to a hardware malfunction, the curve for Apollo 15 is drawn at 100 percent during this period.

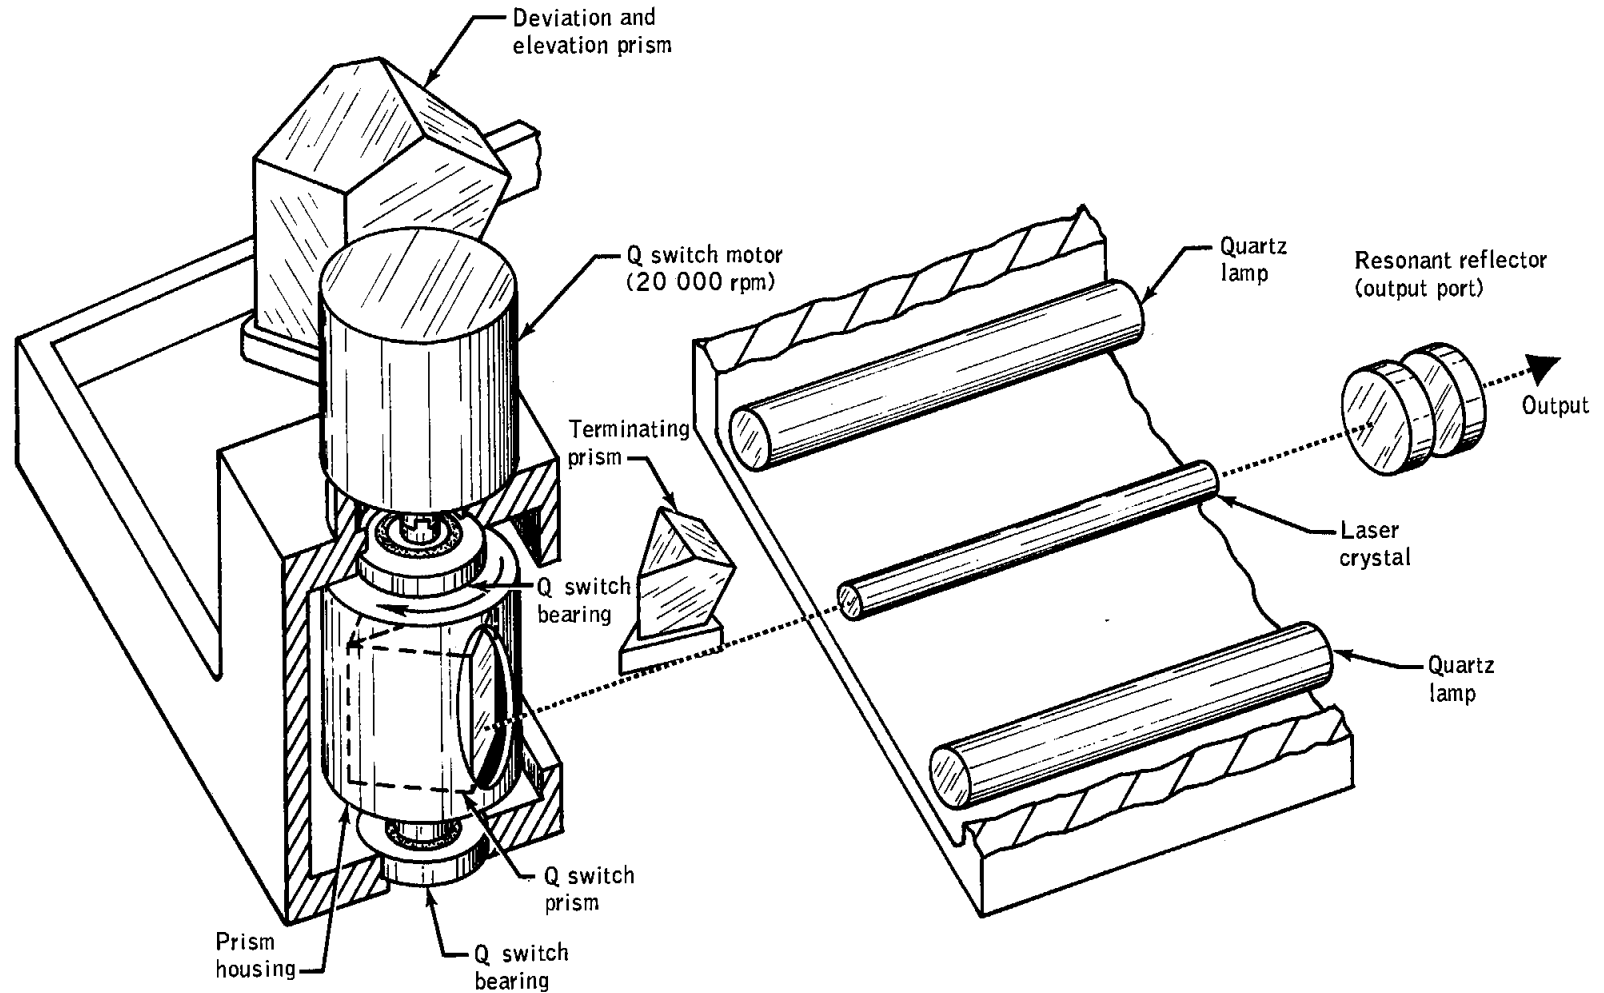
Analysis of the Apollo 15 failure indicated that the most probable cause was contamination of the internal optical surfaces by oil from the Q-switch bearings (fig. 14-69). Consequently, a delta qualification test was performed on a laser module, using new bearings incorporating oil-retainer shields. The qualification test consisted of a 220-hour thermal vacuum test which included a 50.5-hour mission operation timeline. Over 9000 laser firings were performed and the voltage controller had only reached step 4 by the end of the test.

Contamination of the optical surfaces within the laser module is considered to be the most likely cause of the degradation. A secondary cause is the degradation of the flashlamps because of discoloration of the lamp quartz as the result of the repeating high intensity light flashes and impurities in the quartz. The lubricant in the Q-switch motor and rotor bearings is apparently the principal source of contamination. Bearing life tests indicated that elimination of the oil reservoir in the bearings by the use of oil-impregnated bearings does reduce oil migration. Consequently, the Apollo 17 laser module will be modified to incorporate Q-switch bearings with oil-impregnated ball retainers and selection of flashlamps using a high purity quartz which is not as subject to degradation. Cover plates, installed over both access openings to the motor coupling, will complete the enclosure of the motor bearing.

Figure 14-69.- Laser altimeter module light reflection components.

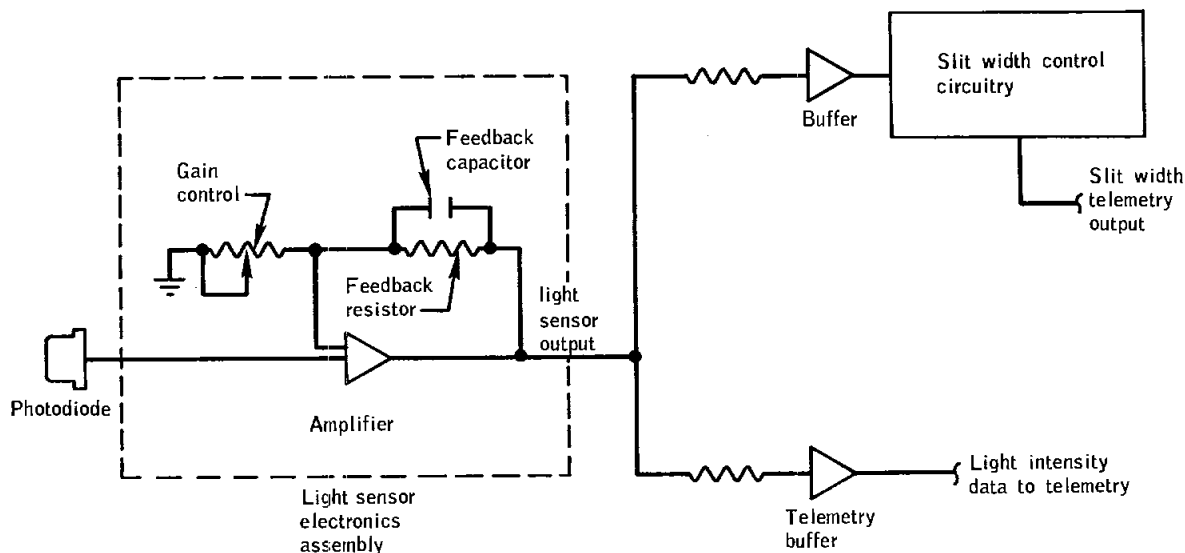
Figure 14-70.- Block diagram of panoramic camera automatic exposure control.

Throughout the mission, telemetry indicated that the sensor output was too low, resulting in a slit width that was too wide. Consequently, an overexposure of the film occurred. Based upon preflight brightness calculations and real-time mapping camera exposure data, the degree of overexposure was estimated to be approximately 1-1/2 to 2 f-stops. As a consequence, the film processing was modified to compensate for this degree of overexposure.

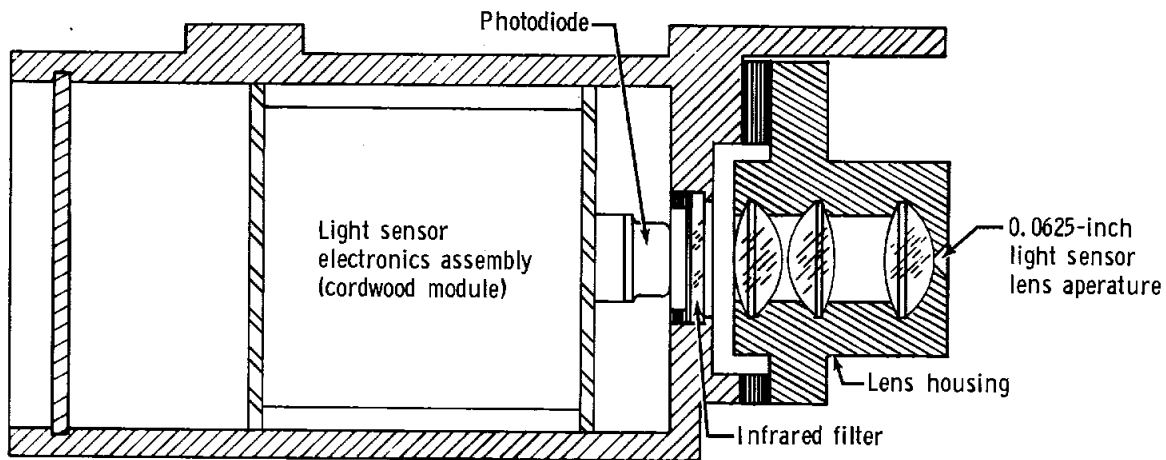
The problem could have been the result of contamination on the sensor optics or a failure in the light sensor or its associated circuitry (fig. 14-71). Analyses and tests have shown that component open or short circuit failures could not have caused the problem since the amount of overexposure could not be duplicated. Feedback capacitor leakage (equivalent to about 6 megohms leakage resistance), or a decrease in the gain of the photodiode input amplifier (an integrated circuit), or a decrease in photodiode sensitivity, shown in figure 14-70, could have caused the problem. These components, however, have no previous history of these types of failures; therefore, no corrective action will be taken.

A review of data indicates that the problem occurred preflight, at some time between January 5, 1972, and February 25, 1972. The failure was not detected because the test merely ascertained that the light sensor responded to stimulation (a light source placed in front of the sensor). Although sensor output voltage was recorded, no voltage tolerances had been established for the test.

Figure 14-71.- Panoramic camera light sensor assembly.

To preclude a similar problem not being detected in ground testing, sensor output voltage limits have been added to the test procedure.

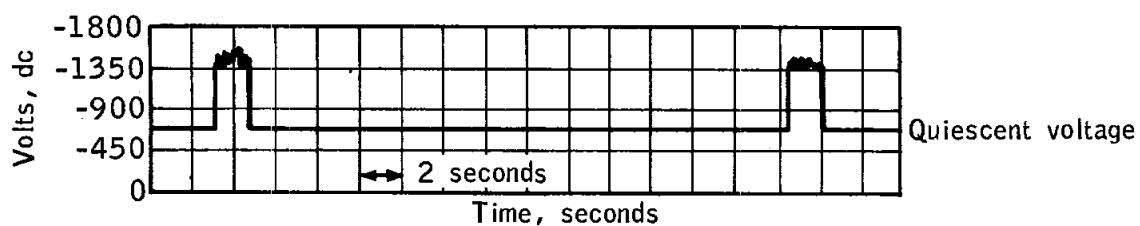
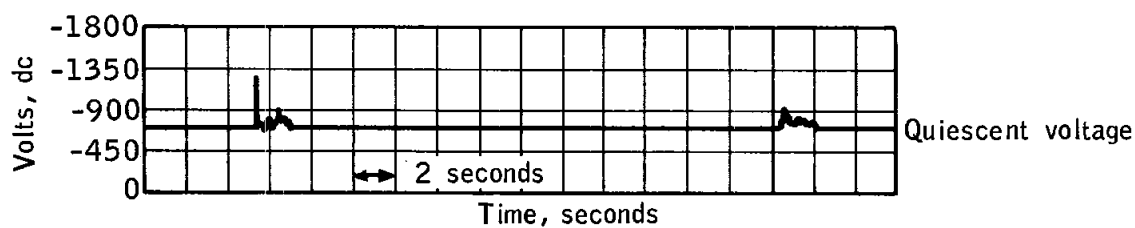
Figure 14-72.- Laser altimeter photomultiplier voltages.

During the revolution-60 operation of the laser altimeter, the high voltage supply for the photomultiplier tube was occasionally erratic. During the next operating period (revolution 63) the erratic behavior became more pronounced (fig. 14-72), and there were several instances when the voltage failed to rise from the quiescent (idling) level.

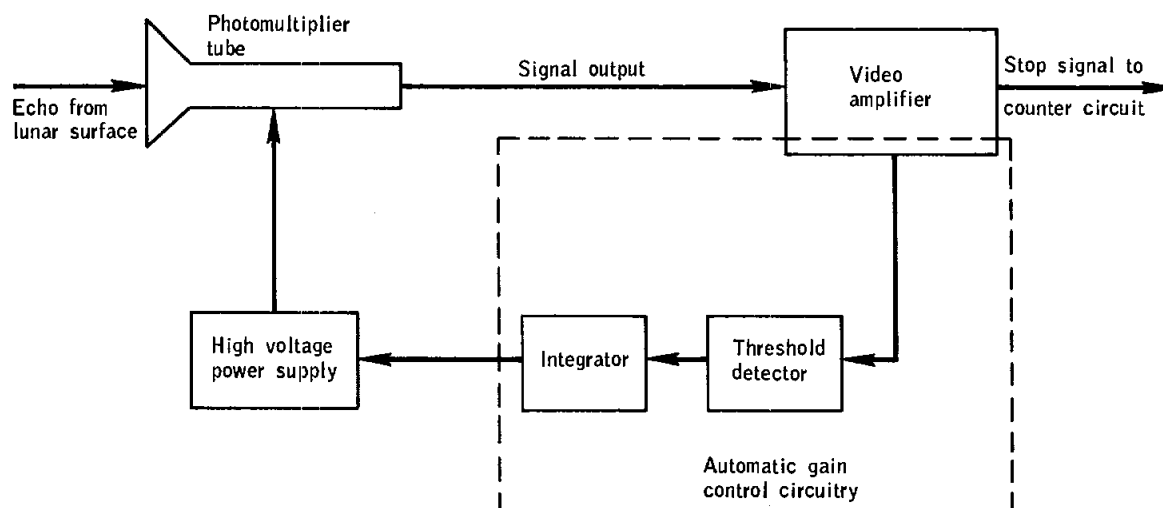
Figure 14-73.- Laser receiver circuitry.

A number of intermittent conditions are possible that could either increase the gain of the photomultiplier amplifier or couple electrical noise into the amplifier's input. Either of these occurrences could cause the effects observed in the data. An intermittent condition could have been caused by the cyclic thermal environment that occurs as a result of lunar orbit operation. Since qualification test results and acceptance tests are considered to be adequate for this equipment, no corrective action will be taken.

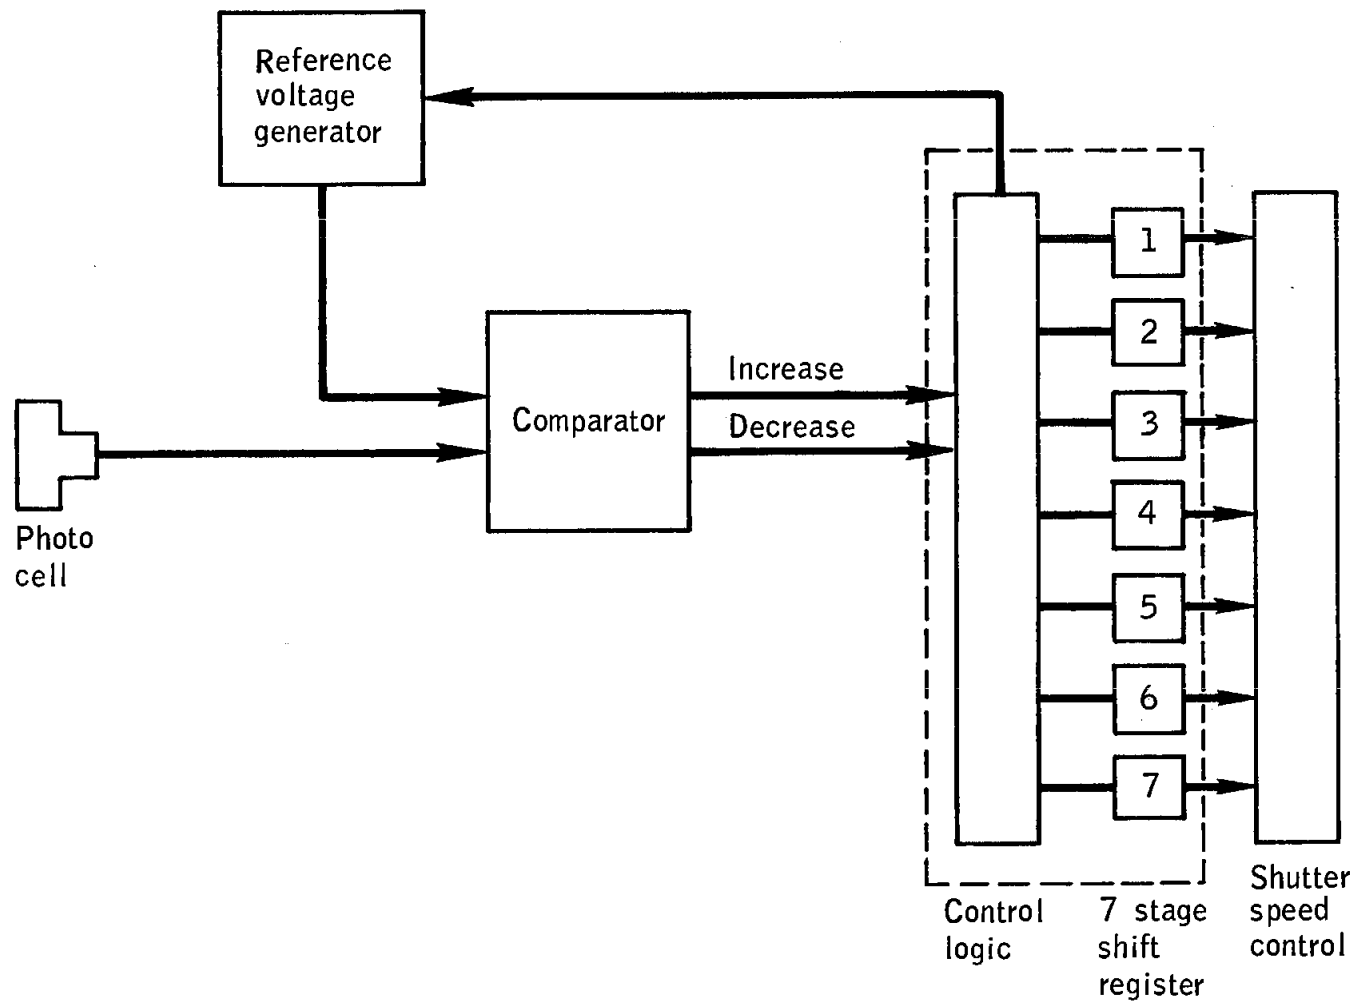
Figure 14-74.- Photocell servosystem.

Shutter speed is controlled by a photo cell which senses the light level in the camera's field of view. The photocell operates in a servo system which controls shutter speed. The photocell servo system consists of the photocell, a comparator, a voltage reference, and a seven-stage shift register, as shown in figure 14-74.

Noise voltage pulses can set or reset (turn on or off) any stage in the register regardless of the condition of any other stage. Thus, more than one stage could be on at the same time, and, in this condition, when the first clocking pulse occurs, the logic would turn stage five on and all other stages off. The remaining five clocking pulses then could still shift to the on stage required by the light level seen by the photocell and no anomalous operation would result. Should the noise pulse occur during the clocking cycle, however, there may not be enough clocking pulses left to shift the on condition back to the required stage. Since the effect of the noise pulse is to shift the on condition to stage five, slow shutter speed and overexposure can be expected to occur more often than fast shutter speed and underexposure.

Noise voltage on the power supplied to the register or generated by some intermittent condition in the camera must have switched one or more stages in the shift register on or off. The camera qualification test results and acceptance tests are adequate. No corrective action is necessary.

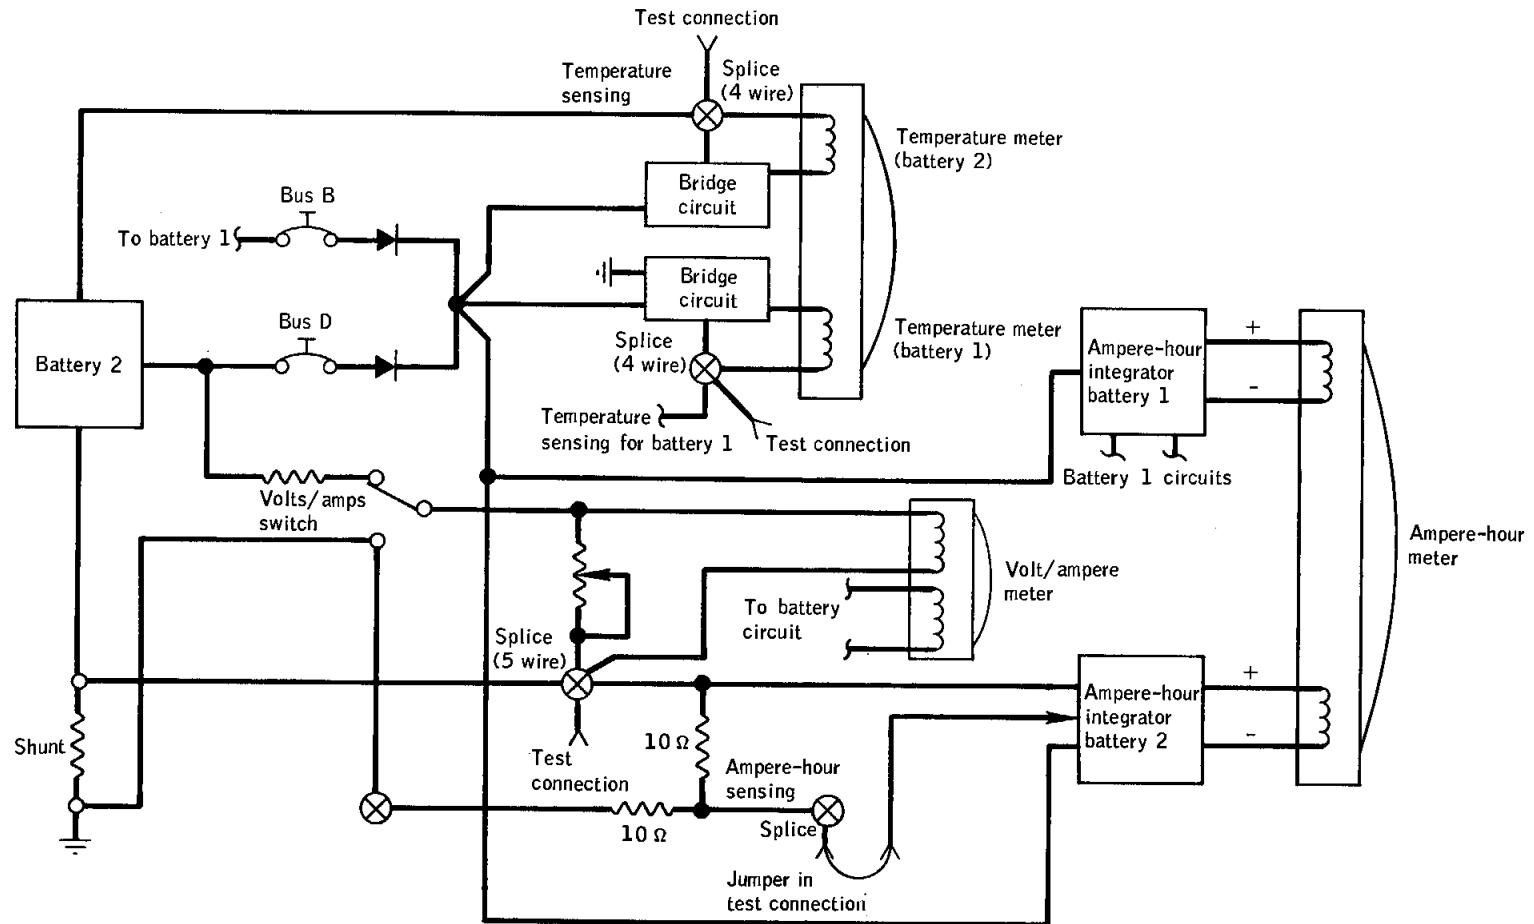
Figure 14-76.- Lunar roving vehicle electrical meter circuitry.

The circuitry associated with the electrical system meters is shown in figure 14-76. Note the multiple wire-crimp splices in the system. The return for the volt/ampere meter is connected to the battery return with a five-wire crimp splice containing one 12-gage wire, one 20-gage wire, and three 22-gage wires. This splice was associated with the electrical modification made on the Apollo 16 lunar roving vehicle at the launch site. An intermittent connection at this splice would explain the volt meter reading off-scale low and then later reading properly. An open connection at this splice would reverse the polarity on the ampere-hour integrator sense line and give a false indication of battery 2 charging as observed during the second and third extravehicular activities (see fig. 14-77). Also, the battery 1 ampere-hour meter indicated a 20-ampere-hour decrease rate which was greater than predicted. However, a review of the data shows that the current readings taken during this period of time were correct and a 20-ampere load was present. Therefore, the ampere-hour integrator for battery 1 was working properly.

Both battery temperatures reading off-scale low and then reading properly could be caused by an intermittent connection at the four-wire splice (fig. 14-76). However, this would require a simultaneous open circuit at two splices initially, which later corrected themselves, and finally, failure of a single splice in the battery 1 temperature circuit.

If no sneak circuit can be identified, the most likely cause of temperature meter anomalies would be the four-wire splice in the temperature meter circuits.

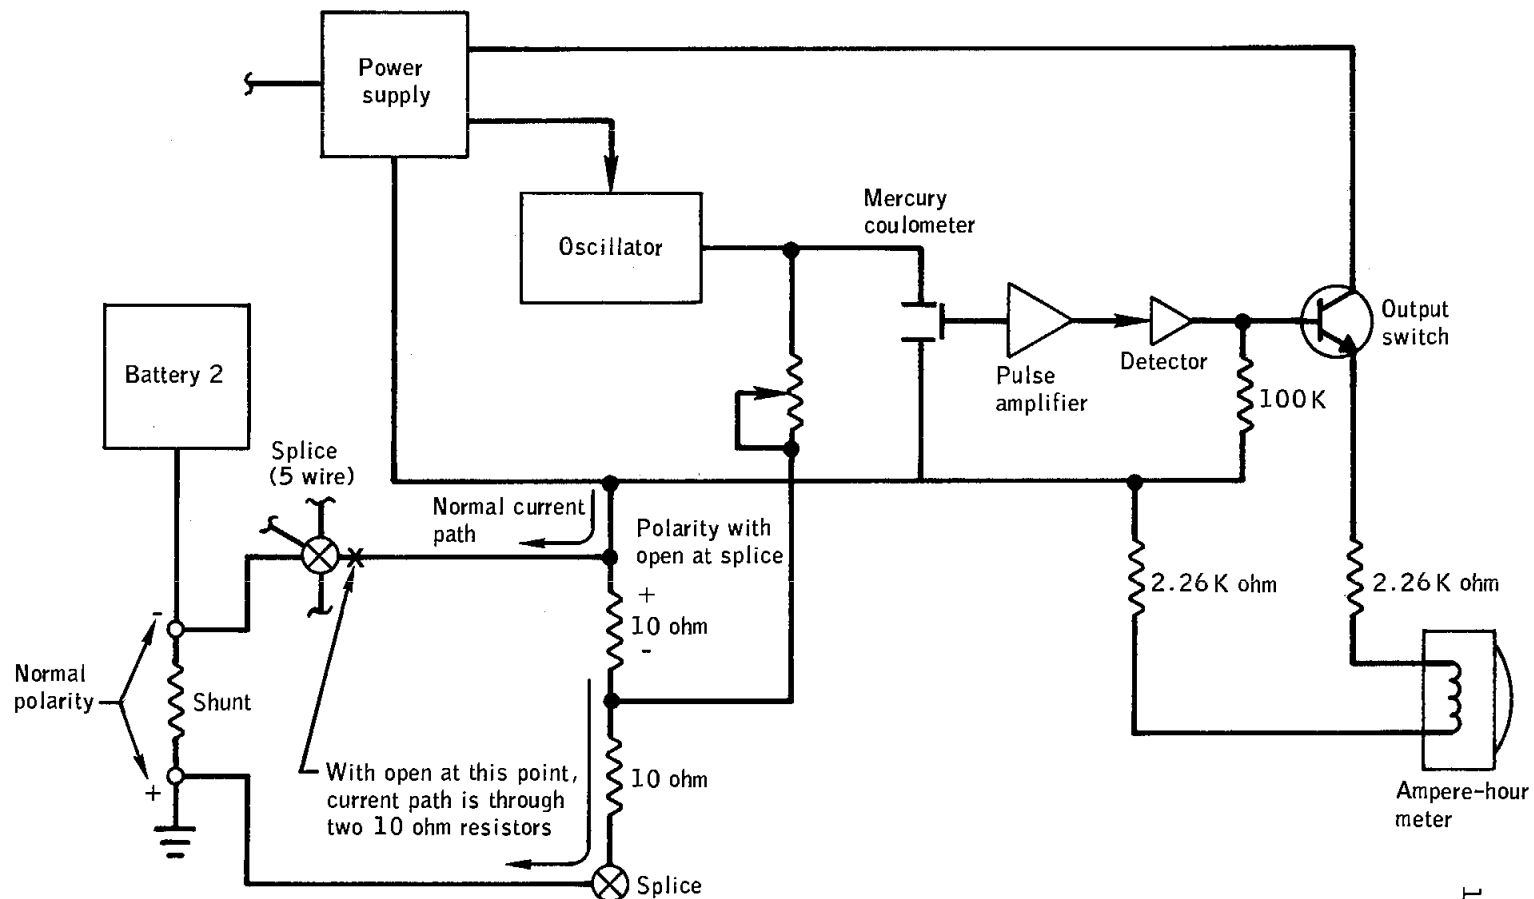
Figure 14-77.- Battery 2 ampere-hour integrator circuit.

The second possibility is that two circuit breakers were not closed electrically, resulting in no power to the temperature meter circuits and ampere-hour integrators. This would also explain the battery 2 ampere-hour integrator reading off-scale low, but would not explain the battery 1

ampere-hour integrator reading full-scale, unless a sneak circuit existed. This sneak circuit must result from an open circuit at the five-wire splice in the battery 2 volt and ampere-hour meter circuit.

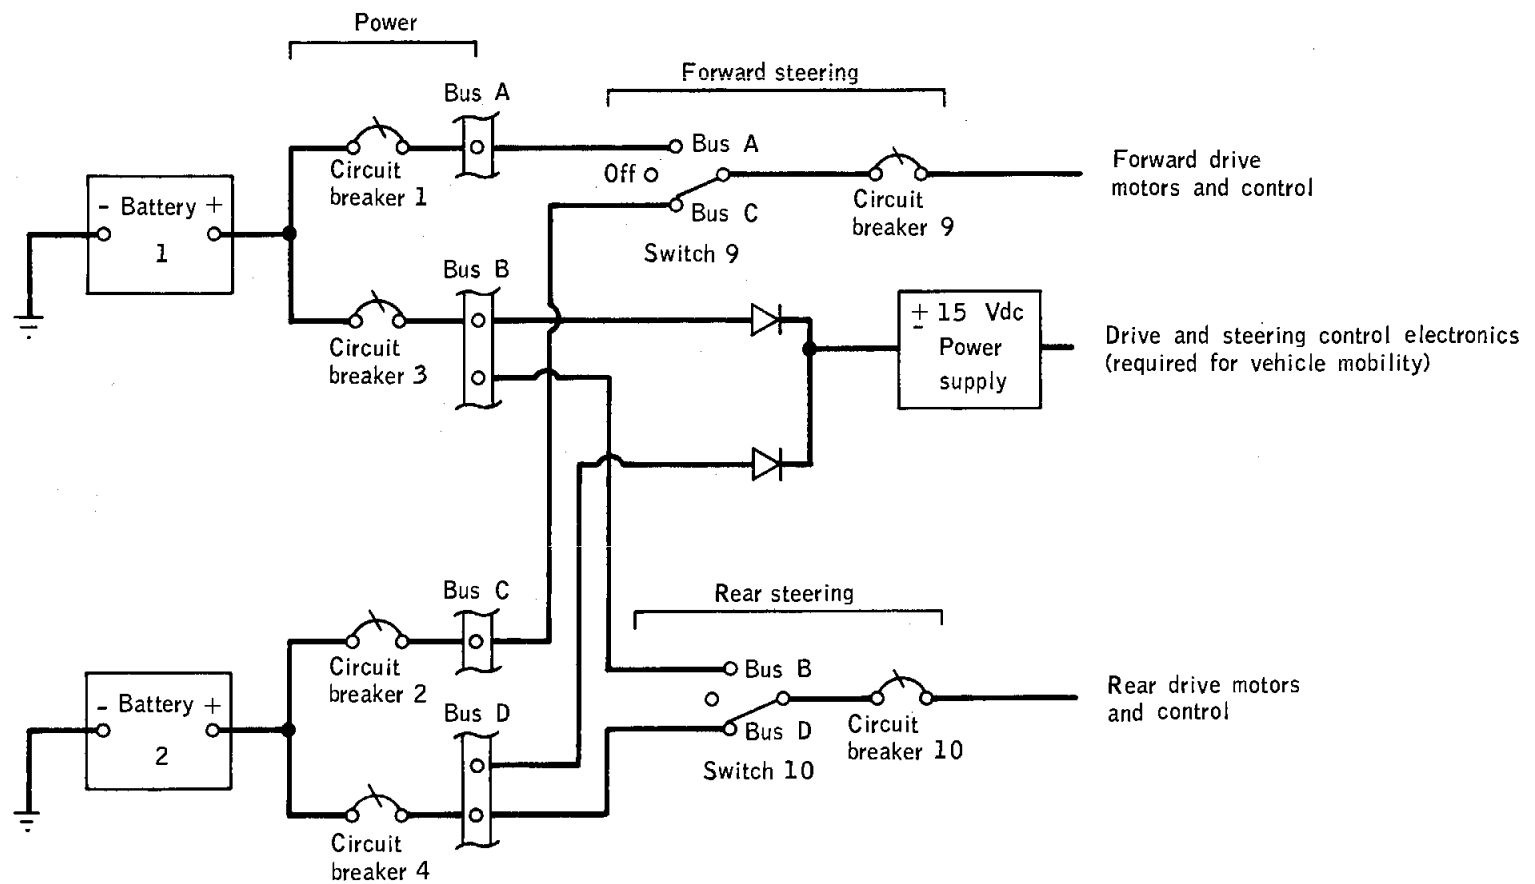
Figure 14-78.- Lunar roving vehicle steering power schematic.

Figure 14-78 shows that switch 10, circuit breaker 10, and circuit breakers 3 or 4 must be closed to provide power to the rear steering system. In addition, circuit breakers 3 or 4 must be closed to provide ± 15 Vdc for the drive as well as steering control electronics. Since the vehicle had both mobility and forward steering, at least one of these breakers made contact. Switch 10 was cycled after vehicle motion; however, the rear steering remained inoperative. Circuit breaker 10 could possibly have been open due to some contaminate existing in the breaker.

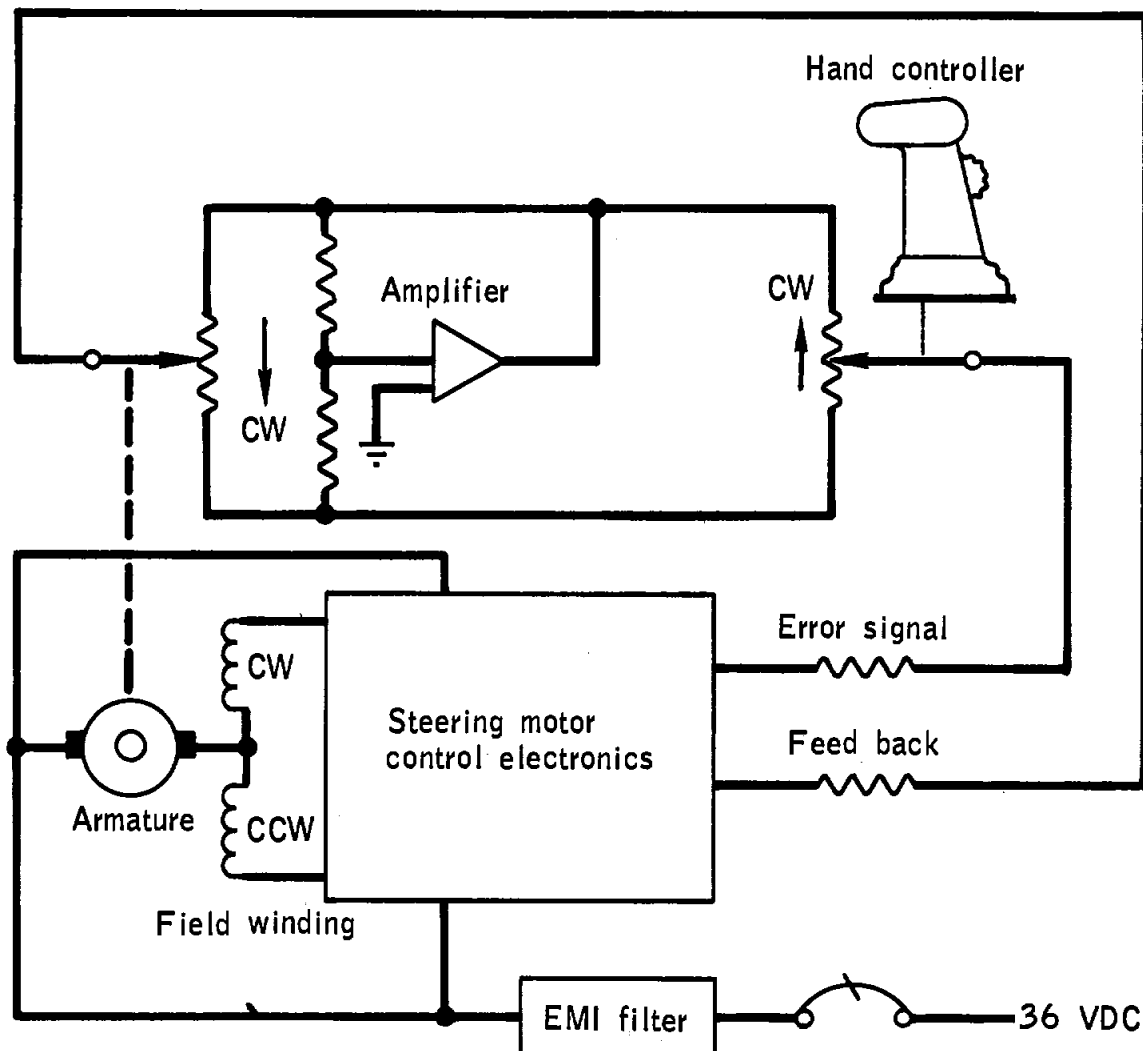
Figure 14-79.- Steering system electrical.

Another possible cause of the anomalous condition is in the steering servo system (fig. 14-79). A signal generated by the hand controller is coupled to the input servo amplifier as an error signal across a bridge. This signal is amplified and applied to the steering motor field coils in a direction determined by the polarity of the input signal which depends upon the direction of the hand controller deflection. The feedback potentiometer is driven by the steering motor in a direction to balance the bridge, thus cancelling the original error signal. A non-conductive lubricant (DC 40), is applied to the wiper and resistive element of the potentiometers to produce smooth operation and reduce noise. At low temperatures, this lubricant could become more viscous and insulate the wiper

from the resistive element. No error signal would then be present at the input to the servo amplifier, although the hand controller was deflected. As the steering electronics heat up, the lubricant becomes less viscous. Exercising the hand controller then cleans the lubricant from the wiper and resistive element, allowing contact to be made. This would account for the anomalous condition. Tests will be conducted to determine the effect of the lubricant on the potentiometers at low temperatures.

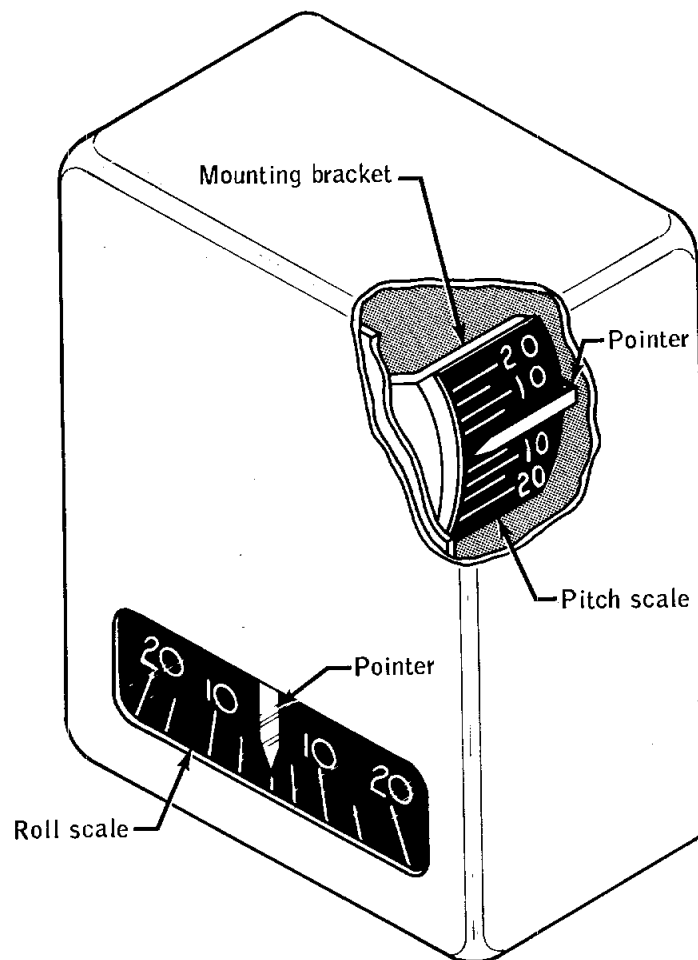
Figure 14-81.- Pitch attitude indicator.

During the second extravehicular activity, the crew reported that the lunar roving vehicle pitch attitude indicator scale had fallen off. The indicator provides a vehicle pitch reference between plus and minus 20 degrees. The loose pitch scale did not impact the mission because the pointer for the indicator continued to work properly and the crew could adequately estimate the vehicle pitch from the pointer position.

The pitch attitude indicator scale is bonded to a bracket (fig. 14-81) which is attached to the indicator case. The scale is constructed of 2024T3

aluminum and the bracket is 6/6 nylon. A comparison of the coefficients of thermal expansion of the materials indicate approximately a 4-to-1 ratio for nylon-to-aluminum. With this expansion ratio, stress factors of safety for an ideal bond are 3 and 4 at temperatures of minus 100° F and plus 250° F, respectively. Although a review of the bonding procedures did not reveal any problems, a flaw most probably existed in the bond and this allowed stress buildup which caused the scale to become unbonded. The crew experienced no difficulty in estimating the pitch angle after the scale became unbonded. The back of the meter case must be machined off to gain access to the scale, and special handling permits must be obtained before working on the meter because of the radioactive materials within the case. For these reasons, no hardware changes will be made for Apollo 17.
