APOLLO 15 MAIN-PARACHUTE FAILURE

By Donald D. Arabian and Joseph E. Mechelay*

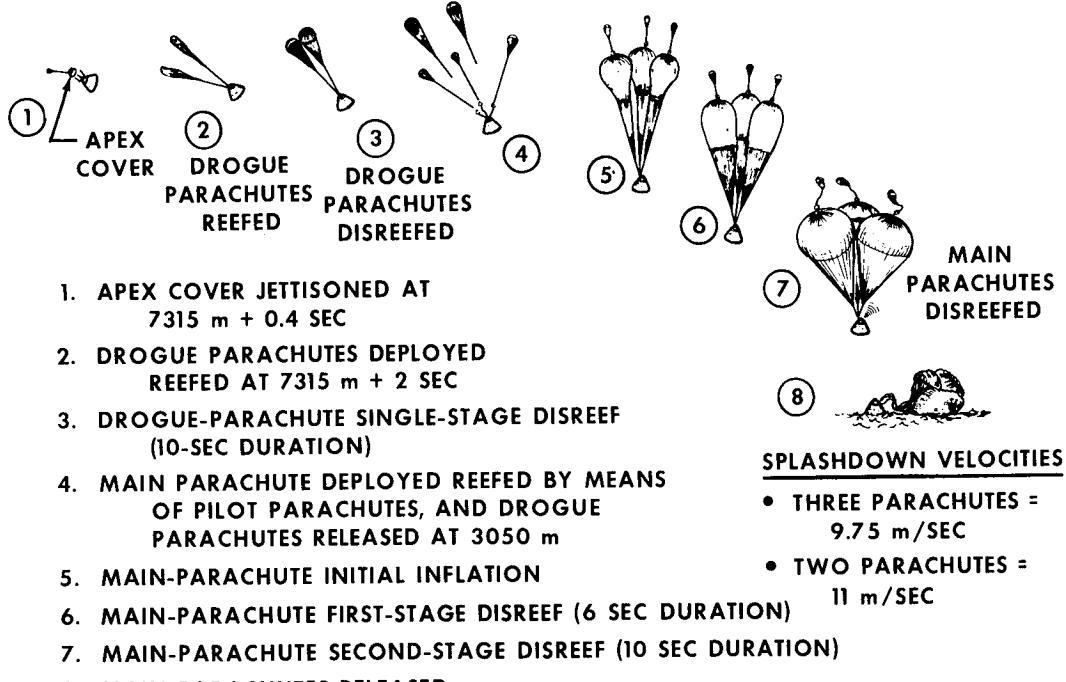
<u>Trajectory analysis.</u> - The landing sequence was initiated at a nominal altitude of 7315 meters with jettisoning of the forward heat shield (fig. 5), which is used to protect the parachute system. Immediately after separation of the heat shield from the command module, a 2.19-meter-diameter parachute was mortar deployed from the forward heat shield, an action that augments separation of the heat shield from the command module. Following a drogue- and pilot-parachute deployment sequence, the main parachutes are deployed and decelerate the command module to its final descent velocity of approximately 9 m/sec. The descent rate of the 172-kilogram forward heat shield is

Figure 5. - Earth landing system normal sequence.
