APOLLO 15 MISSION

TEMPORARY LOSS OF COMMAND MODULE TELEVISION PICTURE

ANOMALY REPORT NO. 4

MARCH 1973

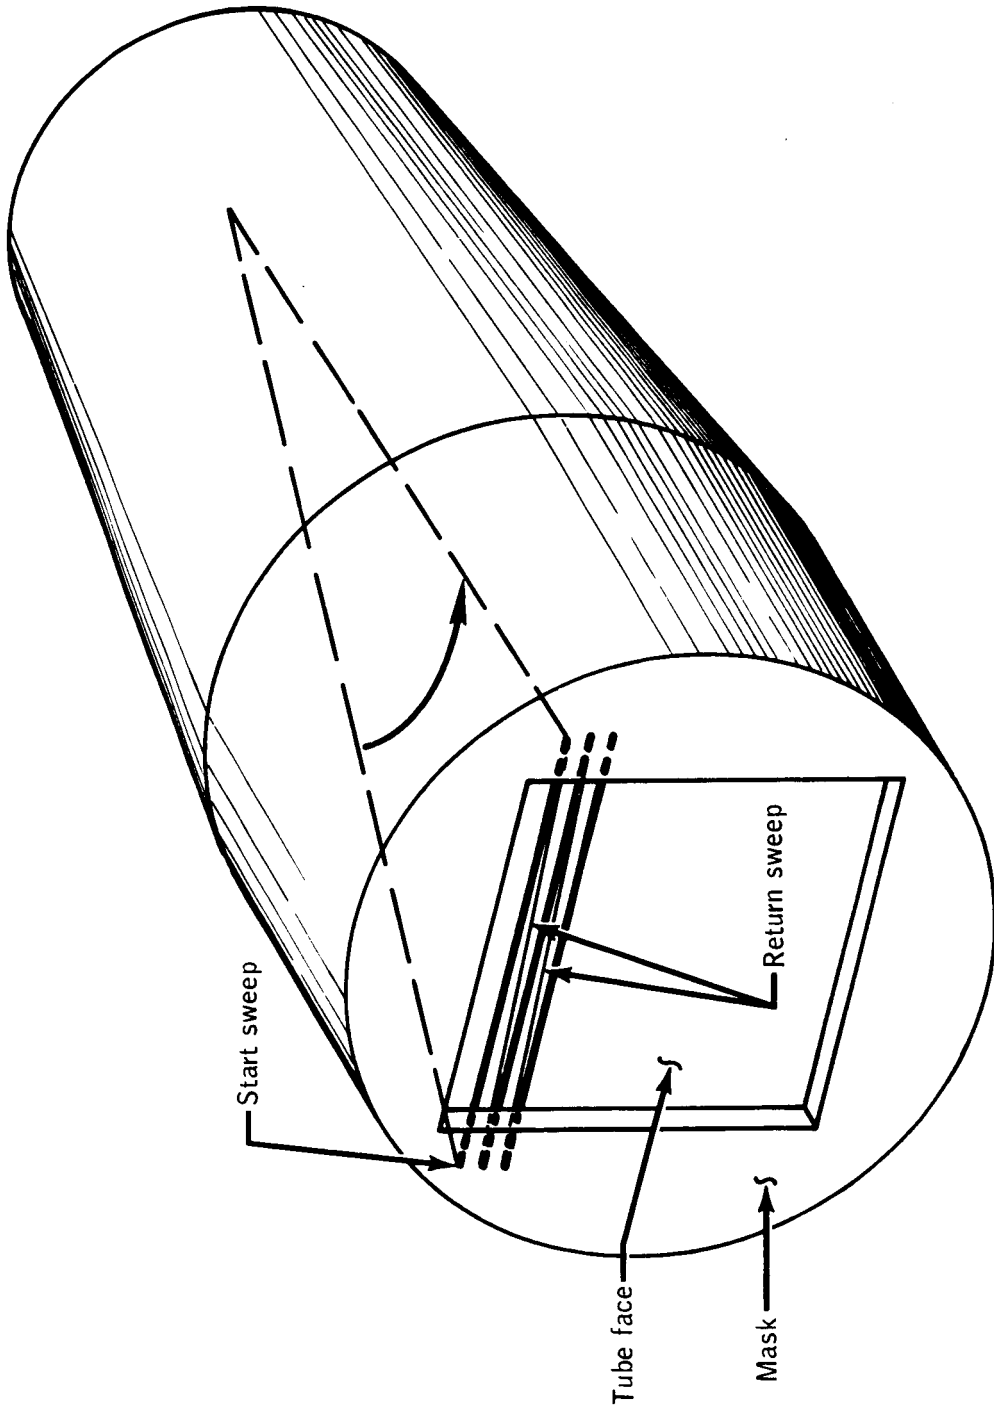
Figure 1.- Video image-converter tube (electron bombardment silicon tube).

With normal lighting in the field of view of the television camera image-converter tube, the area of the tube face behind the mask (fig. 1), where the electron beam sweep from left to right begins, is black, and the signal level is zero volts (fig. 2a). As the sweep for each line progresses from under the mask and across the window, the signal varies from black (zero volt) to white saturation (-1.0 volt).

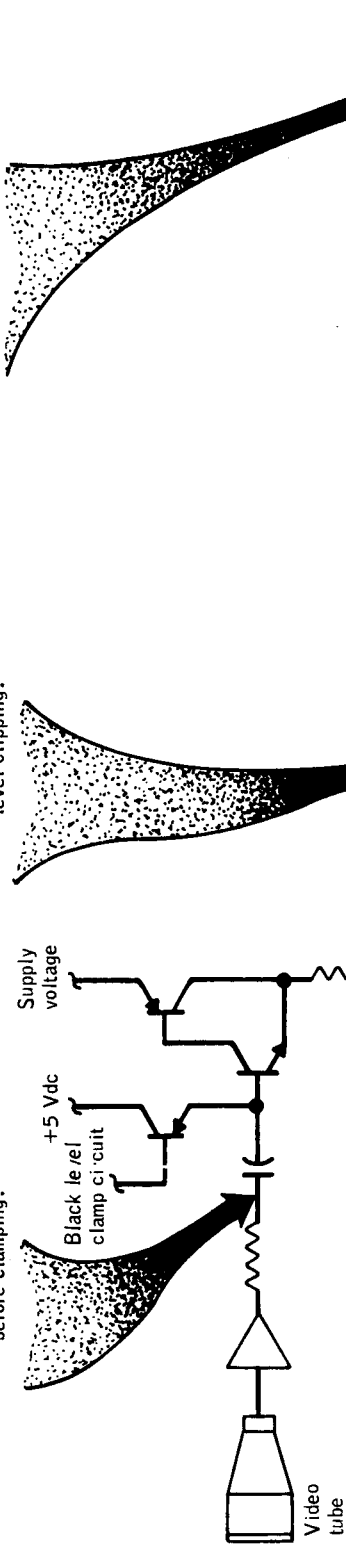
Figure 2b.- Signal after black level clipping.

Black level for the signal is set at a 5-volt reference by the clamping circuit (figs. 2b and 2c) with the resulting signal varying from black level (5 volts) to white saturation (4 volts).

The white saturation level is a function of the video tube characteristics. The black level of the output signal is controlled by the black-level clipping circuit (figs. 2b and 2c) that conducts the portion of the signal above the clipping level through the diode to ground. The signal is clipped approximately 5 percent below the clamp level.

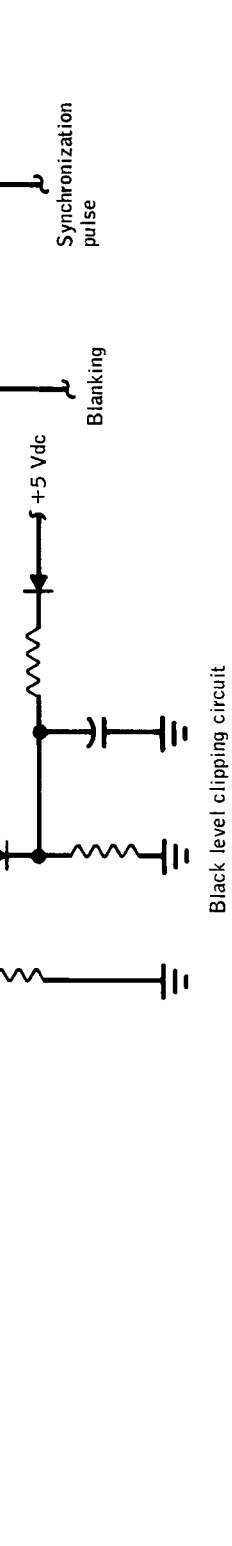
Figure 2c.- Partial circuit.

The last video amplifier, shown in the partial circuit in figure 2c, adds the synchronization pulse to the video signal during the blanking period (fig. 2d). The synchronization pulse controls the start of the electron beam trace in the ground-receiver picture tube, providing the lock-on pulse for the ground station converter.

The temporary loss of the picture was caused by a false synchronization pulse that resulted from the inability of the black-level clipping circuit to respond adequately to the video signal when bright sunlight suddenly entered the camera's field of view. The clipper was not designed to operate with direct sunlight in the camera's field of view.

The black-level clipping circuit was modified to eliminate the diode which could be back-biased by a large charge on the bias network capacitor (fig. 4). The transistor which replaces the diode in the modified circuit isolates the bias capacitor so that it is not charged by the improper black level voltage. The transistor then continues to conduct the excess signal to ground, even in the case of high intensity light inputs to the video tube. In extreme cases (direct sunlight) the picture would go blank temporarily, with the modified circuit, but the normal synchronization pulse pattern would continue.
