APOLLO EXPERIENCE REPORT -THE CRYOGENIC STORAGE SYSTEM

by William A. Chandler, Robert R. Rice, and Robert K. Allgeier, Jr. Manned Spacecraft Center Houston, Texas 77058

NATIONAL AERONAUTICS AND SPACE ADMINISTRATION • WASHINGTON, D. C. • JUNE 1973

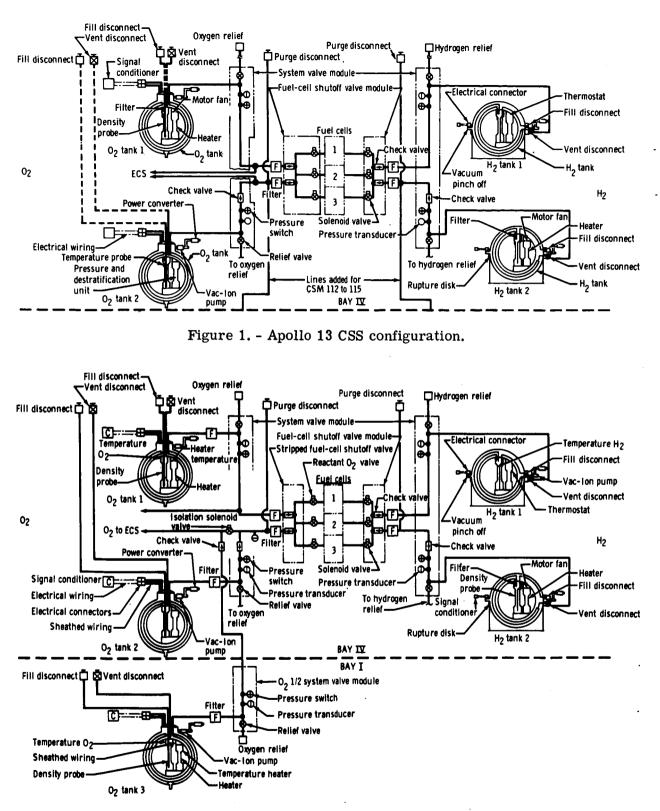
These system arrangements are shown schematically in figures 1, 2, and 3. The third tanks were required for the J-series missions on Apollo 15 and subsequent flights; however, the third oxygen dewar was added for redundancy on the Apollo 14 spacecraft after a total failure of the Apollo 13 oxygen system.

Figure 2. - The CSS configuration, redesigned for Apollo 14.

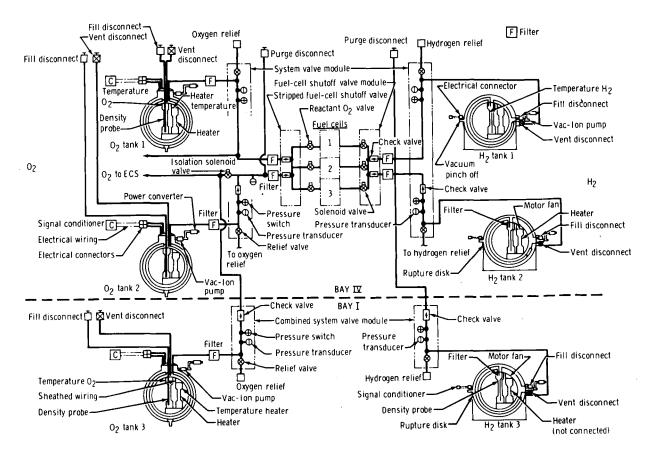
Figure 3. - The CSS configuration, redesigned for Apollo 15.

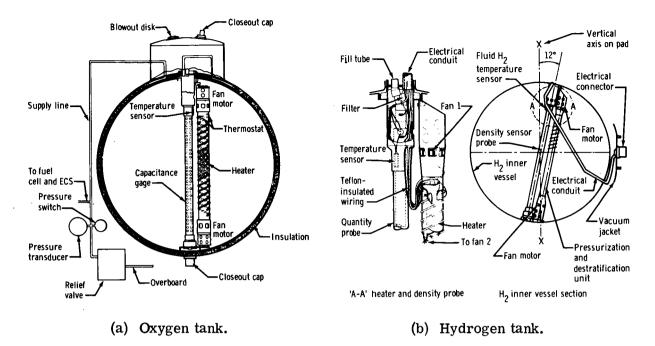
Cutaway views of both the oxygen dewar and the hydrogen dewar are shown in figure 4. Each dewar consists of an inner pressure vessel and an outer vacuum shell with evacuated multilayer insulation in the annulus between the two concentric spheres. The inner pressure vessel contains a capacitance probe for fluid-quantity measurement, a heater element to provide energy to the fluid for pressure maintenance, and temperature sensors that provide an indication of bulk-fluid temperature.

Figure 4. - Apollo 13 tank designs.
