JSC-07954

**APOLLO 17 MISSION**

**ANOMALY REPORT NO. 2**

**MAPPING CAMERA EXTENSION MECHANISM  
OPERATED ERRATICALLY**

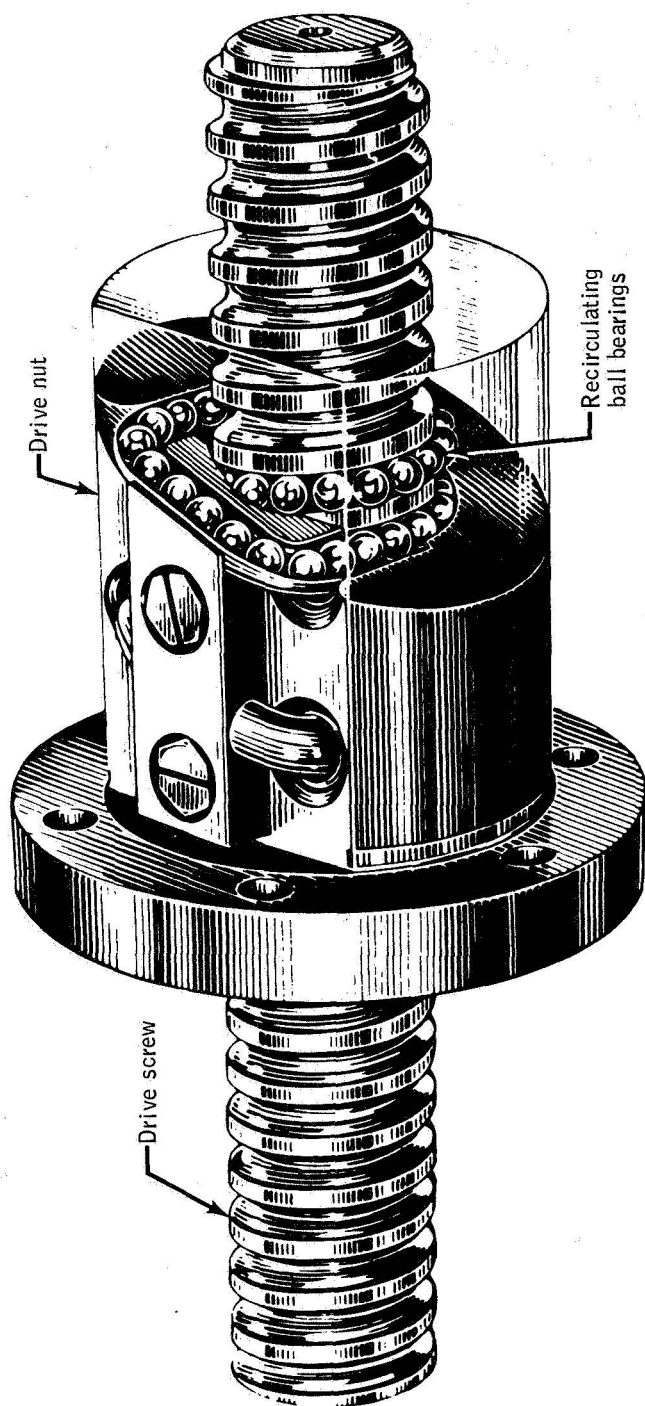
Figure 6.- Drive nut assembly.

The camera was deployed by a drive screw turning within a drive nut that was bolted to the camera assembly (fig. 5). A dry-powder film lubricant of molybdenum disulphide and sodium silicate was used on the drive screw. This lubricant was chosen specifically for its low outgassing quality in the space environment to preclude contamination of the optical surfaces. Friction at the drive nut/screw interface was minimized by the use of recirculating streams of ball bearings (fig. 6). Two deployment rails attached to the bottom of the camera also passed through bushings containing recirculating ball bearings (figs. 3 and 5). The bushings were lubricated with versilube, a mixture of silicone oil and lithium soap thickener. This lubricant was also used in the motor clutches and on the ball bearings in the drive assembly.

Thermal/vacuum tests with the complete deployment mechanism under simulated zero-g conditions showed normal deployment and retraction times. Other tests indicated that the drive screw rear thrust bearing could be damaged by stalling the drive mechanism. A damaged drive screw rear thrust bearing could cause slow deployment and retraction.
