MSC-07571

APOLLO 16 MISSION  
ANOMALY REPORT NO. 3

INERTIAL SUBSYSTEM WARNINGS AND  
COUPLING DATA UNIT FAILURE INDICATIONS

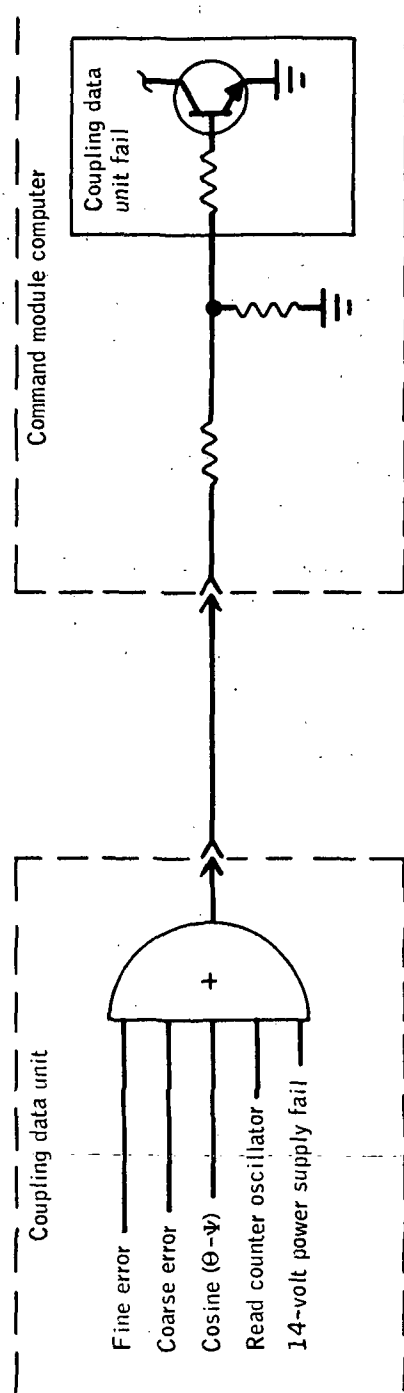
Figure 1.- Coupling data unit data fail indication.

The coupling data unit assembly contains failure detection circuits which monitor the performance of the assembly. There are individual failure detect circuits for the inertial subsystem and the optical subsystem coupling data units. Figure 1 is a functional representation of the pertinent circuits. A failure discrete is sent to the computer if a failure occurs in either subsystem coupling data unit. The failure discrete is sent to the computer if one or more of the following conditions exist:

- a. Coarse error detect - A disagreement of approximately 30 degrees between a read counter and the 1X gimbal resolver.
- b. Fine error detect - A disagreement of more than 0.7 degree between a read counter and the 16X gimbal resolver.
- c. Cosine ( $\theta - \psi$ ) - Voltage less than 2 Vrms. This voltage is normally 4 Vrms when the read counter agrees with the resolver voltage.
- d. Read counter limit cycle - The read counter changes the direction in which it is counting at a rate greater than 160 times a second.
- e. 14-Vdc power supply - The 14-Vdc power supply in the coupling data unit decreases to 8 volts or less.

The computer logic is such that the failure discrete must exist for  $5 \pm 2$  seconds before the computer generates the appropriate failure indications. The measured time delay associated with the failure discrete was 5 seconds during the flight. The failure indications persisted for 4, 12, 16, 894, 10 and 38 seconds. All telemetry data directly or indirectly related to the coupling data unit were reviewed and no abnormalities were observed. If a real failure condition had occurred in the monitored parameters and had lasted as long as 894 seconds, it would be observable in the data. An intermittent condition was indicated, however, with the most probable locations in (1) the failure-detect circuit of the coupling data unit assembly, (2) the input logic in the computer, or (3) the "A" harness (or its connectors) between the coupling data unit assembly and the computer.
