**NASA TN D-7437**

# APOLLO EXPERIENCE REPORT -EARTH LANDING SYSTEM

by Robert B. West Lyndon B. Johnson Space Center Houston, Texas 77058

NATIONAL AERONAUTICS AND SPACE ADMINISTRATION • WASHINGTON, D. C. • NOVEMBER 1973

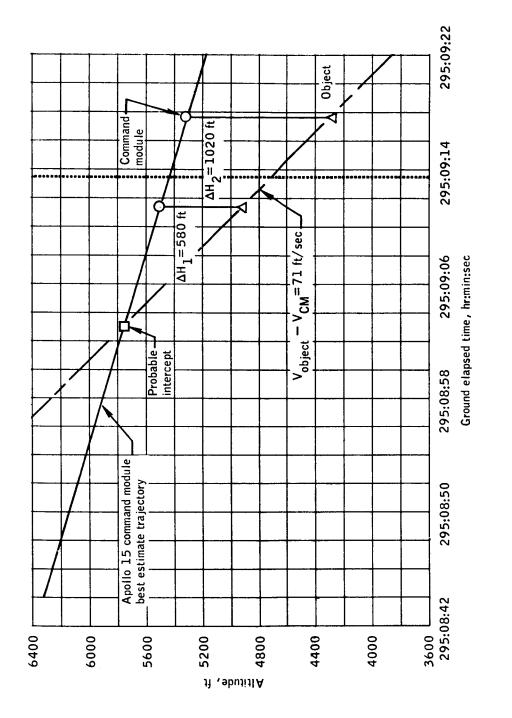
<u>Photographic analysis</u>.- A close examination of the television record of spacecraft descent on the main parachutes establishes that the forward heat shield was below the spacecraft at the time of the failure. Specifically, the forward heat shield is seen below the spacecraft in frame 588 (fig. 9) at 295:09:11:3, approximately 2 seconds before the anomaly occurred. By correlation with frame 775, which shows the parachute and forward heat shield in the same frame at 295:09:17.5, and by direct measurement of the separation distance between the two objects and measurement of the known parachute dimensions, the vertical separation distances between the forward heat shield and the spacecraft were 580 feet for frame 588 and 1020 feet for frame 775.

$\Delta V = \frac{1020 - 580}{17.5 - 11.3} \text{ ft/sec}$  $\Delta V = 71 \text{ ft/sec}$

Figure 9.- Television frame and trajectory analysis.
