NASA CR121238

Improvement Program
for
Polycarbonate Capacitors
by

TRW Capacitors

NASA LEWIS RESEARCH CENTER
Contract NAS 3-15688

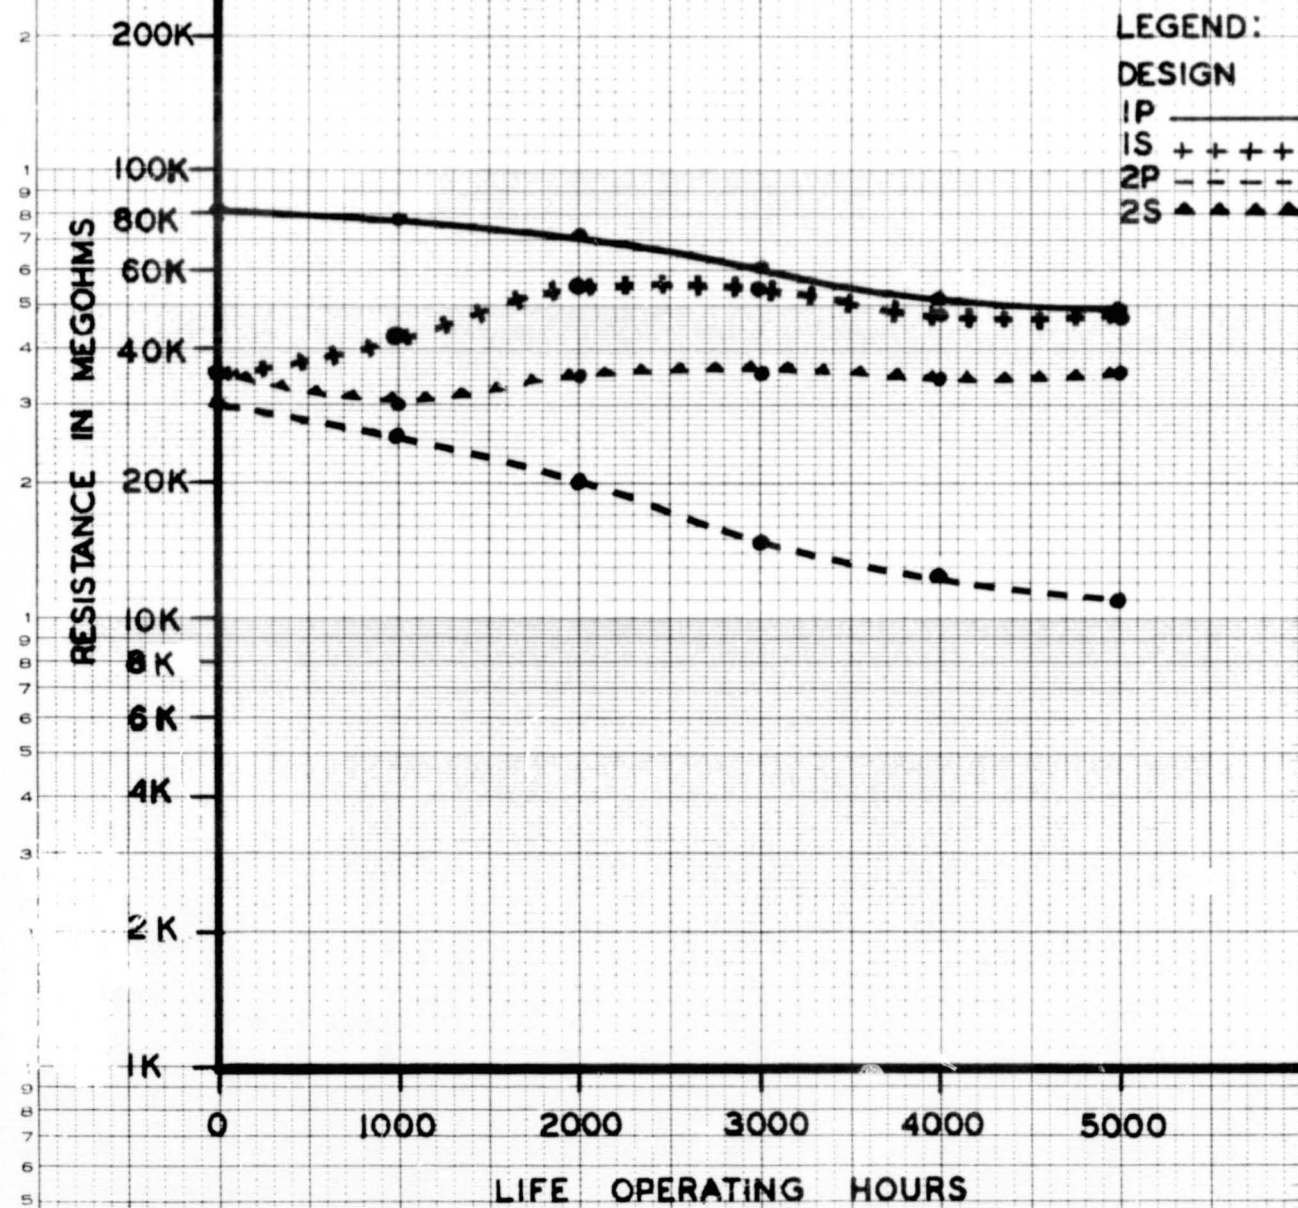
FIGURE 11

The terminal-to-terminal insulation resistance average values at 110°C are illustrated in Figures 11 and 12. It can be noted that for the 1.0 uF designs in Figure 11, the IR remained very consistent or increased slightly for the 1S and 2S designs which use silicone oil. For designs 1P and 2P, IR decreased some. The greatest individual capacitor excursion of IR for the 1.0 uF ranged from 0.4 megohms to 105 K megohms. The range of IR for individual 0.25 uF capacitors went from 6.5 megohms to a maximum of 430 K megohms. The variations of IR related to silicone oil versus polybutene were noted also in the 0.25 uF designs but to a greater degree. This is partly born out by the greater number of failures at 110°C in design 3P compared to 3S in which other failure mechanisms were at work. It indicates that silicone oil may be less affected by sustained heat for long hours and that polybutene may be deteriorating some.

INSULATION RESISTANCE CHARACTERISTICS
OF
POLYCARBONATE CAPACITORS
DURING
400 HZ LIFE TESTING AT 110° C
1.0 μ F

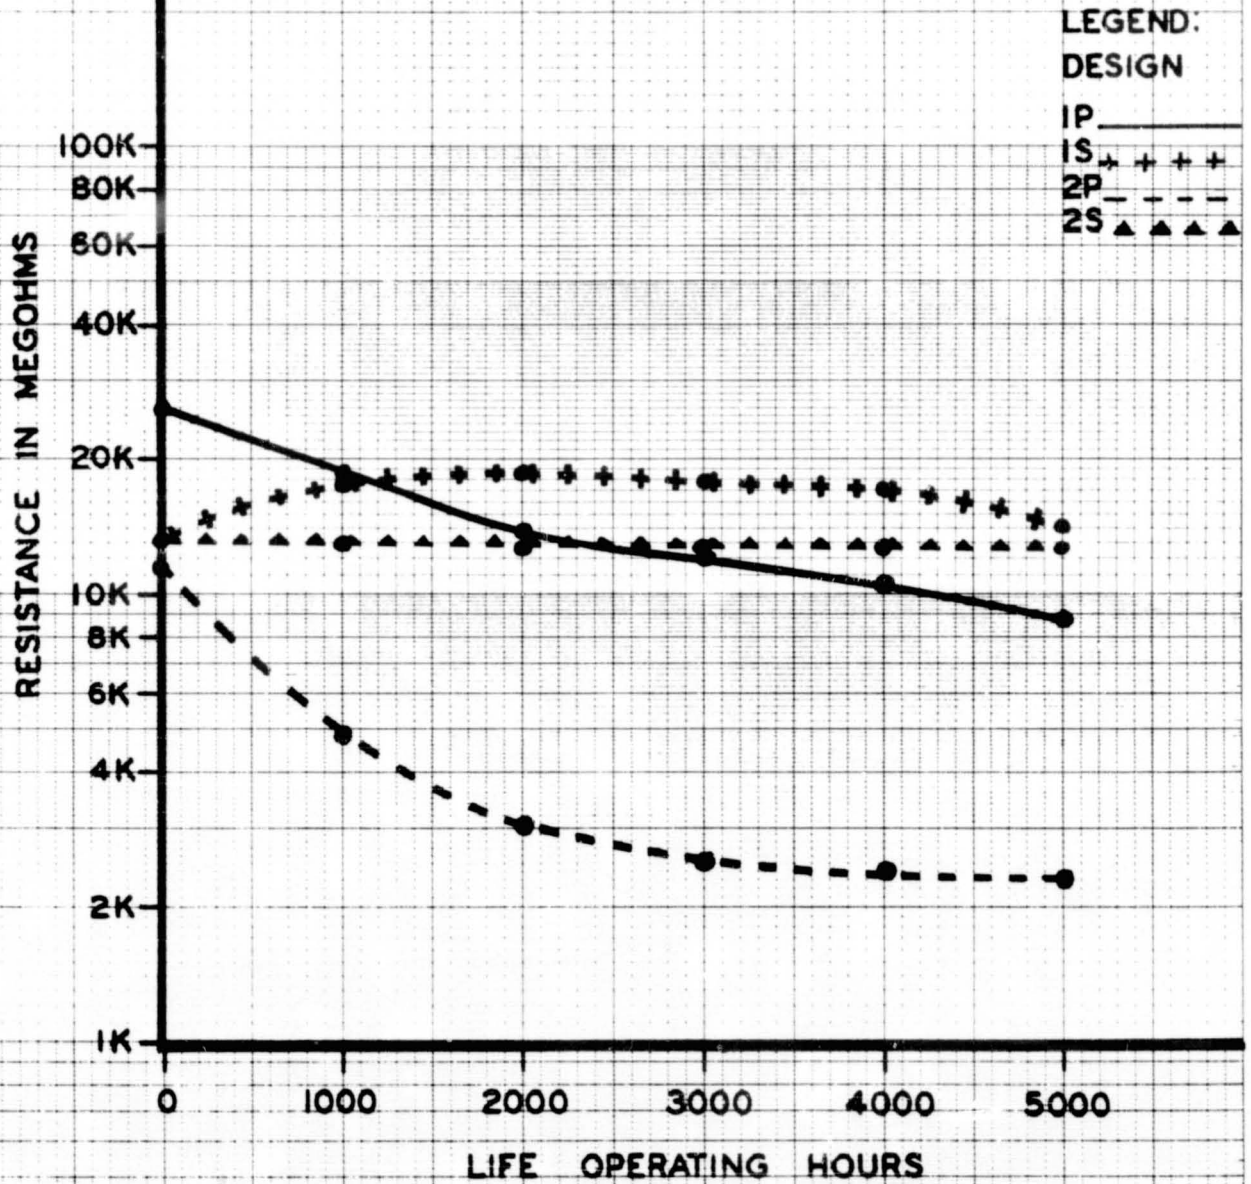
FIGURE 13

The average terminal-to-terminal insulation resistance is shown as a function of time at 125°C in Figures 13 and 14 for the 1.0 uF and 0.25 uF respectively. For the 1.0 uF design, the pattern was the same as at 110°C in which the silicone impregnated parts remained more constant. Total excursion of individual capacitor IR measurements for the 1.0 uF designs ranged from 53 megohms to 39 K megohms and for the 0.25 uF capacitors from 41 megohms to 135 K megohms. In the case of the 0.25 uF designs, there was a drop in IR in the film-foil designs 4P and 4S but only 1 failure occurred in one of these designs so the graphs illustrate by averages the trend of what happened. Because of the failures which occurred on designs 3P and 3S, the shape of the curve based on averages is affected by the ones that failed, however there was a trend for some of those parts remaining to increase in IR with time.

It can be noted in Table IV that the terminal-to-case IR of those capacitors utilizing polybutene was much greater than for the capacitors using silicone oil. This gives an indication that the initial insulating qualities of polybutene may be much higher. On the other hand, a review of Figures 13 and 14 indicates better IR terminal-to-terminal as the life test progresses with silicone oil than with polybutene. This indicates that sustained high temperatures have less affect on silicone oil than on polybutene. If an application requires high temperature operation for long periods of time and terminal-to-terminal IR is a critical parameter, silicone oil would be the better choice. As far as total failures at 125°C, there were 21 failures using silicone oil and 14 using polybutene. The 2 impregnant liquids have their strong points and the selection is left to the manufacturer.

INSULATION RESISTANCE CHARACTERISTICS
OF
POLYCARBONATE CAPACITORS
DURING
400 HZ AC LIFE TESTING AT 125° C
1.0 μ F

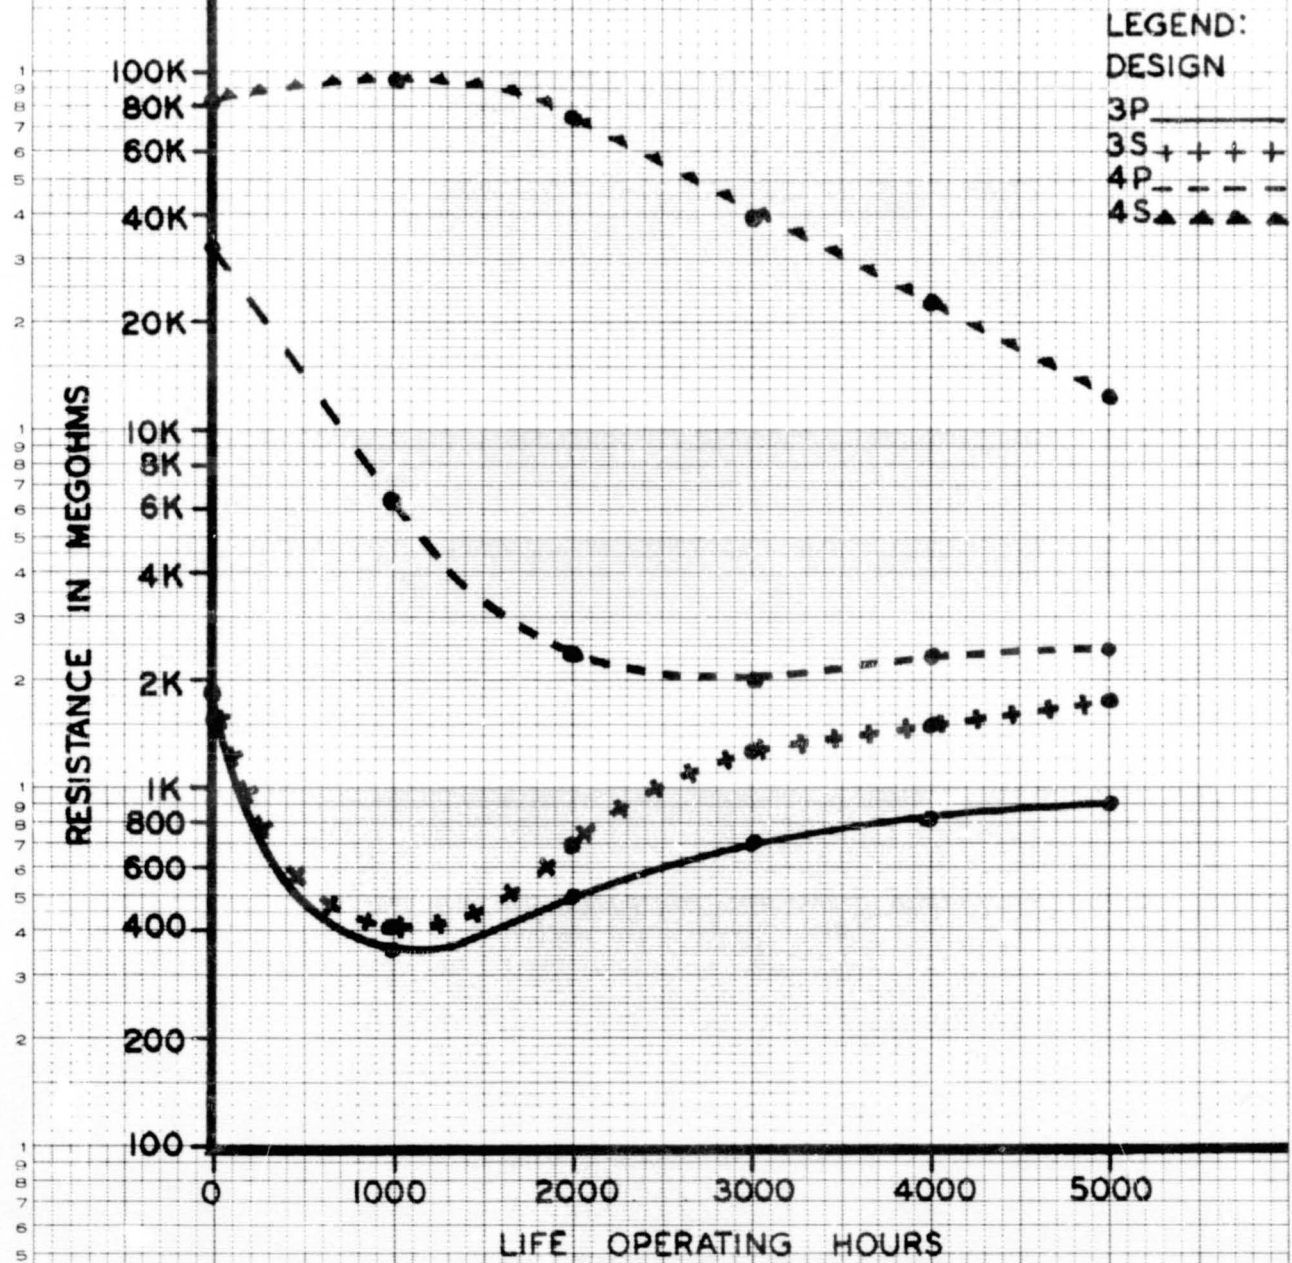
FIGURE 14

INSULATION RESISTANCE CHARACTERISTICS
OF
POLYCARBONATE CAPACITORS
DURING
400 HZ AC LIFE TESTING AT 125° C
0.25 μ F

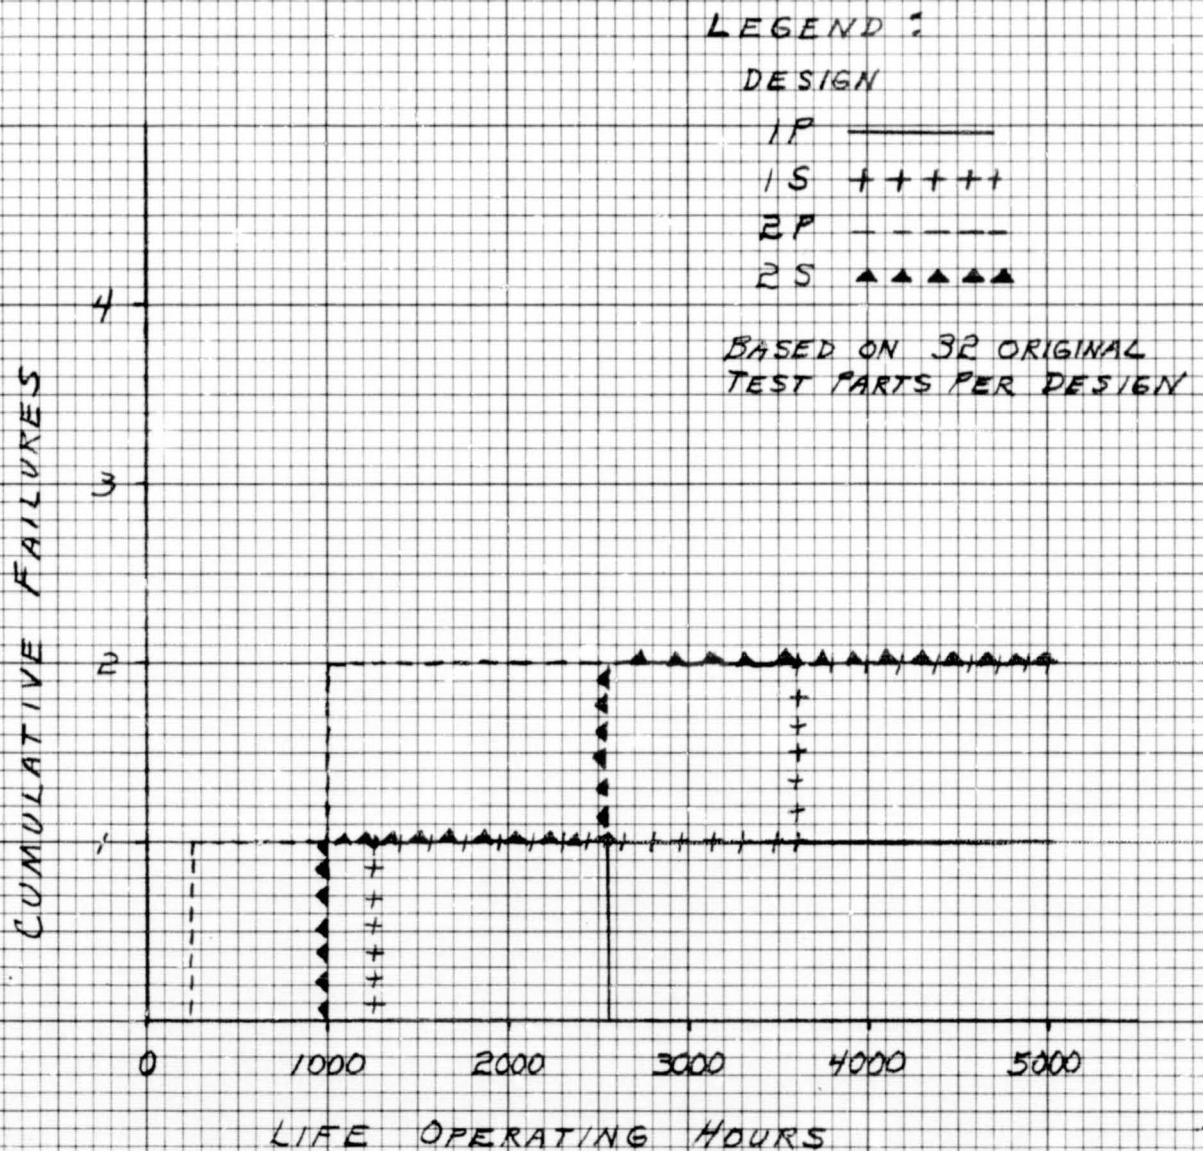
FIGURE 15

There were 4 failures which could be regarded as infantile failures and the remaining 42 catastrophic failures could be regarded as long term, based on the above definition. The total number of catastrophic failures included 39 of original test parts plus 7 replacement test parts. Figure 15 and 16 illustrate cumulative failures vs time based on the original 32 test parts of each design for the 1.0 uF and 0.25 uF parts at 125°C respectively.

CUMULATIVE FAILURES* vs. TIME
FOR
POLYCARBONATE CAPACITORS
DURING
400 HZ AC LIFE TESTING AT 125°C
1.0 μF

* FAILURES ARE CATASTROPHIC SHORTS. NO OPENS OCCURRED

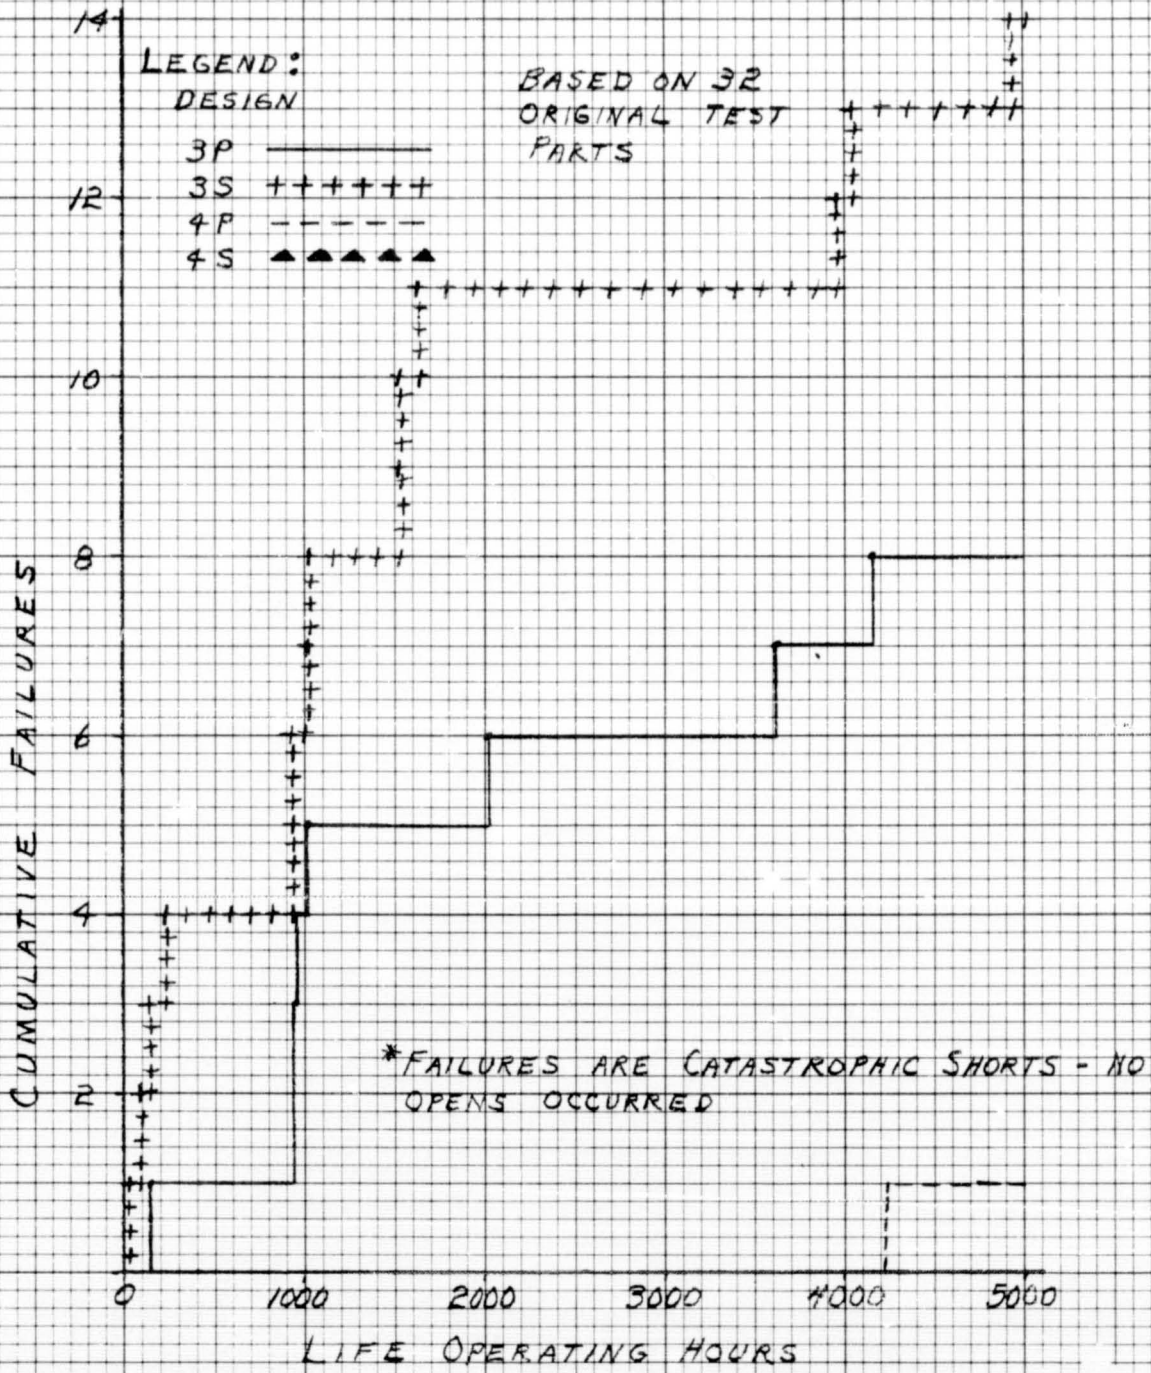
FIGURE 16

CUMULATIVE FAILURES* vs. TIME FOR POLYCARBONATE CAPACITORS DURING 400 HZ AC LIFE TESTING AT 125°C 0.25 MF
