NASA TECHNICAL  
MEMORANDUM

NASA TM X-64825

MSFC SKYLAB CREW SYSTEMS  
MISSION EVALUATION

Skylab Program Office

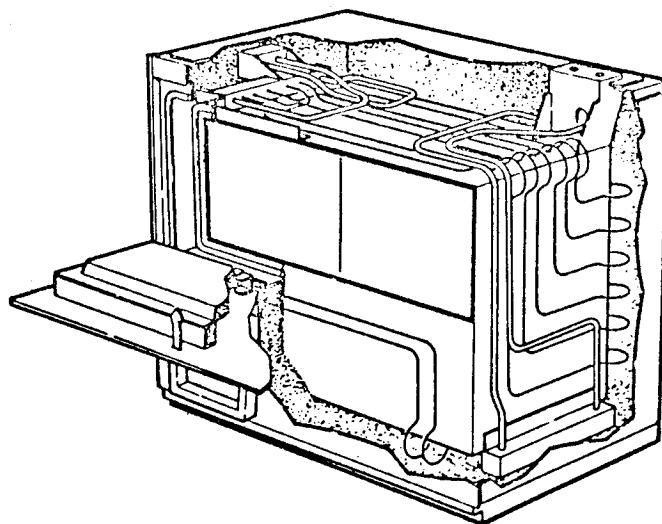
Figure 38. Urine Freezer

b. Post Mission Assessment - The crews used the urine freezer, as planned, during the three missions with the equipment operating as designed. Urine freezer temperatures remained within specification for the duration of the mission.

Some ice formed around the doors during the second mission which necessitated removal by scraping; however, it was not reported to have reoccurred during the third mission.

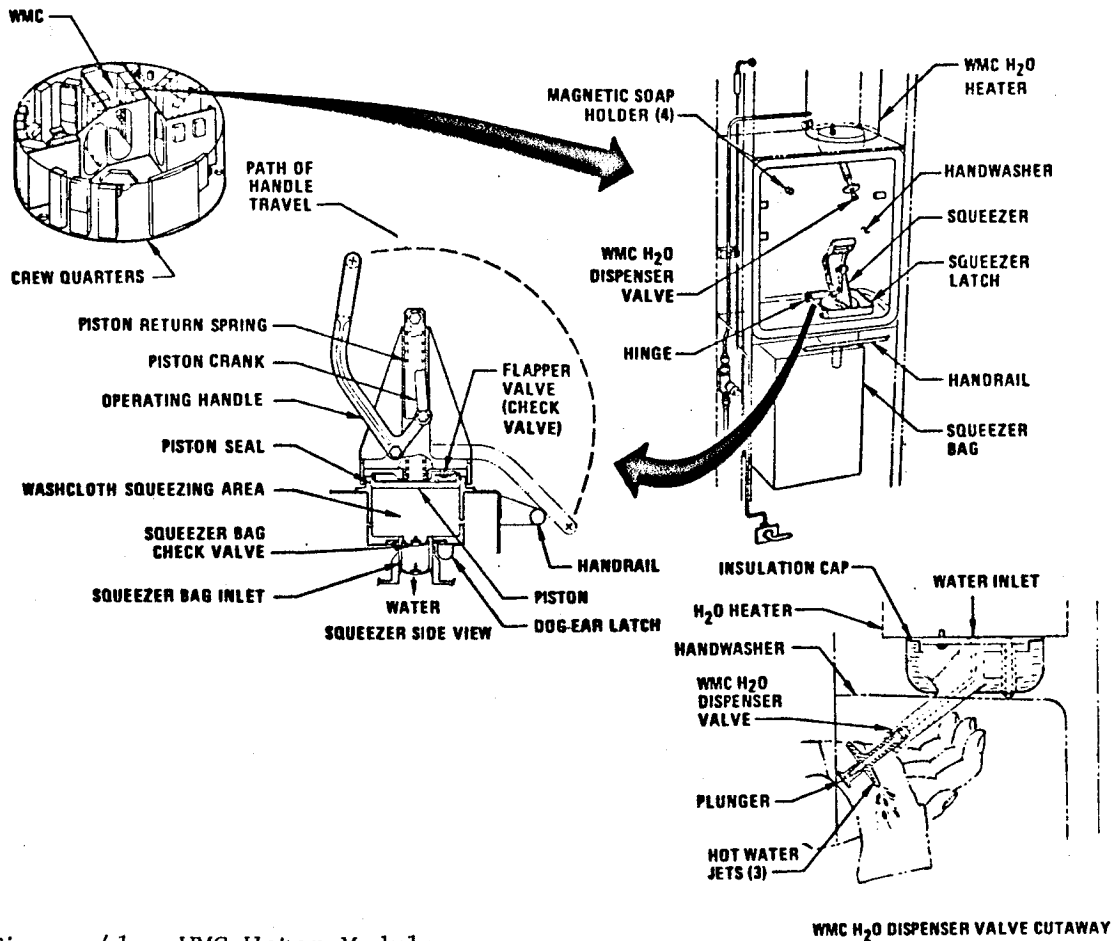
Figure 41. WMC Water Module

During the first mission, the water dispenser valve clogged and was replaced with a spare. The second mission crew carried two spare valves for replacement in the event of additional failures; however, this did not occur.

In general, the washcloth squeezer worked well. Some of the crewmen complained about it leaking around the teflon seal and

During the second mission, the squeezer malfunctioned because of a bad Bal seal, causing water leakage. The seal was replaced, thus correcting the problem. To eliminate this problem in future designs, the crew recommended the use of a double seal.

recommended that a double seal be installed on the piston to prevent leakage and improve the water transfer interface between the cylinder and the squeezer bag. They also recommended that the system be enlarged to accept towels. The crews stated that the technique of placing the washcloth in the squeezer was important to a successful operation cycle, and that a good vacuum in the squeezer bag was also a requirement.

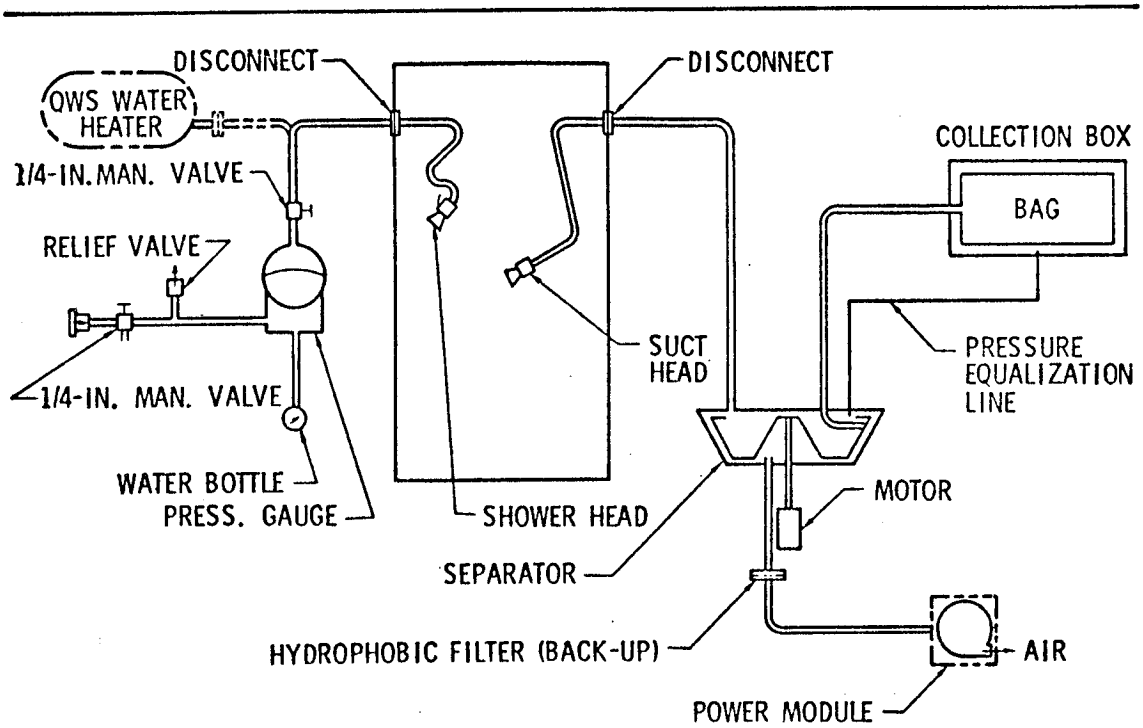
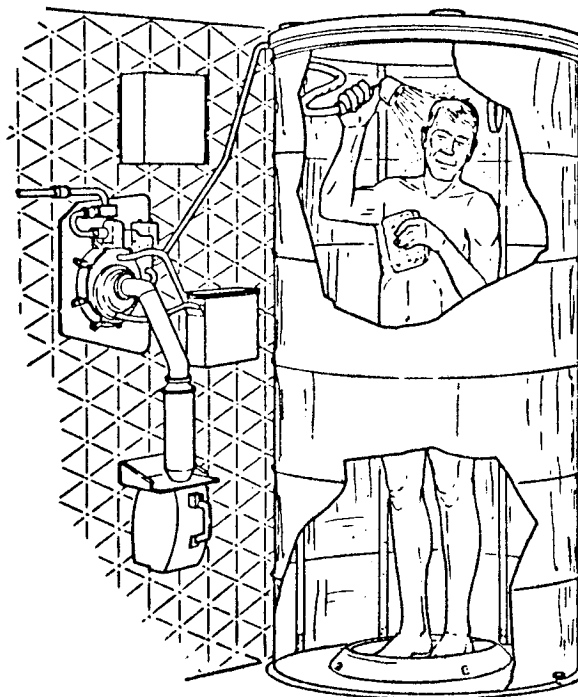
b. Post Mission Assessment - All crewmen agreed that taking a shower periodically was very desirable. However, they also complained, in varying degrees, about the shower system. The primary complaint was the inadequacy of the power module. Because of its low air-flow rates, the time involved in the cleanup of shower water too lengthy. In fact, all crewmen considered the whole showering

procedure too time consuming. In the future, the shower system should be hard-lined to minimize crew involvement. This includes both water dispensing and collecting procedures.

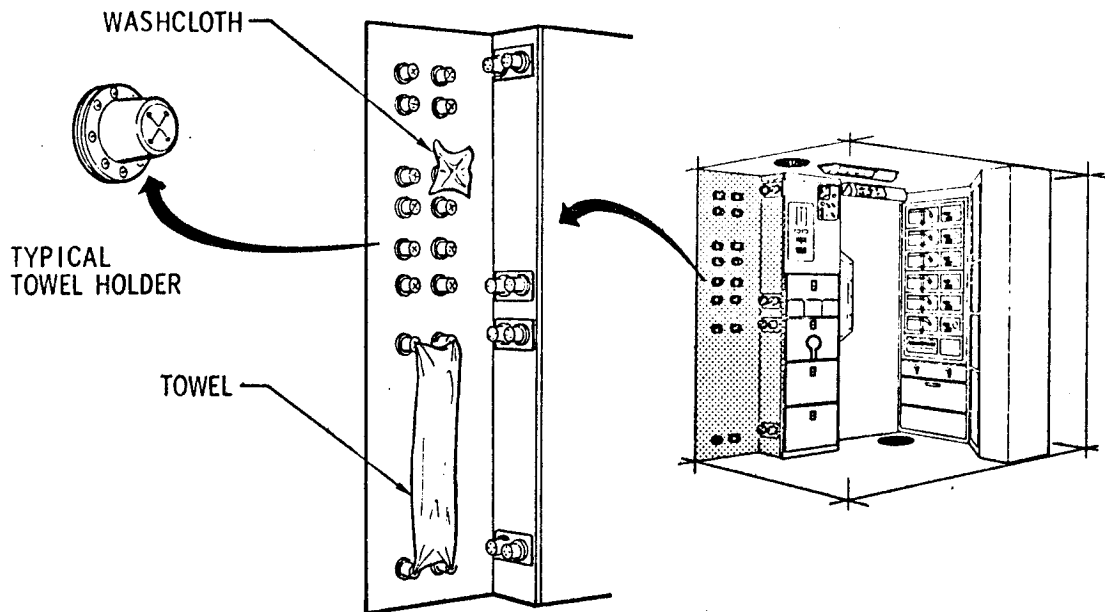
Figure 46. Washcloth/Towel Drying Area

The drying station provided a convenient and effective means of drying the towels and washcloths. The only problem reported was that the towels had a tendency to float away from the wall into the work areas if they were restrained at a single point (one corner). The third crew felt the restraints were too crowded. There was no report of having used the portable towel holders. The restraint approach should be standard equipment on future missions for towel and washcloth drying as well as a general fabric restraint.

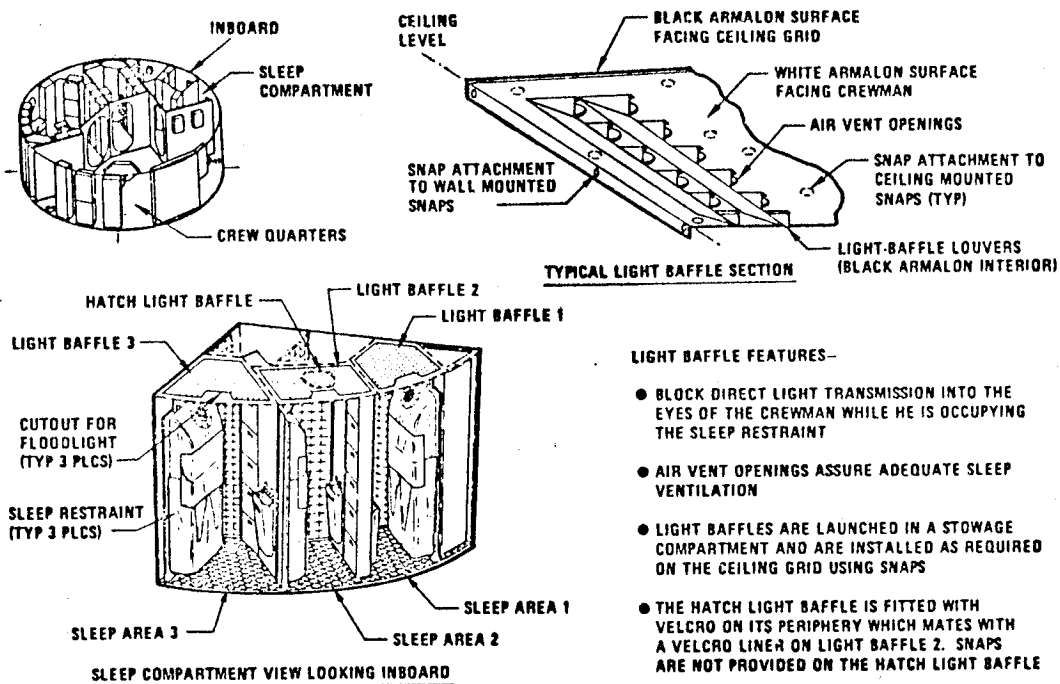
Figure 51. Sleep Compartment Light Baffles

b. Post Mission Assessment - The crew reported the airflow tended to close or collapse the fabric louvres, reducing air circulation. This problem was solved on orbit by cutting some triangular shaped pieces of cardboard and inserting them into the louvre stiffeners, and taping them in place. This fix kept the louvres open and allowed proper ventilation in the sleep areas. The light baffles were not used as often as planned since all OWS lights were usually off and the window shade closed.

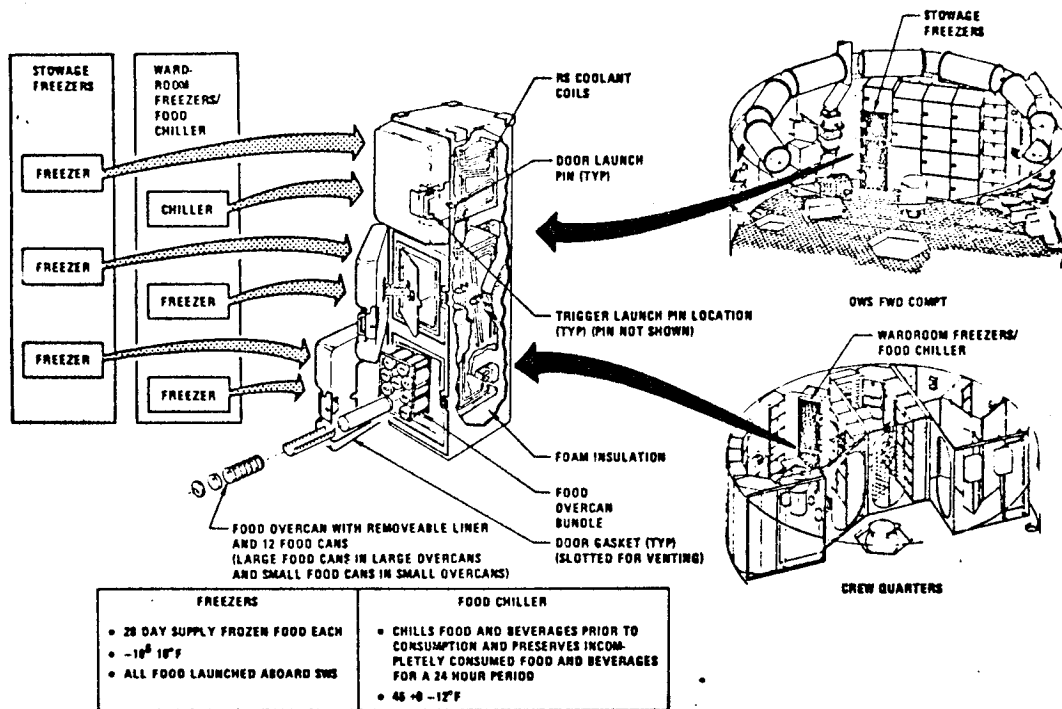
Figure 74. Frozen Food Storage and Supply

b. Post Mission Assessment - The freezers and chillers were satisfactory from a crew standpoint. Although the crews felt the frozen food was the best, they had the following freezer/chiller system comments and criticisms: (1) the freezer space utilization

was poor (approximately 60% to 70%), even though the freezers were relatively small; (2) loose food items in the freezers should have been restrained in some manner; and (3) ice built up in between the freezer and canister doors, reducing freezer accessibility and requiring the crews to develop and perform an unscheduled maintenance procedure. The door ice buildup was a progressive event, requiring the crew to use such implements as a pinch bar or screwdriver to remove the ice when it impaired freezer access. The crews felt that significantly more food could have been stored in the freezers had a different packaging system been used.

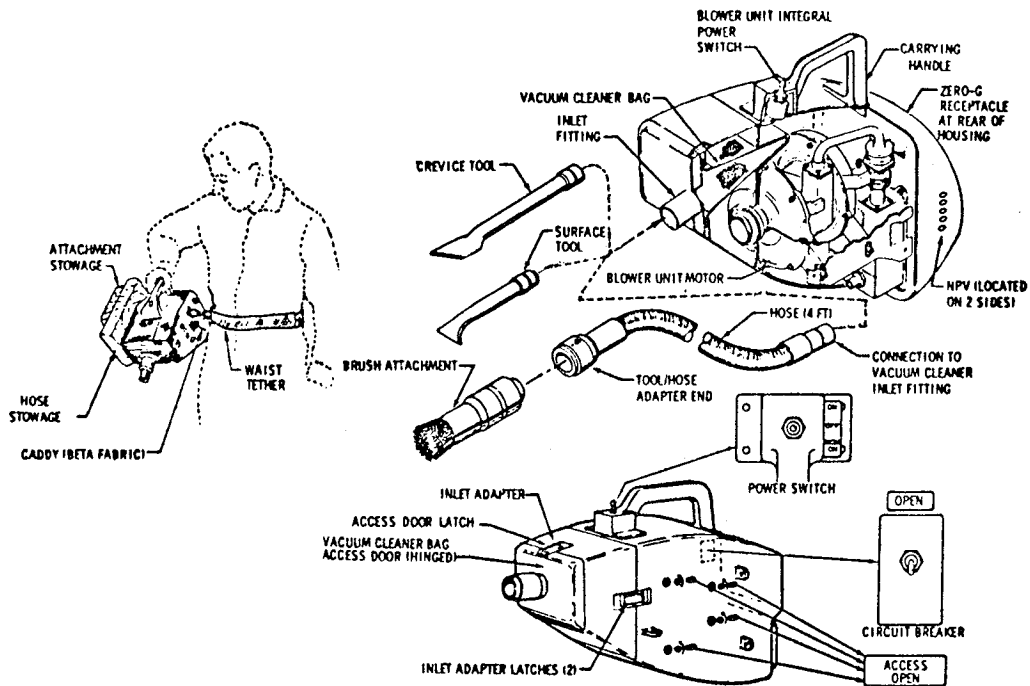
Figure 77. Vacuum Cleaner and Accessories

b. Post Mission Assessment - The crew reported that the vacuum cleaner worked satisfactorily in cleaning the debris screens. The crew decided that housekeeping involving cleaning of ventilation debris screens should be accomplished about every 3 days, instead of once per week.

In general, all vacuum cleaning tools worked well. Twenty-five (25) vacuum cleaner debris bags were used throughout the mission. The vacuum cleaner was not used to collect wet debris nor for any use other than dry debris collection. There were no recommended changes to the vacuum cleaner procedures.

The crew stated that a vacuum cleaner was a very necessary device for many cleaning tasks, but recommended that the system have more capability, more attachments, and additional vacuum power.

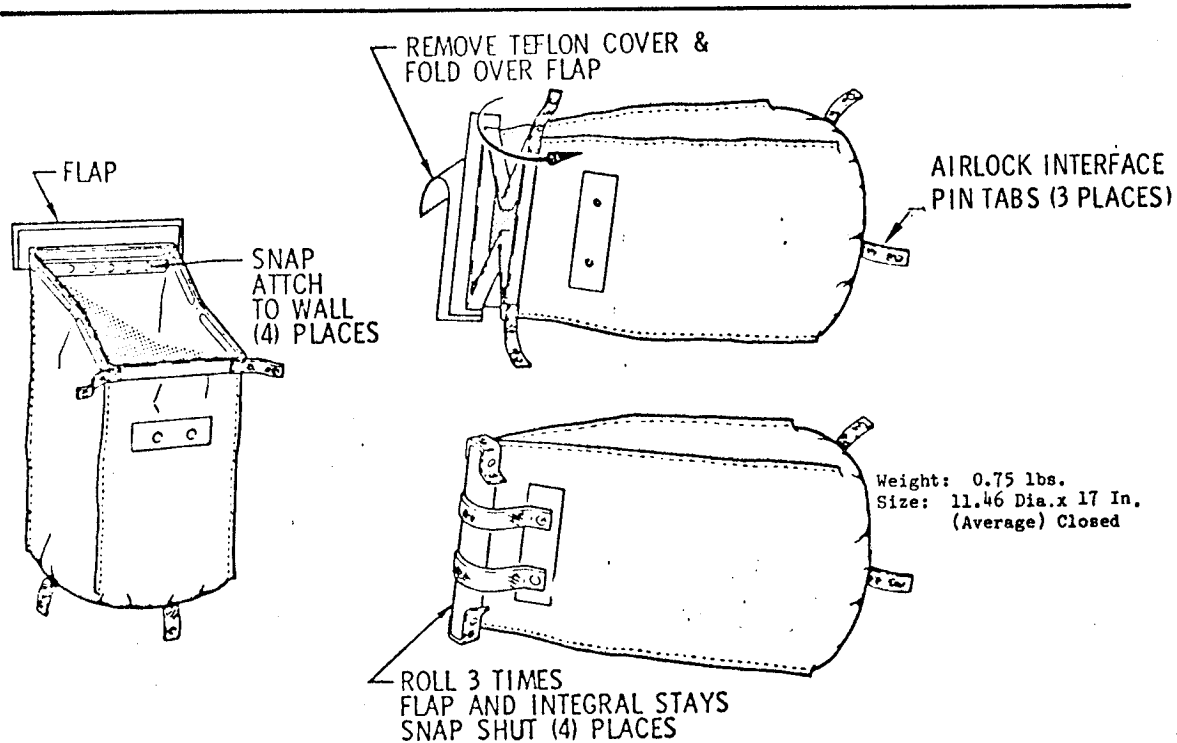
Figure 80. Urine Disposal Bag

spills. The rupture of a urine bag in the trash airlock proved to be a major source of odor. Repeated treatment with the biocide failed to remove the odor from this area. It was believed that the biocide did work on the accessible portion of the trash airlock. However, urine may have passed under the lower lip of the TAL and became entrapped, causing a foul aroma. The solution to this problem would appear to be a redesign of the TAL. Similar design problems were noted when cleaning the spills in the urine separator compartments. The crews complained of poor accessibility while cleaning spills. Poor lighting in the WMC made inspection and cleaning of the urine drawers inadequate. Smooth surfaces within the drawer would have made cleaning easier. There was no way to completely clean the urine drawer.

(5) The spring top on the urine disposal bags was very convenient and worked well. It was pointed out that there should be an easier way of sealing the urine disposal bags to prevent low bleed leaks. The method used was acceptable, but it was considered cumbersome. The flaps were wrapped around and snapped to prevent the urine disposal bags from venting in the waste tank.

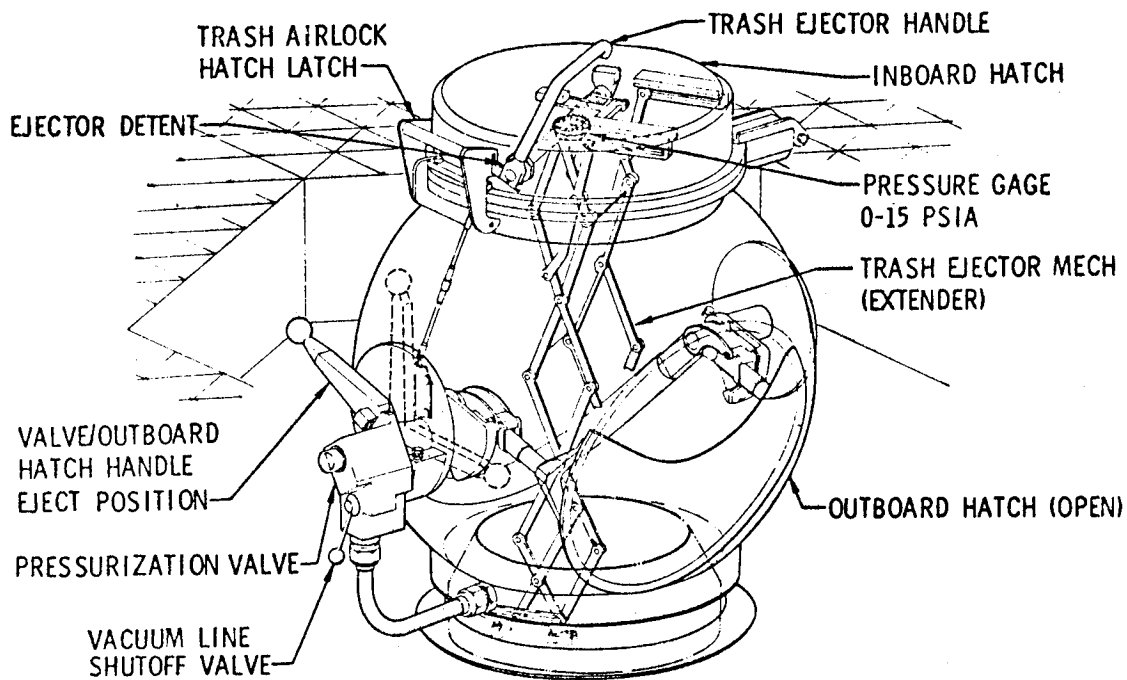
Figure 81. Trash Airlock (TAL)

The TAL, in general, was operated as designed and planned. On occasion, excessive crew effort was required to compress the lid O-Ring and disengage the interlock before the door handle could be moved.

(2) The interlock linkage between the lid lock and the outer door handle was reported bent during TAL operation. In the opinion of the crew, the damage did not appear to impair the operation of the TAL or compromise the safety of the procedure. This opinion was confirmed by ground tests. It was not clear, even after the Second Mission Crew Technical Debriefing, whether the lid closing and locking force had increased. The force required to compress the O-ring sufficiently to disengage the lid-to-latch interlock, so that the lid lock may be latched, had always been marginal for one man in zero gravity. The recommendation was made for the third crew to deactivate the lid-to-latch interlock by taping. This reduced the seal compression, and therefore the closing force required, prior to latching.

Very little additional risk resulted from this interlock deactivation. An assessment was made, using the mission support TAL, to determine the cause of the interlock rod damage. It is believed that the bent rod was a result of operating the lid latch while the outer door handle was in the wrong position. This situation would have caused the interlock rod to experience high compression loads and possibly cause a slight bow (permanent set). Video tapes confirmed that the bend was minor and no loss of interlock function was involved. Additionally, the interlock rod had no effect on the amount of force required to operate the lid latch.

(3) There was a major urine spill (leaking urine bag) reported in the TAL about midway through the mission. This was cleaned with biocide wipes. The crew reported that in spite of cleaning, a urine odor in the TAL persisted throughout the remainder of mission.

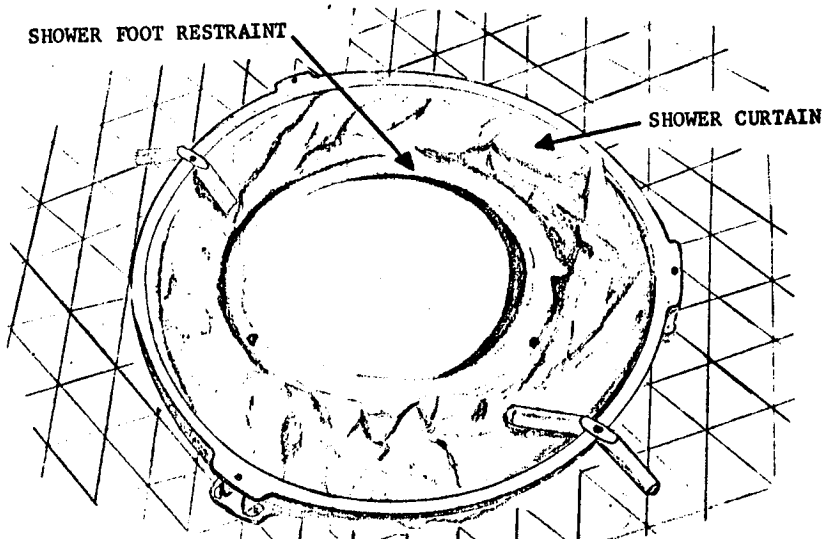
Figure 107. Shower Foot Restraint

(9) Shower Foot Restraint - The shower foot restraint, permanently installed on the shower floor, was doughnut shaped and enabled the crewman to have both hands free while showering. This restraint is illustrated in Figure 107.

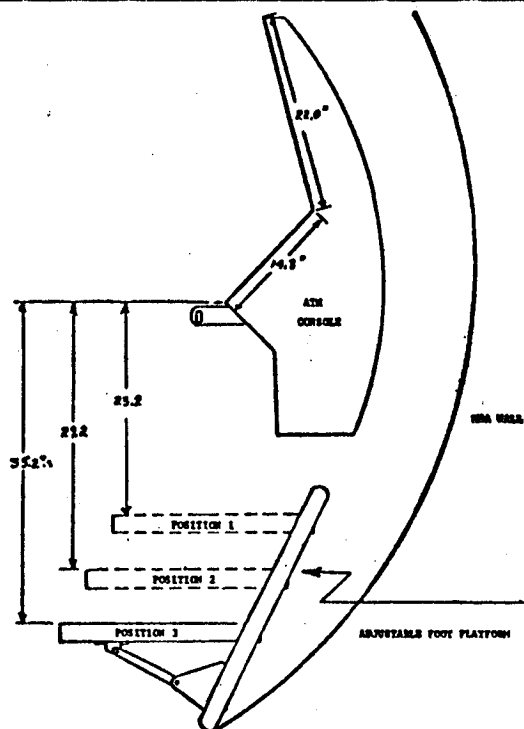
Figure 108. ATM Foot Restraint

(10) ATM Foot Restraint Platform - The ATM foot restraint platform was designed to provide a crew restraint for operations at the ATM Control & Display Console. It was composed of Skylab triangular grid and was the same length as the ATM C&D console with and approximately 20-inches wide. The foot restraint was vertically adjustable in 3 positions, at 6-inch increments, relative to the console. The ATM Foot Restraint Platform, depicted in Figure 108, was designed for use with the triangle shoes and the Skylab Restraint Assembly.

(10) ATM Foot Restraint Platform - The use of the triangle foot restraint, contrasted to the Skylab Restraint Assembly (ATM Seat/Backrest), seemed to be the better operation stability aid. The SL-3 and SL-4 crews did not report or express any fatigue due to remaining upright at the ATM C&D. The crewmen considered this foot restraint very adequate in performing all tasks at the ATM C&D panel. The SL-2 crew did prefer the Skylab Restraint Assembly; however the foot restraint was also deemed acceptable for ATM operations. The ATM foot restraint, used throughout the mission in the lowest position, permitted the crewman an operational envelope completely adequate to perform all ATM operational tasks. It was suggested that the lowest position (position 3, Figure 108) could have been even lower.

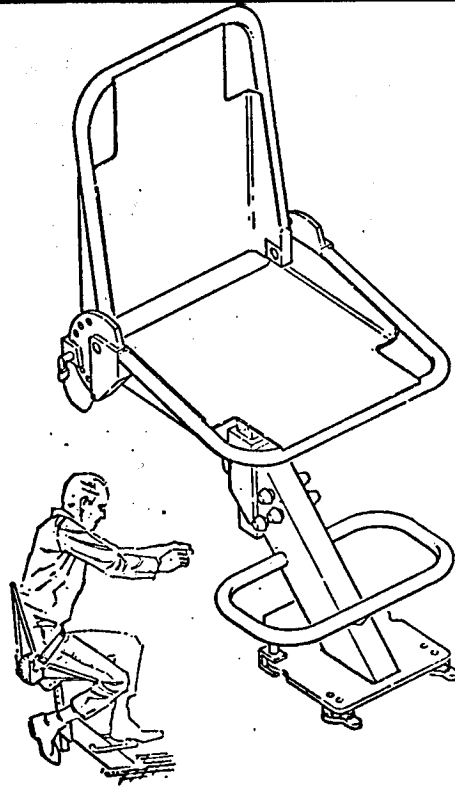
Figure 109. Skylab Restraint Assembly

(11) Skylab Restraint Assembly (ATM Seat/Backrest, ATM Chair, Captain's Chair) - The Skylab restraint assembly was designed to provide the crew with a chair-type body restraint while working at the ATM Control & Display Console. The chair was designed to attach anywhere along the ATM Foot Restraint Platform. The chair had eleven height adjustment positions above the ATM Foot Restraint, while the back of the chair was adjustable to nine positions of tilt. The seat had five tilt adjustment positions with respect to the ATM Foot Restraint Platform. A tubular foot restraint rail, which the crewman could employ as a foot reaction point, was also provided. Figure 109 illustrates this restraint.

restricted their reach envelope, therefore, used it very little. The SL-3 and SL-4 crews did not recommend a seat/backrest to be part of future consoles. For those crewmen who used the ATM seat/backrest assembly for additional restraint, the freedom of motion and reach envelope was restricted. The reach envelope at the ATM C&D crew station, while using the chair, included the entire ATM C&D panel, SIA, TV selector switch on the left, and the very nearest checklists and the checklist compartment. By loosening the chair lap belt, the Video Tape Recorder (VTR), all the checklists, and the radio noise burst monitor were within easy reach.

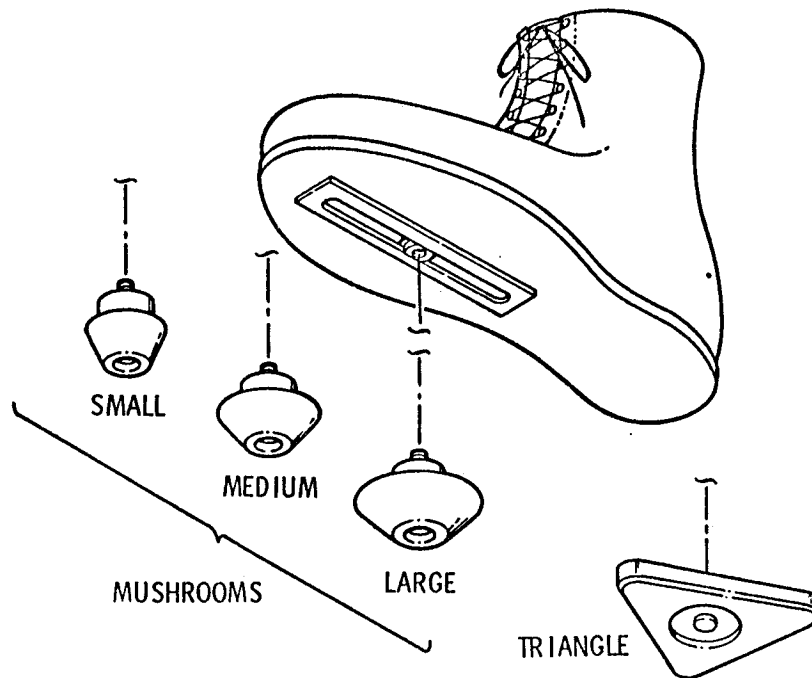
Figure 111. Shoe Restraints

c. Shoe Restraints (Triangle Shoes) - Triangle shoes were provided for each of the crewmen to enable them to lock their feet into open floor and ceiling grid, the water tank foot restraint platforms, the bicycle ergometer foot pedals, and the food table foot restraints. The triangle shoes provided a means of stabilizing, maintaining body orientation, and applying forces with both hands free. In addition to the triangular indexing cleats, three sizes of conical (mushroom) cleats were also provided. Shoe and cleat configurations are shown by Figure 111.

One triangle cleat was broken during the third mission when the film vault door accidentally hit the side of a crewman's shoe. However, it was suspected that the triangle had already fatigued, and no additional details were provided.

The crews had a tendency to drag their toes over surfaces, in order to slow down, causing the shoe toes to abrade. In recognition of this problem, protective wear caps were launched on the second and third missions. This corrected the toe wear problem but did not halt the overall shoe wear problem. The third crew expressed displeasure with the design, as well as the detailed and lengthy installation procedure, of the toe guards.

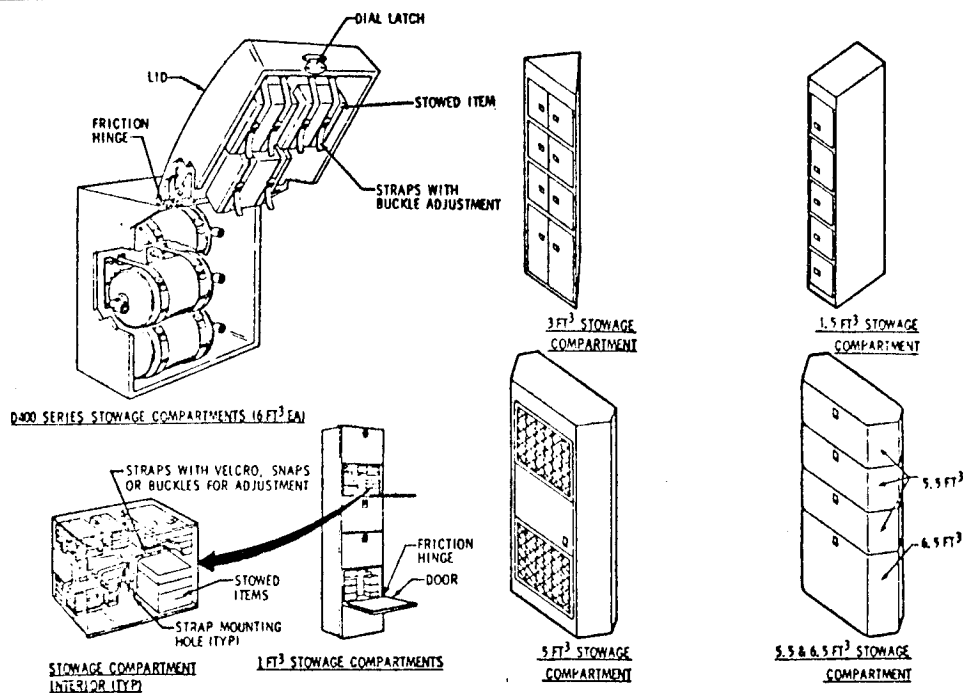
Figure 114. OWS Stowage Compartment Configuration

OWS stowage compartments were of six basic sizes as illustrated in Figure 114. These stowage compartment interiors, with the exception of the D400 series, had holes on the top and bottom of the compartments into which adjustable straps and other restraint hardware were attached for launch and/or orbit restraint of the stowed items. The D400 series stowage compartments stowed items were restrained with permanent straps or bolts, since each stowed item was custom-mounted.

Several of the OWS standard compartment door latches failed or did not provide a positive latch. The third crew considered them under designed.

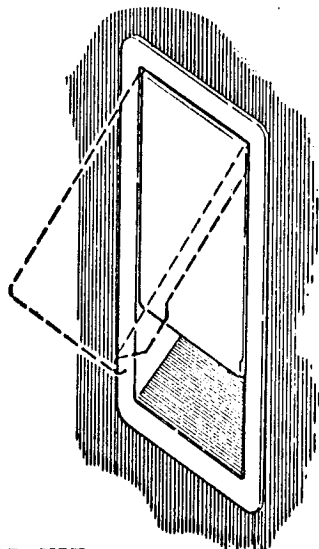
<p>SKYLAB USE: Food freezer and refrigerator doors.</p>
<p style="text-align: center;">CREW CONSENSUS</p> <p><u>4</u> RANK</p> <p style="text-align: center;">8.50 MEAN RATE</p> <p>COMMENT:</p> <p>Easy to use, however requirement to slam the door or lift the latch handle to achieve proper latch engagement on closure is an undesirable feature.</p>	<p style="text-align: center;">DESCRIPTION</p> <p style="text-align: center;">Lift Handle Latch (Adamsrite) FASTENER</p>

Some of the lift handle latches (used on OWS standard lockers) were broken as previously mentioned.

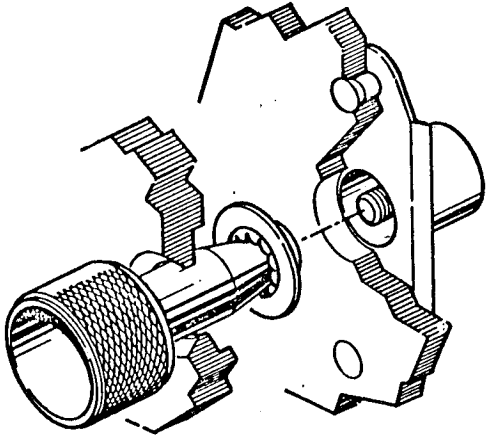
<p style="text-align: center;">CREW CONSENSUS</p> <p><u>13</u> RANK</p> <p style="text-align: center;"><u>4.75</u> MEAN RATE</p> <p>COMMENT:</p> <p>Wide variance of opinion. Good for small items but not on large bulky, covers; difficult to align; retainer ring may be broken if used frequently; may be adequate for infrequent use.</p>	<p style="text-align: center;">DESCRIPTION</p> <p style="text-align: center;"><u>Locking Screw Latch (Calfax)</u> FASTENER</p>

Several of the locking screw latch (Calfax) captive retainers were broken.

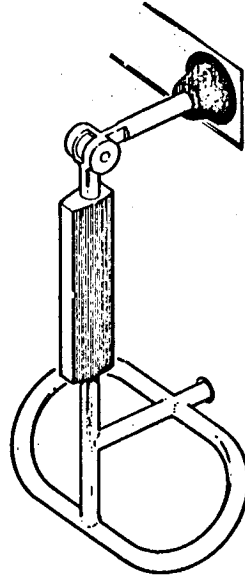
Figure 115. ATM VC Film Access Door

In addition to the fasteners in Table 11, two latches were provided outside the vehicle on the film access doors of Apollo Telescope Mount (ATM) for use during Extravehicular Activity (EVA). The center work station (VC) access door latch, Figure 115, functioned adequately but was criticized by the crewmen because its operation (push-to-open, pull-to-close) was opposite of that normally expected. It is noted, also, that a separate lock was required for launch.

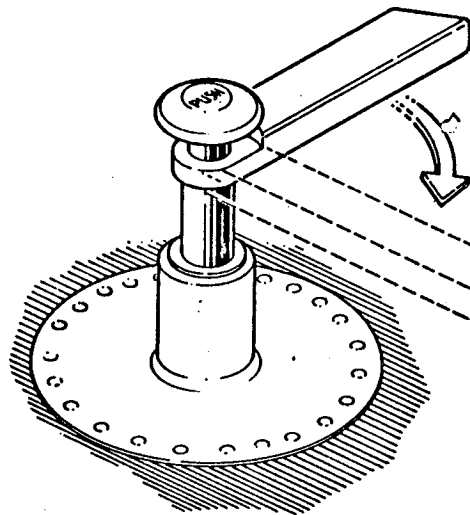
Figure 116. ATM VS Film Access Door Lock

The Sun End Workstation door latching mechanism, Figure 116, combined launch restraint and orbital operation in the same mechanism. Its orbital operation as a door lock was excellent. It also served as a handhold when in the locked position.

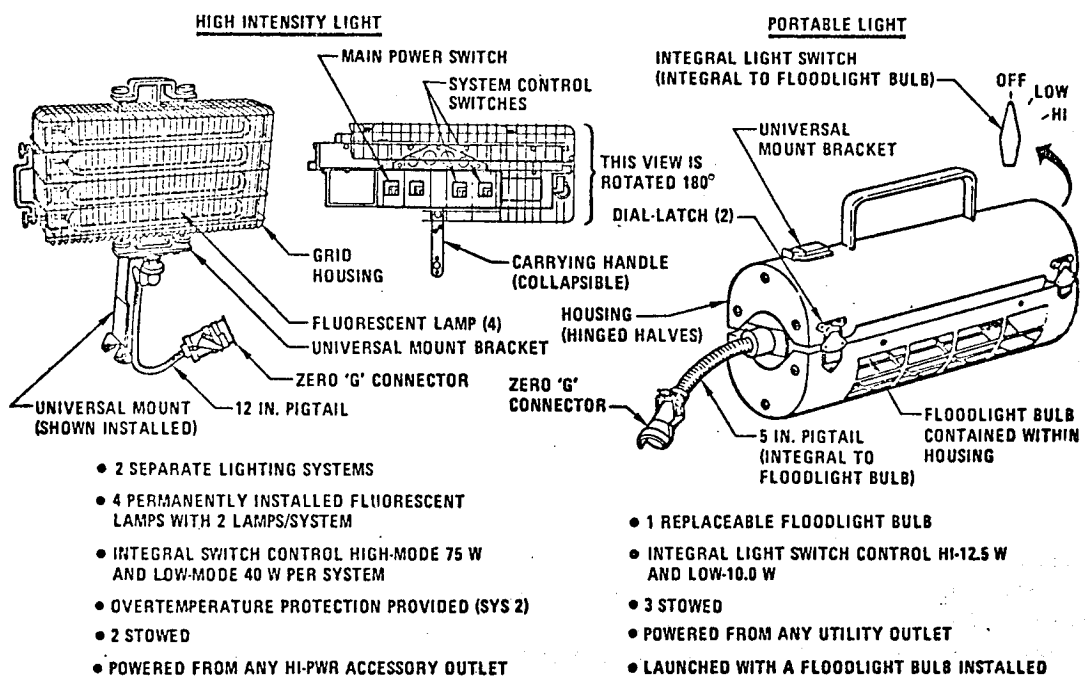
Figure 118. Portable Lights

The high-intensity lights were used as planned and met all requirements. Prolonged use of the high-intensity light in certain areas resulted in locally elevated temperatures

There were no reported bulb replacements associated with these lights.

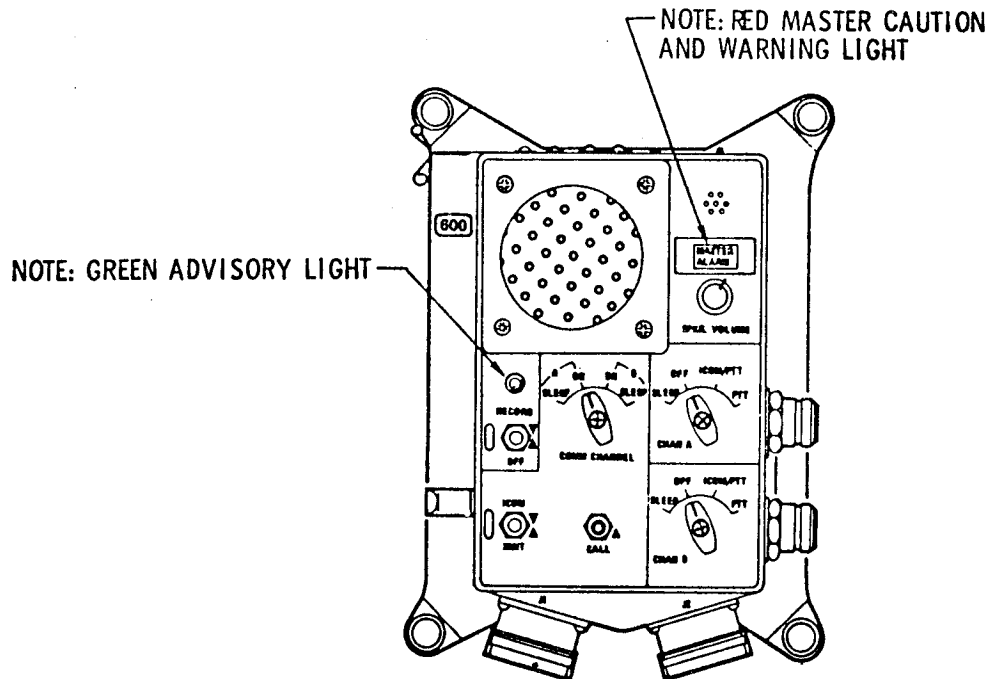
Figure 120. Speaker Intercom Assembly (SIA)

Reduction of this feedback condition required volume setting adjustments on the intercom boxes or utilization of SIA's in other areas. Use of the SIAs tended to be limited to one SIA at a time, at usable volume, although the Sleep Compartment SIAs could be left on without interfering with other SIAs. SIAs in the Experiment Compartment and at the -Z SAL had the most frequent feedback problem.

A malfunction of a hand-held microphone occurred. The mike was subsequently marked with red tape and stowed. The crew considered the microphone a desirable item and recommended that replacements be brought up with the third crew. It was also reported, at the Crew System Debriefing, that the second mission crew replaced the SIA at the -Z SAL because the transmit switch had failed in the ON position.

Use of the headset did not disable the speaker in the SIA and caused interference and annoyance with other crew activities.

initiation caused loss of the green recording light on the SIA, poor coordination occasionally occurred. To avert the loss of AM tape recorder data/information, system design should prevent simultaneous tape recorder dump and crew operation.

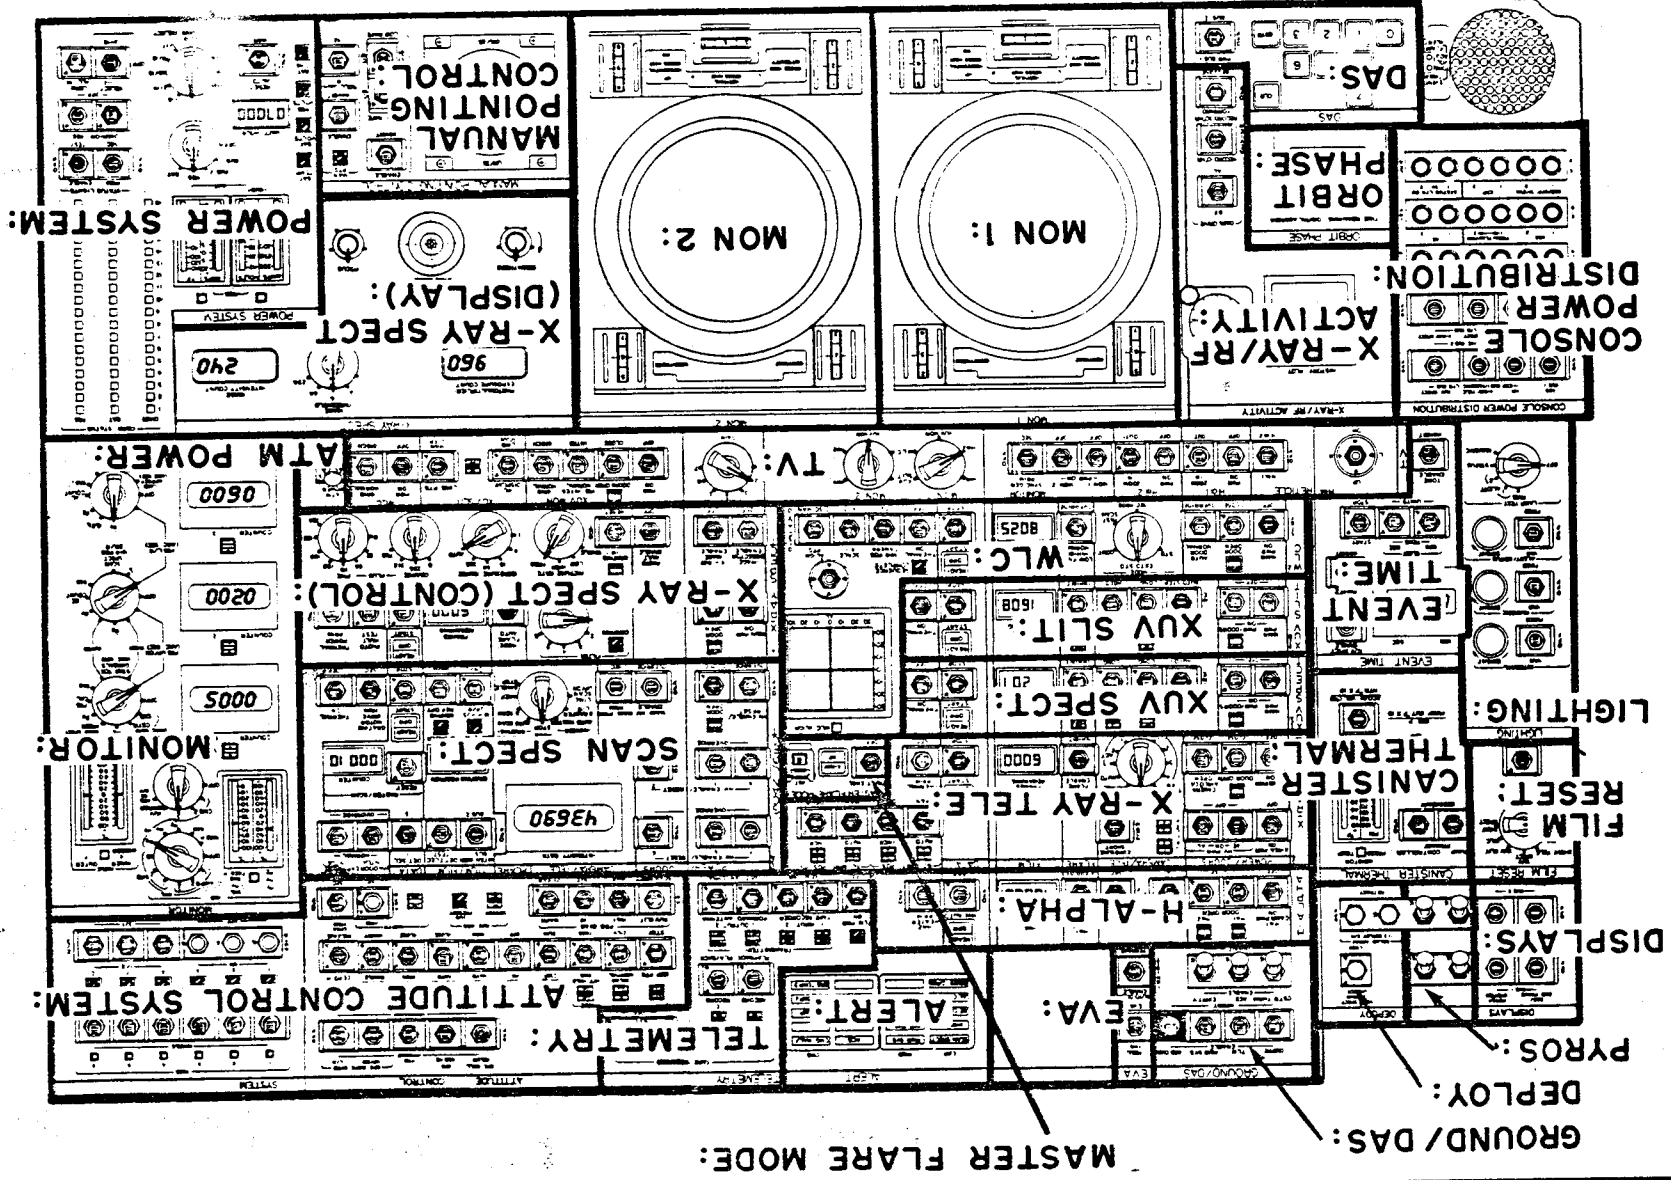
Figure 121. ATM Control and Display Panel

Two causal factors for this occurrence have been postulated. First, the frames/minute mode is controlled by a three position toggle switch, but other experiment mode switches are rotary types. The specific problem associated with a toggle switch is that determination

of the actual position of the switch commanded is solely dependent on the operator's visual reference. This means that a crewman looking straight onto the panel at some angle below eye level may be unable to distinguish the actual position of the switch. This problem is inherent in the use of latching toggles without position talk-backs.

A second factor that might explain the inaccurate switch positioning is the location and symbology used for displaying the operational procedures for H $\alpha$ . These instructions are located on the bottom line of the building block, and they are not highlighted by a block as are instructions for the other experiments.

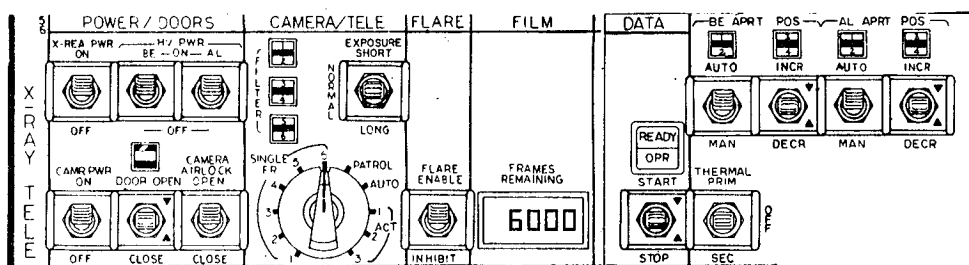
Figure 123. S056 X-Ray Telescope C&D

b. S056 X-Ray Telescope - The S056 experiment, Figure 123, had certain internal hardware design problems; the "active modes" took an additional frame, or timed out longer than specified. This

created certain interface problems with other experiments in relation to the total time required for a particular operating set of experiments. The controls and displays allocated to the S056 experiment appeared functionally adequate, and no sequential operation problems occurred. The only area which might have been improved was the separation of functions allocated to the X-Ray Event Analyzer portion of the panel and the experiment area.

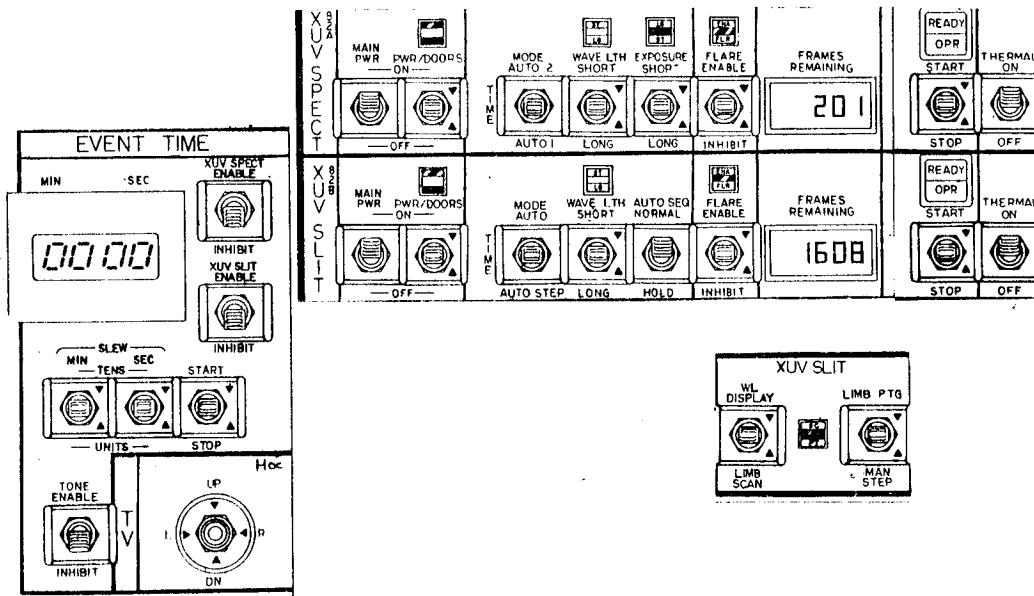
Figure 124. S082A and S082B XUV Instruments C&D

c. S082A XUV Spectrograph (Extreme Ultraviolet) and S082B Extreme Ultraviolet (XUV) Slit - The reason for combining discussion of these experiments is that most of the problems associated with them resulted from the similar appearance of the two (Figure 124), thereby creating many points of confusion. Indeed, in some areas on the control panel, there is a one-to-one switch correspondence -- a reasonable causal factor for error. For example, the crew would often set up an operational sequence correctly on one of the experiments but would then activate the START switch on the other experiment.

The failure of the S082B experiment timer function during the Skylab Mission required the addition of an auxiliary timer. The timer consisted of a MODE SELECT switch, a START/STOP switch, and a READY/OPERATE light. The timer was very similar in purpose to the S054 experiment but differed functionally because of the interconnection

with the ATM electronics power distributor located in the ATM console. The interconnection between the ATM and the auxiliary timer involved the making of two electrical connections. The crew was able to perform this using connector pliers contained in the on-board tool kit. The auxiliary timer was affixed to the top of the ATM console and operated satisfactorily during the entire Skylab Mission. The crew incurred no significant interface problems with the exception of the reach distance between the two modules.

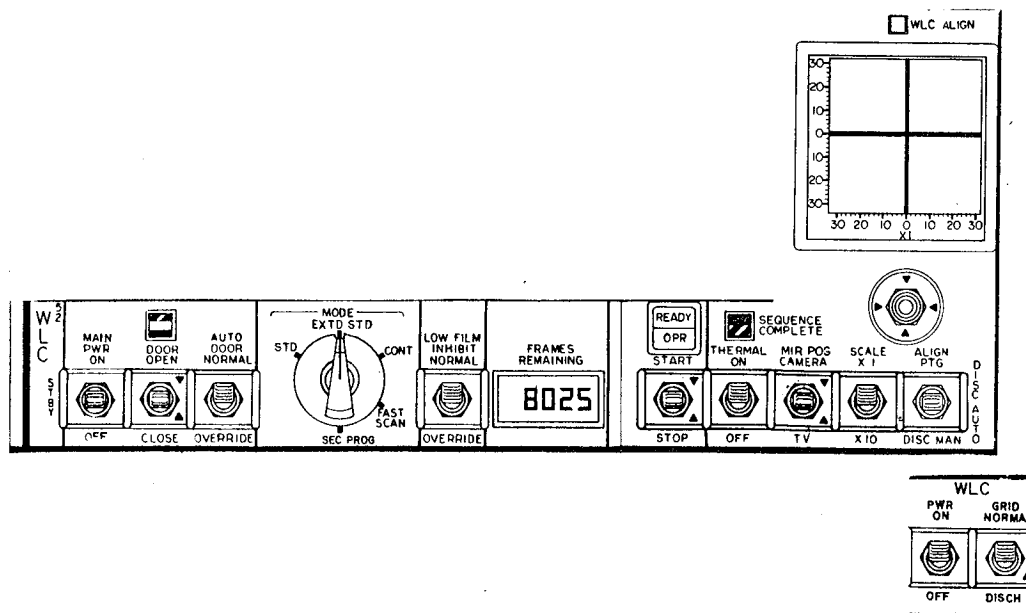
Figure 125. S052 White Light Coronagraph C&D

d. S052 White Light Coronagraph (WLC) - From its original design, the S052 experiment, Figure 125, had one inherent man/system interface problem associated with the READY/OPERATE light. The indication for an operate condition was only given after the completion of the first frame ( $\approx 10-15$  sec). The null state before this illuminated condition served to indicate that the experiment was in an off condition, which, if the crewman were not paying close attention, could be very confusing.

The second problem area on S052 involved the procedural step of turning off the S052 WLC TV power before closing the aperture door. The crewman often forgot to perform this function (which was not required during nominal experiment operations). Although this error was made on several occasions by the crew, no irreparable damage was done to the WLC vidicon from exposure to direct sunlight. For future designs, however, when this type of oversight must be prevented, a mechanical or electrical interlock is desirable. Reliance on crewman memory of procedures is not a dependable preventive measure.

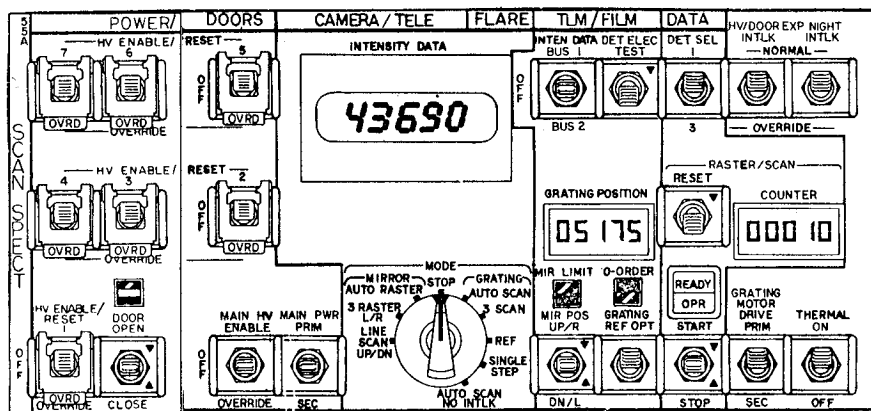
Figure 126. S055 Scanning Spectroheliograph C&D

e. S055 Scanning Polychromator Spectroheliograph - There were no major problems in performance of the S055 experiment, Figure 126, with the unimportant exception that the crew frequently allowed the experiment to collect data past the appointed building block end times. As this instrument had no limit on film, however, this overrun factor was not significant, as long as it did not impact the overall timeline.

The installation of the lockout switch guards on the high voltage detectors prevented any occurrence of inadvertent selection of the override position. This design addition facilitated efficient man/machine interface.

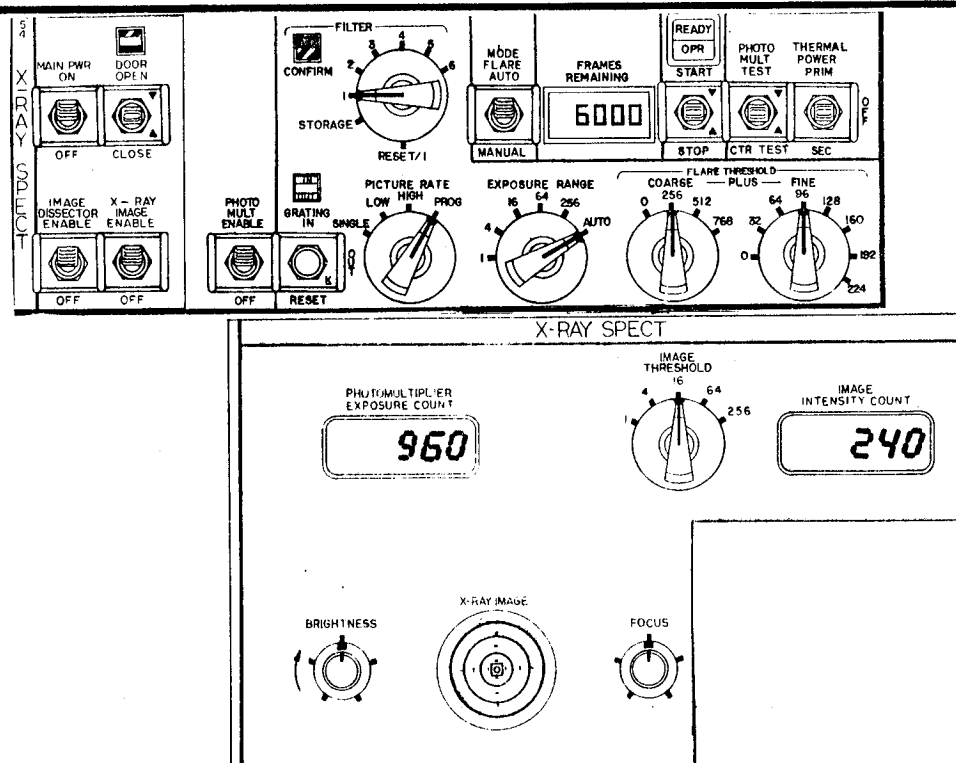
Figure 127. S054 X-Ray Spectrographic Telescope C&D

f. S054 X-Ray Spectrographic Telescope - The S054 experiment, Figure 127, was considered the most operationally complex of all ATM experiments. The crew exercised only a limited number of the experiment's operational modes, due to the limited variety of solar activity occurring during mission flight. The mode most frequently used was the manual preprogrammed mode which used only a limited amount of film and had a simplified operational sequence.

There were several equipment malfunctions which caused operational interface problems during the mission. These problems were significant, but did not severely impact operational data collection. The primary problem which occurred during the SL-2 Mission was the failure of the experiment's READY/OPERATE light. This failure created an inability to determine when the experiment was actually in an operating mode. To rectify this problem during SL-3, an auxiliary timer was flown. This timer consisted of an ON/OFF switch, a mode TIME SELECT switch, and a READY/OPERATE light, and it was located on top of the control/display console. Because the timer module was equipped with a long electrical extension, the SL-4 crew was able to affix it adjacent to the START/STOP switch. The cord was strung along the rows of toggle

switches, near the inner edge of the experiment borderline, and taped to the toggle switch wicket guards. There was no interconnect between the timer and the ATM switching circuitry or the experiment. A 28V auxiliary outlet next to the C/D panel in the MDA was used as a power supply.
