NASA TECHNICAL  
MEMORANDUM

NASA TM X-64825

MSFC SKYLAB CREW SYSTEMS  
MISSION EVALUATION

Skylab Program Office

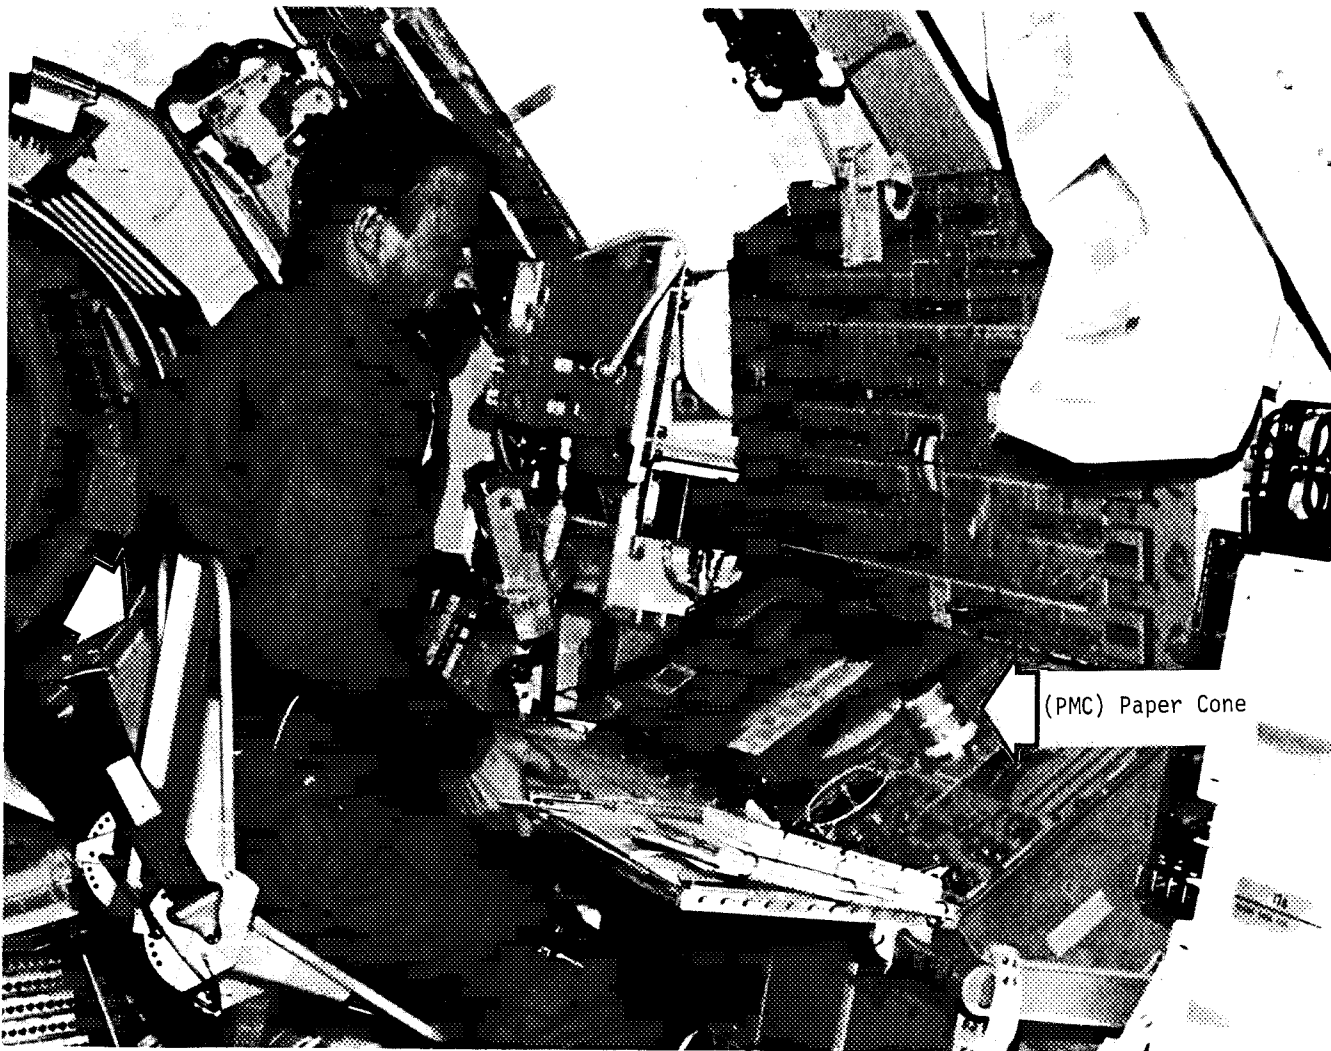
Figure 128. ATM Restraint Device

The X-ray scope which displays PMEC X-ray activity was also too high in intensity, and the crewmen found it uncomfortable to look at. They compensated for this inadequacy by placing a paper cone, Figure 128, over the scope, allowing it to be visible only from directly above and thereby eliminating its interference with other C&D activities. This significantly improved the operator interface by extending the total time an operator could remain at the panel without becoming fatigued.

d. The ATM Control and Display Console Restraint (Chair) - The ATM C&D console restraint, Figure 128, was designed and built because it was known that prolonged hours of operating the ATM console would be tiring. The restraint, designed for all nine Skylab crewmen, was based on current anthropometric data, Figure 132. The primary users of the system were the SL-2 crew, who originated the concept. Further information on the ATM C/D seat restraint is given in Section II, K of this document.

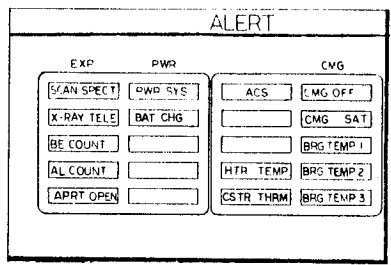
Figure 129. ATM Alert Status Lights C&D

a. ATM Alert Lights - The alert status lights on the ATM panel, Figure 129, were intended to provide an instantaneous indication of some abnormal and potentially critical system condition. These system alert indicators covered system parameters such as CMG-bearing temperature, aperture door position, etc. The philosophy of this concept was basically acceptable in that it supplied status of noncritical system functions, but it was not anticipated that certain of these functions would persist during the entire mission with contingency procedures failing to remedy the alert condition. As a result, these persistent indications caused extensive confusion. When a new alert would be illuminated, the crewman could not detect its presence because of the surrounding color noise. This problem existed throughout the mission and rendered the system ineffective. It was recommended that the crew place masking tape over the illuminated status lights to temporarily eliminate their interference.

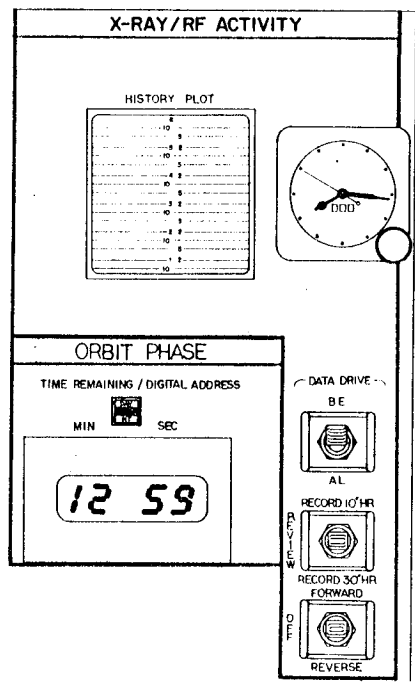
Figure 130. ATM X-Ray History Plotter C&D

b. X-ray Activity History Records - The activity history plotter, Figure 130, had one extremely undesirable feature involving the review capability built into the unit. A crewman could easily run all the recording paper off the roll and jam it, if close attention were not paid. As a result, this malfunction occurred on the first mission and was irreversible, because the unit was sealed and the stuck mechanism could not be reached.

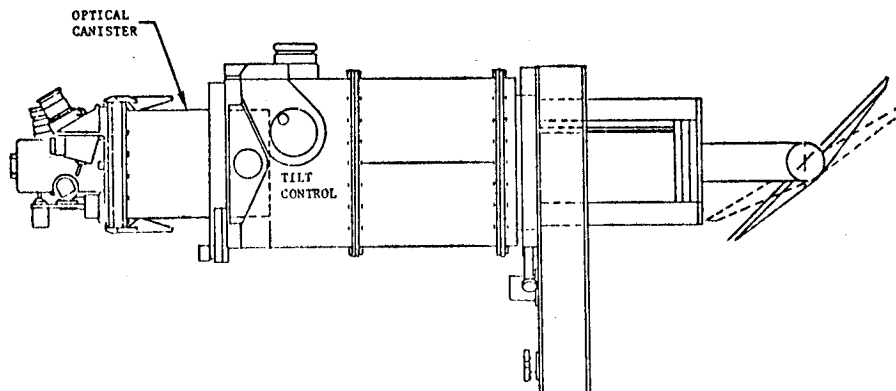
Figure 135. Experiment S019/Articulated Mirror Operating Configuration

During an SL-3 S019 pass, the crew reported that the film advance/shutter lever stopped at the "CARRIAGE RETRACTED" position, and could not be moved on to the "SLIDE RETRACTED" position. This film canister was replaced with the new canister and the remaining exposures were taken as scheduled during SL-3. The failed canister was taken to an area of subdued light (the WMC, with lights out and door closed), the cover removed, and the sliding film hatch opened. Inspection, by feel, was performed on part of the carriage and shutter mechanism. The crew could not identify any apparent damage or discrepancy that could be corrected. Consequently, the film canister unit was returned to earth for malfunction analysis.

It was found, from the review of acquired data, that during performance of the S019 experiment, the system was extremely sensitive to motion and some blurs occurred on one S019 slide. It was felt that

this could have been caused when the canister was used as a writing surface. The PI requested that the S019 system not be touched when taking data. This was necessary for the acquisition of clear photography. The crew had no difficulties complying with this request except when opening or closing the shutter. At this time, momentary jiggling of the S019 system could not be prevented.

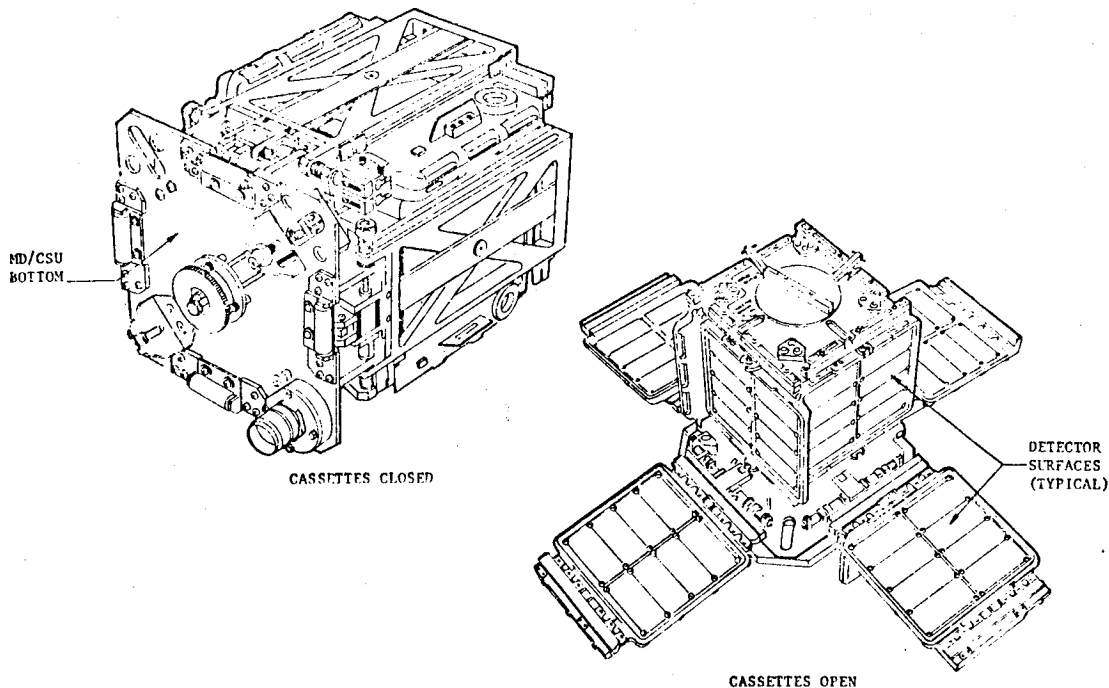
Figure 140. S149 MD/CSU With Detector Cassette Set, Operational Configuration

A problem was reported by the SL-3 crew during retraction of the SL-2 deployed S149 MD/CSU. During retraction the UXM rod tended to extend back out to space when released. The crew had to maintain a continuous retraction force on the UXM rod while the SAL door was closed (this involved a two-man effort). Once the SAL door was closed the final extension rod stopped about one-inch from full retraction and prevented engagement in the UXM capture latch. After allowing the system to warm-up, full retraction and engagement of the capture latch was accomplished. The T027 UXM system canister containing S149 was then removed from the SAL, dismantled, and stowed.

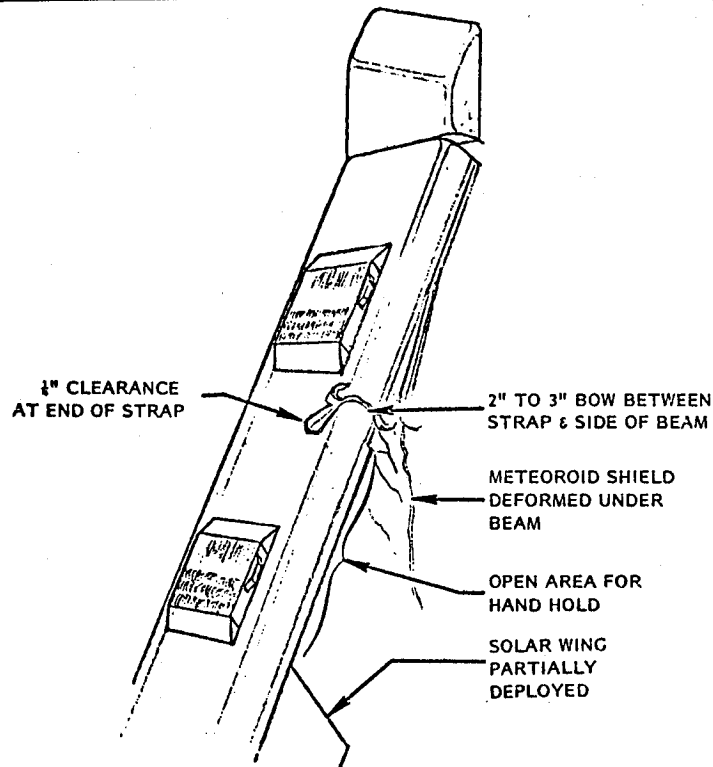
Figure 168. SAS Beam and Debris Strap

- The end of the debris strap was firmly attached on top of the SAS Beam with what appeared to be a row of bolts in the strap. These bolts seemed to be cutting into the beam skin.
- The debris strap was bowed out along the side of the beam two to three inches.
- Debris from the Micrometeoroid Shield was visible under the SAS Wing.

Based upon the data received from this discussion with the crew, a neutral buoyancy mockup of the #1 SAS Wing Assembly was prepared and is illustrated in Figures 168 and 169.

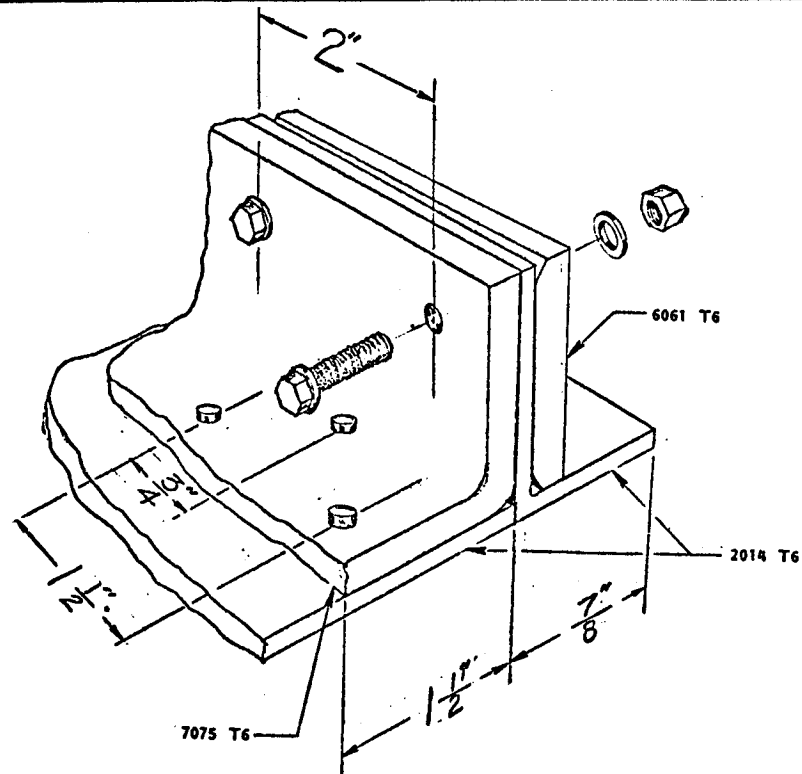
Figure 170. Debris Strap Cross Section

a. Description of the Deployment Problem - It was determined by review of flight hardware drawings that the strap described by the crew was probably a section of the micrometeoroid Shield composed of two pieces of aluminum angle and an extrusion (Figure 170). By using the fly-around video tape and the Skylab Mission Support Mockup, this strap was determined to be approximately 25 ft. below the top of the FAS and 1-1/2 ft. below the first vent module (Figure 171). For the SAS beam to be erected, this strap would have to be either cut or pried away from the beam skin.

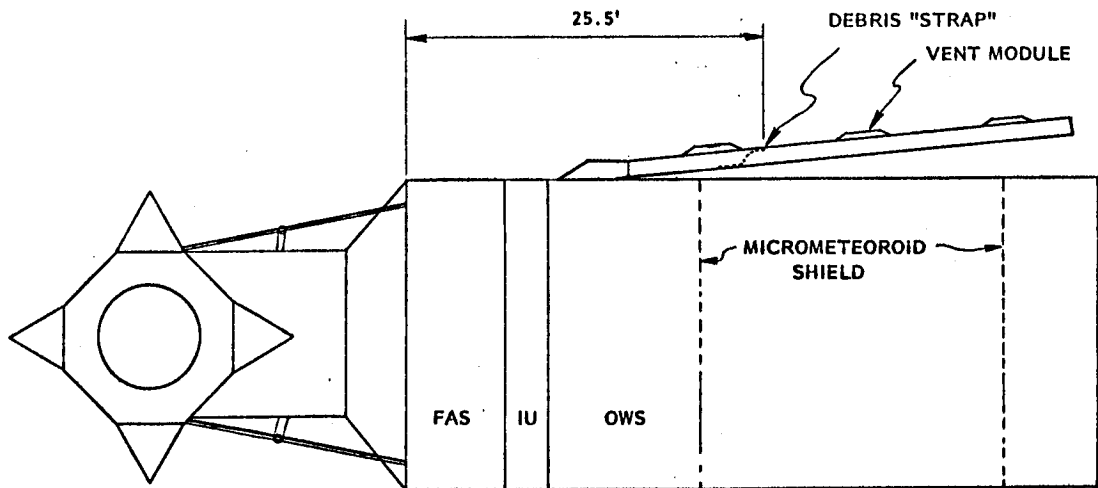
Figure 171. SAS Beam Configuration After Launch

It was also predicted that if the strap were removed, the SAS beam would rise approximately two feet at that point on the beam and would then stop because of frozen oil in the damper/actuator. The beam would then have to be pulled up with a force of approximately 15 lbs. (measured at beam end) to break the damper/actuator mounting bracket in the beam hinge mechanism.

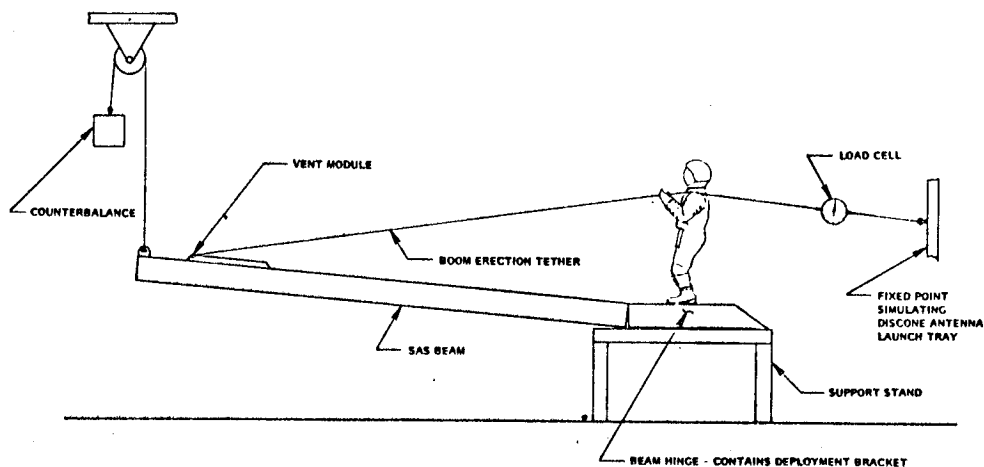
Figure 177. One-g SAS Beam Deployment Test Setup

(2) One-g Testing - On June 1, 1973, a SAS Beam deployment test was conducted to verify that a crewman could exert enough force on a tension line to break the deployment bracket in the beam hinge. The SAS Beam mockup was held by a support stand on the hinge end and by a counterbalance/pulley system on the other (Figure 177). A tension line, fabricated of SEVA clothesline (PBI), was attached to the vent module and a fixed point that simulated the discone antenna launch tray. A load cell was mounted in the line to record the tension.

During the test, the bracket broke at 167 lbs of tension which was lower than the maximum tension (309 lbs) that the suited crewman could generate.

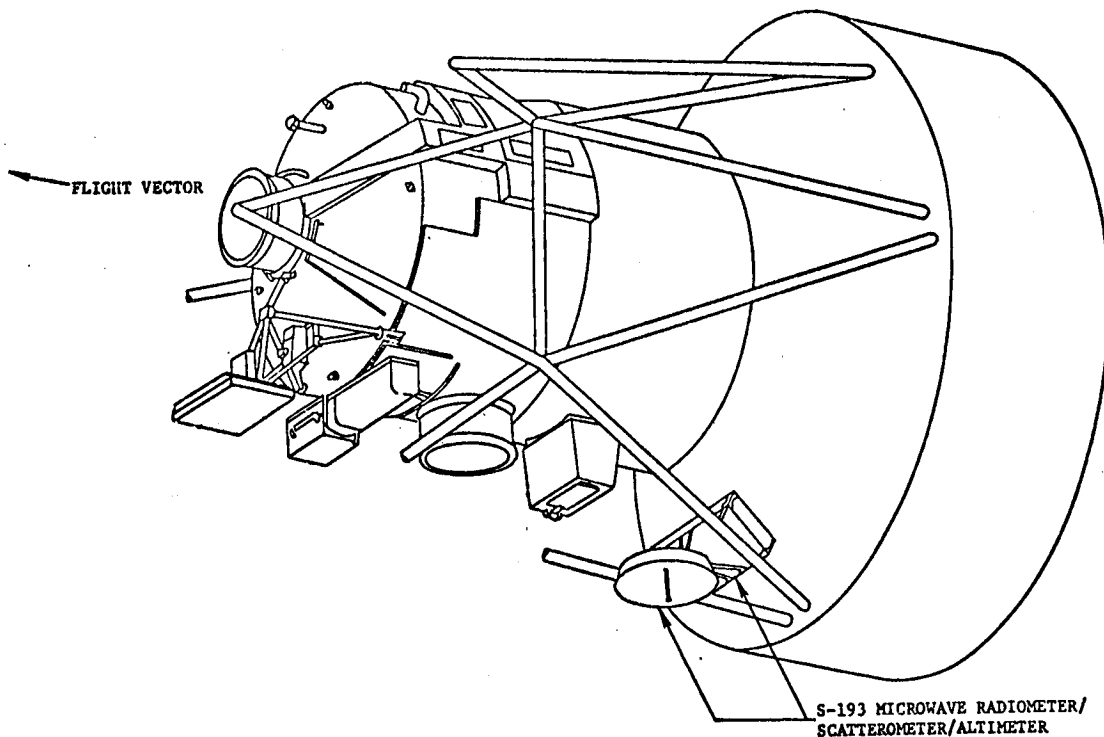
Figure 192. S193 Antenna

13. S193 Antenna Repair - The purpose of experiment S193, Microwave Radiometer/Scatterometer Altimeter was to investigate active and passive microwave sensing systems from an orbital altitude. The experiment included a mechanically driven parabolic reflector (Figure 192) that scanned in several programmed modes.

During SL-3 the antenna began to malfunction and would not scan properly. To correct this problem, hardware and procedures were developed to enable two EVA crewmen to check out and repair the antenna or its associated electronics package. Several major problems had to be solved: (1) the S193 antenna was on the side of Skylab where nominal EVA operations were not performed and no EVA lights, handrails, or foot restraints were available near the antenna, (2) the antenna was large (44.5 in. x 21.2 in.) and massive (294 lbs), (3) the electronics were located beneath the antenna and would not be very accessible to the crewmen, and (4) attempts to diagnose the problem from the ground were only partially successful.

It was determined that crew translation to the S193 antenna from the EVA hatch could be accomplished by using the mole sieve vent duct along the exterior of the Multiple Docking Adaptor (MDA). The major problem, however, was restraint of the crewmen at the antenna; development was begun on a "universal" foot restraint that would attach to a variety of external hardware, including the trusses around the S193 antenna. After several iterations, a design was evolved which would secure the OWS portable foot restraint to round trusses from 1 to 6 in. in diameter, to the Fixed Airlock Shroud (FAS) ring, to the solar panel back-up structure, and to various other external points which included adjustments in roll and pitch to position the crewman at the worksite.

Two sets of foot restraints were developed for experiment S193-- one at MSFC and one at JSC. The JSC set was selected for use. This foot restraint was not universal, but was designed to fit into a lightening hole on the discone antenna launch tray near the S193 antenna. The JSC foot restraint was lighter than the MSFC concept, and was therefore selected to be carried aboard SL-4 for the antenna repairs.

Although this task was difficult and the crew had not been trained, the repair operations were successfully performed.
