DESIGN, MANUFACTURE, DEVELOPMENT, TEST, AND EVALUATION OF BORON/ALUMINUM STRUCTURAL COMPONENTS FOR SPACE SHUTTLE

VOLUME IV + REPAIRABILITY

GENERAL DYNAMICS
Convair Division

August 1974

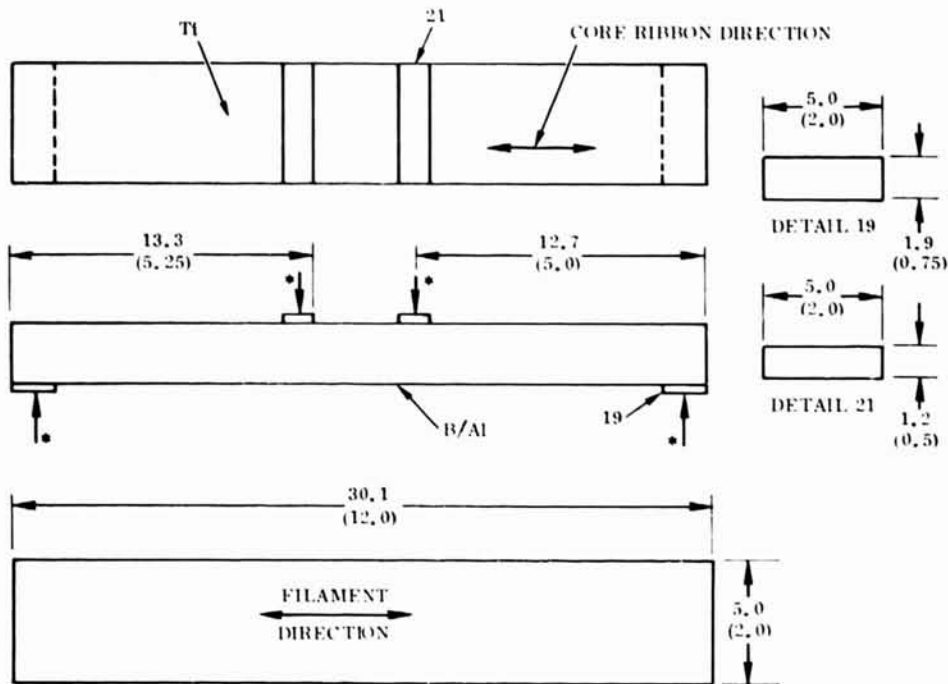
Figure 3-1. B/Al Sandwich Beam Specimen

The original specimen configuration is shown in Figure 3-1. The overall dimensions of the beam were 30.1 by 5.0 by 2.5 cm (12 by 2 by 1 in.). The load introduction tabs were made from 6061-T6 aluminum. The compression skin was made from 6Al-4V titanium, the core from 3.1 mm (0.125 in.) cell diameter by 0.06 mm (0.0023 in.) thick aluminum honeycomb, and the tension skin from a 0.51 mm (0.020 in.) thickness of 0.1 mm (4.0 mil) boron reinforced aluminum. The panel was bonded together using FM-123 adhesive. It was assumed that a facing sheet tensile stress of 1207 MPa (175 ksi) would be developed; using this as the design value, a failure load of 13.7 kN (3090 lb) was anticipated. The specimen failed by a tensile fracture of the B/Al skin; the actual failure load was 15.8 kN (3545 lb), which corresponds to a tensile stress of 1306 MPa (189.5 ksi) in the tension skin.

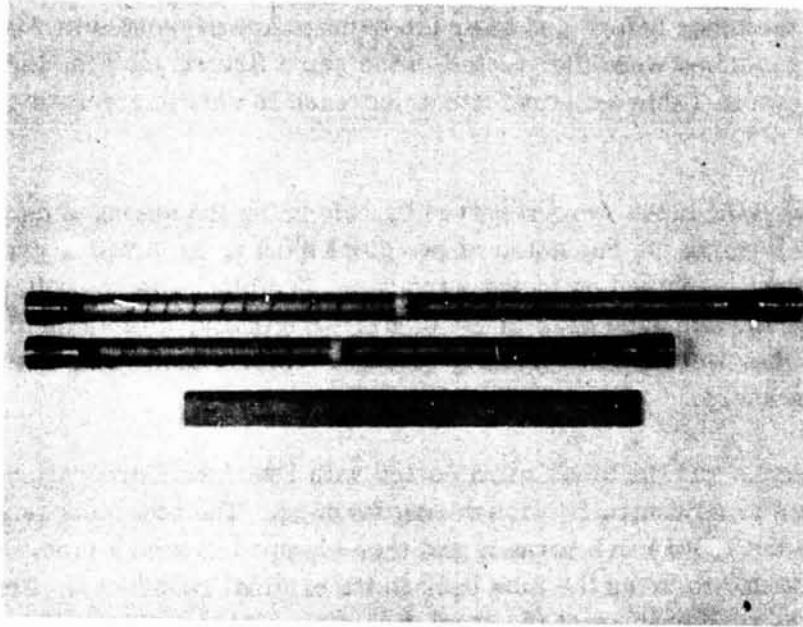
Figure 3-5. B/Al Tubes Prior to Damage (136478)

range, there was no permanent deformation in the tubes. There is, however, always a chance that thin-walled tubes could be crushed during service or due to abusive handling. To simulate this abusive handling, the tubes were crushed in a vise. Photographs showing the tubes before and after the damage are presented in Figures 3-5 and 3-6. The damaged tubes were then tested in the same fixture used for initial testing. The results, shown in Table 3-2, indicate a decrease in elastic strength of approximately 28%.

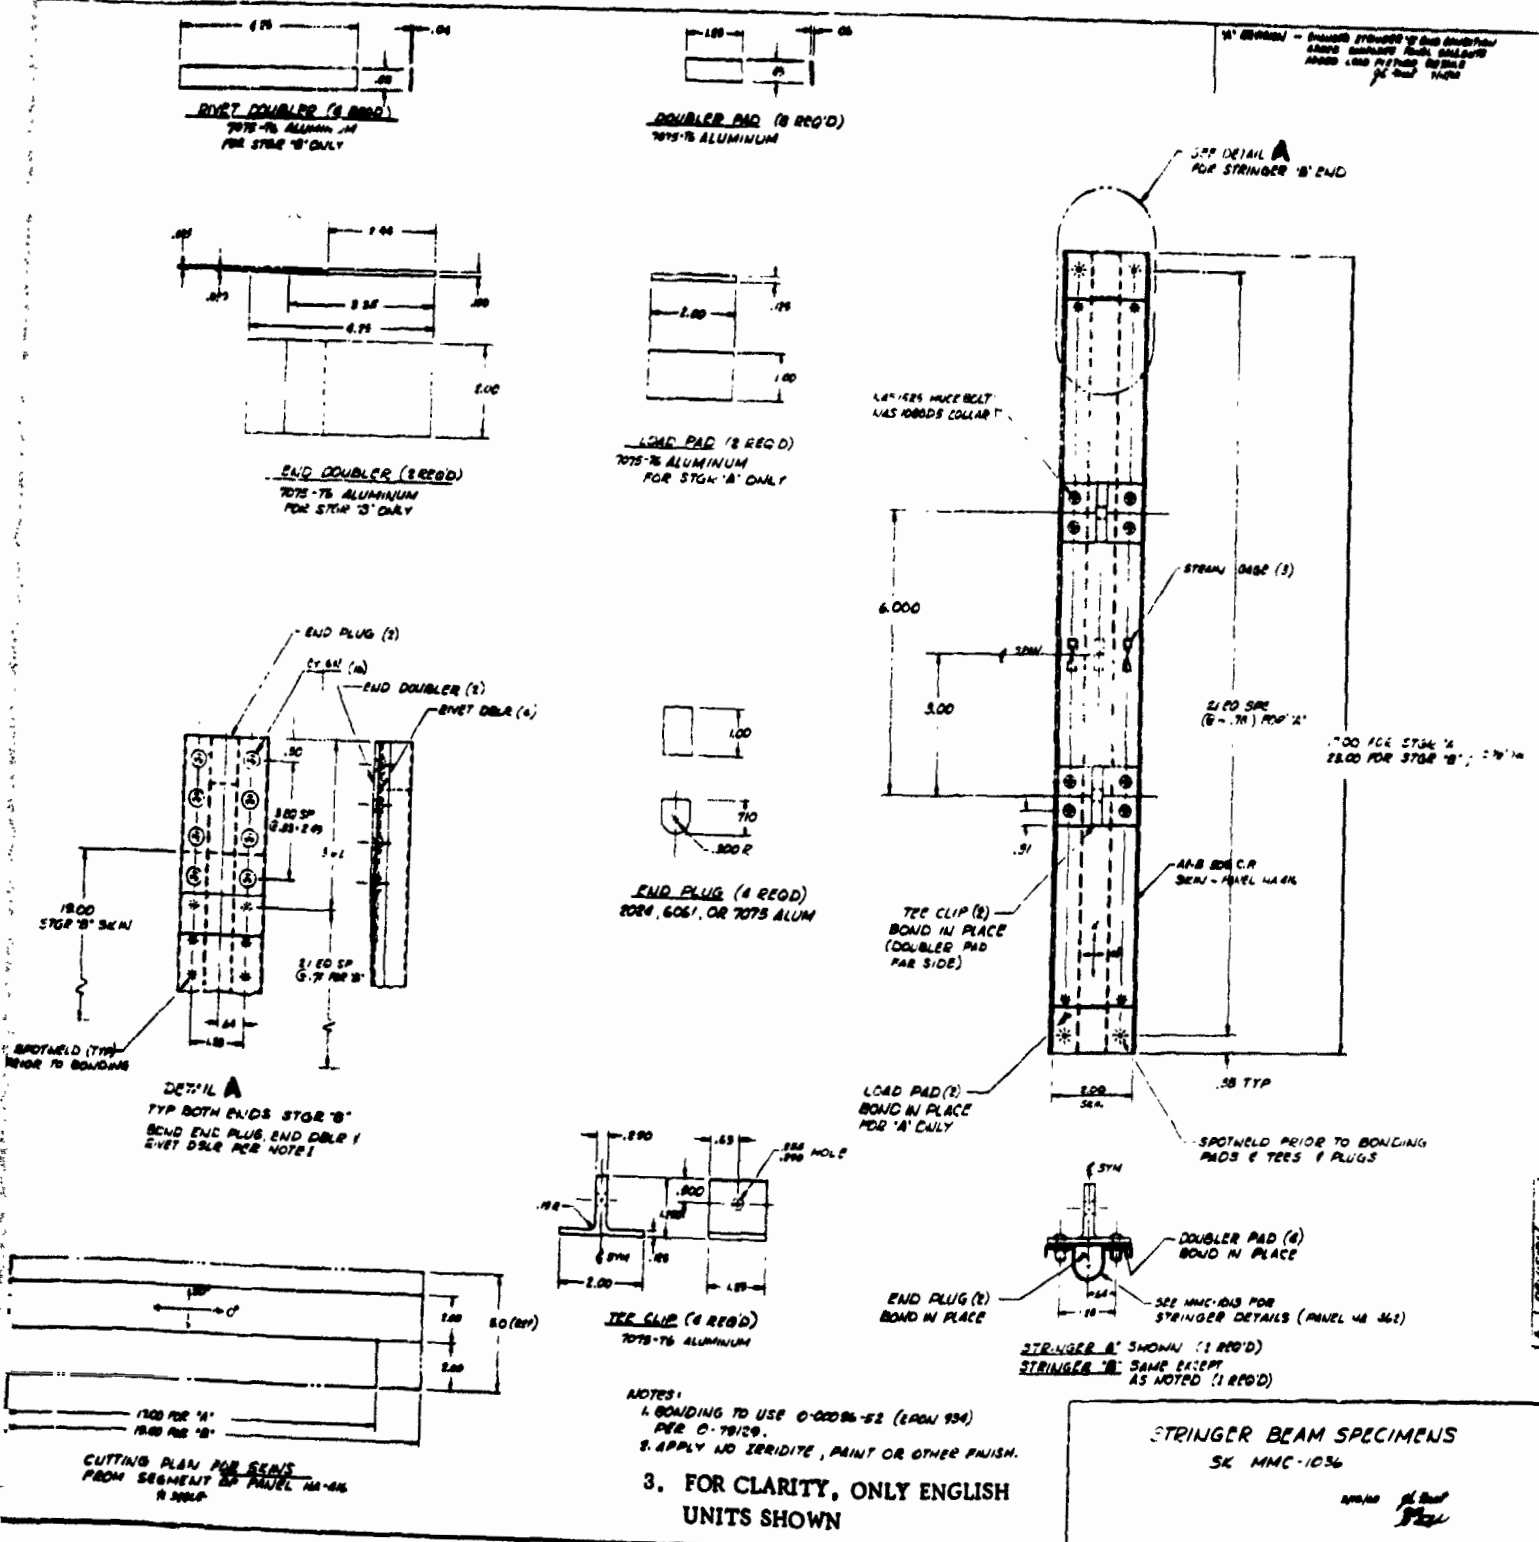
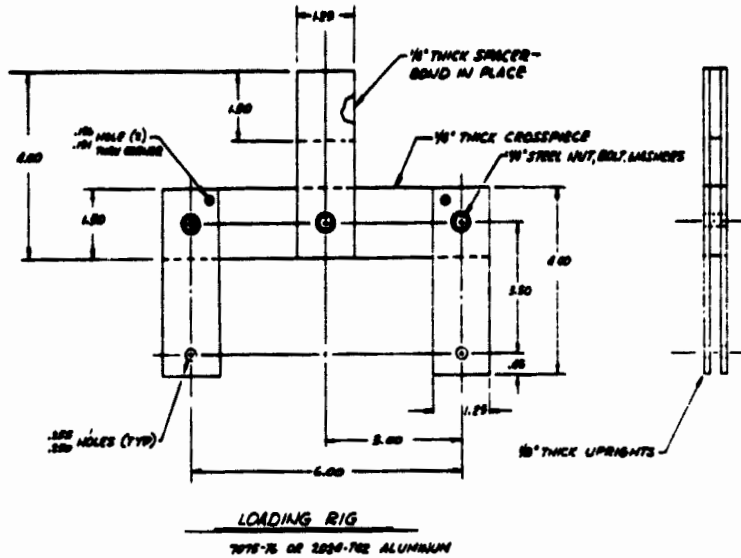
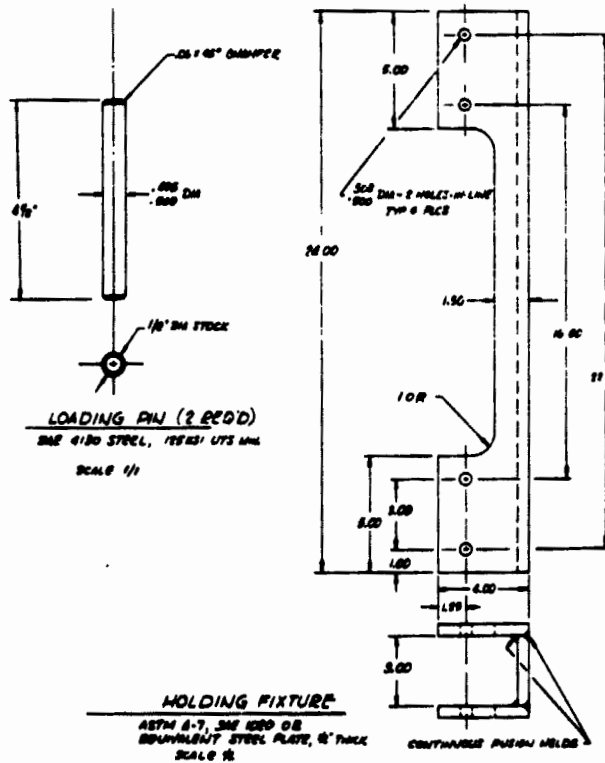
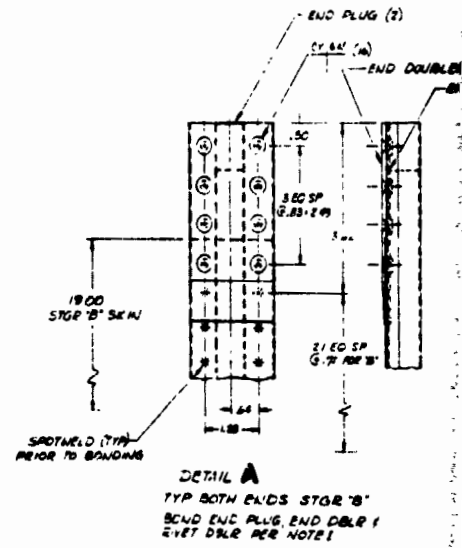
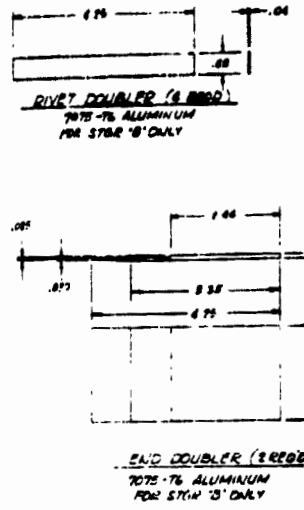
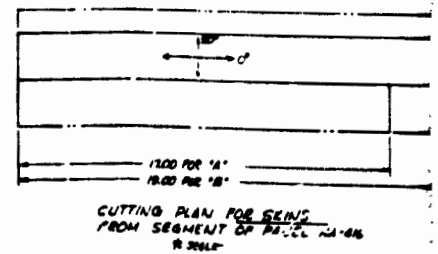
Figure 3-9. Sheet Stringer Specimen
REPRODUCIBILITY OF THE
ORIGINAL PAGE IS POOR 3-9

A B/Al sheet-stringer specimen tested as a subcomponent demonstration article during development and fabrication of a B/Al adapter for the PRIME missile (Reference 3) was also selected for the reparability program. The test specimen consisted of a uni-directional B/Al hat section stringer resistance spot welded to a 0-90 crossply B/Al skin. Details of the test specimen and test fixture and attachments are shown in Figure 3-9.

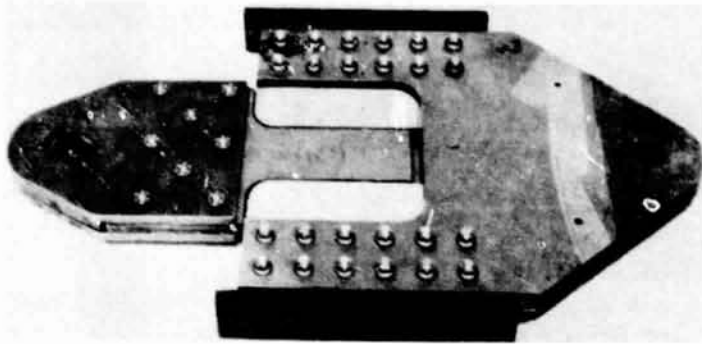
Figure 3-19. Web Splice Test Specimen and Fixture (122407B)

Two B/Al web splice test specimens were installed in test fixtures (one of which is shown in Figure 3-19) and tested in tension (double shear of the spotwelds). Failure of one specimen occurred at 100,085N (22,500 lb) of load. The failed test specimen is shown in Figure 3-20.

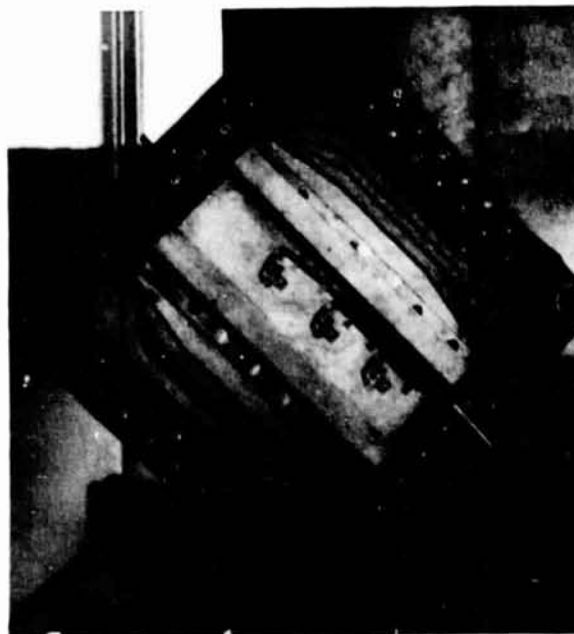
Figure 3-23. Tension Field Test in Progress (122589B)

The $\pm 45^\circ$ B/Al tension field panel selected for reparability studies was one of two tension field test specimens originally fabricated and tested to determine the tension field properties of 0.254 cm (0.100 in.) thick B/Al shear web material. Two Z-section stiffeners, fabricated from unidirectional B/Al, were positioned to isolate the tension field panel from the test fixture. The stiffeners were sized to provide simple support to the panel and withstand secondary compressive loads. The aspect ratio was approximately 2:1. The tension field panel was tested in a "picture frame" test fixture, Figure 3-23, on a universal testing machine. Initial buckling of the specimen occurred at 334,000N (75,000 lb) and failure occurred at 369,000N (83,000 lb) of load. Details of the original test are given in Reference 1.
