MSC-PT-R-68-22

APOLLO 6
ANOMALY REPORT NO. 6

ABNORMAL STRUCTURAL PERFORMANCE
DURING LAUNCH PHASE

February 1969

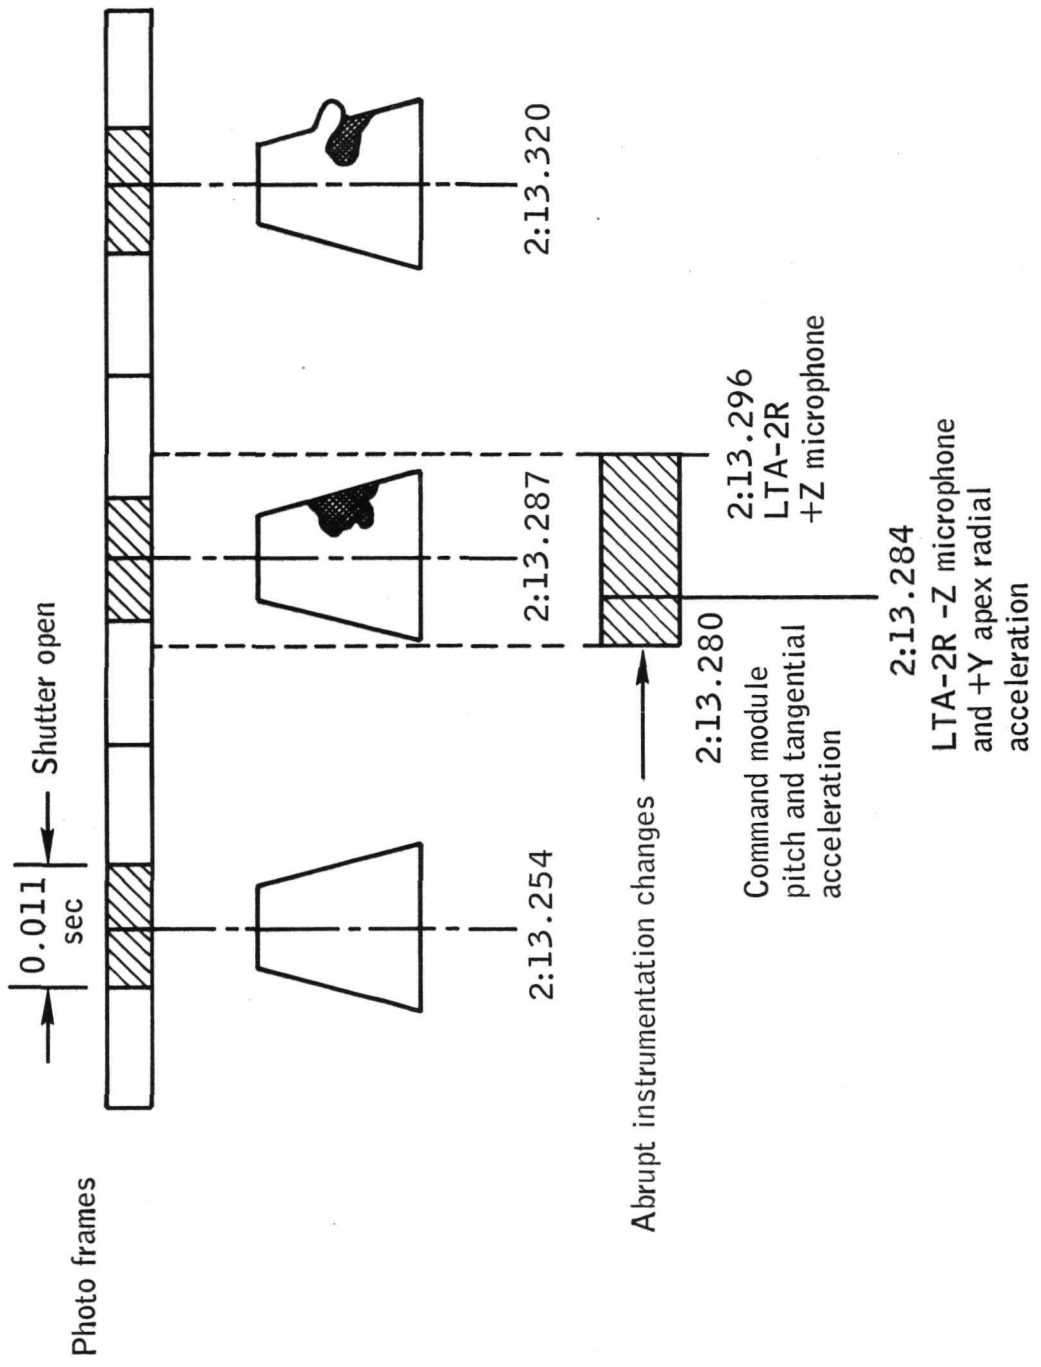
Figure 3.- Timeline.

The photographic frame at 2:13.287 captured the first visual evidence; however, accelerometers and microphones provided evidence that the failure was several milliseconds earlier. Timing of pertinent instrumentation changes during the anomaly is shown in figure 3.
