Document No. QTR-72-1039
Revision _____
Release Date DEC 5 1972

QUALIFICATION TEST REPORT
BUMP PROTECTION HAT
(SUBASSEMBLY OF
T020/M509 HEAD PROTECTIVE ASSEMBLY)

CONTRACT NAS 9-11905

ABSTRACT

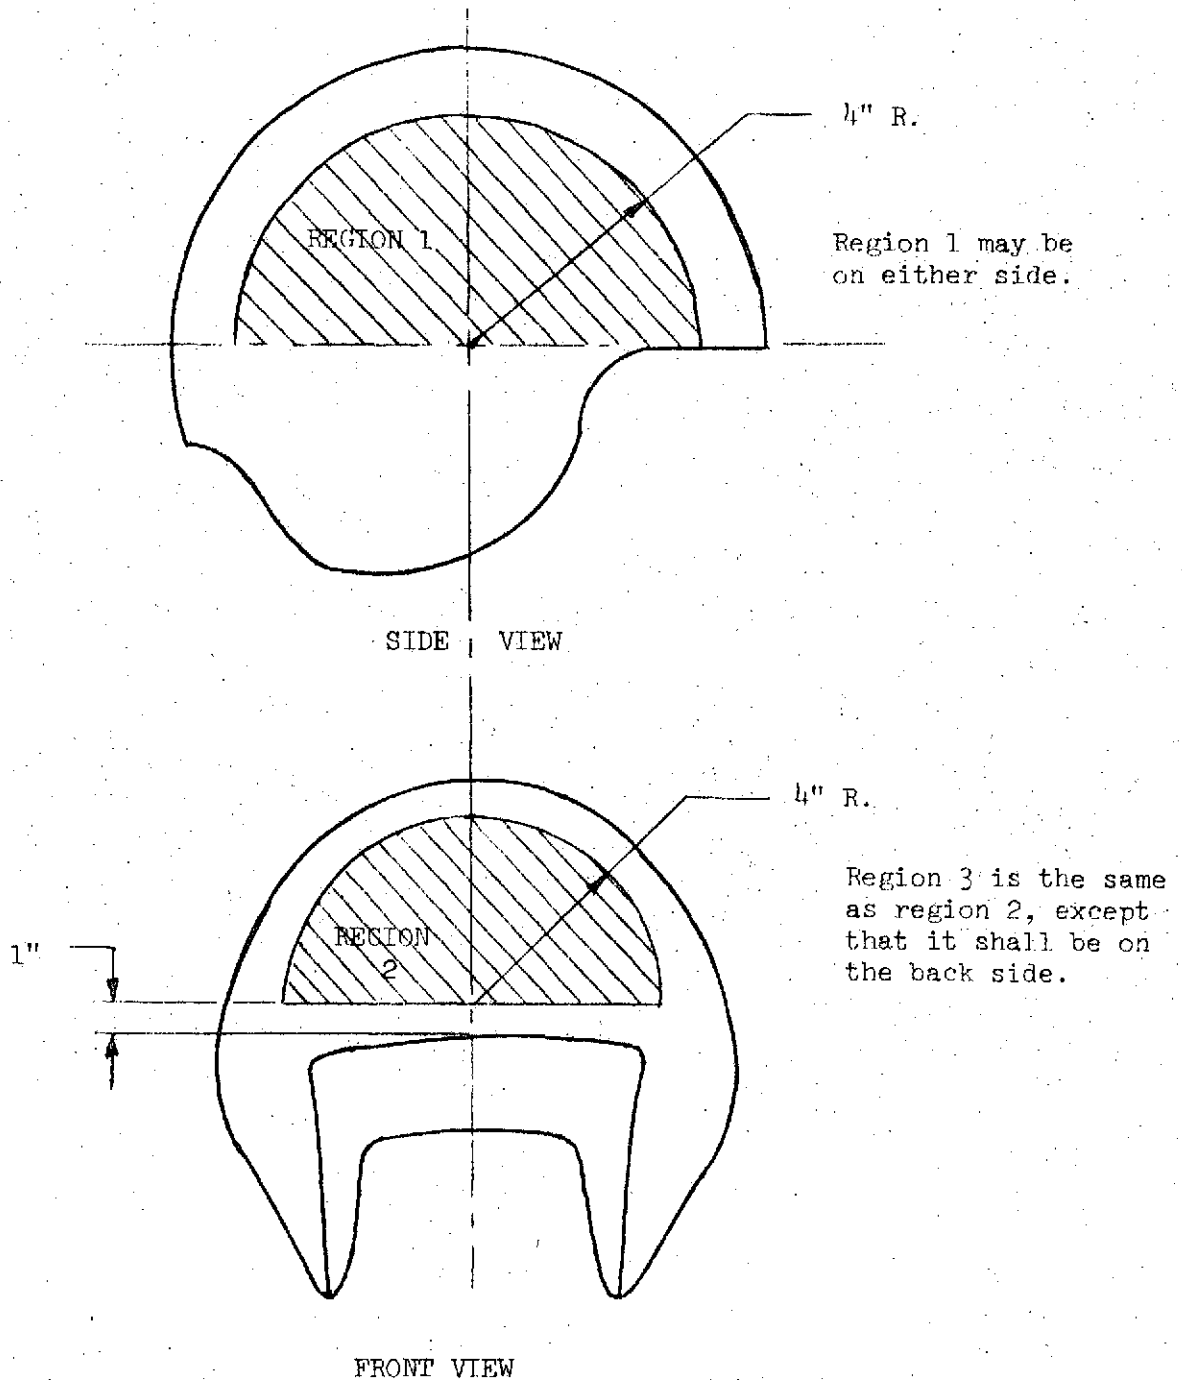
Testing was performed in accordance with QTP-72-1037, Impact Test Qualification Test Procedure for the BPH (see Appendix A). Testing was performed on GE-TPS-C-010 (Appendix B). One deviation was made to the test procedure. Figure 3 of the test procedure called for impacts to be performed on one side, the front, and the back of the helmet. The actual impacts were performed on one side, the front, and the top of the helmet. The top was impacted instead of the back for two reasons: (1) It was felt that a top impact would be more realistic than a back impact. (2) The test facility would have to be modified to perform a back impact.

- a. Stop watch not calibrated.
- b. Region three on Fig 3 replaced by a top of helmet impact (see TPS 6E-TPS-C-010)

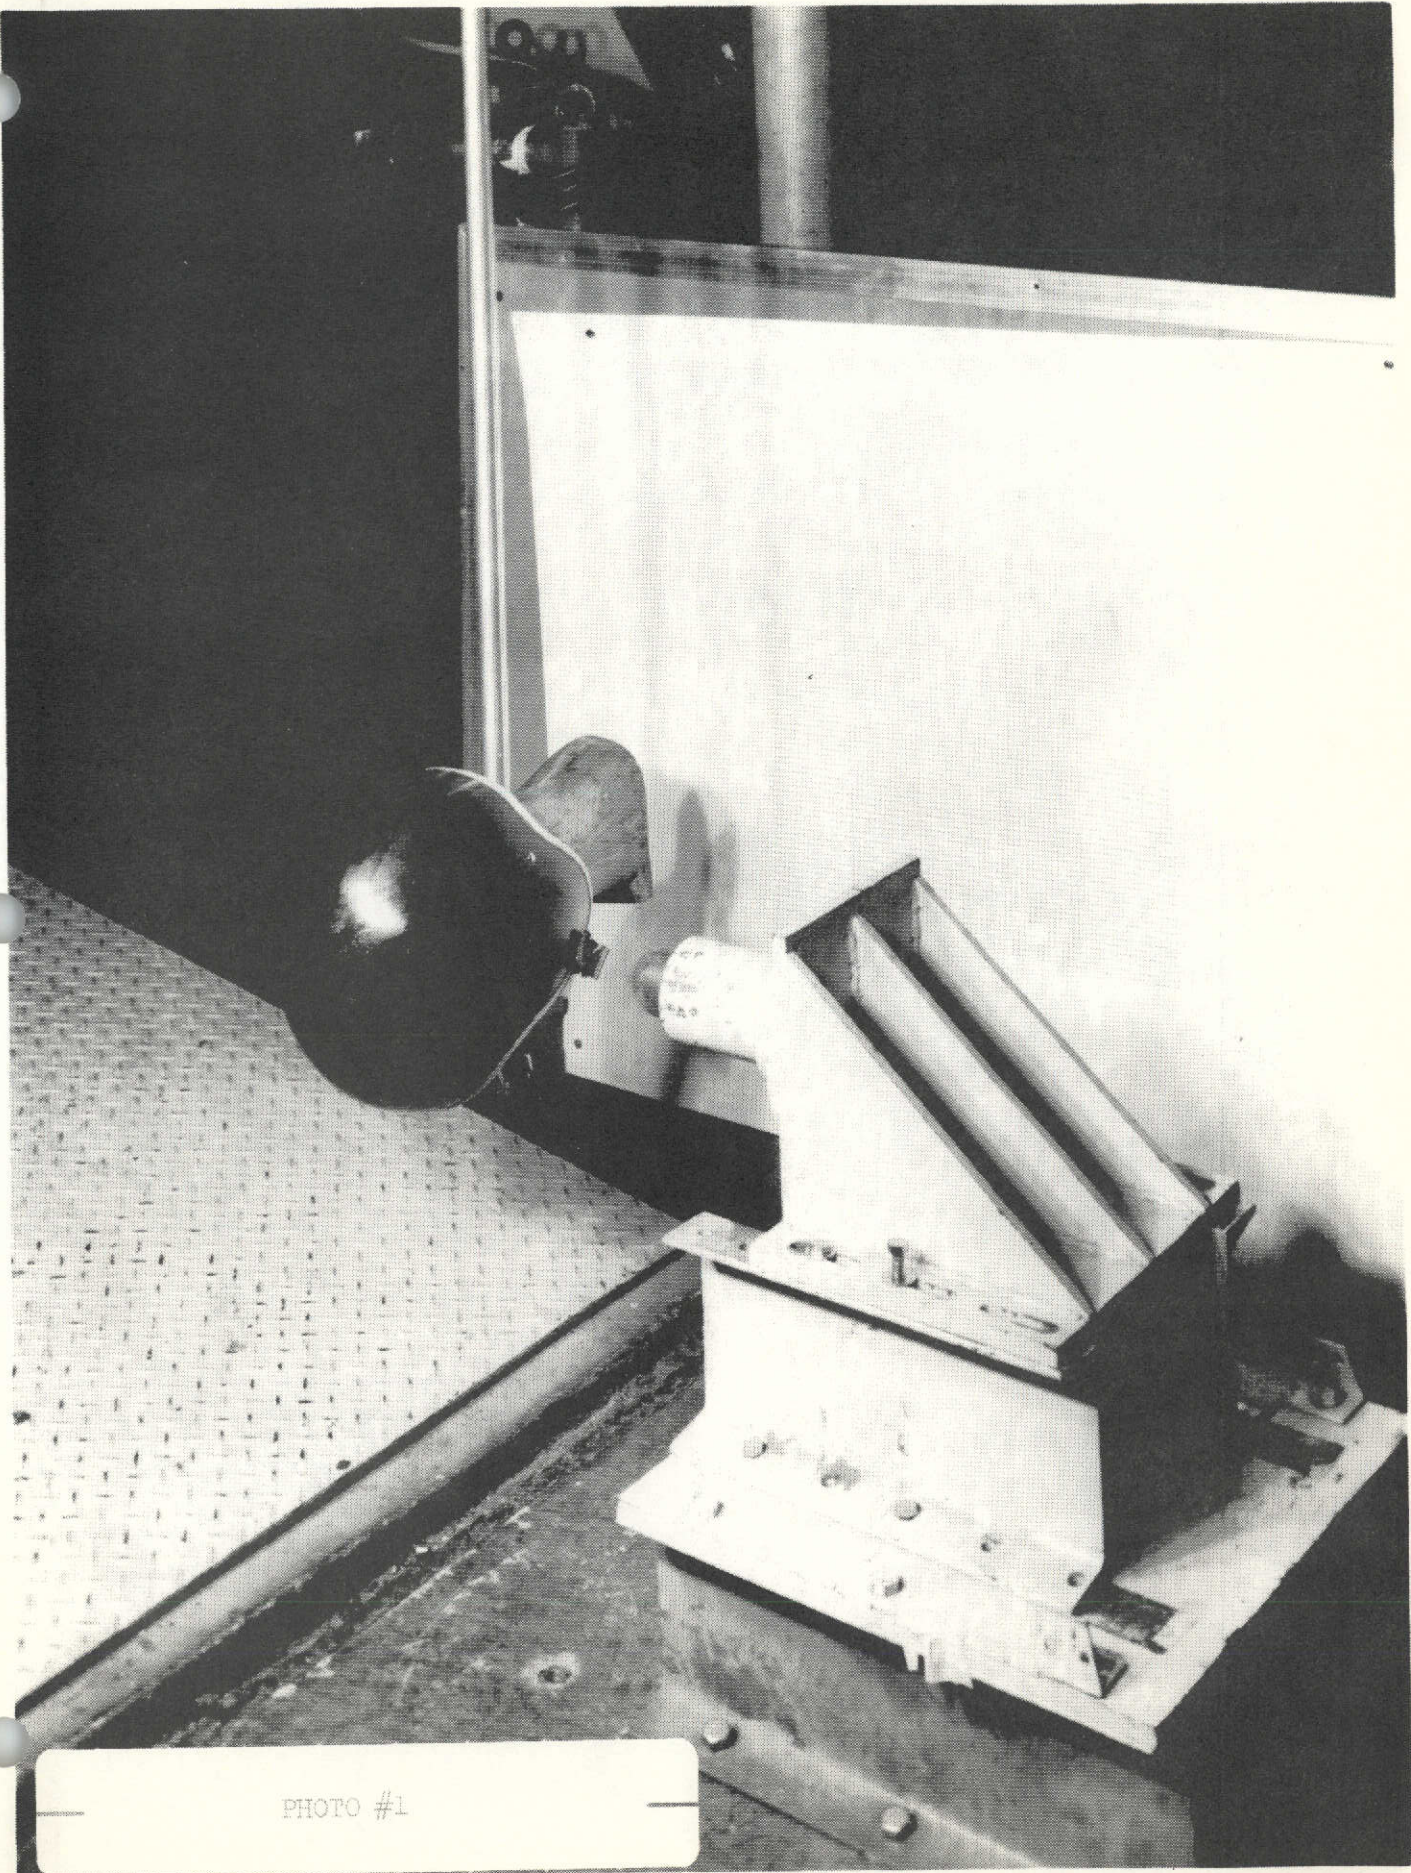
PHOTO #1

The test equipment is shown in Figures 1 and 2 of the test procedure (Appendix A). Photographs number 1, 4, and 8 of Appendix C show the test setup for the three impacts performed. The stop watch used during testing was not calibrated, as indicated on the Test Summary Sheet (Attachment A of QTP-72-1037).
