ANALYSIS OF TURBOFAN ENGINE PERFORMANCE DETERIORATION  
AND PROPOSED FOLLOW-ON TESTS

G. P. Sallee, H. D. Kruckenberg, and E. H. Toomey

AMERICAN AIRLINES, INC.

CONTRACT NAS 3-18537

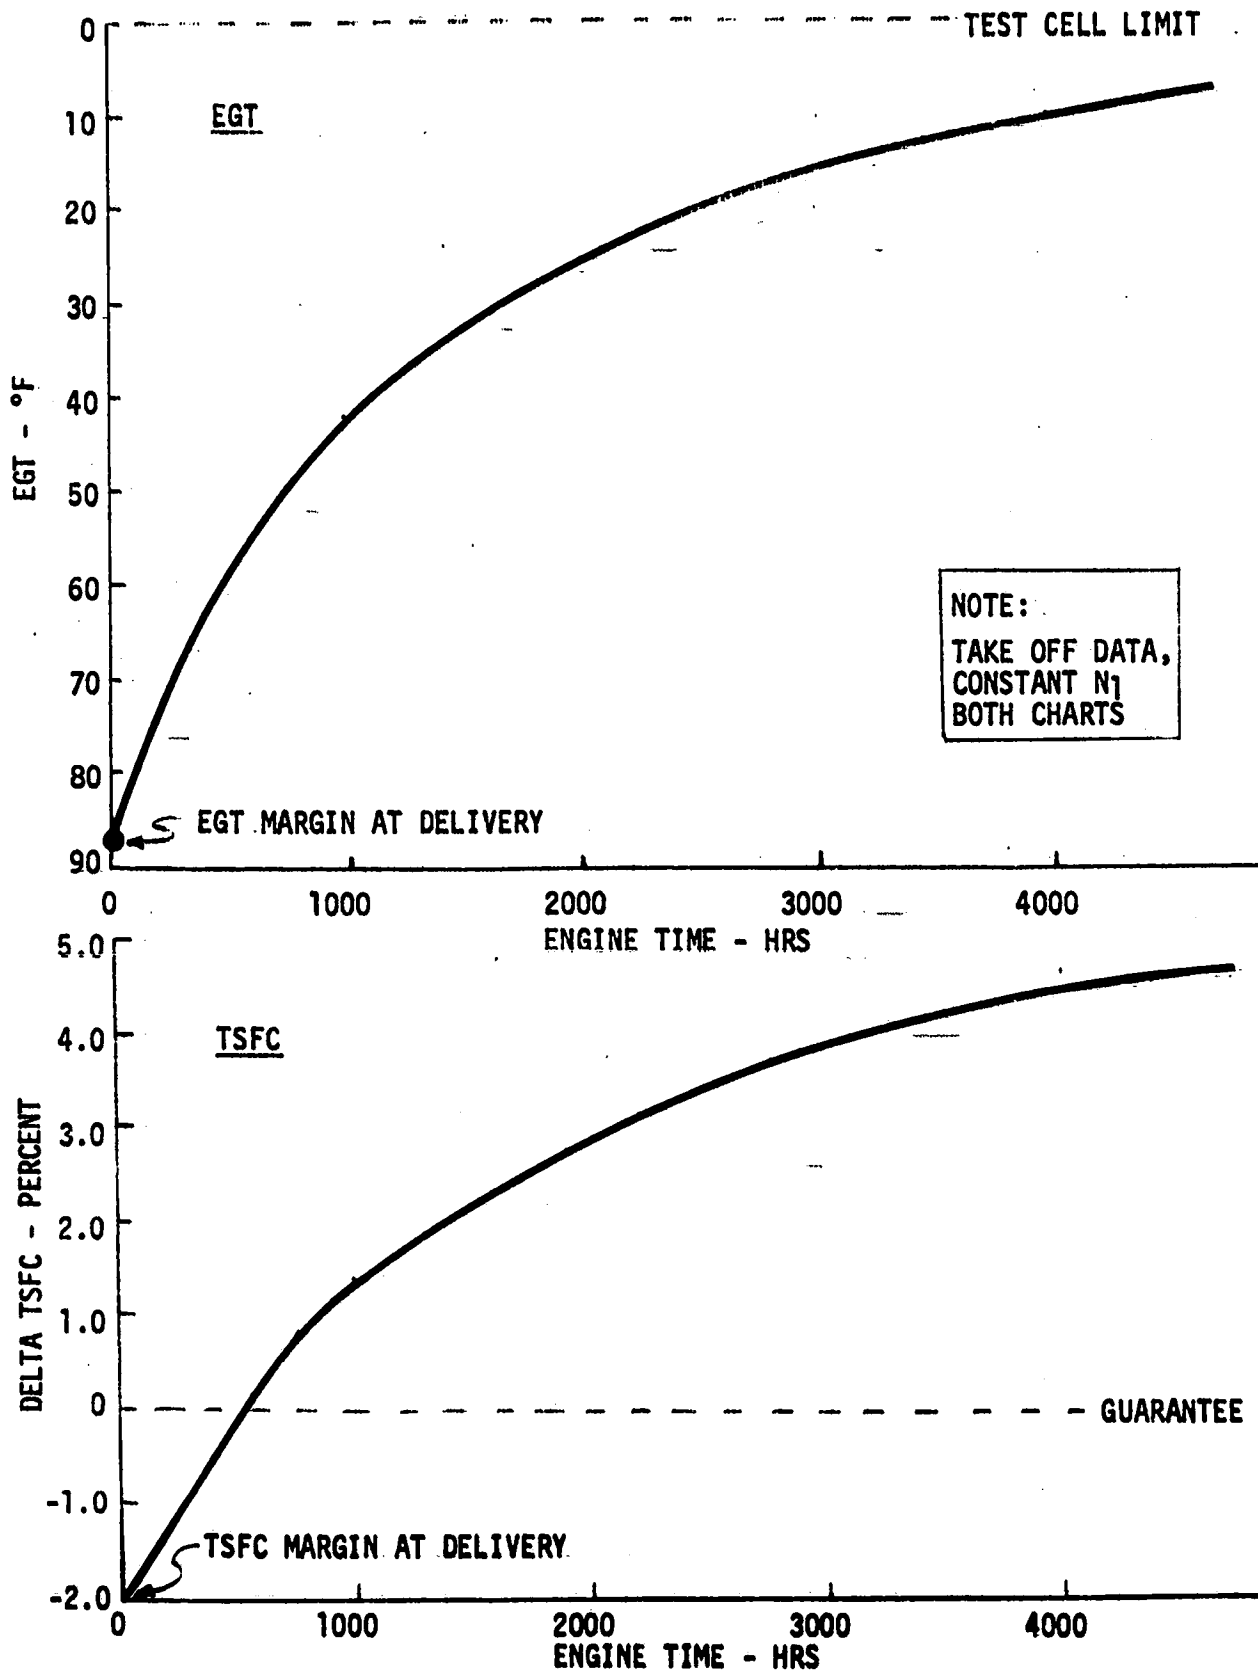
FIGURE 1 - TYPICAL HIGH BYPASS ENGINE DETERIORATION RATE

Short Term Deterioration - When delivered new, seals are at their minimum tolerance and the aerodynamic flow path performance is usually as designed. But, considerable performance loss is experienced during the first 1,000 hours of engine operation due mainly to seal wear in. From 1,000 to 3,000 hours of operation the aerodynamic flow path is interrupted by a gradual change in blade profile brought on by blade erosion. The high bypass ratio engines usually exhibit a more pronounced short term deterioration than is noted for the JT3D and JT8D engines. Figure 1 represents a typical high bypass engine deterioration profile.

Long Term Deterioration - Long term deterioration usually occurs after the engine has been in service for 2,000 to 3,000 hours (Figure 1). Long term engine deterioration is usually associated with hot section distress (1st stage nozzle guide vane condition, fuel spray pattern, etc.). When an engine goes through American Airlines' repair shop most of the long range performance deterioration associated with the hot section is eliminated during engine build. Current repair practices do not recapture much of the short term deterioration due to seal wear and longer term deterioration due to compressor blade erosion.

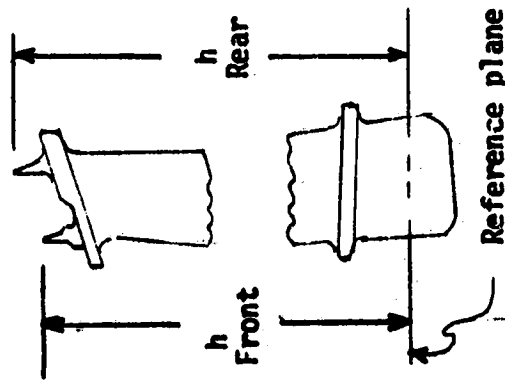
Figure 25. Impact of Observed & Measured Turbine Deviations on Engine Fuel Consumption

STAGE NUMBER	JT3D		JT8D		FUEL FLOW PENALTY (PPH)
	▲ TIP CLEARANCE (INCHES) FRONT	▲ TIP CLEARANCE (INCHES) REAR	▲ TIP CLEARANCE (INCHES) FRONT	▲ TIP CLEARANCE (INCHES) REAR	
2	-0.002	+0.030	+0.006	+0.008	0.0
3	+0.018	+0.031	+0.003	+0.002	0.0
4	+0.006	+0.004	+0.009	+0.015	10
					10
					20
					5.0
					3.0

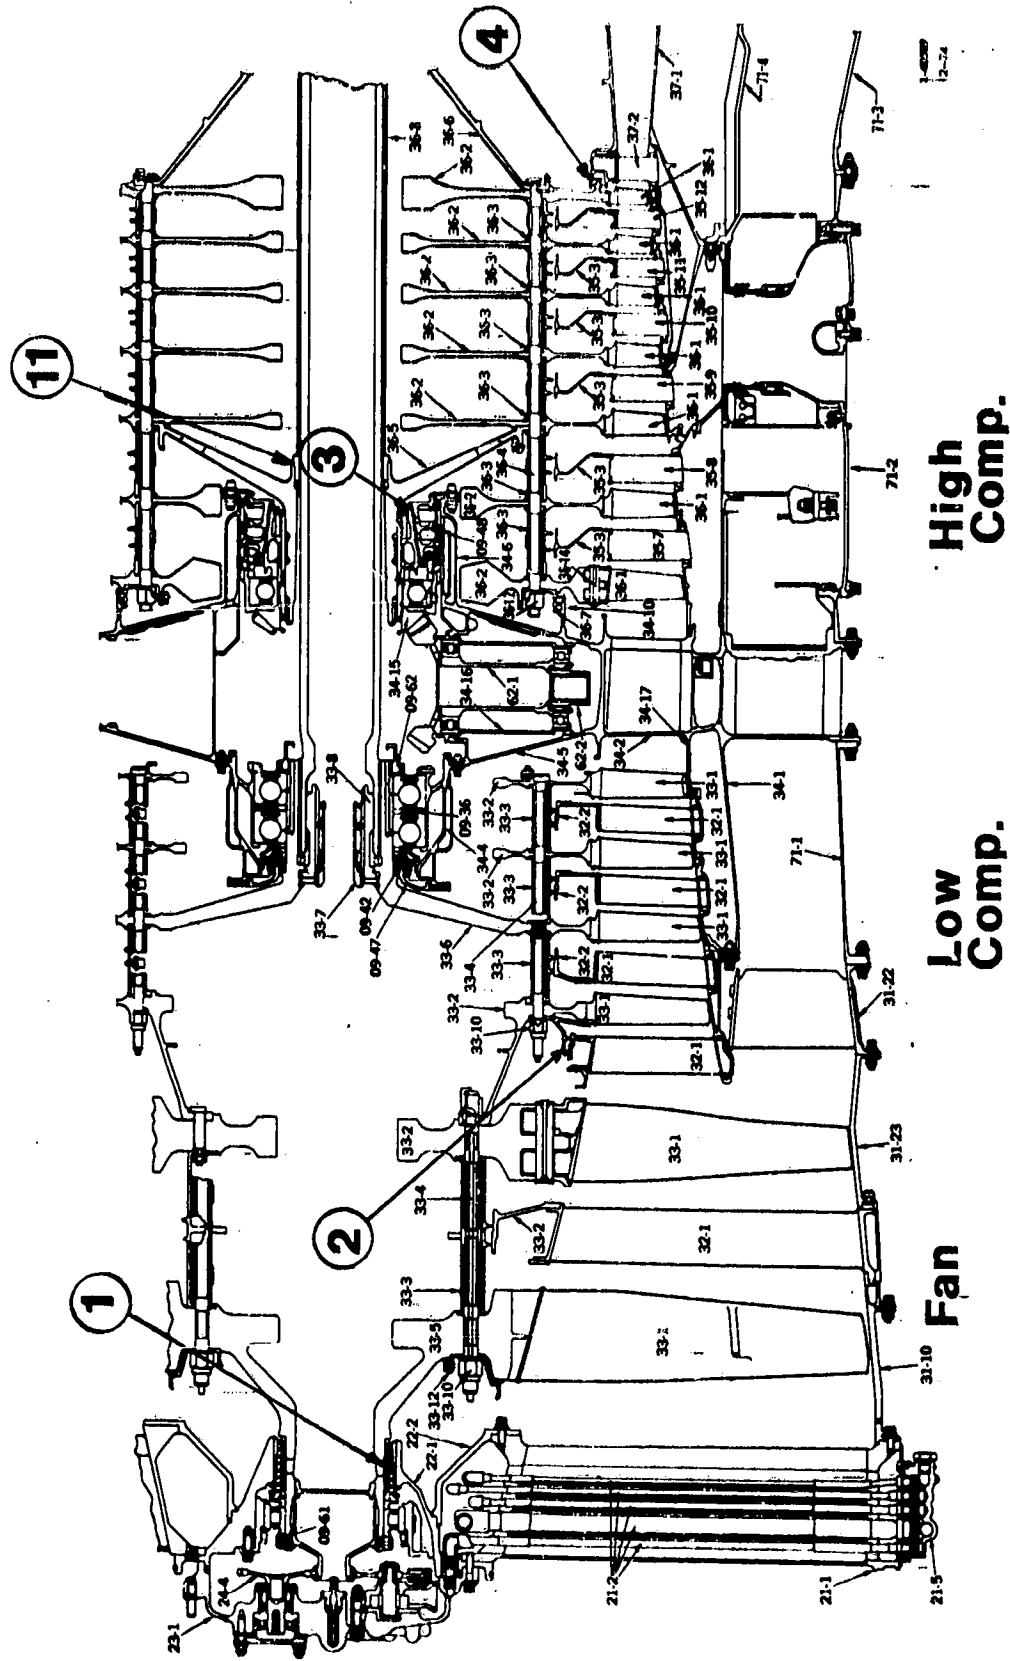
FIGURE 41 - JT8D FAN, LOW COMPRESSOR & HIGH COMPRESSOR  
AREAS OF MEASURED SEAL TOLERANCES

The seals in the JT8D engine are designed to prevent recirculation of air from an area of high pressure to an area of low pressure. For example, Figures 41 and 42 indicate the basic critical seal areas of the JT8D which could allow recirculation in the compressor or loss through the turbine seals of a certain amount of airflow above the design value which will result in considerable increase in fuel flow and EGT.

Measurements were recorded for the JT8D seal areas indicated by items number 1 thru 11 in Figures 41 and 42. These measurements were given to P&WA Engineers who used the information to make analytical performance loss estimates. The analytical performance estimates are discussed in the Seals and Clearances Section of the main report. The seal areas except those noted as follows were found to be within P&WA manual limits.

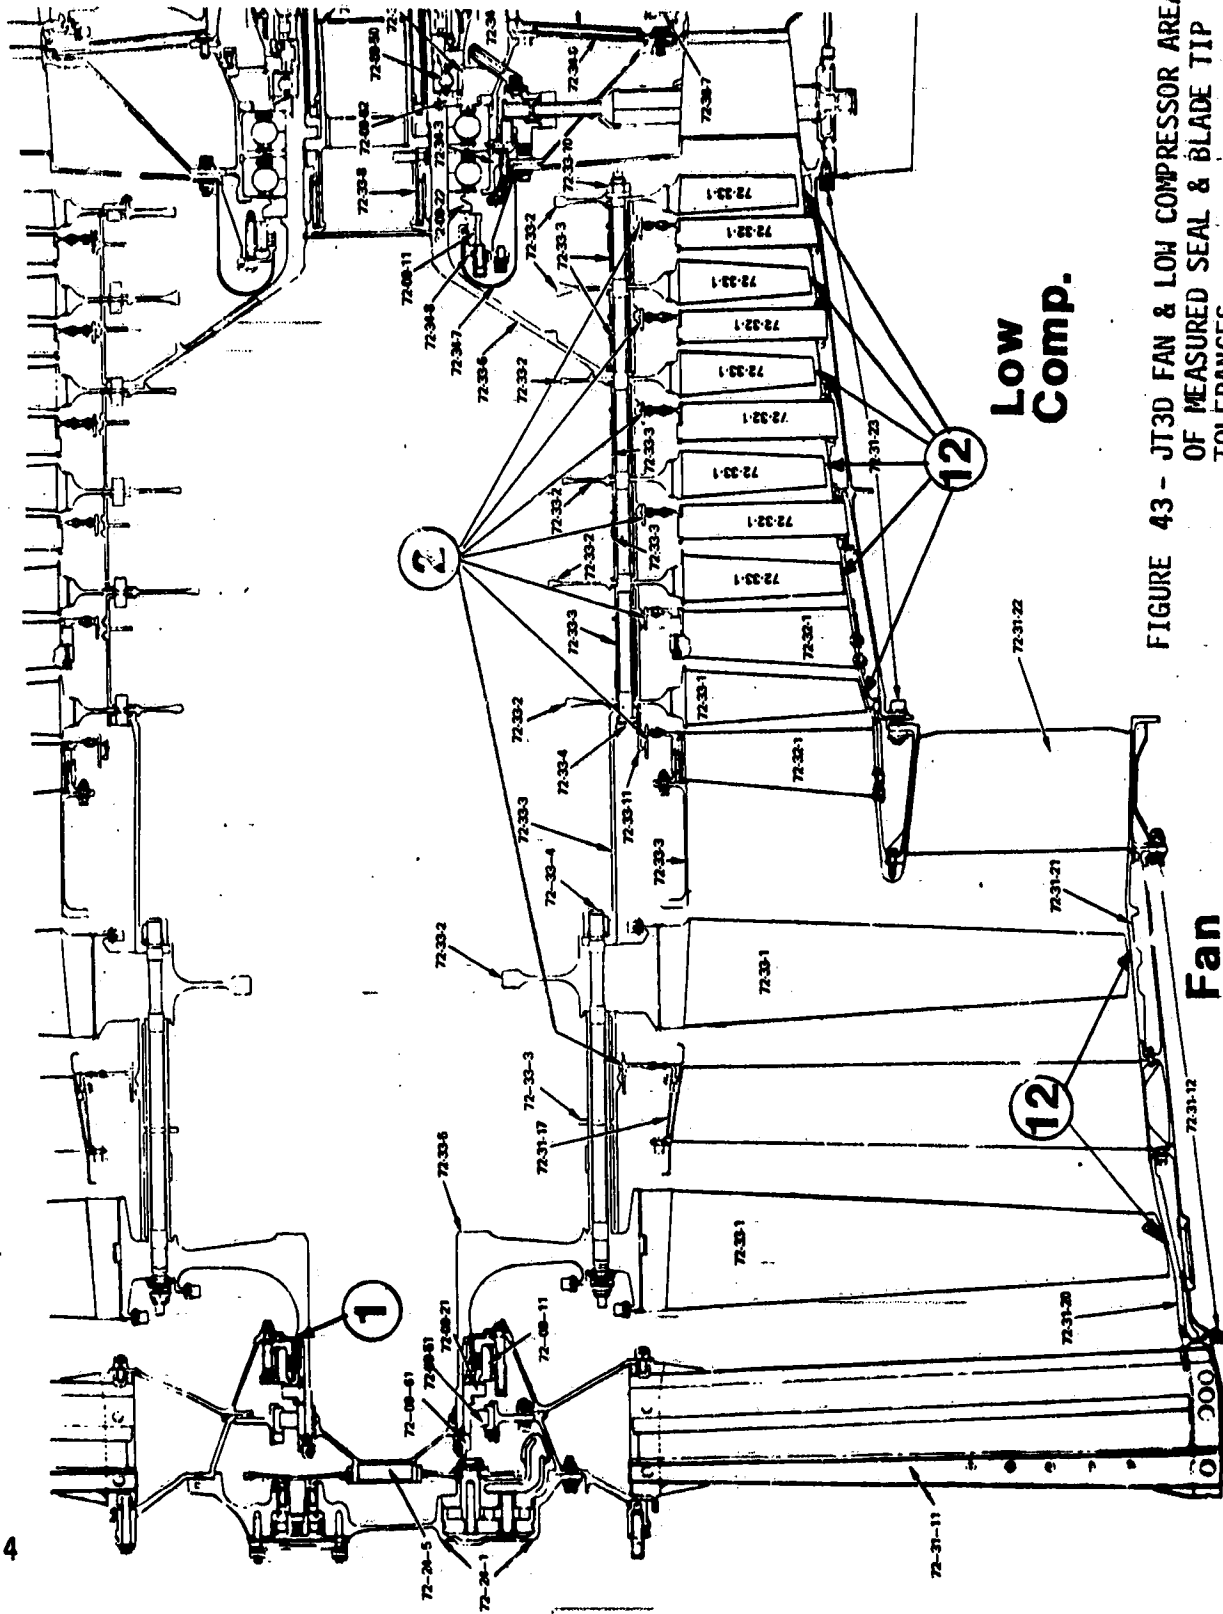
FIGURE 43 - JT3D FAN & LOW COMPRESSOR AREAS OF MEASURED SEAL & BLADE TIP TOLERANCES

Review of the dimensions recorded as illustrated in Figure 43 relates to both the fan and low compressor sections of the engine. The air seal measurements indicated by number 2 in Figure 43 was found to be a 50 percent split between those falling within the P&WA reference dimensions (manufactured limits) and replace limits. No dimension exceeds the replace limit for the seal land diameters.

The seals indicated as numbers 1 and 2 (Figure 43) were found to be within P&WA check and repair limits with the exception of the 7th to 8th stage fwd seal land diameter which exceeded the P&WA check and repair limit. The fan and low compressor blade tip tolerances (see number 12) were found to be within limits with the exception of the 1st and 2nd fan blade tip clearances. Some blades in the first stage fan had tip clearances which exceeded the maximum allowed in the P&WA repair manual. Second stage fan blades exceeded both the minimum and maximum limits given in the Maintenance Manual.

In summary, engine S/N 667783 exceeded the P&WA manual limits concerning individual blade tip clearances for the 1st and 2nd fan blades and for the 1st through 3rd turbine blades. The various seal areas in Figures 43 through 45 were found to be within manual limits with exception of the 7th to 8th stage fwd seal land diameter and the 15th and 16th stage aft seal land diameter which exceeded manual limits. The performance data for this engine is given in the main report.

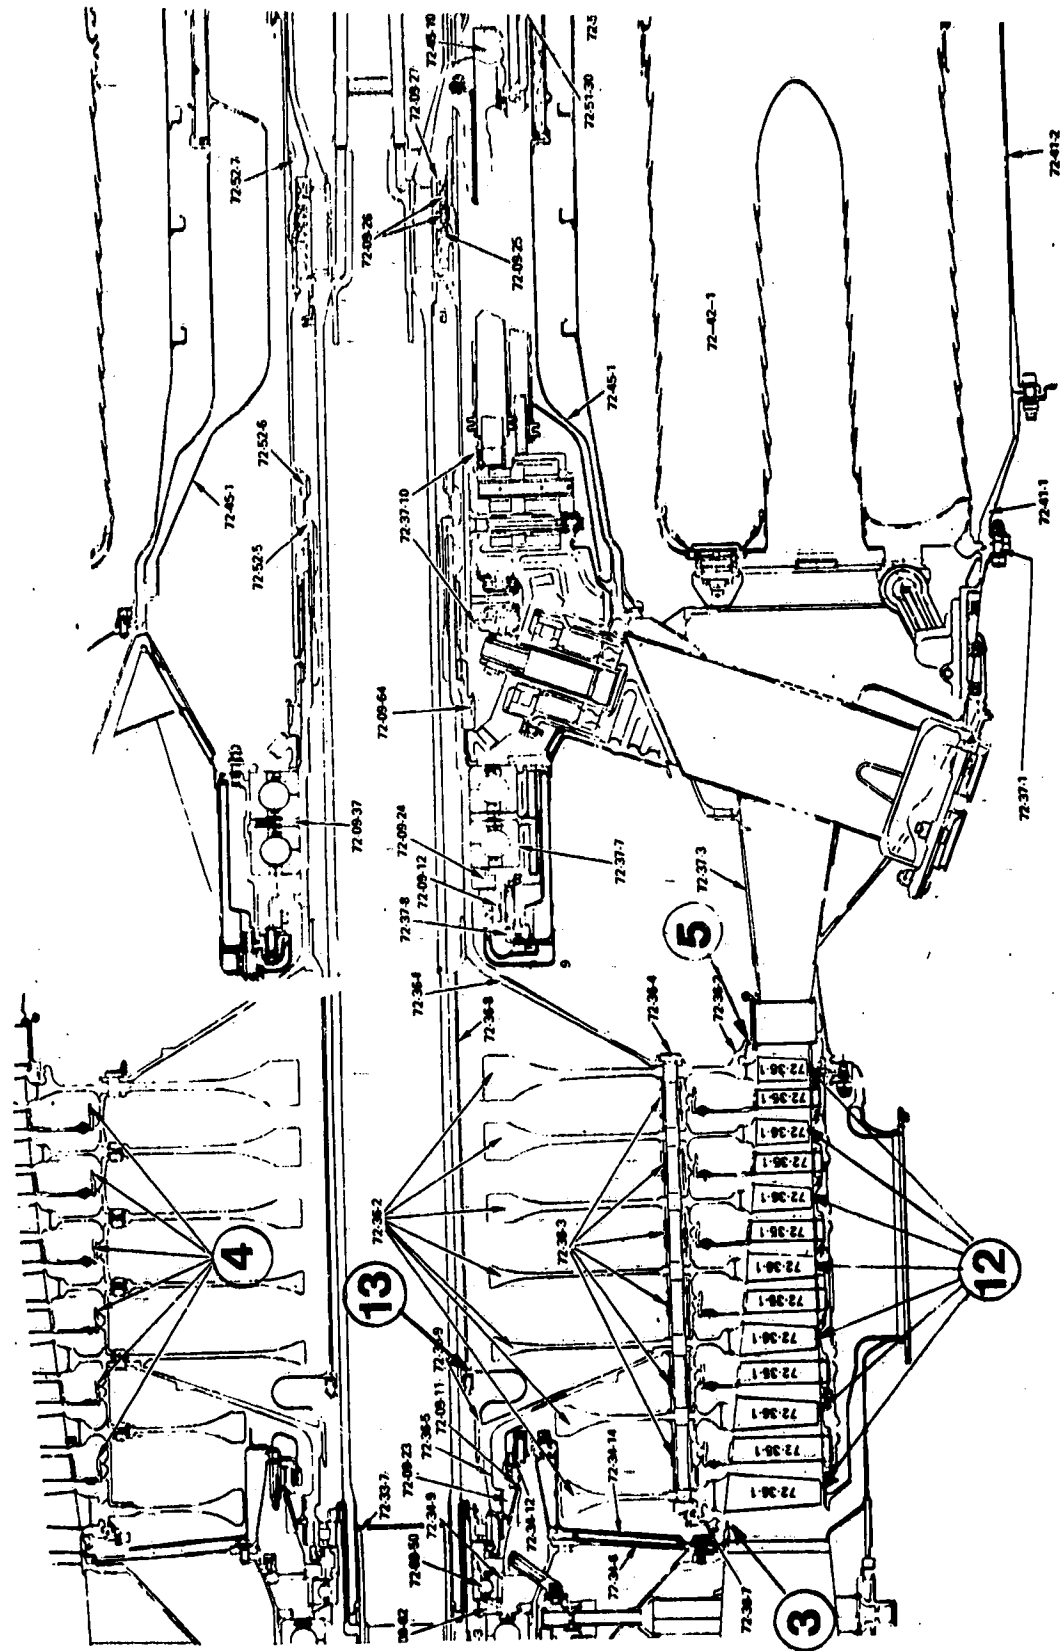
FIGURE 44 - JT3D HIGH COMPRESSOR AREAS OF MEASURED SEAL & BLADE TIP TOLERANCES

The seal tolerances and blade tip clearances were recorded for those engine areas indicated in Figure 43 thru Figure 45 during buildup of engine S/N 645738. The same number representing different engine locations on the figures is used to indicate that the minimum and maximum tolerances are the same value for each of those locations (Figures 1 thru 3). The seal areas and blade tip clearances except those noted as follows were found to be within P&WA manual limits.
