NASA TN D-7992

APOLLO EXPERIENCE REPORT -
GUIDANCE AND CONTROL SYSTEMS:
MISSION CONTROL PROGRAMMER FOR
UNMANNED MISSIONS AS-202,
APOLLO 4, AND APOLLO 6

Gene F. Holloway
Lyndon B. Johnson Space Center
Houston, Texas 77058

NATIONAL AERONAUTICS AND SPACE ADMINISTRATION • WASHINGTON, D. C. • JULY 1975

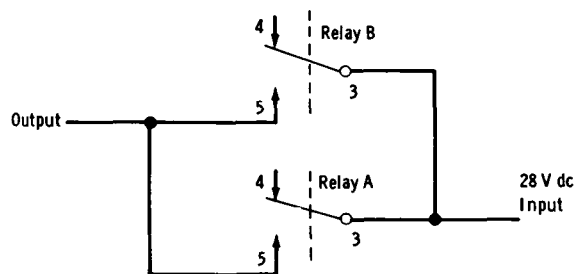
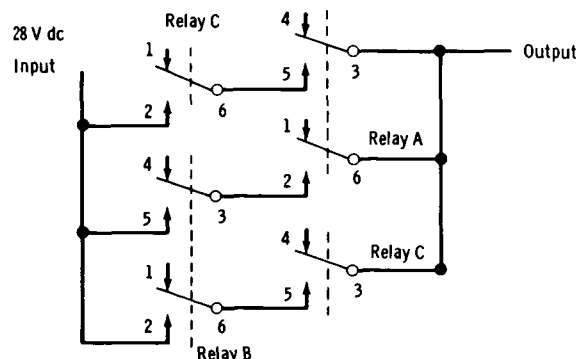
Figure 8. - Circuit logic and switching relays.

2. Dual series (redundant) — The MCP output or real-time-command function shall not fail ON as a result of any single MCP component failure (fig. 8(b)).

3. Dual parallel (redundant) — The MCP output or real-time-command function shall not fail OFF as a result of any single MCP component failure (fig. 8(c)).

4. Dual series, triply parallel (redundant) — The MCP output or real-time-command function must respond correctly in the event of a single MCP component failure (fig. 8(d)).

The redundancy options that were used in the MCP are shown in figure 8. Examples of equivalent redundancy could also be illustrated within the MCP, showing the use of time delays, capacitors, diodes, et cetera. The relays are used for illustration because they represent the majority of the components in the MCP.

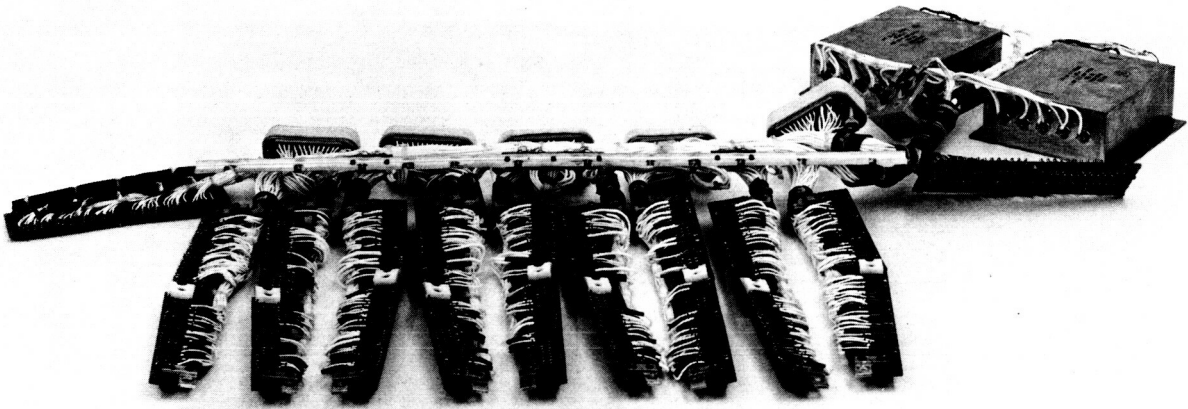
Figure 9.- Cable assembly wire harness.

A triply redundant grounding network was used throughout the cable-harness and panel-harness assemblies (fig. 9) to provide electrical grounds for the MCP. This grounding scheme was important in accomplishing the bench tests and spacecraft tests that verified the redundant components within the MCP. During tests, these grounds (G_1 , G_2 , and G_3) were alternately cycled (opened and closed) or cycled in combinations (G_1G_3 , G_2G_3 , or G_1G_2) to isolate and verify the operation of specific redundant paths. For example, in figure 8(d), assume relay A operates with ground G_1 ; relay B with ground G_2 ; and relay C with ground G_3 . The redundant paths would be verified as follows.

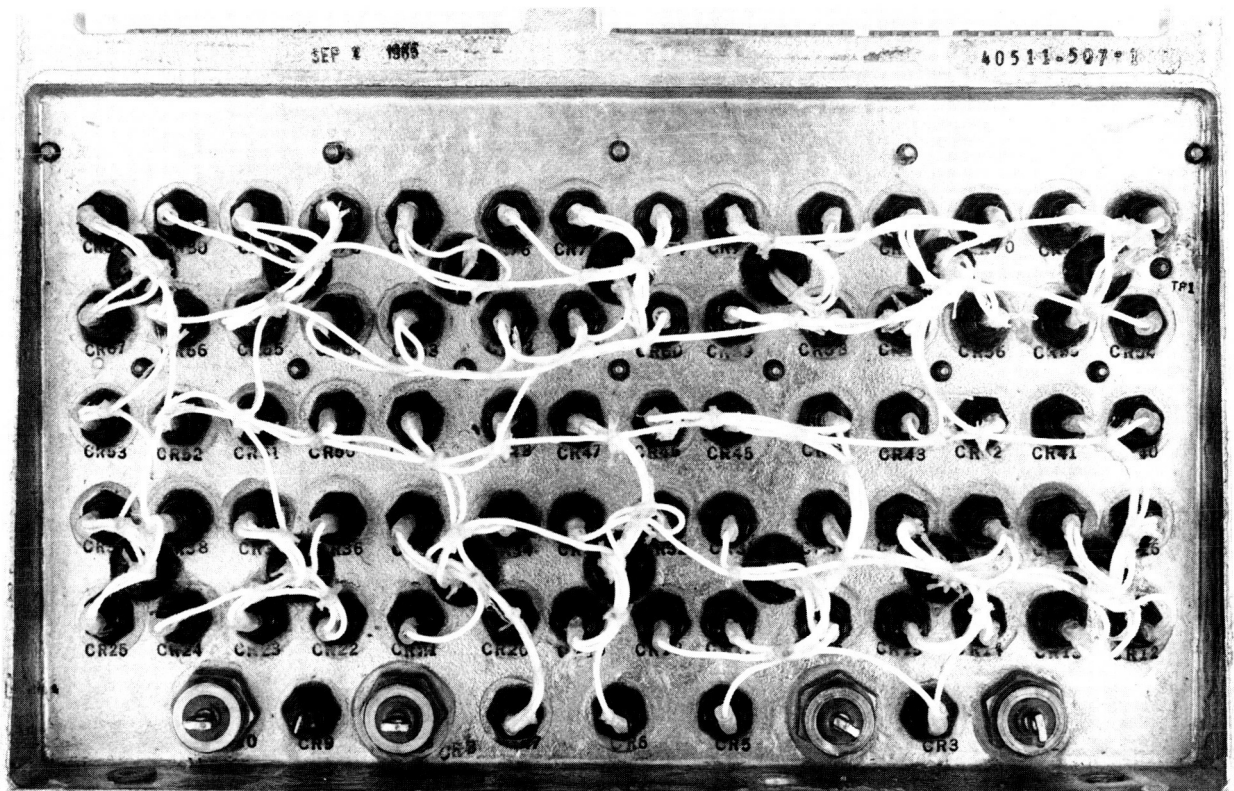
Figure 16. - Typical diode mounting bracket.

The second significant problem was detected during the humidity and posthumidity functional test portions of the qualification program. The reverse impedance of the MCP diode quads was below the specification limits after the 16-hour humidity test. These impedances were within the specified value (greater than 700 kilohms) after about 1 hour of drying. The diodes in the SCC were affected after being exposed to 95 ± 5 percent relative humidity; but, for normal unmanned flight, humidity was not expected to be a problem. The corrective action was to provide added protection by applying polyurethane (polycoat) to the control assemblies containing the diode quads (fig. 16). On April 22, 1966, after the polyurethane was applied to the control assemblies in qualification unit 2, the unit was retested in the humidity environment and satisfactorily met the specifications. The qualification tests were completed on April 23, 1966, and the test report was released on May 31, 1966.
