NASA CR - 145167
(SER - 50983)

**STUDY TO INVESTIGATE DESIGN ,
FABRICATION AND TEST OF LOW COST CONCEPTS
FOR LARGE HYBRID COMPOSITE
HELICOPTER FUSELAGE - PHASE II**

April 1977

Sikorsky Aircraft

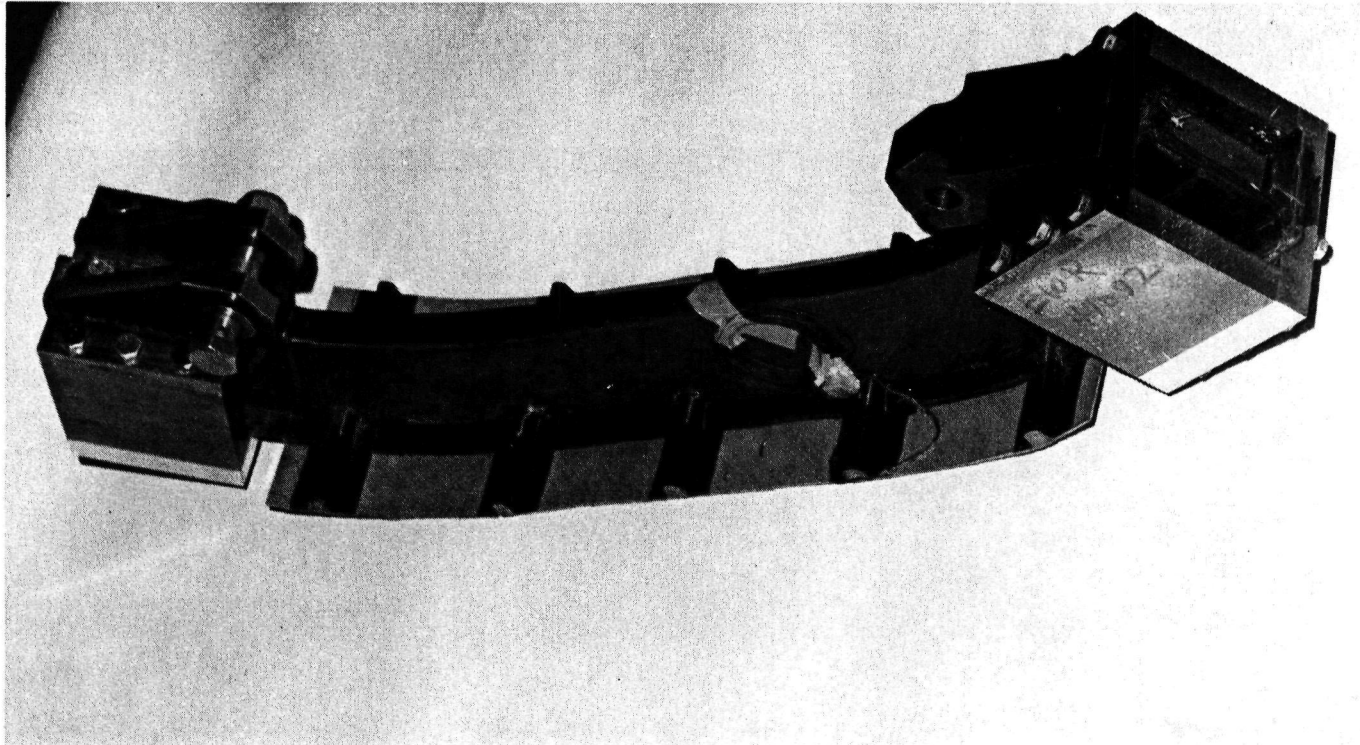
FIGURE 30 . FRAME FATIGUE SPECIMEN WITH TEST END FITTING INSTALLED.

The first EWR 32381 frame fatigue specimen, Figure 30, was installed in the test fixture and loaded with the upper cap in compression. Load was applied in 4.45 kN (1000 lb) increments to determine the spring rate of the specimen. At 43.6 kN (9800 lb) or approximately 60 percent of design ultimate load, the specimen failed suddenly and catastrophically in the area of the 50.8 cm (20 in.) radius adjacent to the built up test fixture doublers as shown in Figure 32. The frame specimen was separated at the fracture to inspect the damage which had occurred. Sections were cut from the specimen as shown in Figure 33 to determine the extent of damage. Figure 34 shows the fracture surface (Figure 34a) and the damage at a point 5.08 cm (2 in.) away from the fracture surface (Figure 34b). In the area of fracture, the upper cap laminate was completely separated from the web laminate, and forced downward approximately 2.54 cm (1.0 in.) into the foam core causing localized crushing of the foam. The web laminate was buckled on both sides of the frame section and had completely separated from the stabilizing foam core. Examination of sections cut from the frame specimen in areas C&D (Figure 33) shows a separation of the shear webs from the stabilizing foam core and indications of cap/web separation. No damage was apparent in the center portion of the frame specimen (Sections E, F, G, H, I (Figure 33)). In Sections J, K, L (Figure 33), the curved area opposite the primary fracture area of the specimen, a separation of the shear web from one side of the foam core was found. A longitudinal crack extending from the shear web to foam separation was discovered in the upper cap laminate extending to the cap to web interface. From these preliminary observations, no conclusions to determine the mode or sequence of failure could be established. To provide the information necessary to thoroughly understand the premature failure of this first specimen, five separate areas of investigation were established.

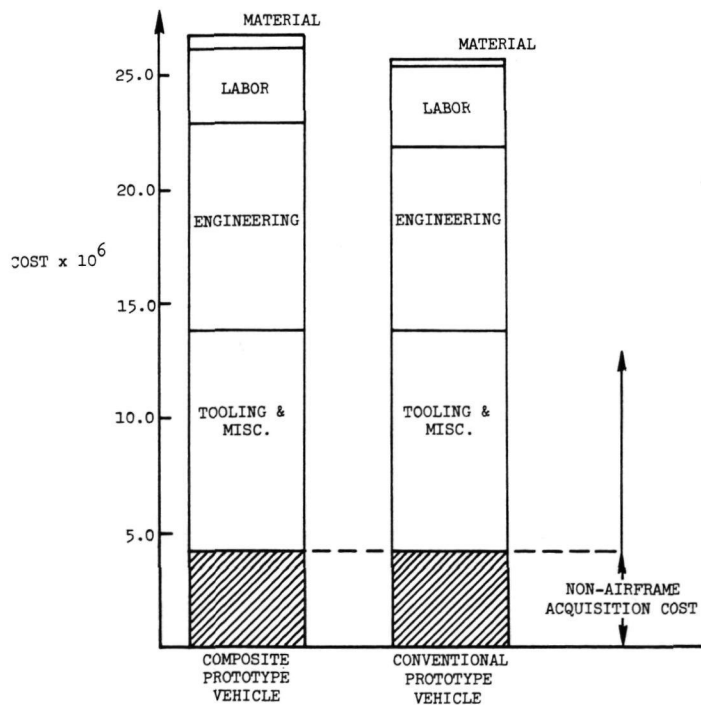
FIGURE 49. COMPOSITE PROTOTYPE VEHICLE COSTS
 3.6% MORE THAN PROTOTYPE
 CONVENTIONAL DESIGN.

From the cost breakdown shown in Figure 49, it is apparent that a major source of the 3.6 percent higher cost for the composite vehicle is the higher engineering cost. This is introduced by the additional design and analysis effort which would be required for prototype design using composite materials. This cost increase together with the higher composite material costs is offset only slightly for the prototype by the reduction in fabrication labor costs using composite materials. Although the single cure concept has been proven feasible and will reduce the cost of tooling for major airframe components, the additional cost for tooling to produce composite hardpoints or attachments is unknown. Therefore, the conservative estimate is made that the tooling costs are the same.

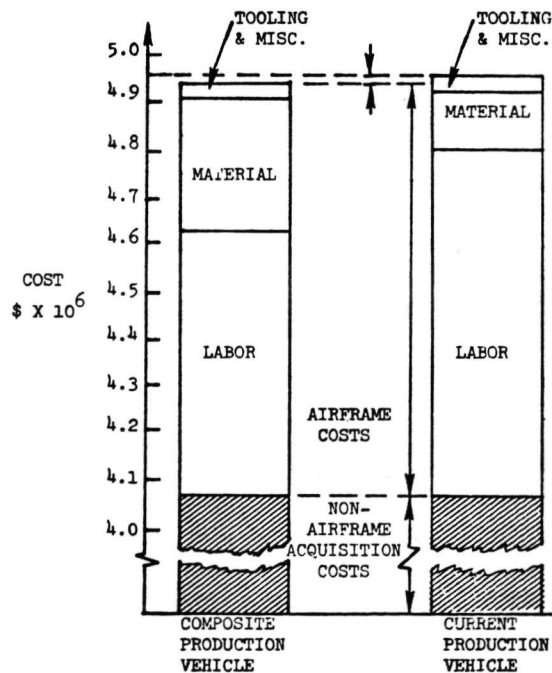
The small saving in composite vehicle acquisition cost (approximately 0.3 percent) is shown by the cost breakdown of Figure 50 to be largely attributable to the increased cost of composite materials compared with the metals used in the current vehicle. This increase is offset by the reduction in labor cost for fabrication using composite materials.

FIGURE 50. COMPOSITE PRODUCTION VEHICLE COSTS 0.3% LESS THAN CURRENT PRODUCTION VEHICLE.
