# 737 GRAPHITE COMPOSITE FLIGHT SPOILER FLIGHT SERVICE EVALUATION

**THIRD ANNUAL REPORT  
APRIL 1976 THROUGH APRIL 1977**

**Prepared under contract NAS1-11668 by  
BOEING COMMERCIAL AIRPLANE COMPANY  
P.O. Box 3707  
Seattle, Washington 98124**

**August 1977**

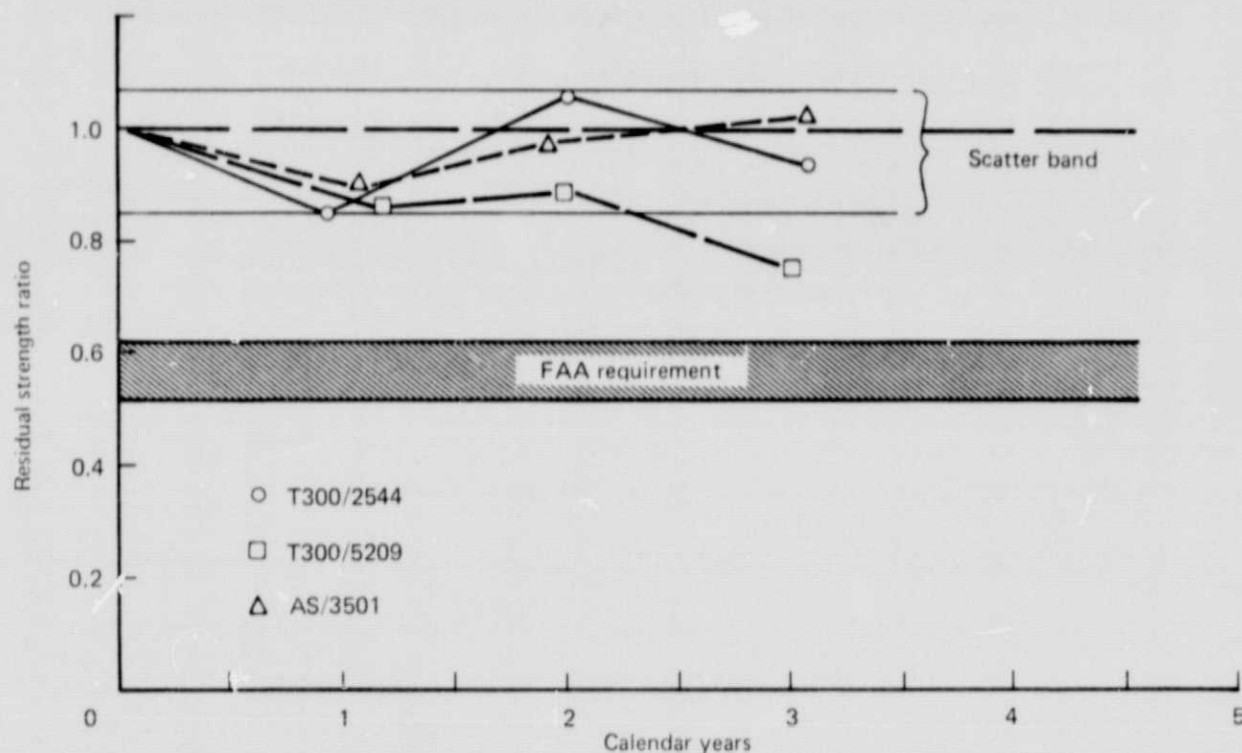
Figure 2. — Residual Strength After Exposure

A plot of the residual static strength data accumulated to date appears in figure 2, and is plotted as a function of time. This data not only continues to point out the scatter in the strength data being collected, but begins to show an identifiable trend relative to both the 250° F curing system and the 350° F curing systems. As shown in figure 2, both 350° F systems are maintaining a relative stability in residual strength as contrasted to the 250° F system.

The scatter band represented by these values is displayed graphically on figure 2. Consideration of this scatter contributes to the previous observation that the 350° F curing systems are maintaining relatively stable residual strength.

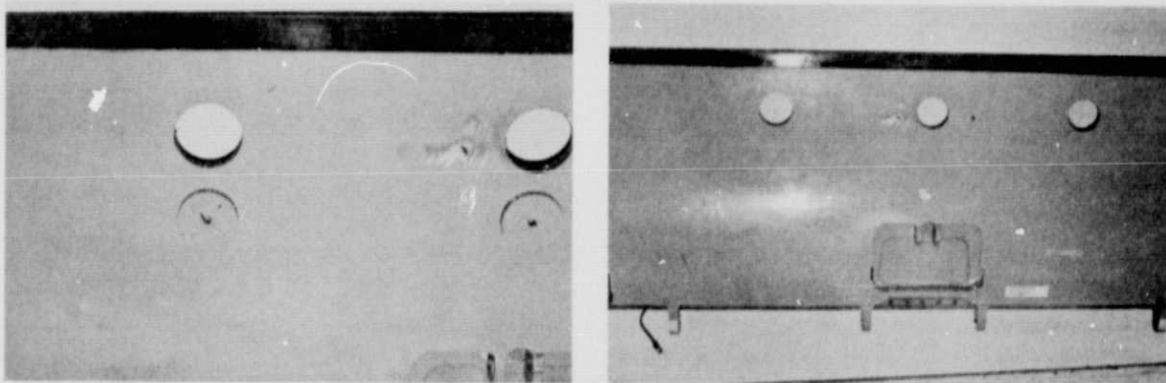
*Figure 5. — Core Sampling of Environmentally Exposed Panels*

During the past year, a new and significantly more reliable system of moisture absorption measurement was devised. Since there exists within Boeing no suitable nondestructive technique for determining moisture content in laminates, the revised approach core-samples all spoiler panels scheduled for destructive testing. These samples are removed from environmentally exposed spoiler panels at locations near the trailing edge (see figure 5). This procedure maximizes the percentage of composite weight in the sample (approximately 65% composite by weight) while avoiding interference with the structural testing process and results.

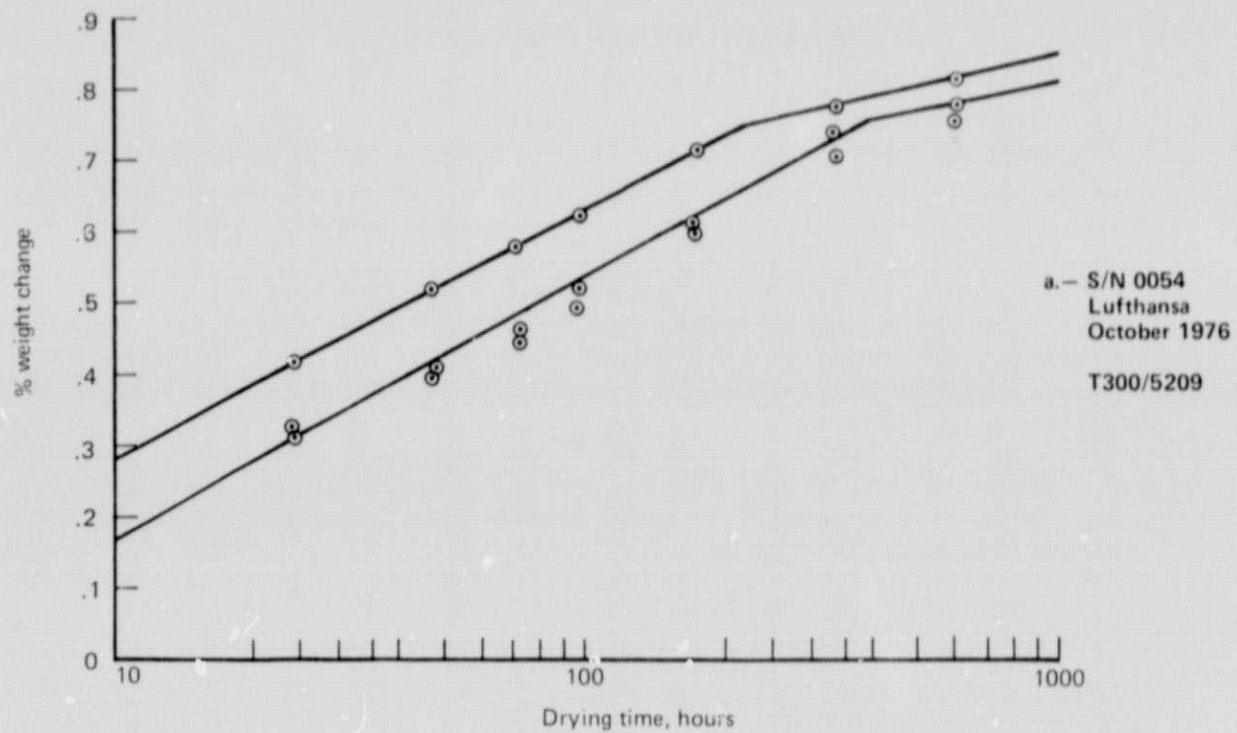
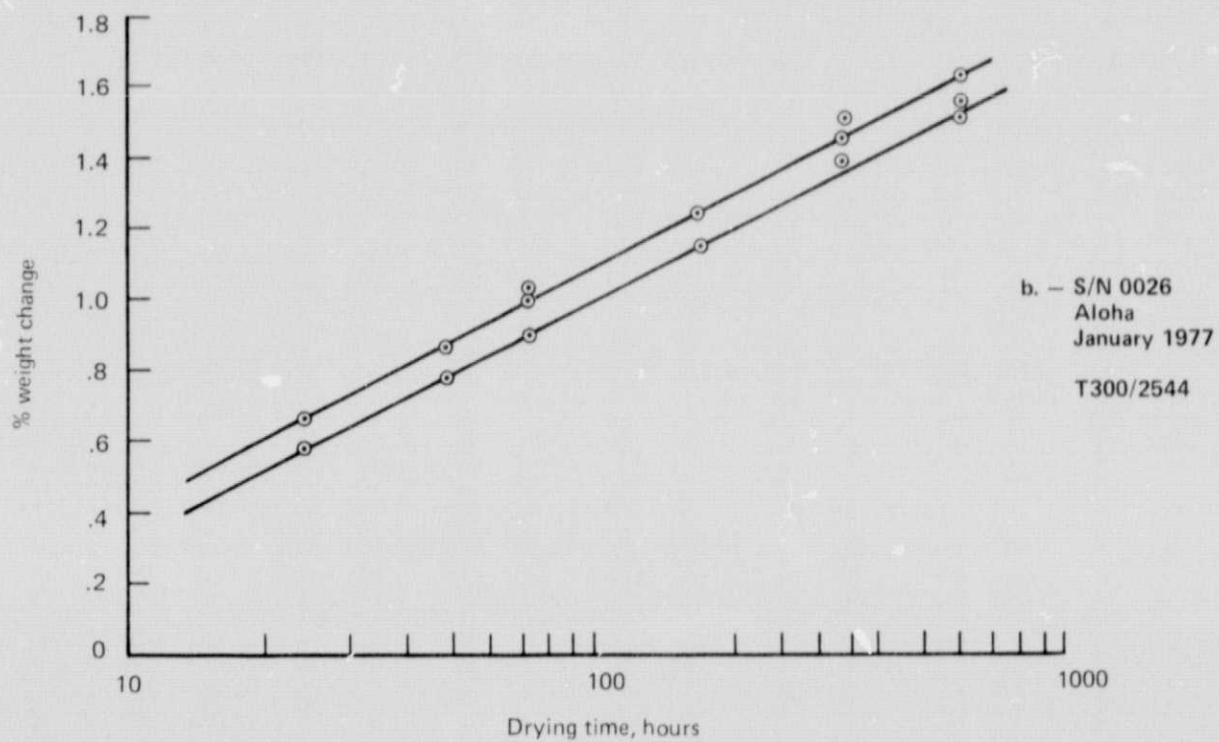
Figure 6. — Moisture Weight Change

The core samples (three per spoiler) are subjected to a 25-day drying environment at 160° F. The samples are weighed at discreet intervals in order to construct the weight-loss curve, an example of which is shown in figure 6. Actual weights of EA9628 adhesive and calculated weights of aluminum core are included in the final values. The final delta weights include moisture absorbed by the laminates and by the two layers of adhesive. Separation of the moisture content in each medium remains to be accomplished.

Two spoiler panels (S/N 0026 and S/N 0054) have been core-sampled prior to static test. The results of drying these samples are given in figure 6. Correlation of the effect of moisture absorption on the residual strength of the spoiler panels remains to be accomplished.

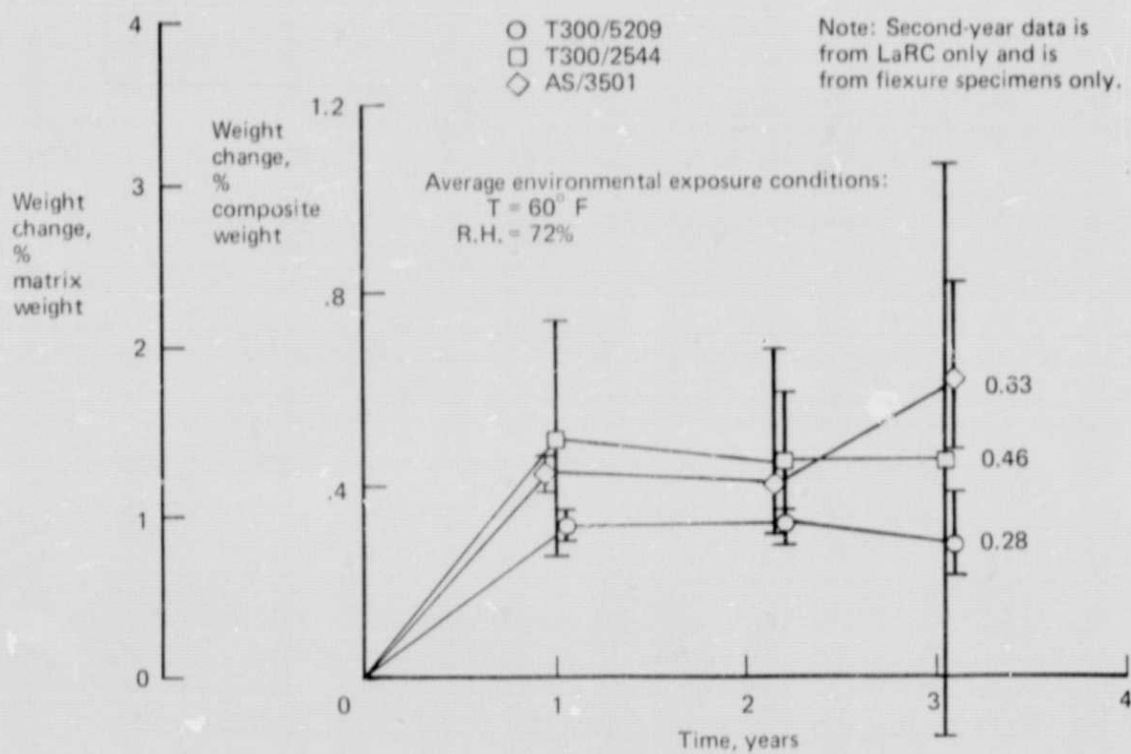
Figure 11. — Moisture Pickup in Exposed Epoxy-Matrix Laminates

Material property specimens were removed from the ground-based environmental exposure program following the third year of exposure. The specimens were returned from the various sites to NASA-Langley for laboratory evaluation. The reduced moisture absorption data has been plotted in figure 11, which also contains the first year data and the "NASA-only" second year moisture data. Current program plans call for a retrieval schedule at the completion of 1, 3, 5, 7 and 10 years of exposure.

The plotted data continued to exhibit a stabilizing trend, with an increasing scatter within the averages. The tabulated moisture data is presented in tables 9, 10, and 11. Plots of strength retention similar to those that appeared in references (1) and (2) are shown in figures 12, 13, and 14. The data for the strength retention plots is also included in tables 9, 10, and 11.
