Space Shuttle Orbiter Approach and Landing Test

Final Evaluation Report

February 1978

Lyndon B. Johnson Space Center
Houston, Texas

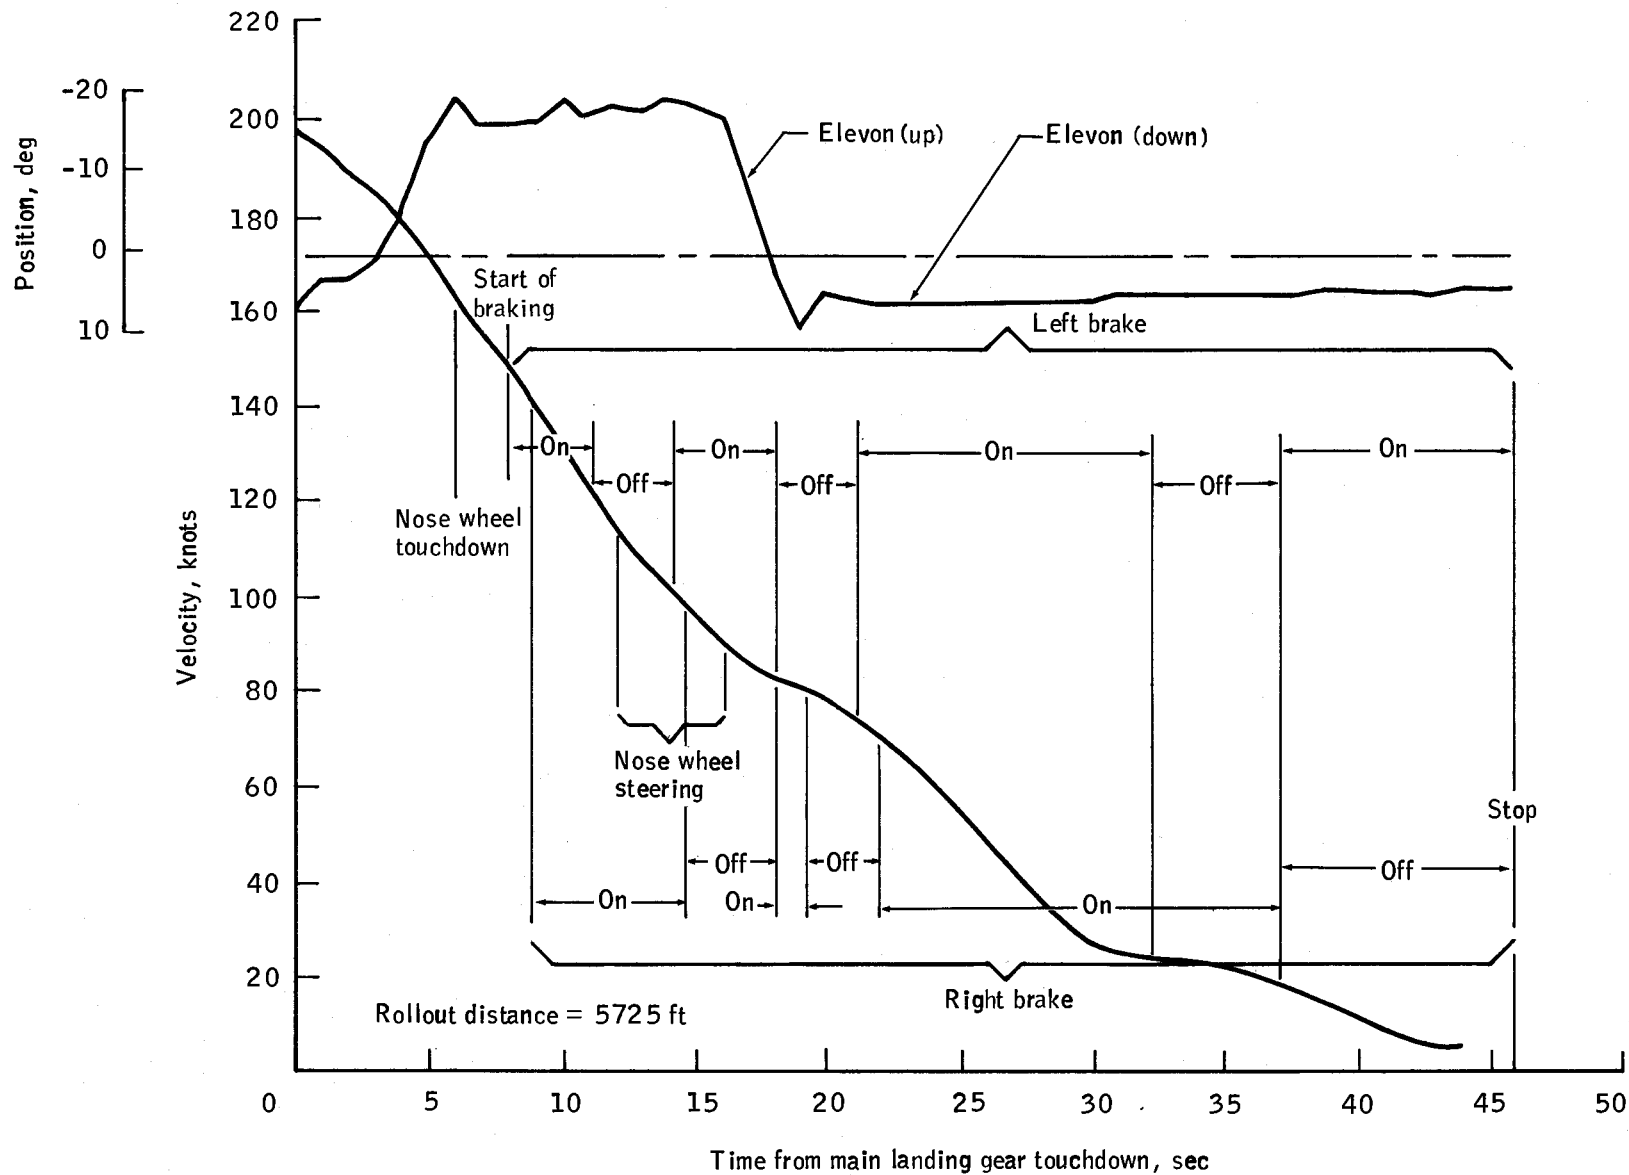
Figure 4-9.- Flight 4 landing-rollback time history.

Landing and rollout on flight 4 were normal in all respects. As shown in figure 4-9, nose wheel steering was engaged at 115 knots for 4 seconds, thus demonstrating its use at high speed. Postflight inspection of the brakes revealed that one carbon lining segment was loose. This anomaly is discussed in paragraph 7.2.11.

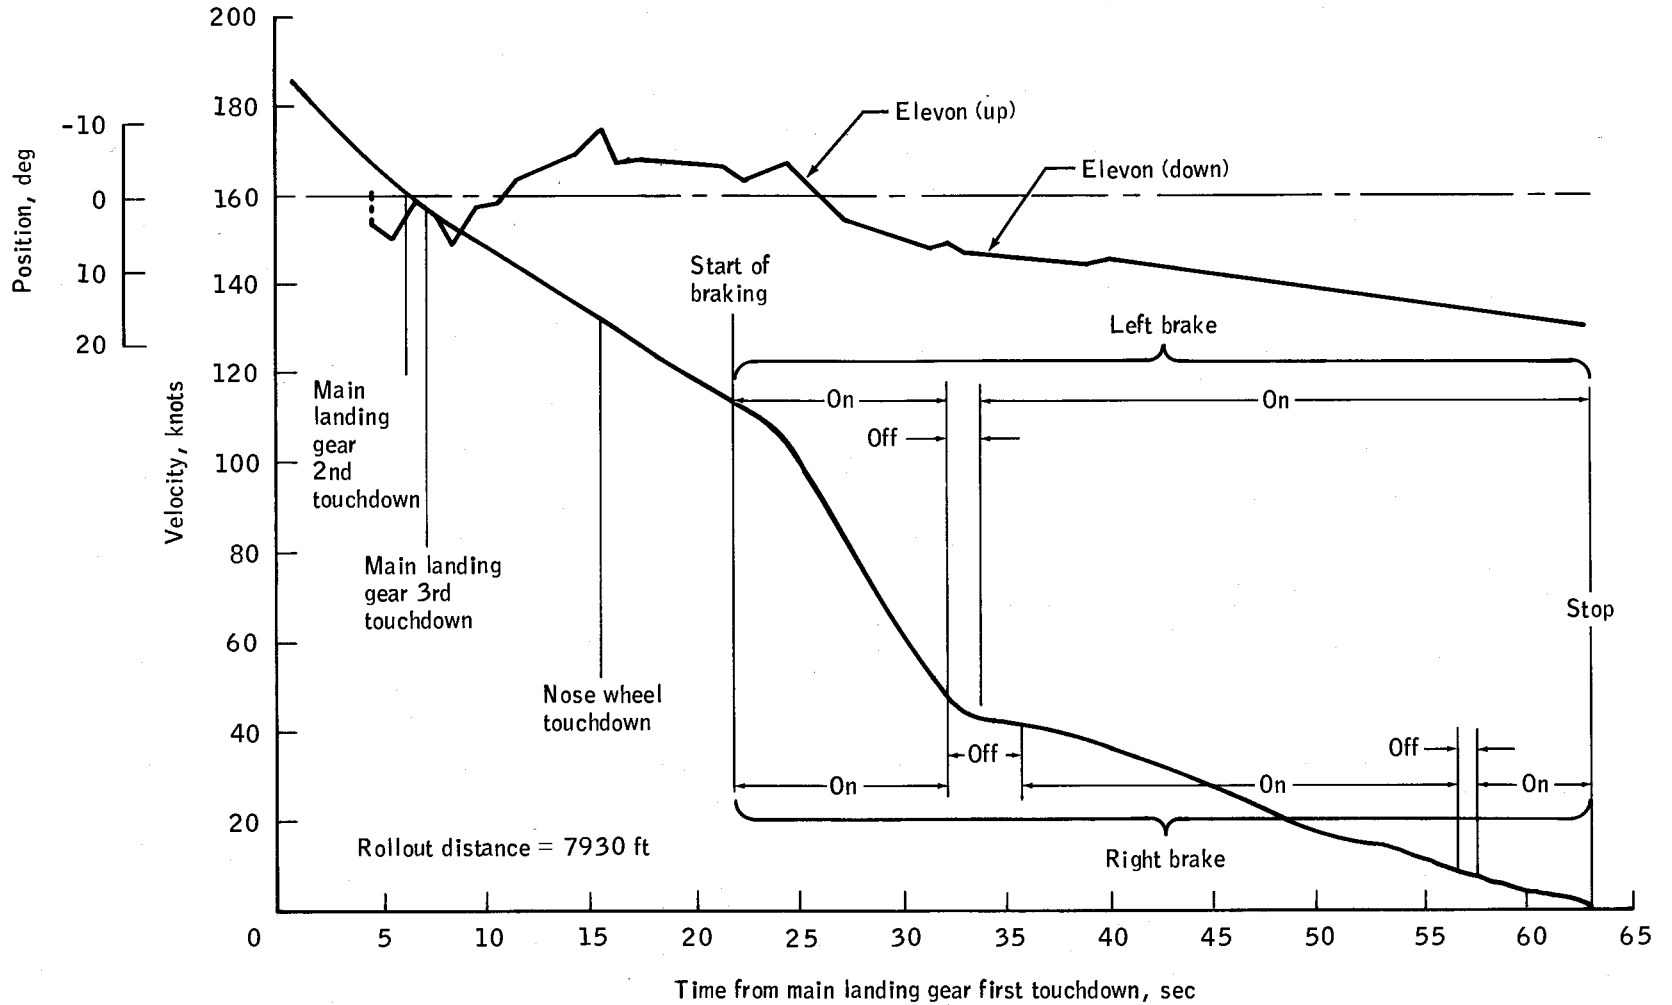
Figure 4-10.- Flight 5 landing-rollback time history.

Flight 5 was conducted using all new brakes. Hard braking was applied following nose landing gear touchdown (fig. 4-10) and was reported to be smooth and effective. Postflight viewing of orbiter camera film revealed apparent smoke coming from the left outboard tire; this would be a normal result of a tire producing hard braking on a dry surface. The anti-skid system performed normally during partial skids in that it dumped pressure to the brakes and allowed the tire to spin up. On the basis of the pressures applied and wheel speed data, all tires were slipping partially as commanded by the skid control system to provide optimum braking with the left-hand outboard tire exhibiting the highest momentary slip ratios. Postflight inspection of the tires showed scuffing of all main landing gear tires with that of the left outboard tire being the most severe. The tire wear was determined to be commensurate with the hard braking applied. Postflight inspection of the brakes has been accomplished and a minor amount of chipping was found on four of the 160 carbon lining segments of the left-hand inboard brake (ref. par. 7.2.11).

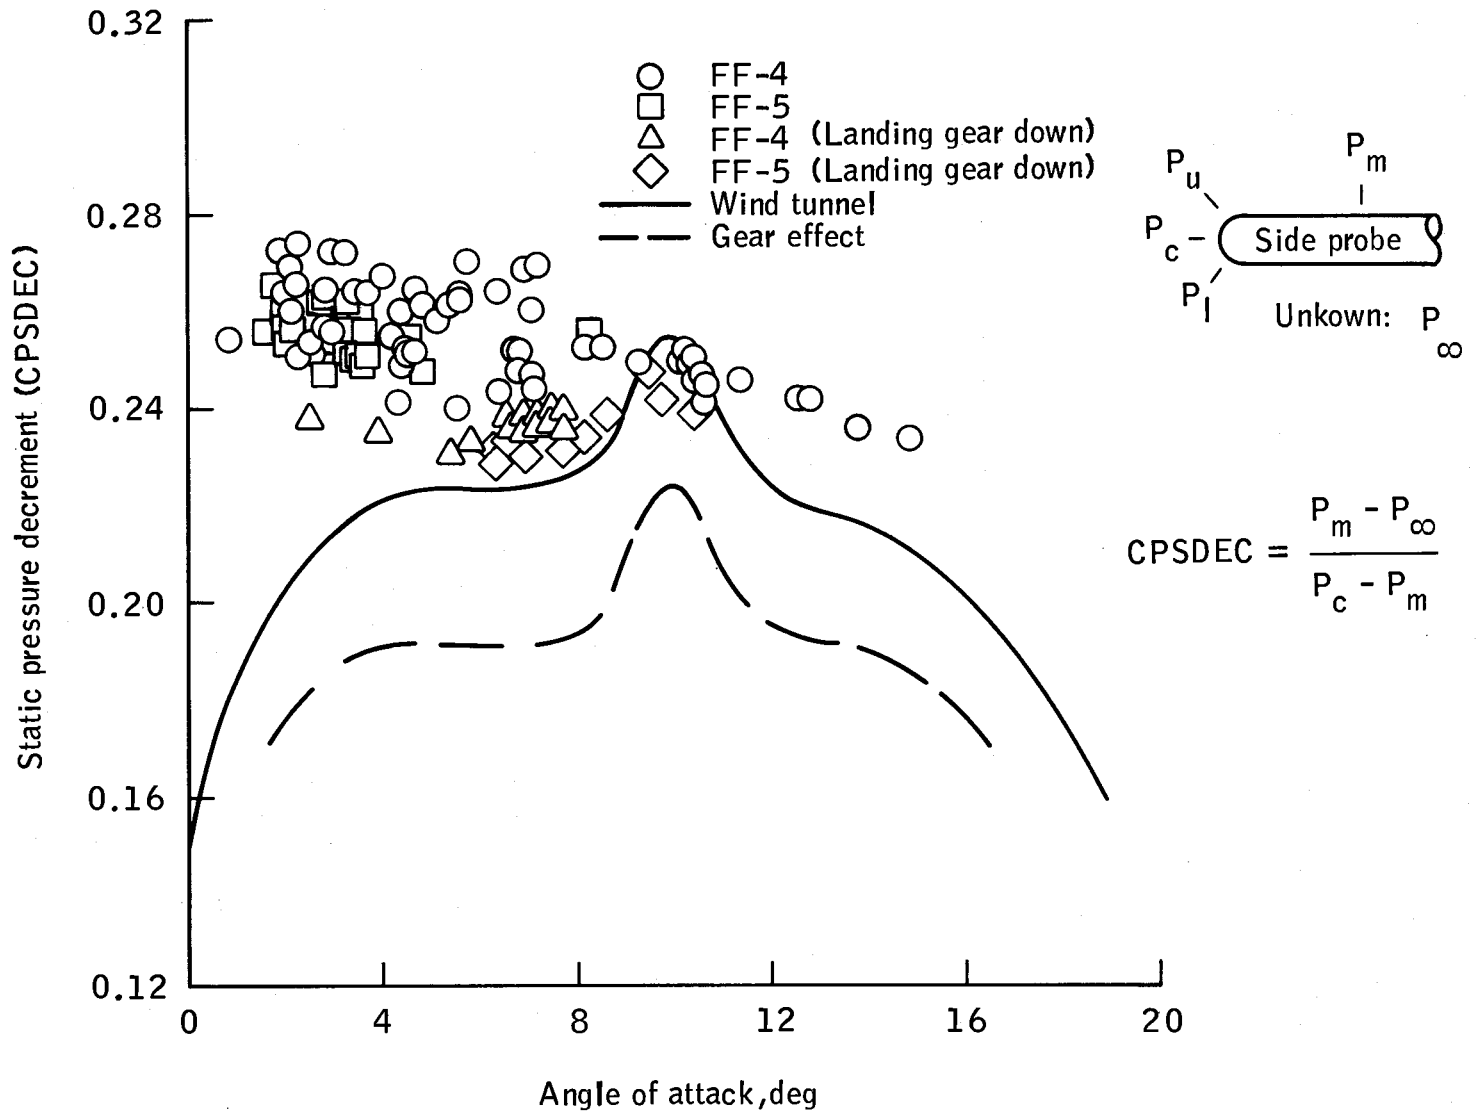
Figure 4-12.- Comparison of flight and wind tunnel static pressure decrement.

Static pressure decrement presented in figure 4-12 shows that the flight data do not have the "hump" at an angle of attack of 10° as predicted by the wind tunnel data. The general trend of the flight data shows a positive bias of approximately 0.04. The flight data confirms that the magnitude of the difference caused by the deployment of the nose landing gear is correct.

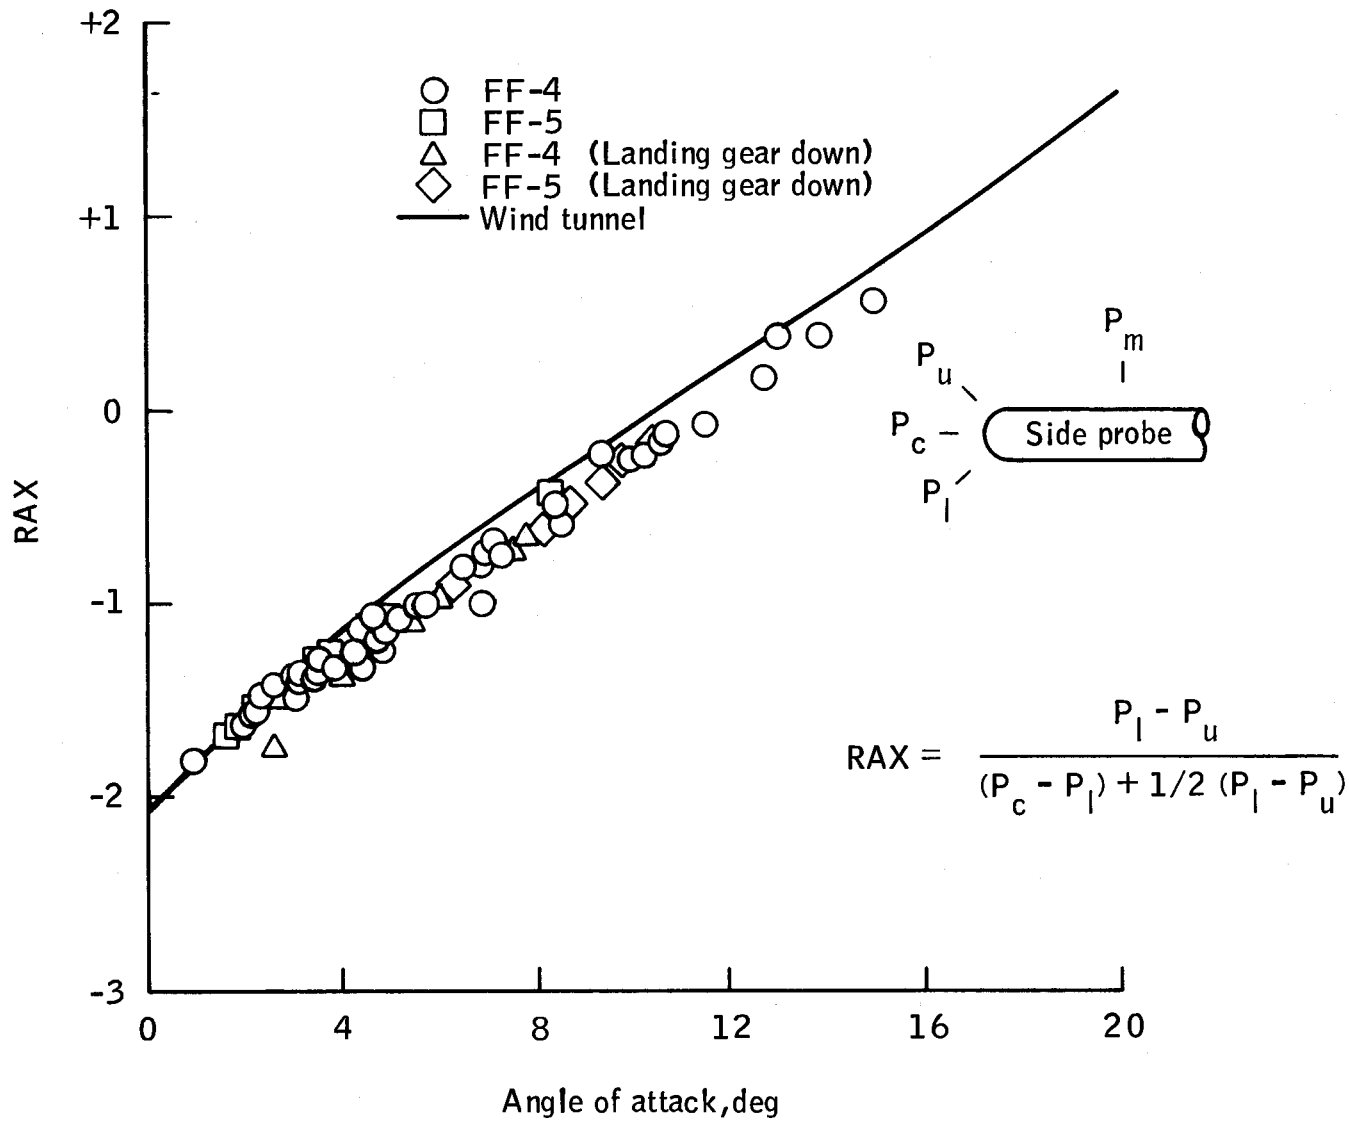
Figure 4-14.- Comparison of flight and wind tunnel RAX parameter

The RAX parameter, used to calibrate angle of attack, is shown in figure 4-14. Note that there is a negative bias of approximately 0.02 at the higher angles (this equates to approximately 1° in angle of attack). No significant effect of nose landing gear deployment is seen. No difference was seen between the tail-cone-on versus the tail-cone-off configuration.

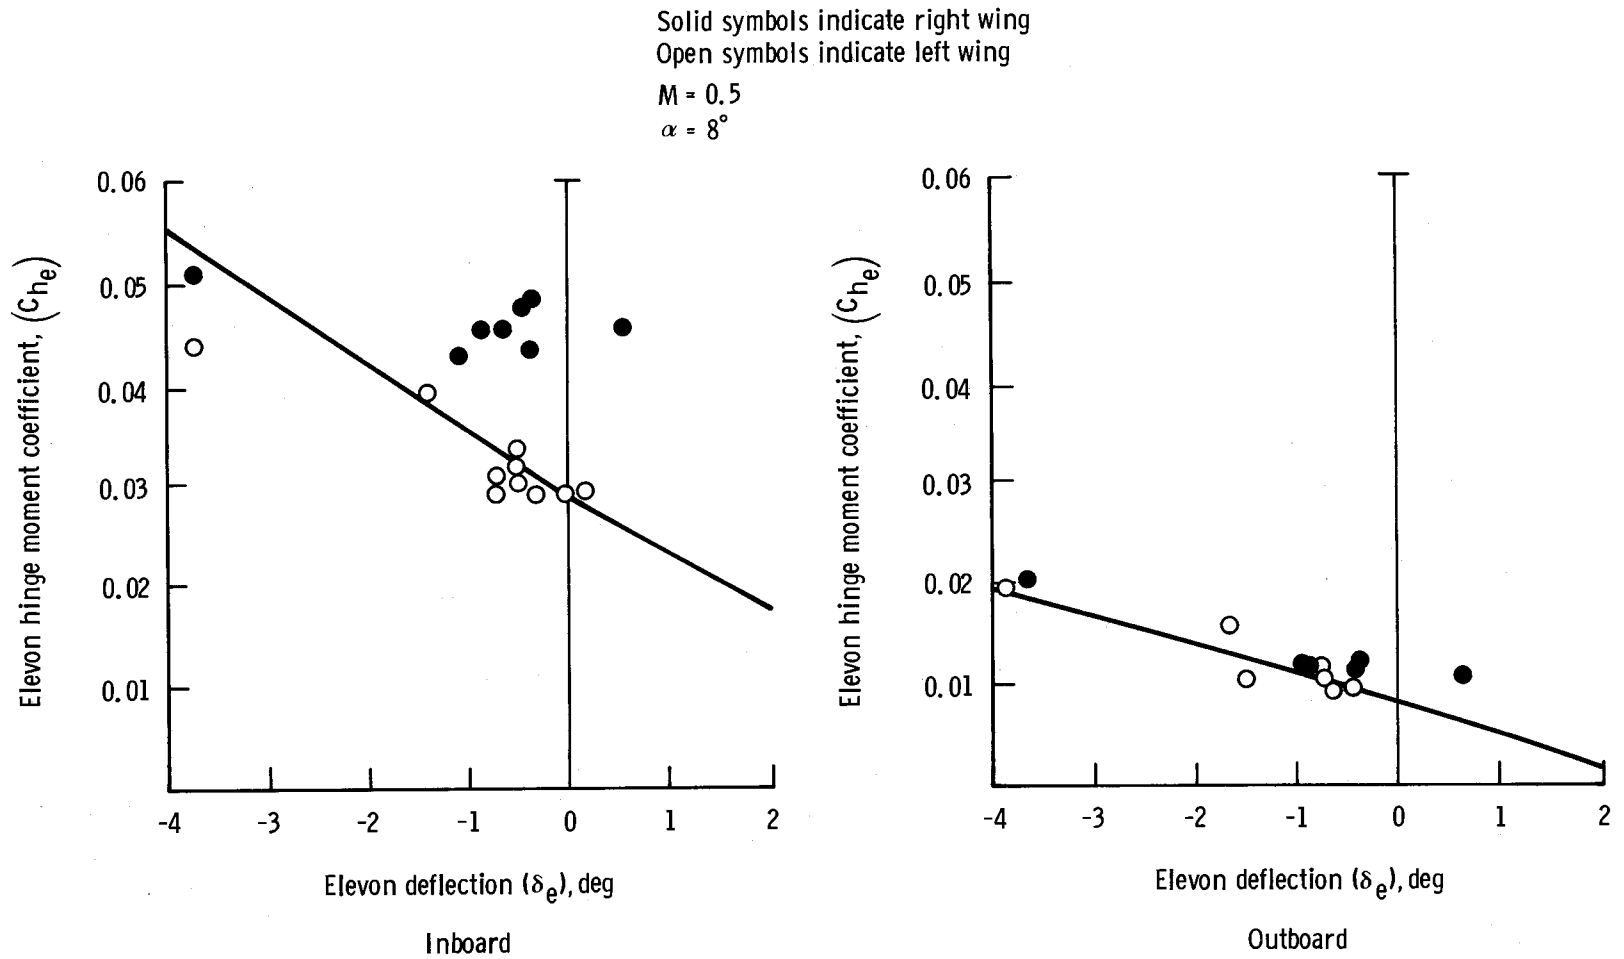
Figure 4-24. - Elevon hinge moments - tail cone on.

Elevon hinge moments have been correlated with predictions for tail-cone-on only. As shown in figure 4-24, the flight data agree with predictions except for the right inboard panel. The high right inboard data are possibly due to incorrect actuator pressure calibrations.

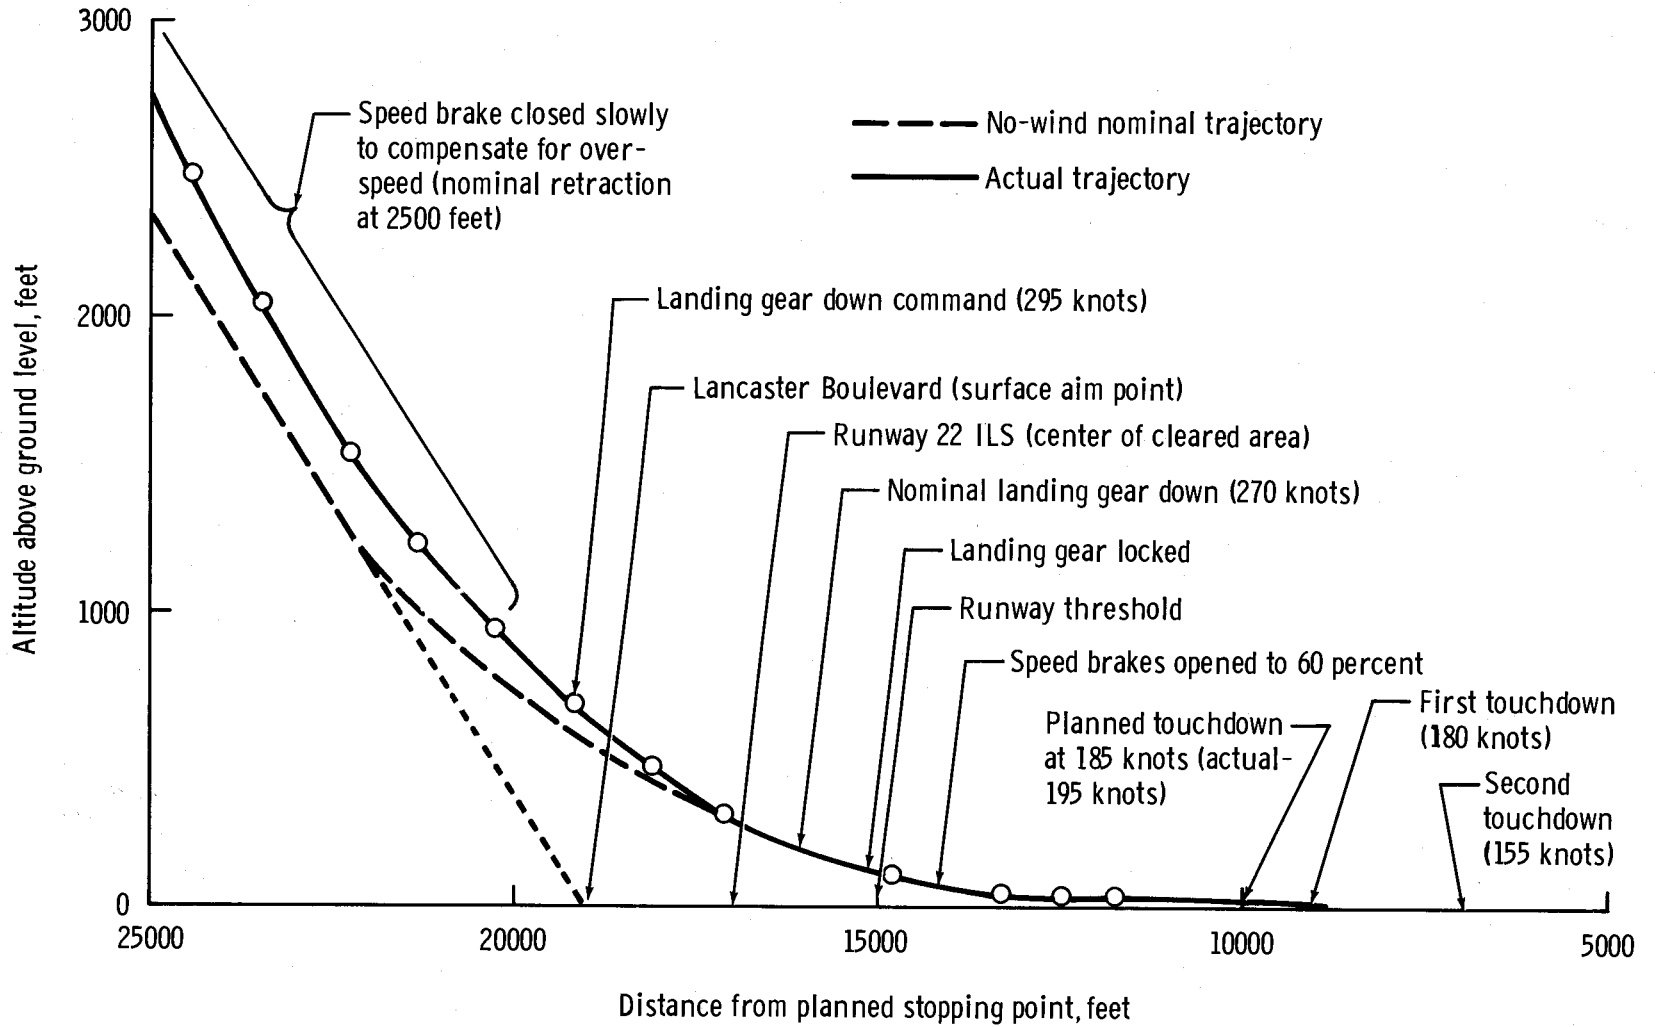
Figure 4-28. - Final approach and landing events.

As the preflare point was approached, the velocity was 294 knots, 4 knots higher than planned, and the velocity vector was directed toward Lancaster Boulevard, the desired aim point. (The actual flare point is masked somewhat in the data by pitch adjustment with speed brake reduction to hold airspeed and the aim point.) Following the Chase aircraft call at 2500 feet, the flare was started after the primary air data and radar altitude indications were that the orbiter was passing through 2000 feet above ground level. Speed brake retraction was delayed to compensate for the excess speed. The actual low-altitude winds were a 7-knot tailwind shear (half the training worst case). This required dropping

the landing gear at the edge of the bullseye landmark closest to the runway at an expected 275 to 280 knots. When coming up on the outer edge of the bullseye with 290 knots, it was apparent that the vehicle was not slowing as expected and the gear were lowered at 290 knots. Approaching the runway threshold, the altitude was correct but airspeed was 20 knots faster than planned. Another call that airspeed was 20 knots too fast at the 14 000-foot-to-go marker warranted further action. Therefore, the speed brakes were opened to approximately 50 percent. Based on free flight 4 results where a similar speed brake setting was used after flare, the expected result was that the vehicle would be slow at the planned touchdown point. In actuality, the velocity checks continued to be high with 200 knots being called out within 500 feet of the touchdown line across the runway. At this point, the vehicle seemed to "hang up" at an altitude of 4 feet. Attempts to push the vehicle on with forward rotational hand controller commands seemed to have no effect in overcoming the floating tendency.

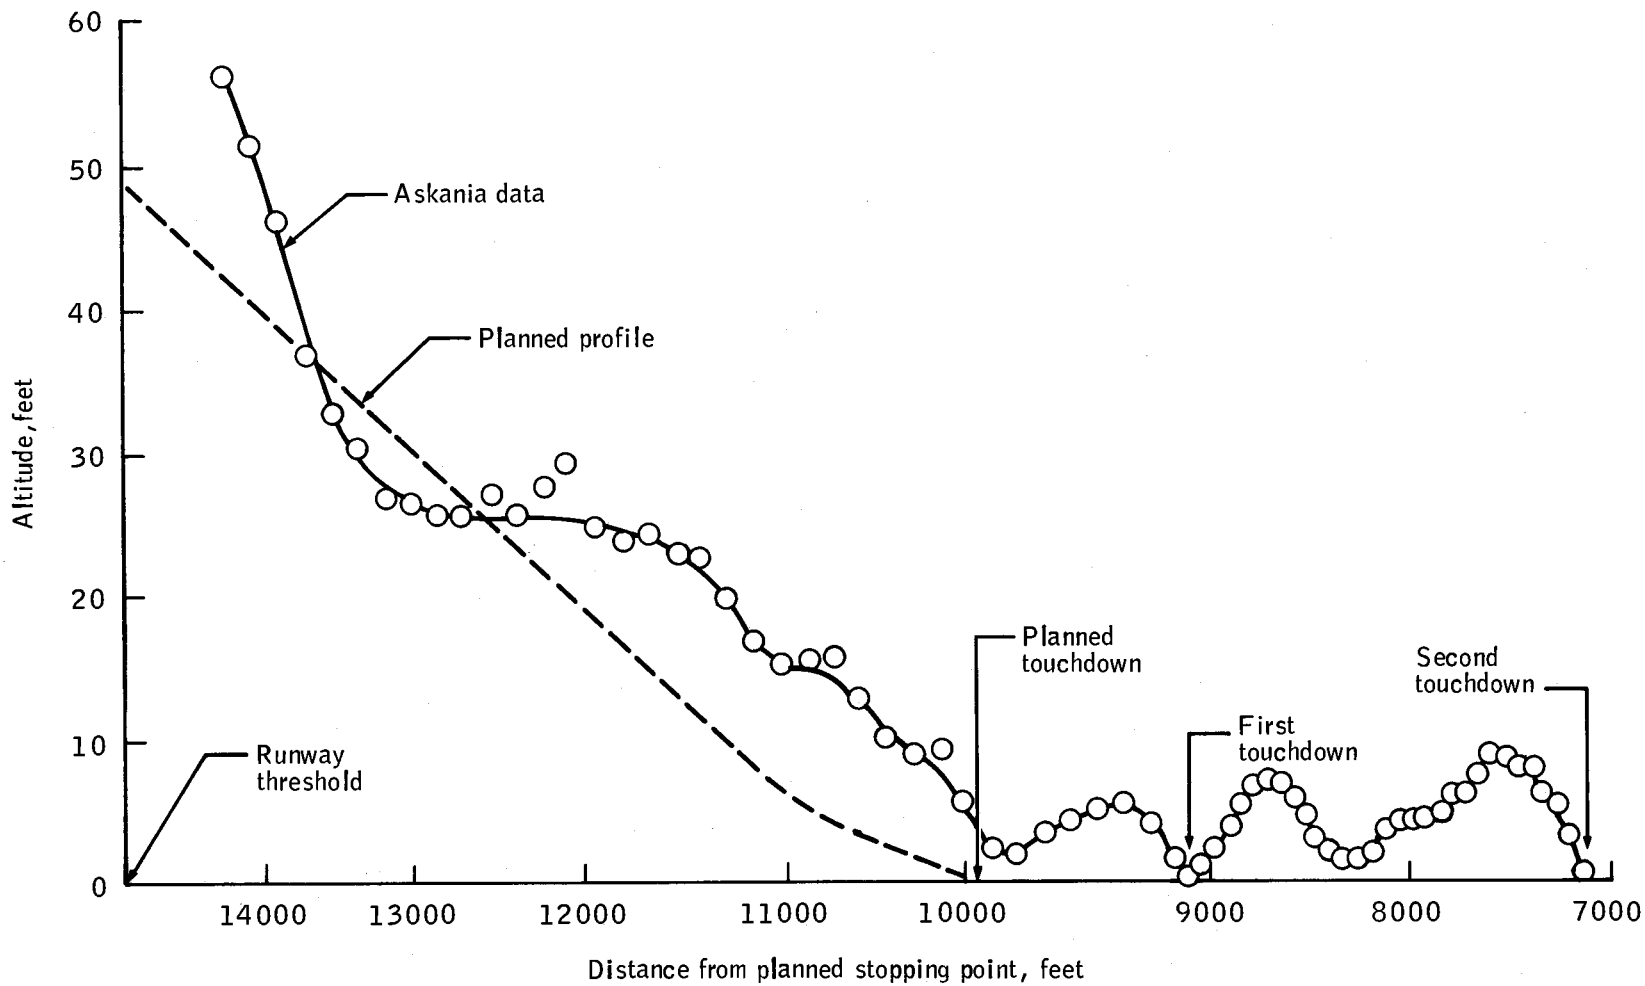
Figure 4-29.- Altitude versus runway position during landing.

After almost touching down, the vehicle ballooned slightly, then touched down smoothly 1000 feet beyond the planned point. The vehicle then skipped gradually back into the air and touched more firmly 6 seconds later, rebounding slightly. Figure 4-29 shows the actual altitude versus runway position during the touchdown sequence. Pitch inputs were made between the touchdowns to keep the vehicle airborne until roll oscillations could be damped. During this entire period, pitch control of altitude and sink rate seemed normal. However, a review of flight data indicates that pitch rate oscillations of $\pm 3^\circ$ per second occurred during this interval which caused elevon rate saturation. It is significant that these pitch oscillations were not apparent to either crewman at the time from visual or physiological cues. The crew impression was that the pitch rotational hand controller commands were small in amplitude which is contrary to the up-to-half deflection shown in the postflight data. This impression is possibly due to the light stick force gradient, whereby deflection is related to the response noted as compared to actual stick movement. There was an additional 10 percent speed-brake-open command to approximately 60 percent at 15:54:24.5, just before the near-touchdown. This cannot be accounted for except by an inadvertent movement of the speed brake controller.

Impressions of the lateral-axis control are best separated into the period before the first touchdown and thereafter. As on previous flights, there was virtually no roll task from preflare up to just short of the near-touchdown at 15:54:29.5. At this point, one wing dropped slightly. A manual input larger than that required for the small bank angle correction was made which resulted in an overshoot of bank past wings-level. Vehicle response appeared to be normal in picking the wing up and achieving the desired near-wings-level attitude prior to touchdown. The first touchdown at 180 knots felt very light, comparable to previous landings. This was followed shortly by the realization that the vehicle had skipped back into the air with a roll off to the right. In attempting to level the wings, a lateral pilot-induced oscillation developed and was sustained for several oscillations. It was perceived in real time that the rotational hand controller commands in roll were abnormally large and the response was lagging the inputs. On previous flights, no delay had been noted in bank angle response to the controller. With a cue from the Pilot, the large input commands were discontinued and the roll rate damped to a near-wings-level attitude. The bank-angle excursions were judged to be about $\pm 5^\circ$ which was of

sufficient concern to warrant holding off at 5 to 6 feet altitude before reattempting a landing. A noticeably higher-than-normal sink rate was accepted because of concern about airspeed bleedoff for the second touchdown at 155 knots. The sink rate was judged to be about 5 to 6 ft/sec qualitatively (actually 4.0 ft/sec). The vehicle seemed to lift up slightly with a landing gear oleo rebound; however, the actual data indicated that the left main landing gear became airborne again for about 2 seconds. During all the preceding activity, the vehicle tracked down the centerline and there were no directional concerns at any time.

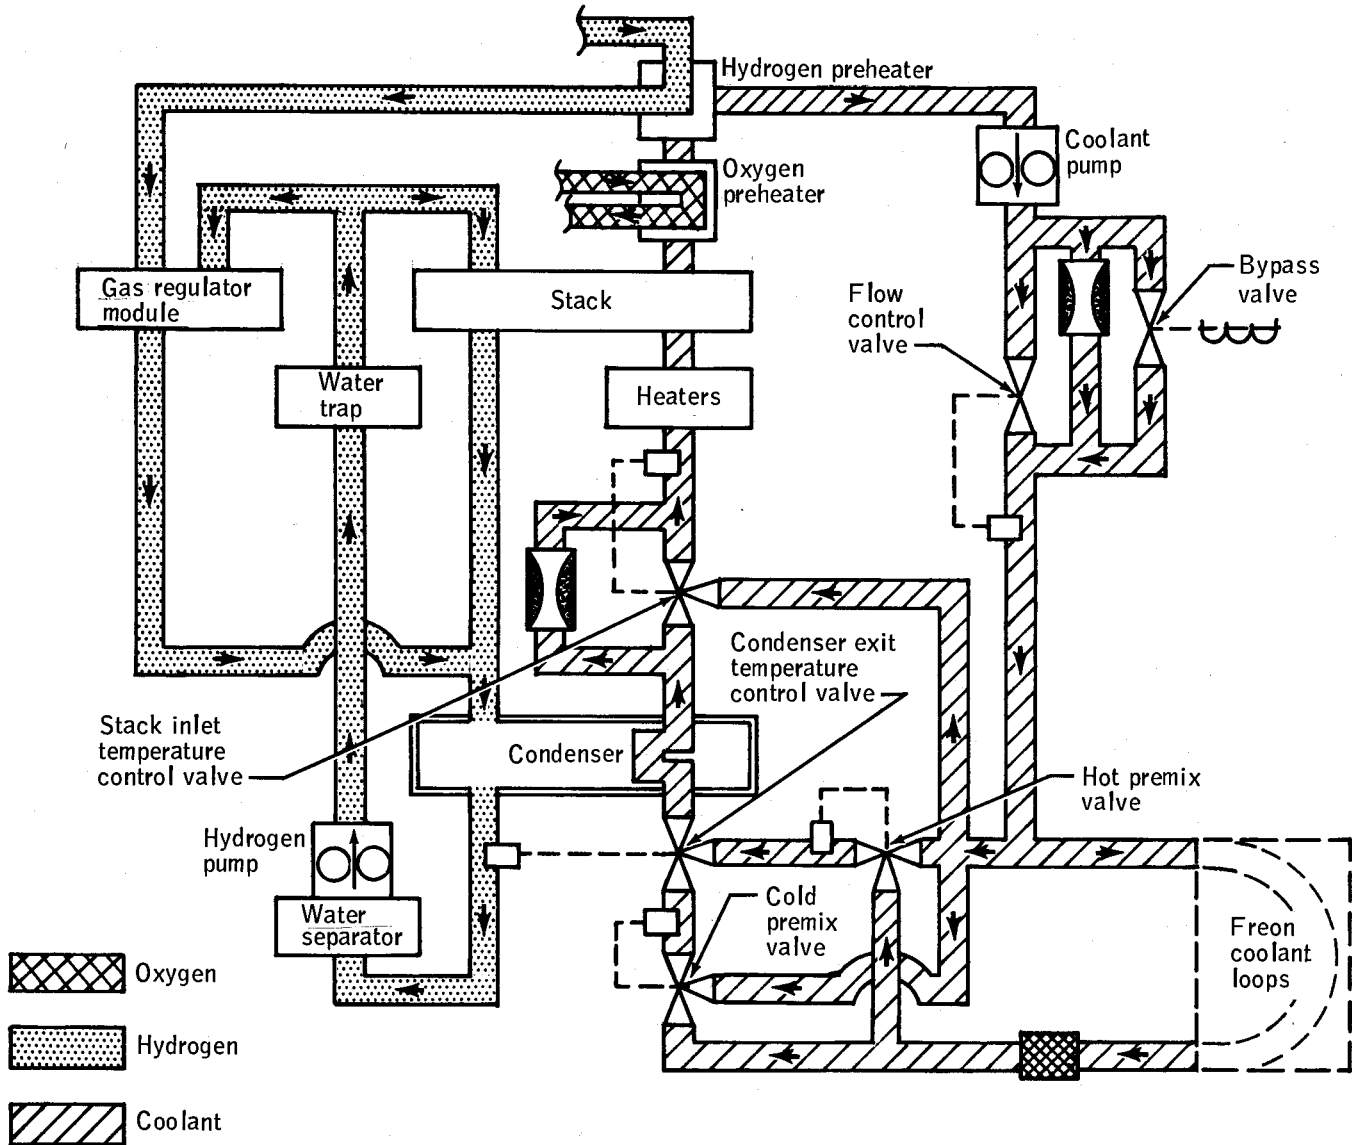
Figure 7-8.- Fuel cell thermal control system.

The condenser exit temperature is controlled by selective mixing of hot and cold coolant by the condenser exit temperature control valve. The mix position of the valve (fig. 7-7) is directly controlled by the plunger and the sensor medium (expanding/contracting wax) assembly, which is mounted in the flow stream of the condenser exit line (fig. 7-8). The temperatures at the hot and cold inlets to the valve are controlled by the hot premixing valve and the cold premixing valve. An off-nominal condition in either of these three valves could result in abnormal condenser exit temperatures.

Figure 7-7 is typical of both the hot and cold premixing valves, and similar to the condenser exit temperature control valve. The wax expands as it heats, forcing the plunger out of the housing, gradually closing off the hot fluid inlet, and gradually opening the cold fluid inlet. Swelling of the Viton boot by fuel cell coolant absorption would tend to shift the valve setting so as to admit more cold and less hot fluid. A similar 8° to 10° F shift occurred during fuel cell development because of swelling of the Viton boot.

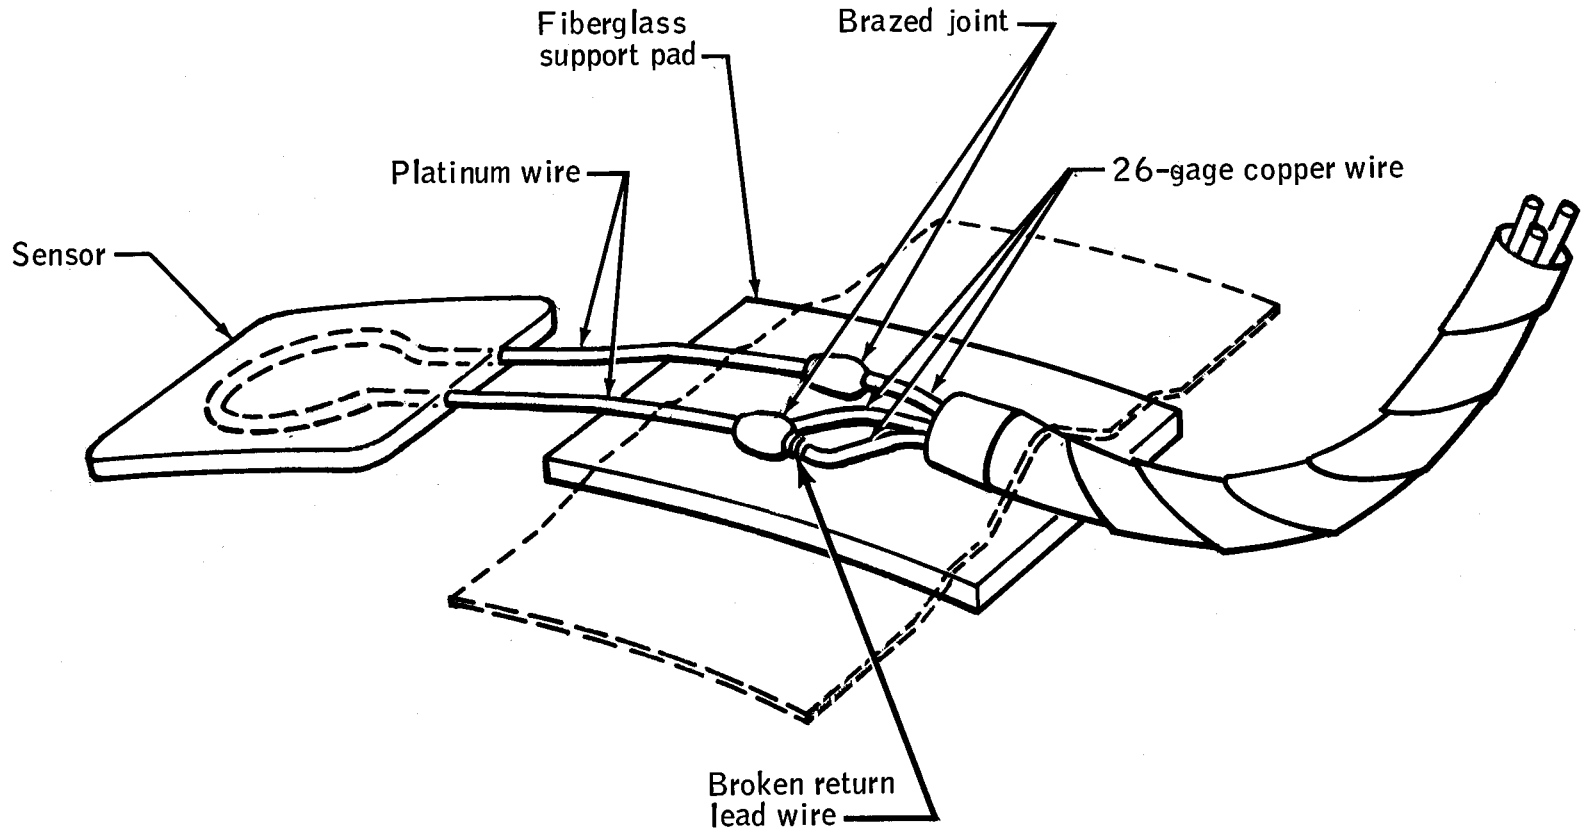
Figure 7-9.- Auxiliary power unit temperature measurement.

Postflight examination confirmed that a break existed on the copper wire side of the platinum-to-copper-wire brazed joint of the power return from the sensor. The inspection also revealed that the fiberglass support pad between the brazed joint and the exhaust duct wall was degraded, charred, and crystallized (fig. 7-9).
