# LONG-TERM CF6 ENGINE PERFORMANCE DETERIORATION - EVALUATION OF ENGINE S/N 451-479

W. H. Kramer and J. J. Smith

General Electric Company  
Aircraft Engine Group  
Cincinnati, Ohio 45215

Prepared for  
NATIONAL AERONAUTICS AND SPACE ADMINISTRATION  
Lewis Research Center  
Cleveland, Ohio 44135  
February 1978  
Contract NAS3-20631

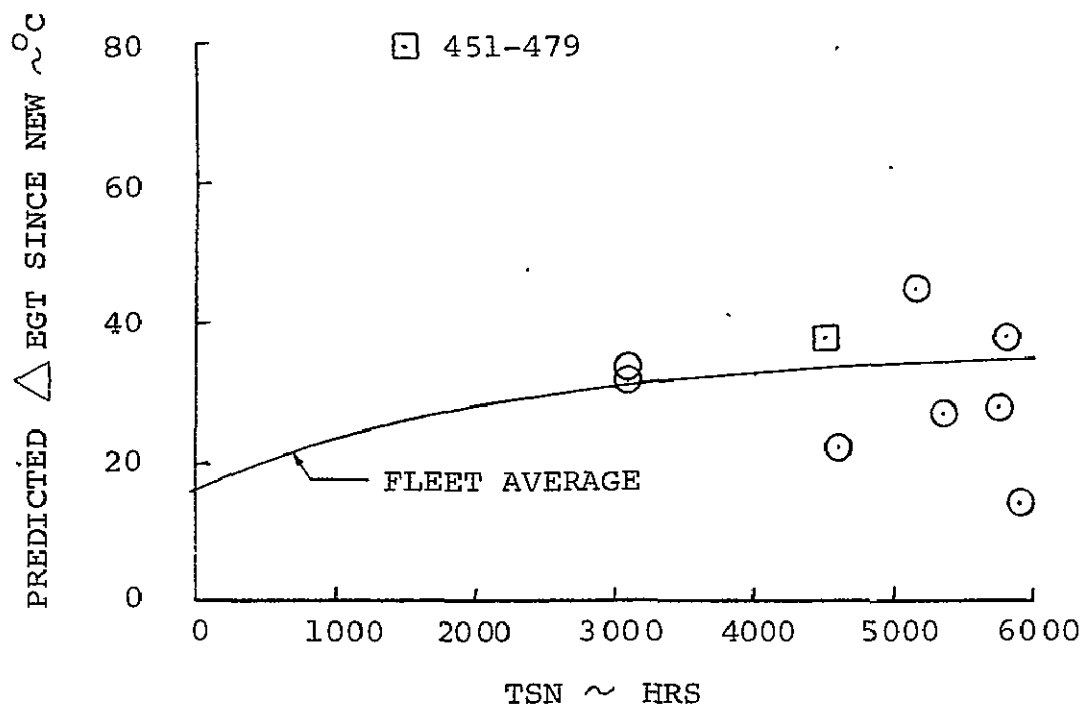
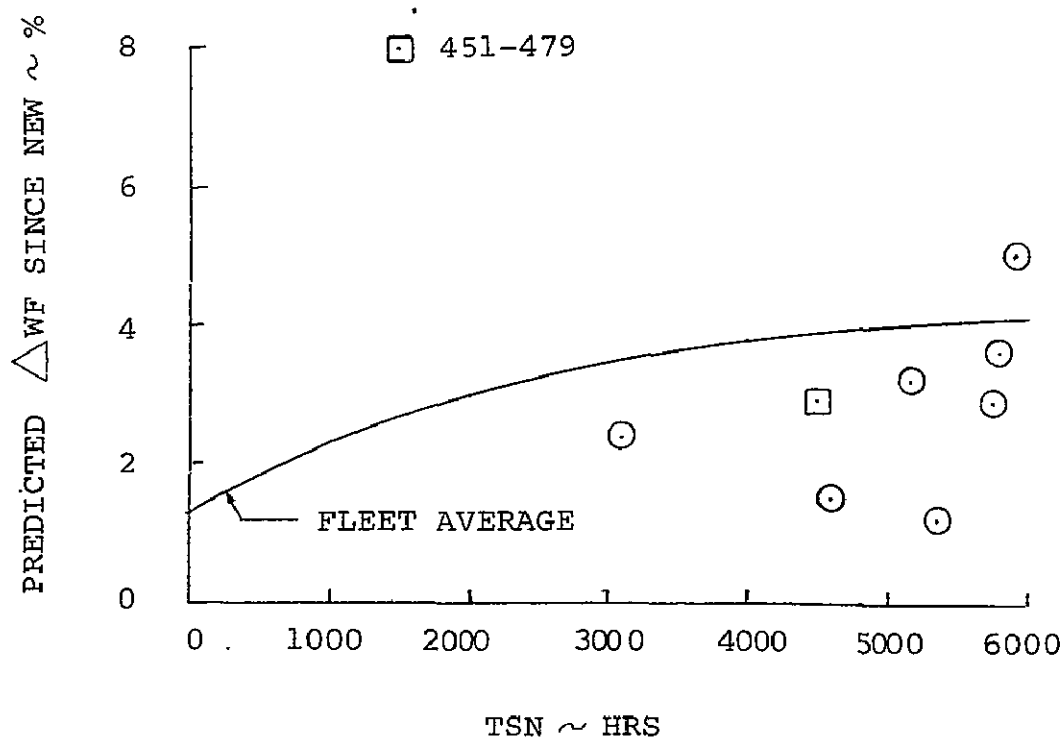
The measured performance deterioration (production new to ASO/O inbound) was consistent with the level obtained for eight other inbound tests. Figure 5-1 presents aircraft cruise trend data as compared to these sample engines. Shown on these curves is a "fleet average" level which corresponds to the average cruise deterioration level of CF6-6D engines S/N 451-406 and up. Figures 5-2 and 5-3 present the inbound test cell deterioration levels for 451-479 and the other eight inbound engines. The "sea level fleet model" shown is based on sea level-to-altitude correlations of 0.7 for SFC, 0.8 for EGT, and 1.0 for WF (i.e.,  $\Delta \text{EGT at cruise} = 0.7 \times \Delta \text{EGT at sea level}$ ).

Figure 5-1. CF6-6D Cruise Deterioration.

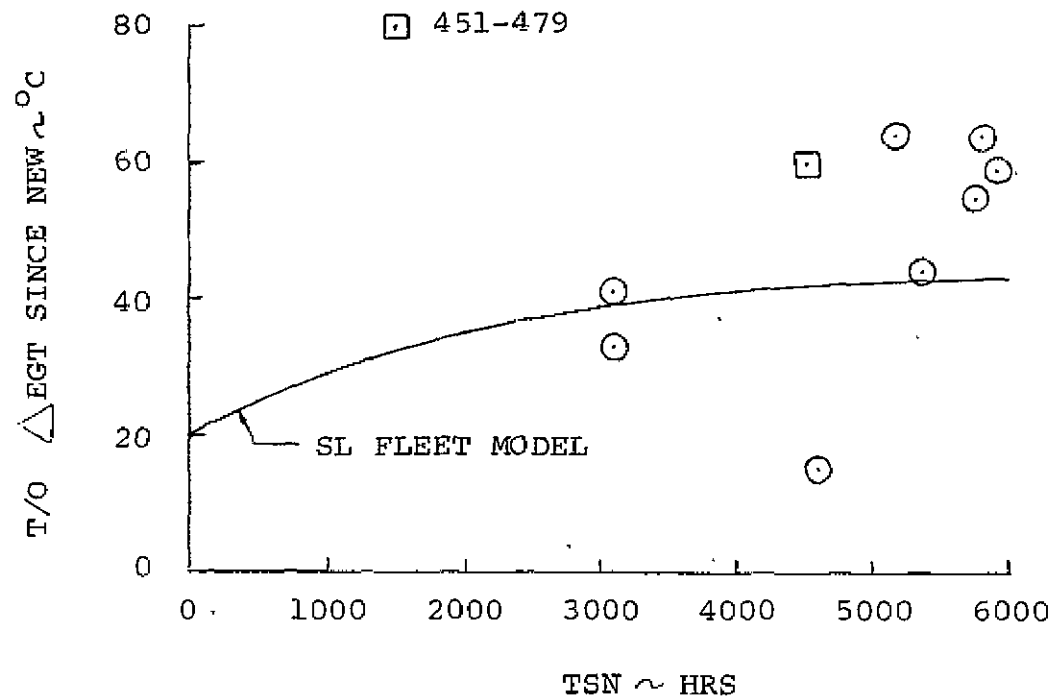
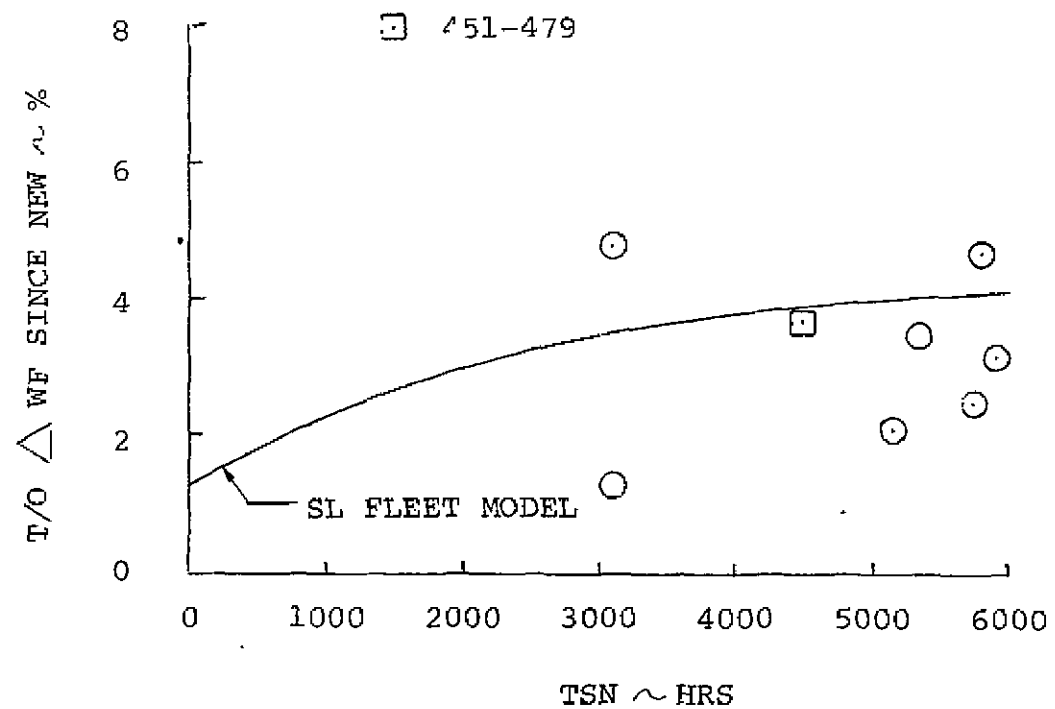
Figure 5-2. CF6-6D Inbound Sea Level Deterioration.

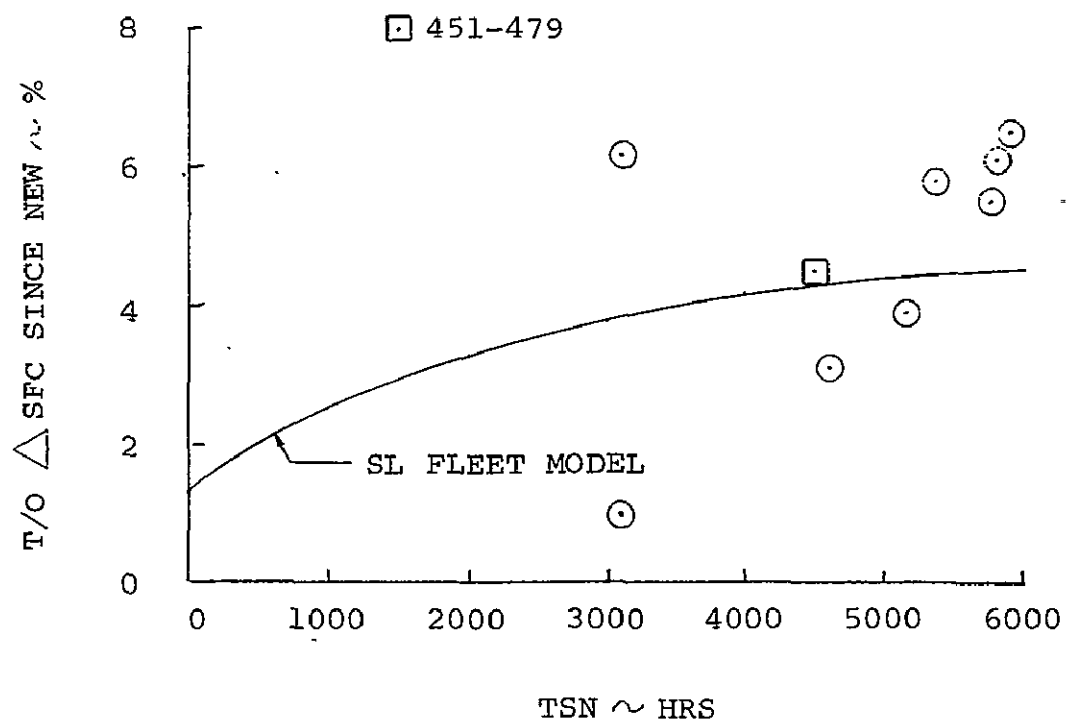
Figure 5-3. CF6-6D Inbound Sea Level Deterioration.

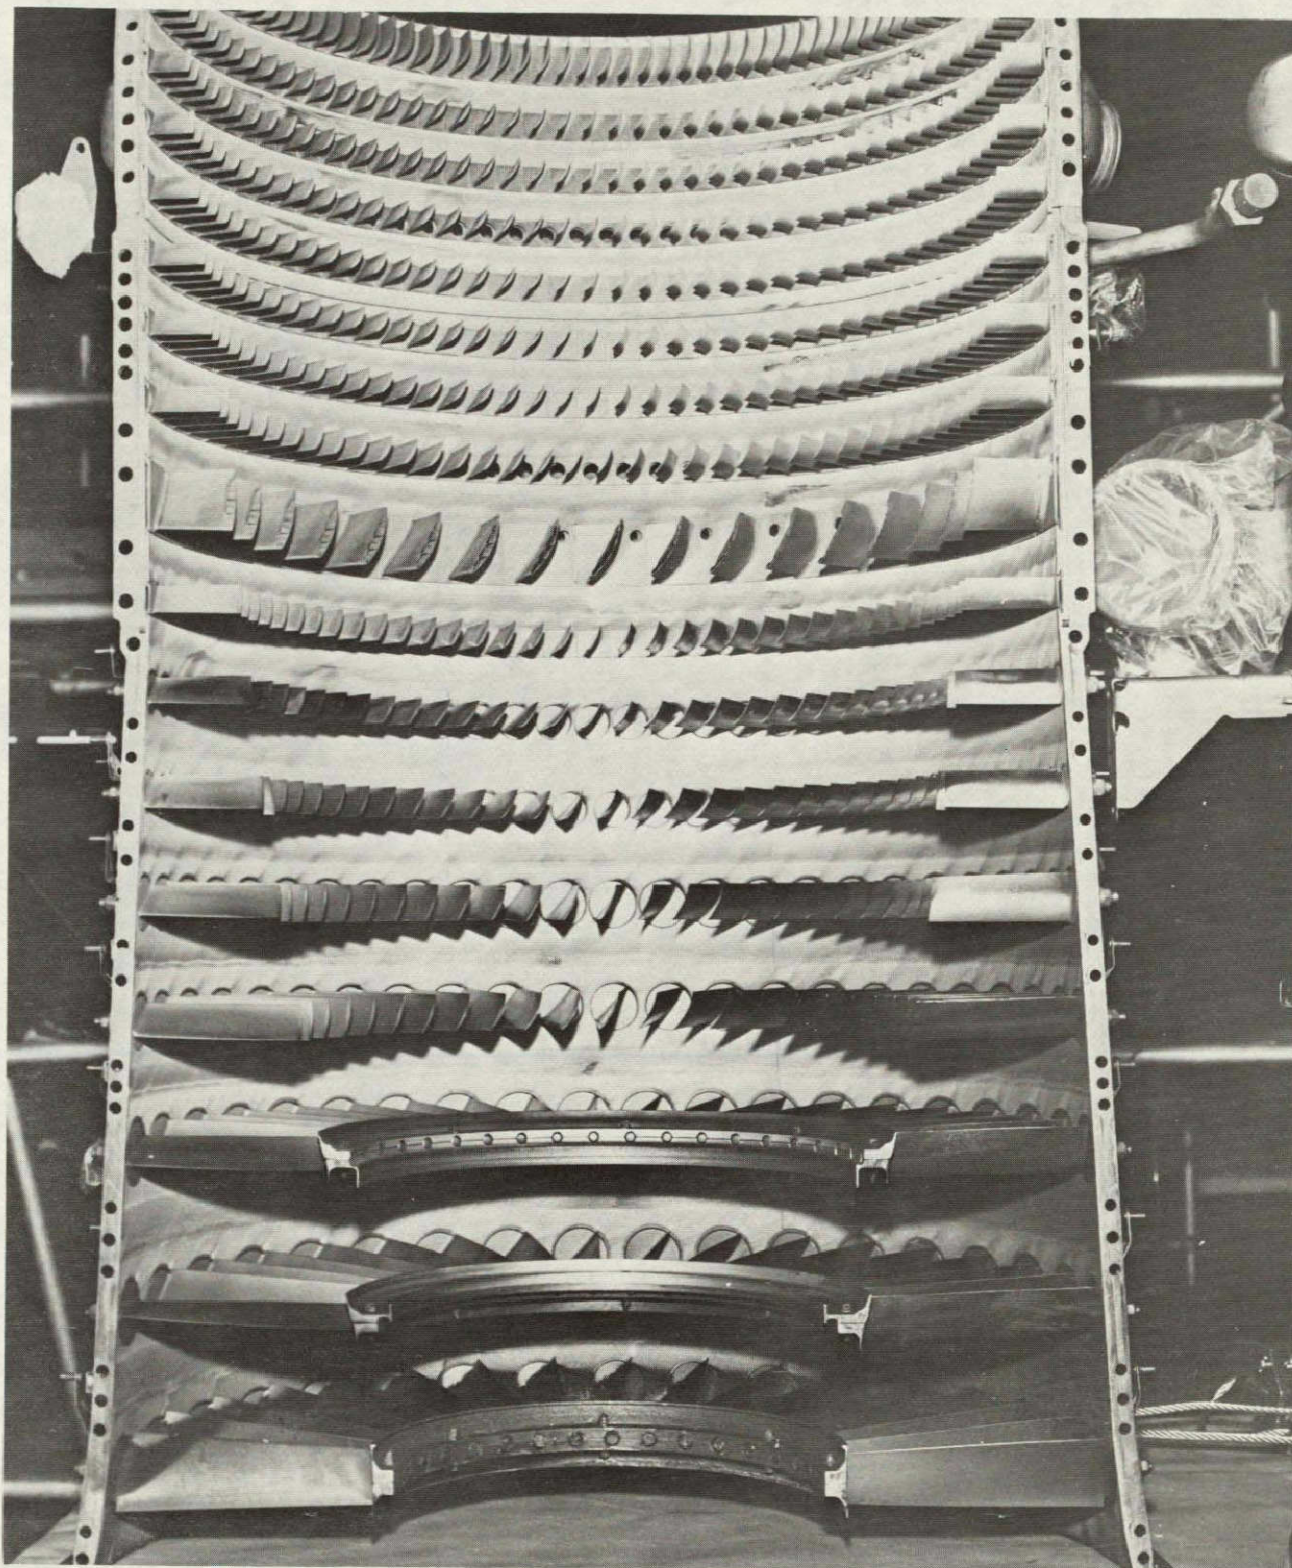
Inspection of the HP compressor stator assembly revealed a heavy mixture of oil and dirt in the forward stages, through Stage 6. The heaviest buildup accumulated on the IGV's and the IGV inner shrouds, and got progressively better from stage to stage. The remaining vanes, though not oily, were extremely dirty. There was a very mild splattering of aluminum on the Stage 13 vanes and OGV's. A photograph of the upper stator case can be seen in Appendix B, Figure 8-3.

Figure 8-3. HP Compressor Stator Upper Overall Oil, Dirt, Rubs.

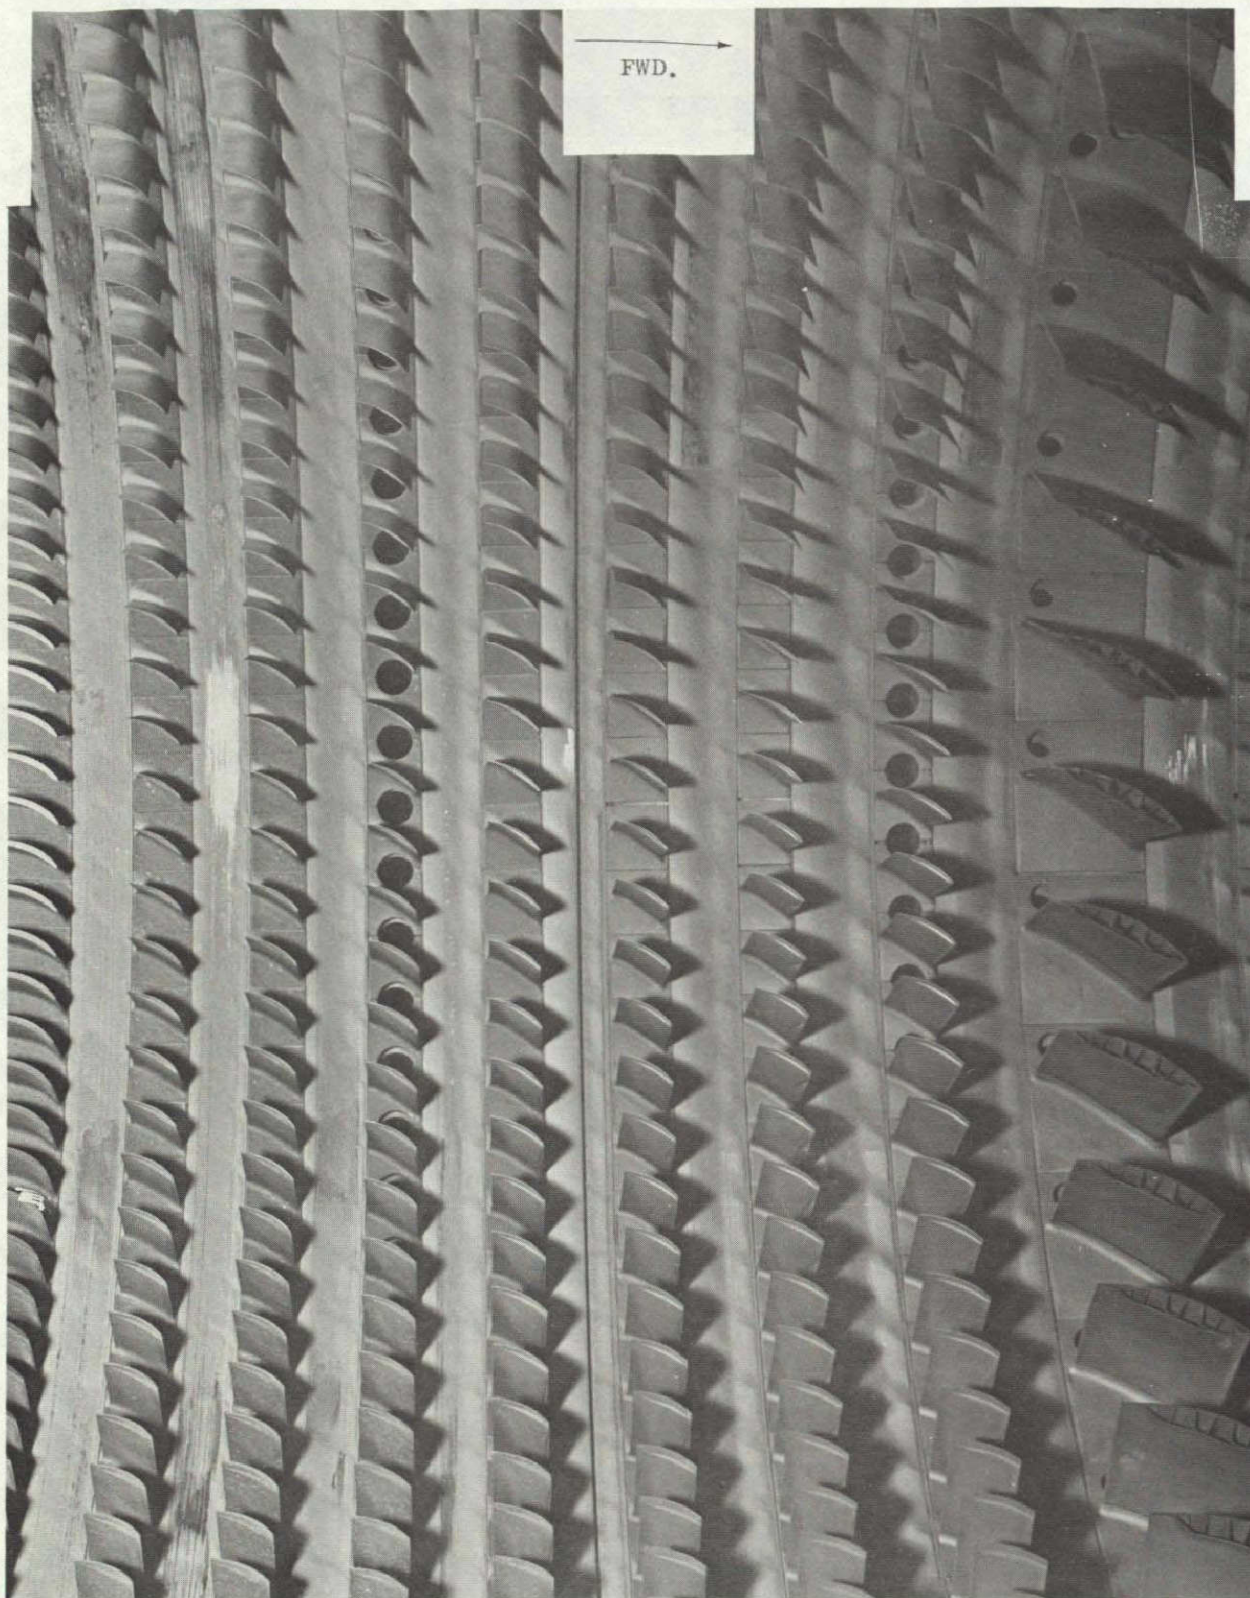
##### HP Compressor Casing Rubs - Upper (See Photo, Figure 8-4 in Appendix B)

Figure 8-4 . HP Compressor Stator, Upper Stage 7 to OGV - Rubs.

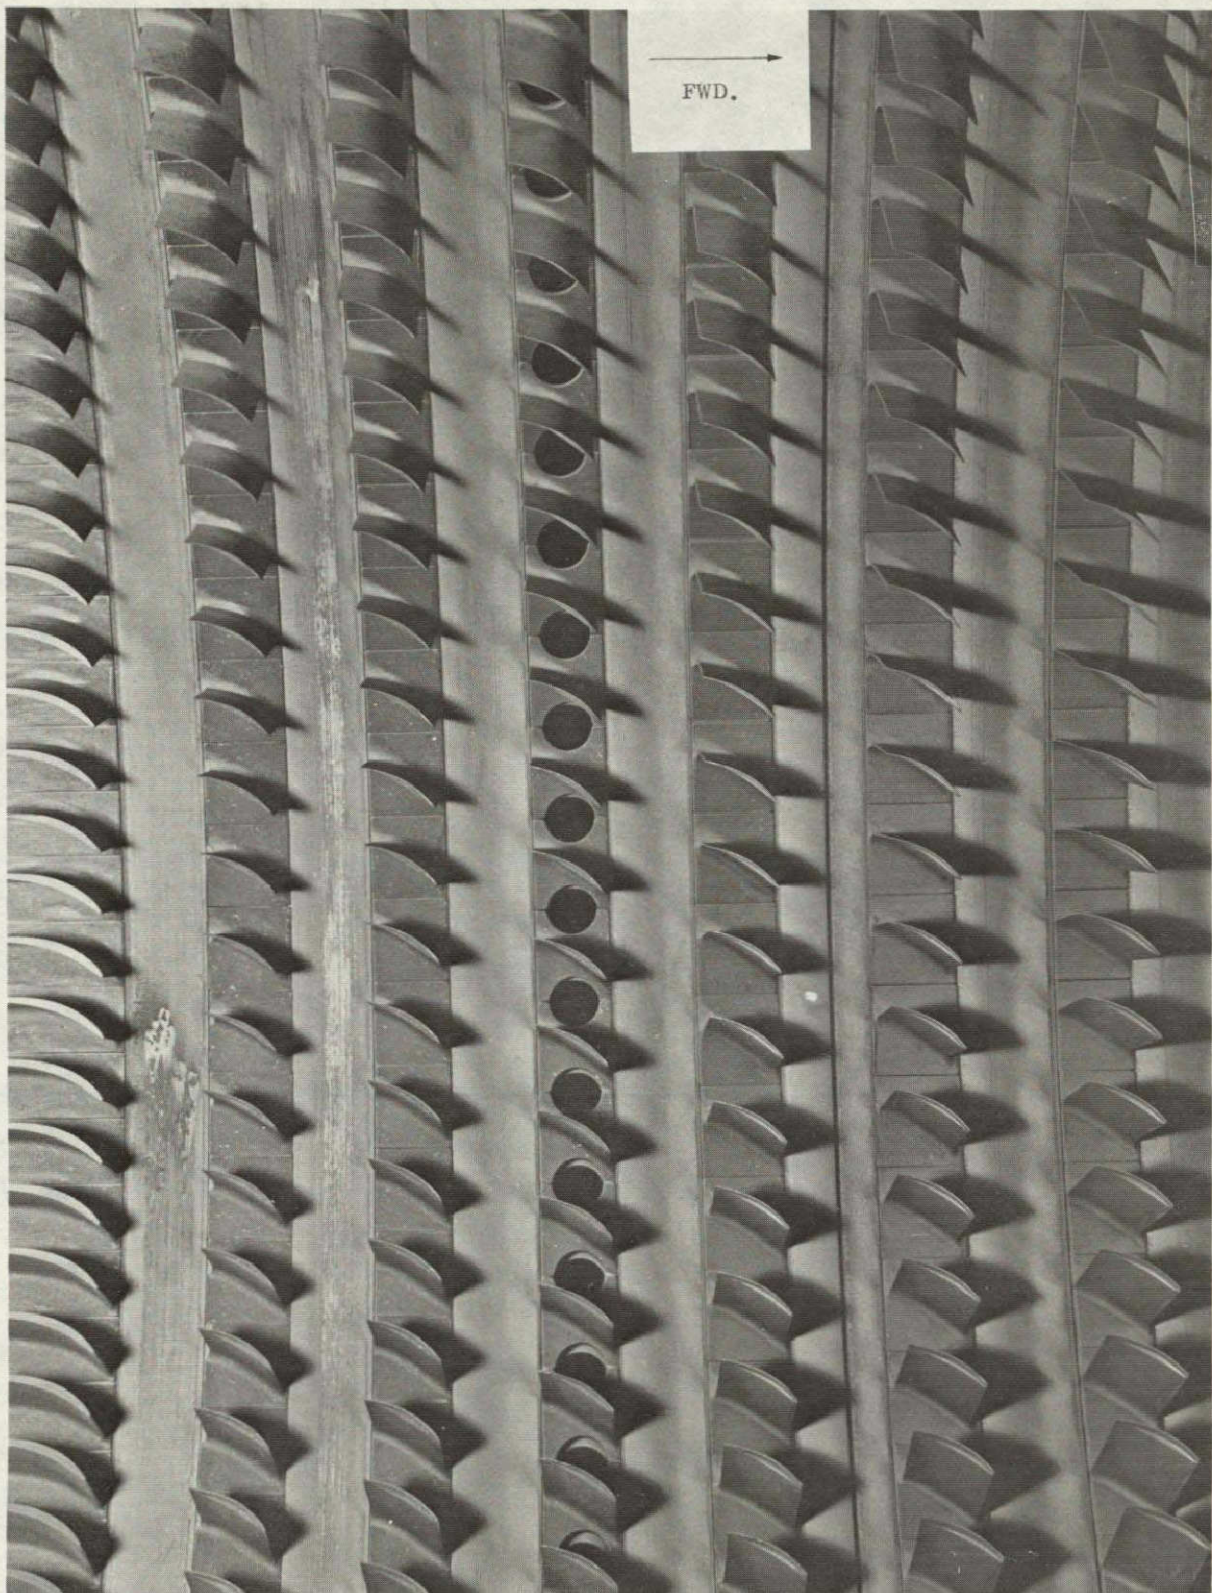
HP Compressor Casing Rubs - Lower  
(See Photo, Figure 8-5 in Appendix B)

Figure 8-5. HP Compressor Stator, Lower Stage 9 to OGV - Rubs.

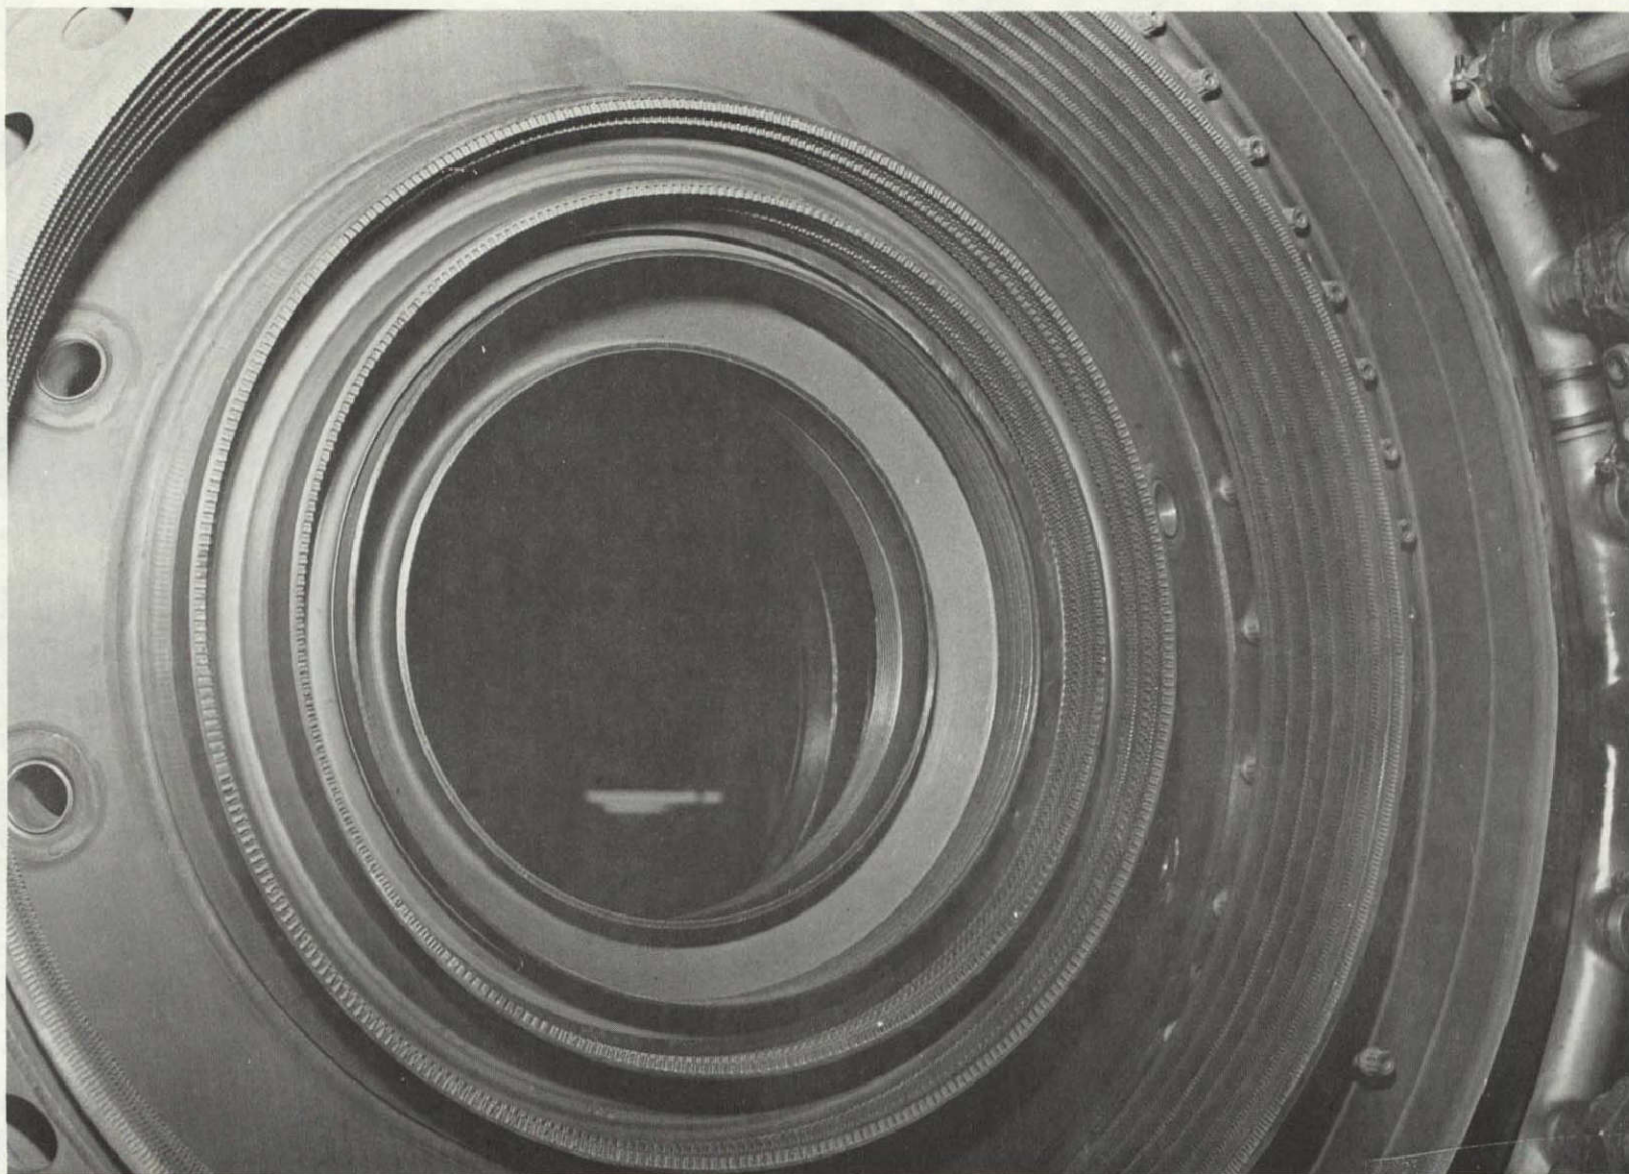
Figure 8-8. Compressor Rear Frame, Forward Seals - Overall View, Installed.

Measurements of each of the lands on the 4R CDP seal were taken and recorded. (A view of the forward CRF seals can be seen in Appendix B, Figure 8-8.) The results were as follows (all dimensions are in inches):

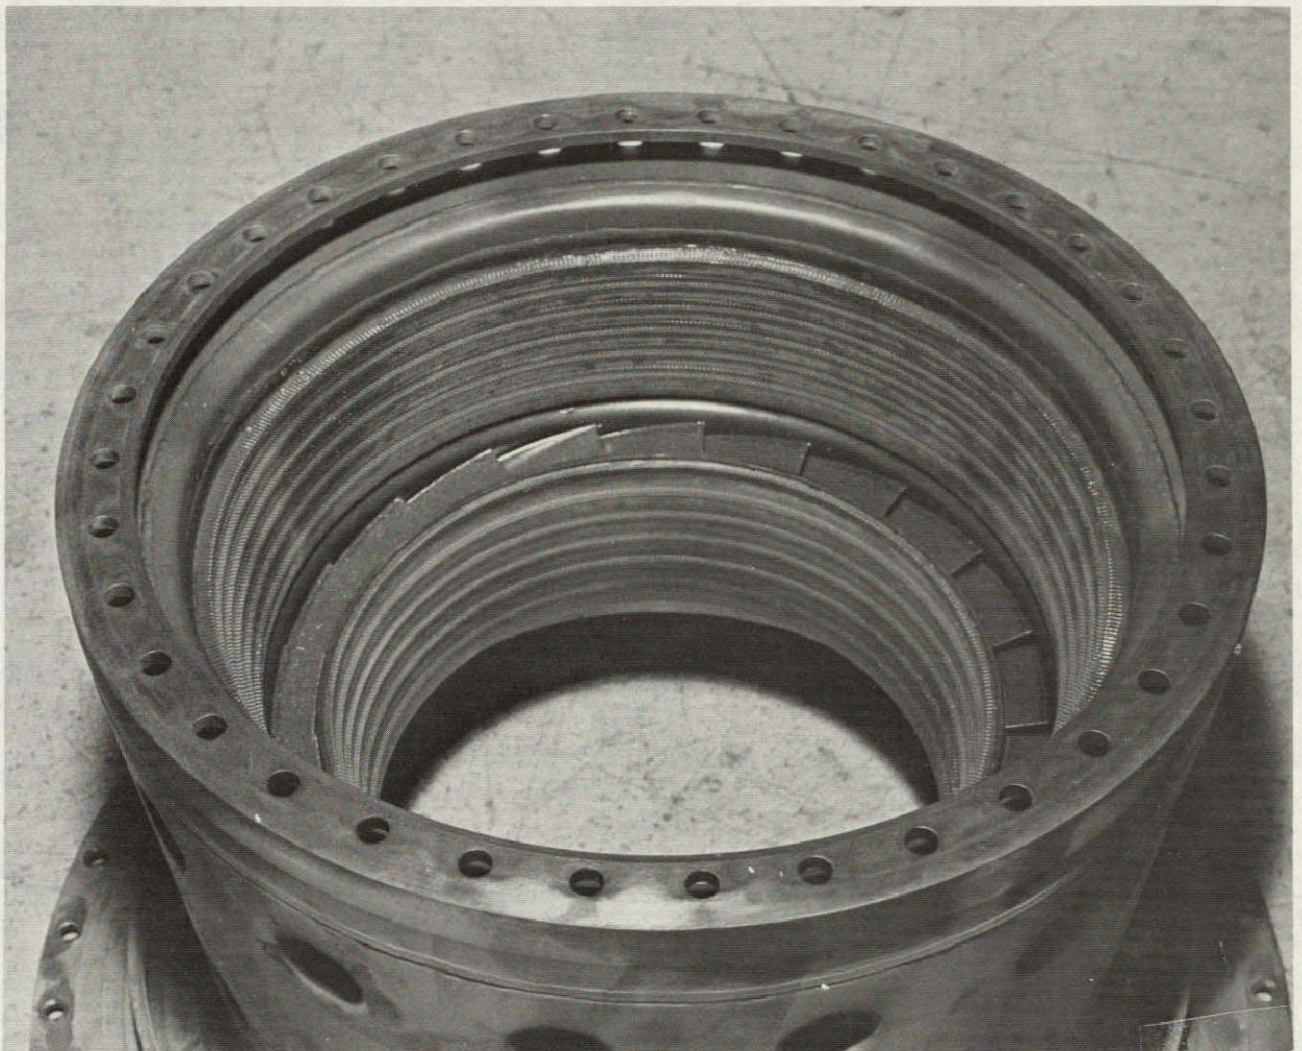
Figure 8-9. No. 4B Pressure Balance Seal, Overall View.

Diameter measurements of each land of each of the aft seals in the No. 4B pressure balance seal (mini-nozzle) were taken and are recorded below (dimensions are in inches). These are the seals that mate with the high pressure turbine rotor forward shaft seals. (A photograph of the mini-nozzle is contained in Appendix B, Figure 8-9.)

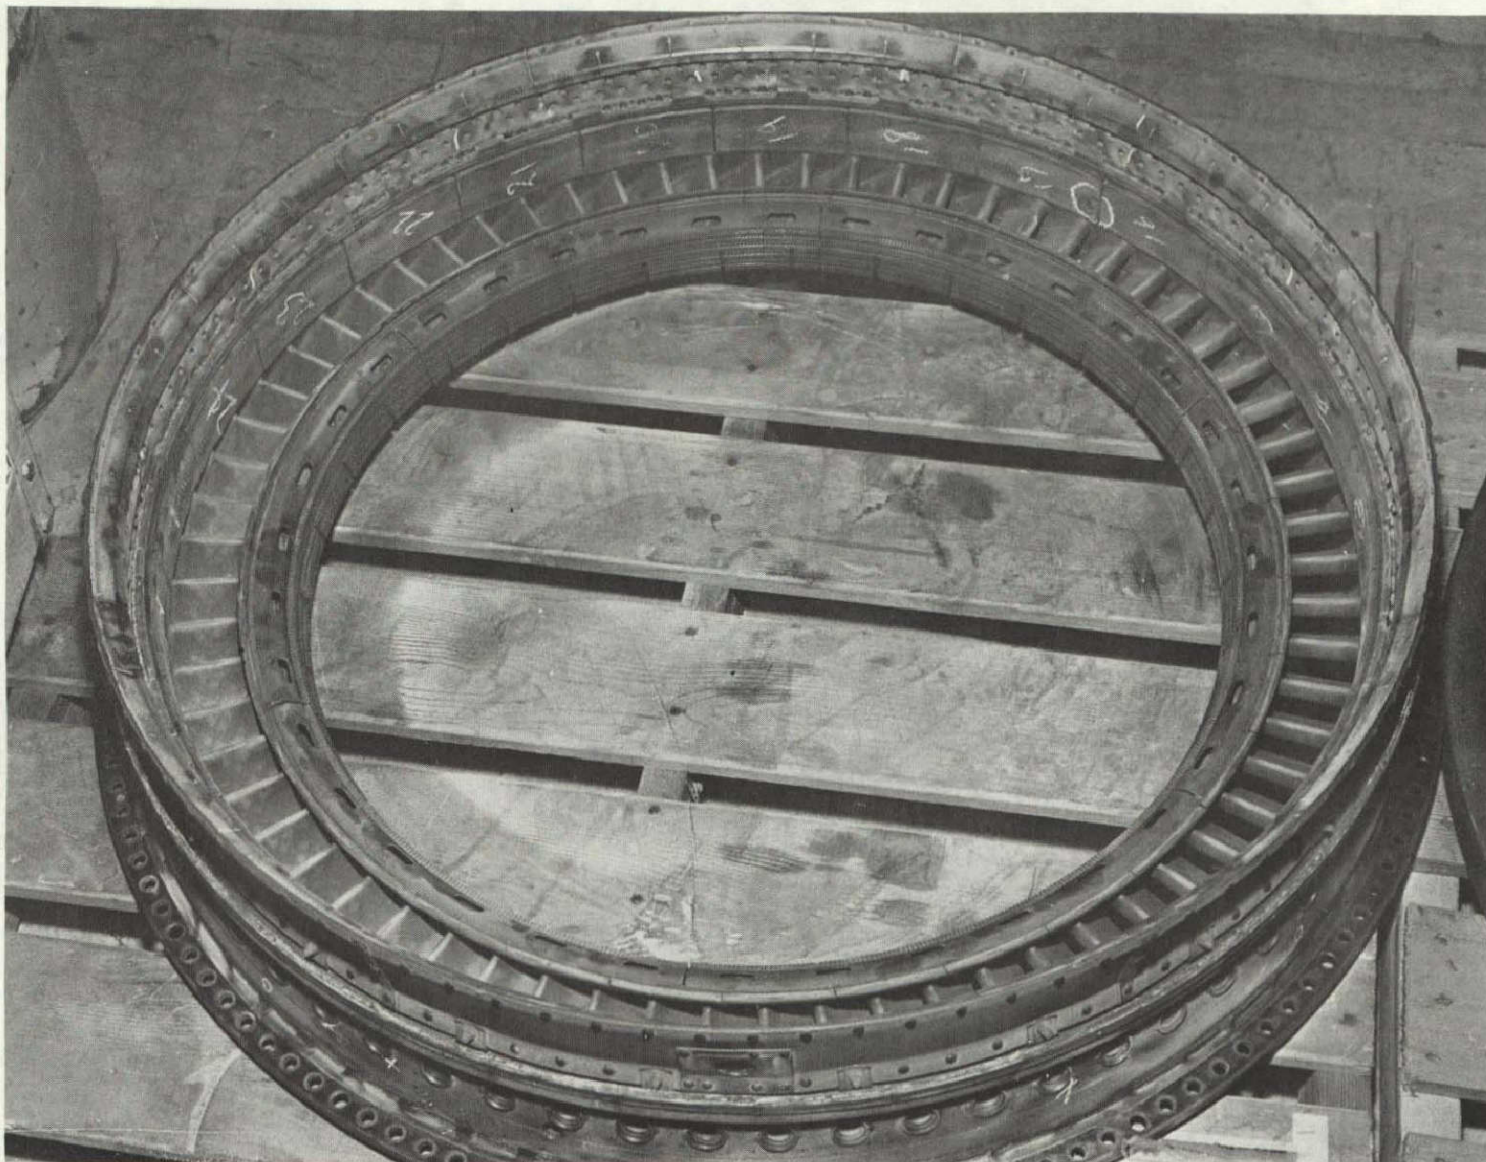
Figure 8-14. HP Turbine Nozzle Assembly, Overall View, Forward End.

A visual inspection of the Stage 2 high pressure turbine nozzle, as assembled, produced no surprising results. It proved to be about as expected for an assembly with this amount of running time (see photograph, Figure 8-14, for an overall view of the assembly). The more noteworthy results of the inspections are covered in the following paragraphs.

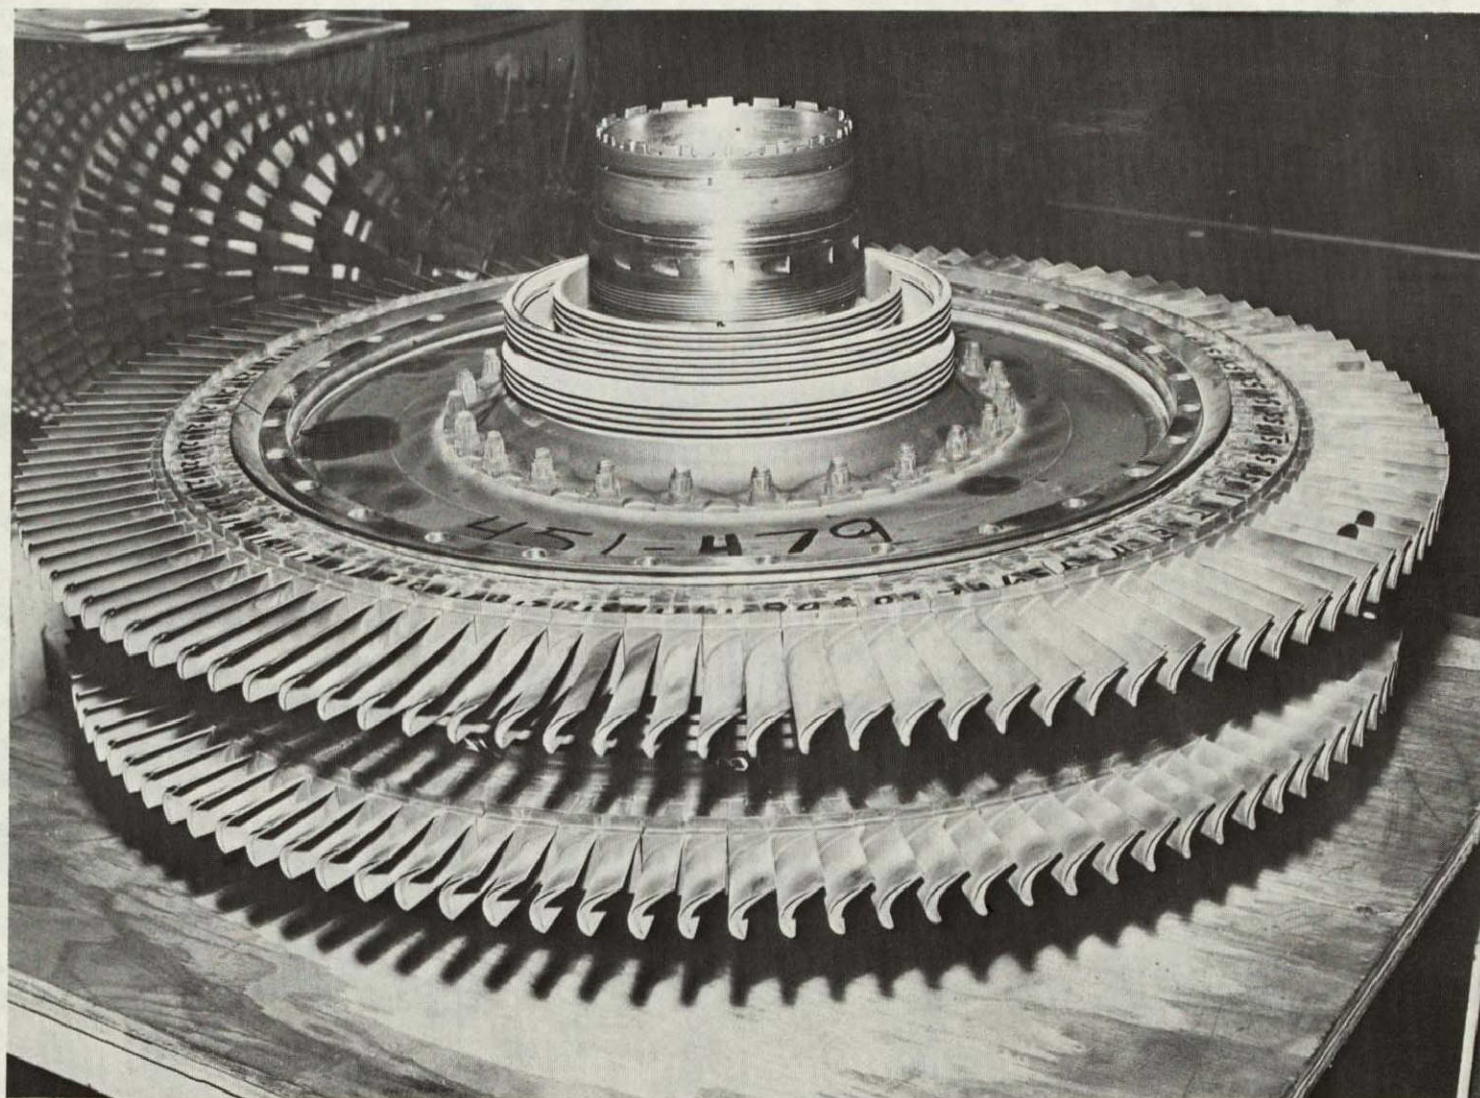
Figure 8-17. HP Turbine Rotor, Overall View of Blades.

Photographs of the HTPR can be seen in Appendix B, Figures 8-17 and 8-18.

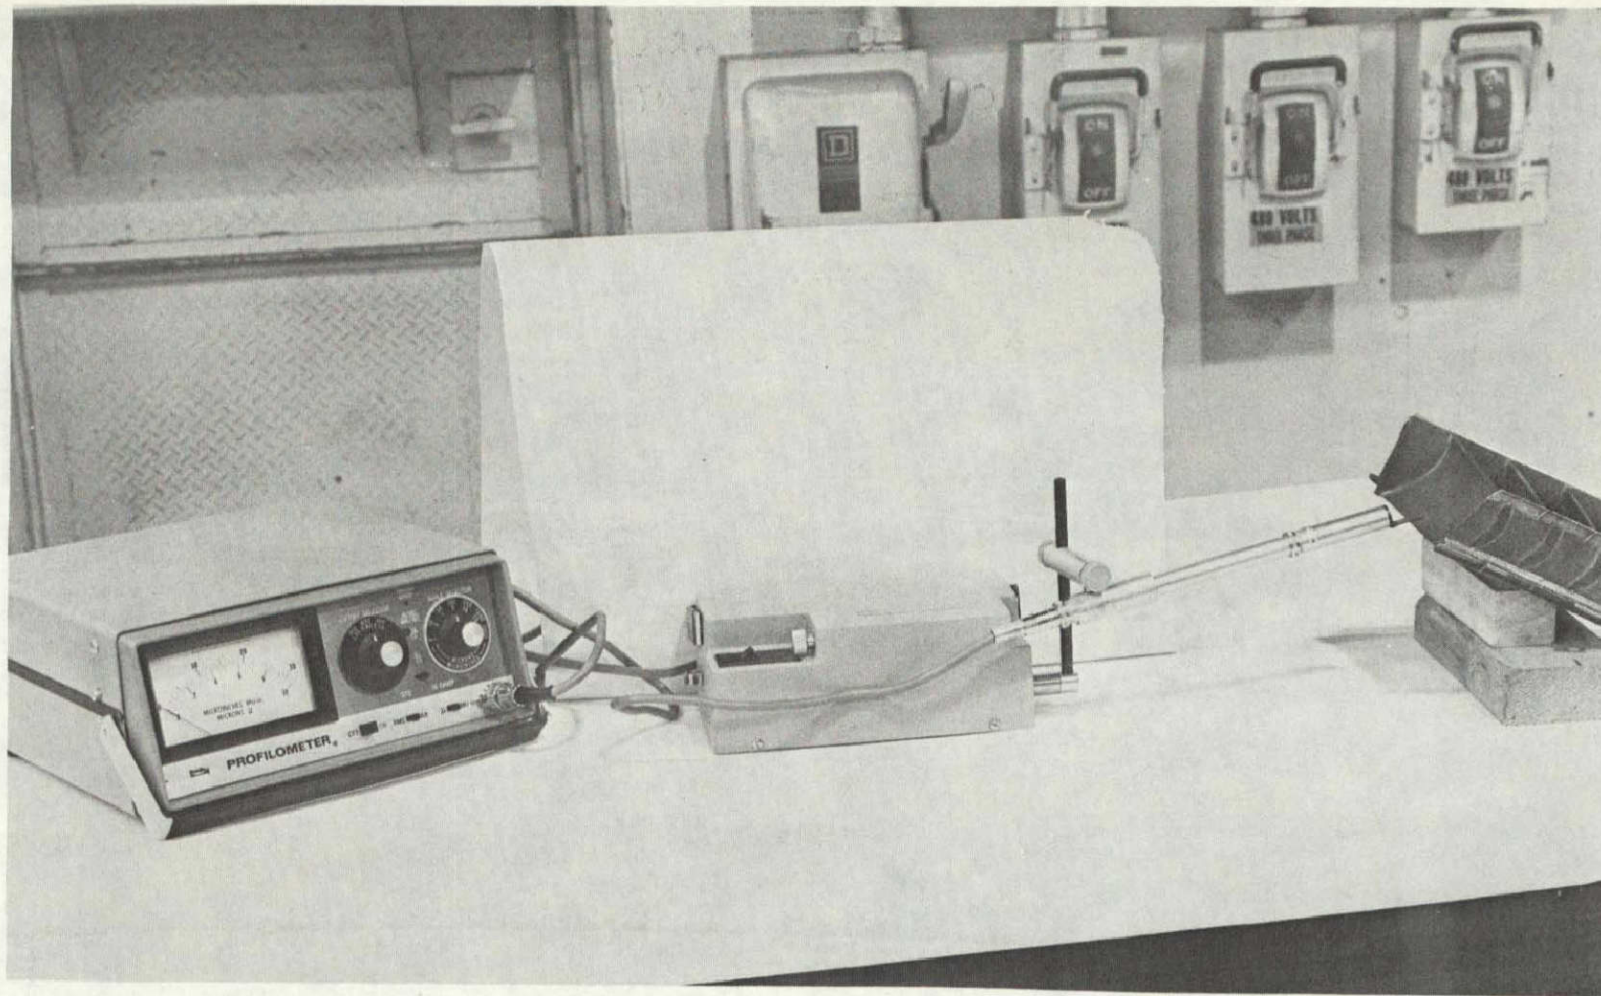
Figure 8-20. Profilometer Setup, LP Turbine Nozzle Segment, Concave Side.

were inspected after removal from the TMF. The profilometer and associated hardware used for these surface-finish checks were supplied by Airline Support Engineering (ASE), Evendale. A typical setup of this equipment can be seen in Figures 8-20 and 8-21 in Appendix B.

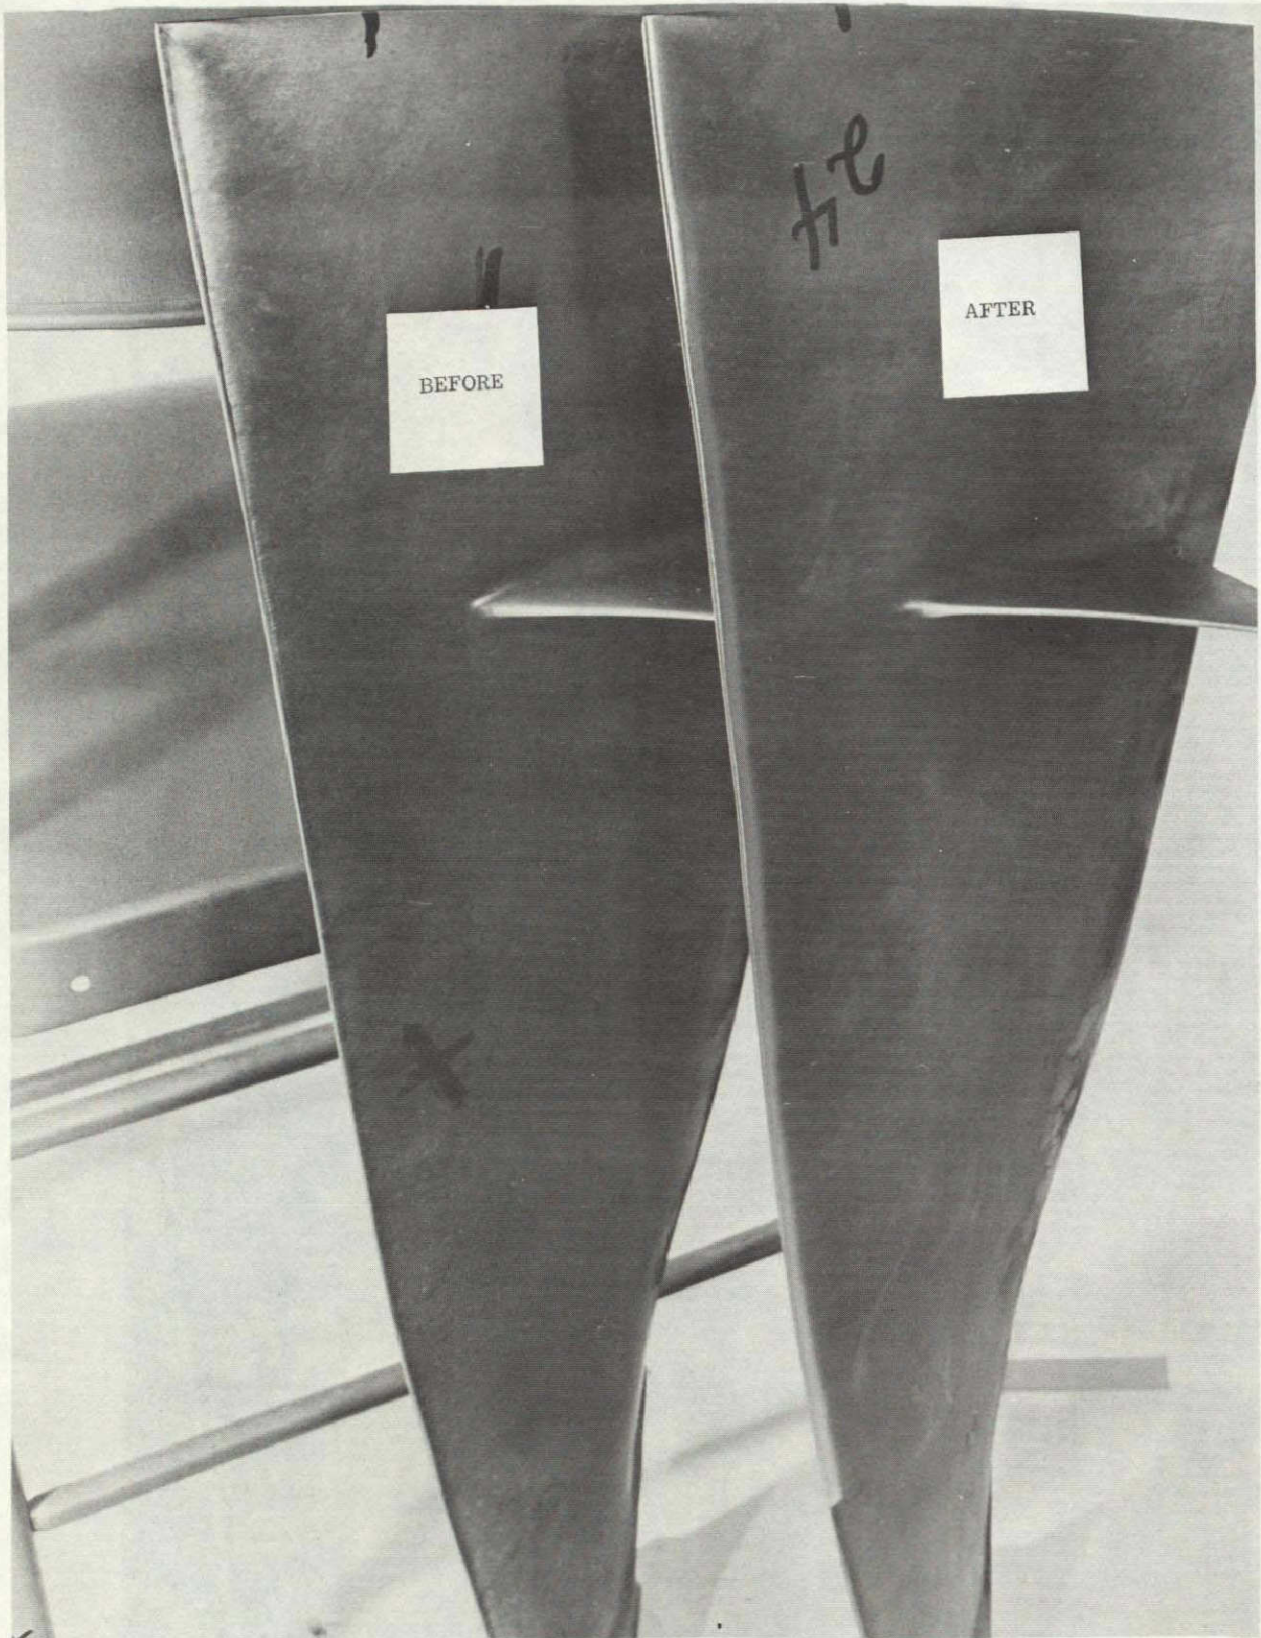
Figure 8-26. Stage 1 Fan Blades Before/After Recontour.

Leading edge contour was such that during the test plan, when the blades were reconditioned for test evaluation purposes, only minor rework using Tool 2C7546 was required to bring the contour into limits. See photograph, Figure 8-26, in Appendix B, depicting one blade before and another blade after re-contour. The pressure side radius was already in limits, so no hand-blending was necessary on any of the blades.

To determine the performance effects for the fan section components, the following method was employed: The test cell run after the LPT blade and vane refurbishment served as a baseline for subsequent tests. Following this run, the Stage 1 blades were removed, cleaned, and the leading edges recontoured per Shop Manual. Another test cell run was then conducted. Since no other changes were made to the engine during this time period, the performance improvements achieved were attributed to the fan blade refurbishment. Figure 8-26 in Appendix B compares a recontoured blade with one that had not yet been reworked.
