# DOE/NASA TECHNICAL MEMORANDUM

DOE/NASA TM-78163

## OWENS-ILLINOIS LIQUID SOLAR COLLECTOR MATERIALS ASSESSMENT

By R. L. Nichols  
Materials and Processes Laboratory

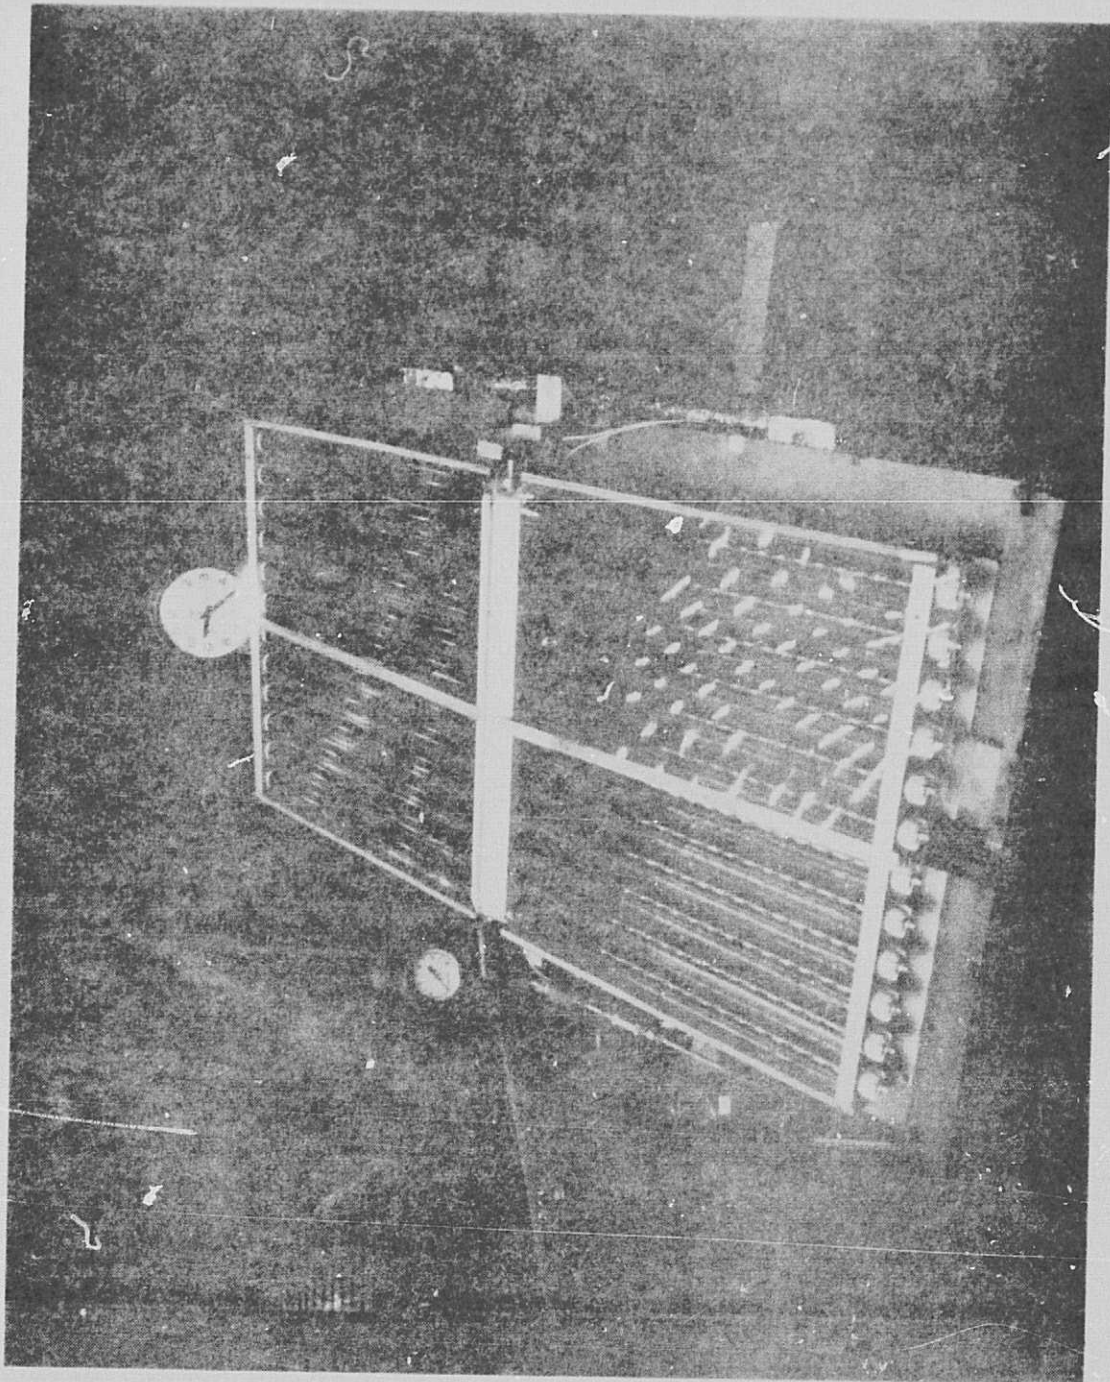
Figure 1. Assembled O-I Sumpak solar collector array.

A photograph of the assembled O-I system is shown in Figure 1. The 24 glass collector tubes are manifolded together so that the fluid flow is channelled sequentially through each individual tube. Figure 2 shows the configuration for a tube pair. It also shows the detail parts and components of the system. An individual collector tube (Fig. 3) consists of two concentric glass tubes, sealed together at one end, with a hard vacuum in the annular space between the tubes. A selective absorber coating, with high solar absorptivity and low emittance, is applied to the outer surface of the inner tube. The hard vacuum protects the vacuum-deposited metallic absorber coating from atmospheric degradation and suppresses gas conduction heat loss from the inner tube. The efficiency of this construction results in inner tube temperatures of approximately 650°F (340°C) when the tube is stagnated, i.e., exposed to full sunlight while filled only with air or steam, with no flow through the tube.
