LONG-TERM CF6 ENGINE PERFORMANCE DETERIORATION - EVALUATION OF ENGINE S/N 451-380

PREPARED BY: W.H. Kramer
J.J. Smith

General Electric Company
Aircraft Engine Group
Cincinnati, Ohio 45215

August 1978

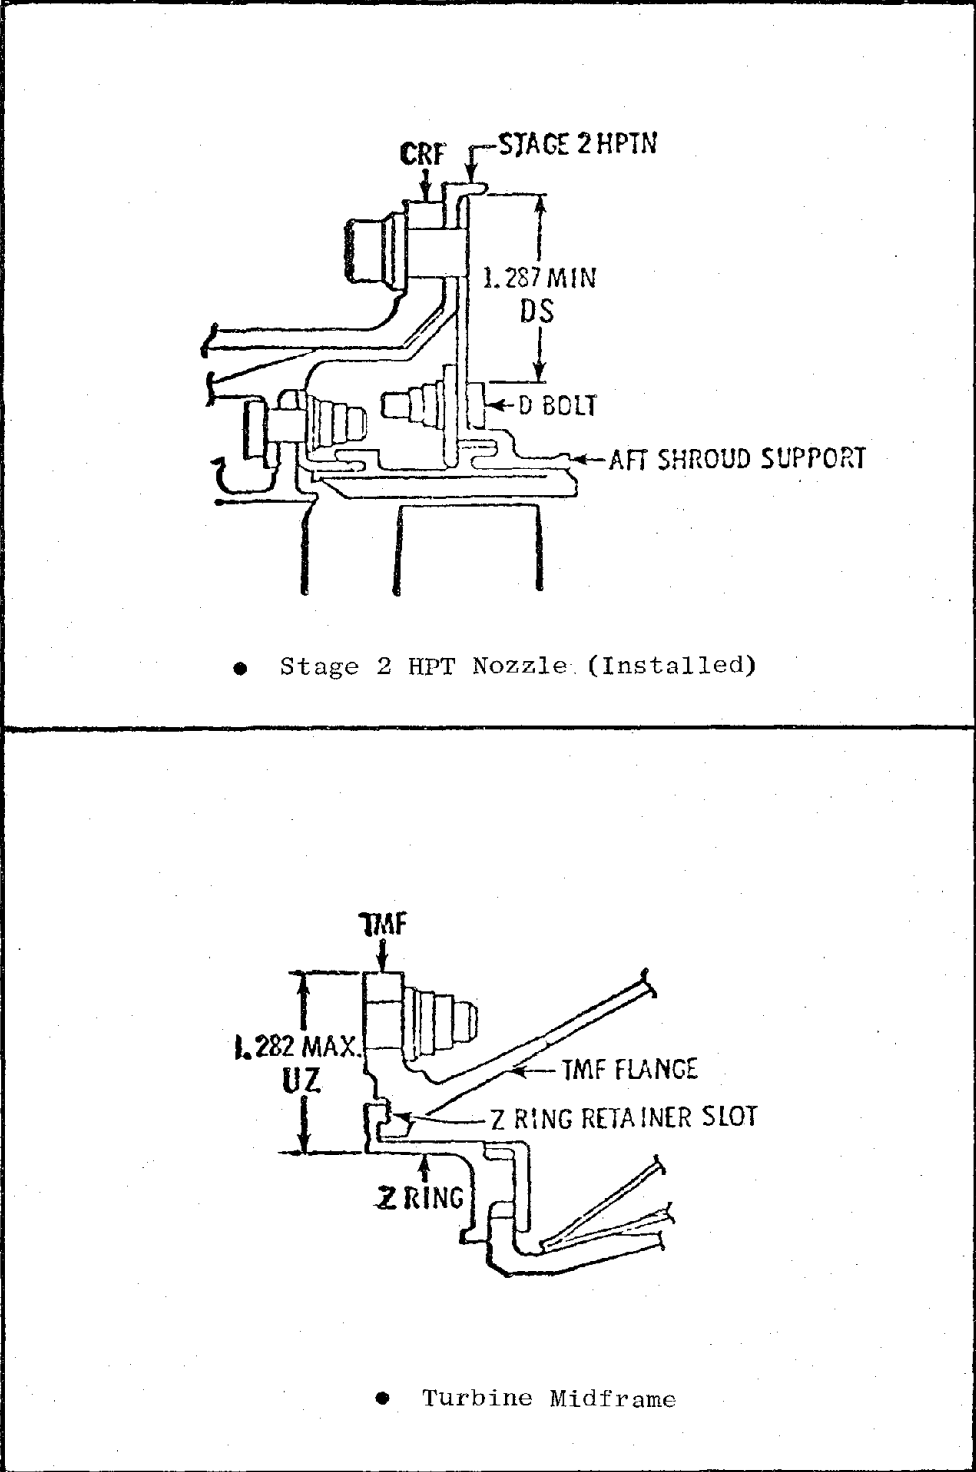
Figure 13. LPT EMU Dimensional Checks.

In addition to the outer diameter of the frame, the inner diameter of the liner "Z" ring also controls the concentricity of the Stage 2 nozzle support. A gage was used to check the dimension UZ (see Figure 13) throughout the full 360° circumference. Except for one snug area, approximately 2 inches long at Strut Number 7, the gage passed freely throughout.

The corresponding dimension, DS, on the Stage 2 nozzle support (refer to Figure 13) was also checked with a gage and found to be acceptable.

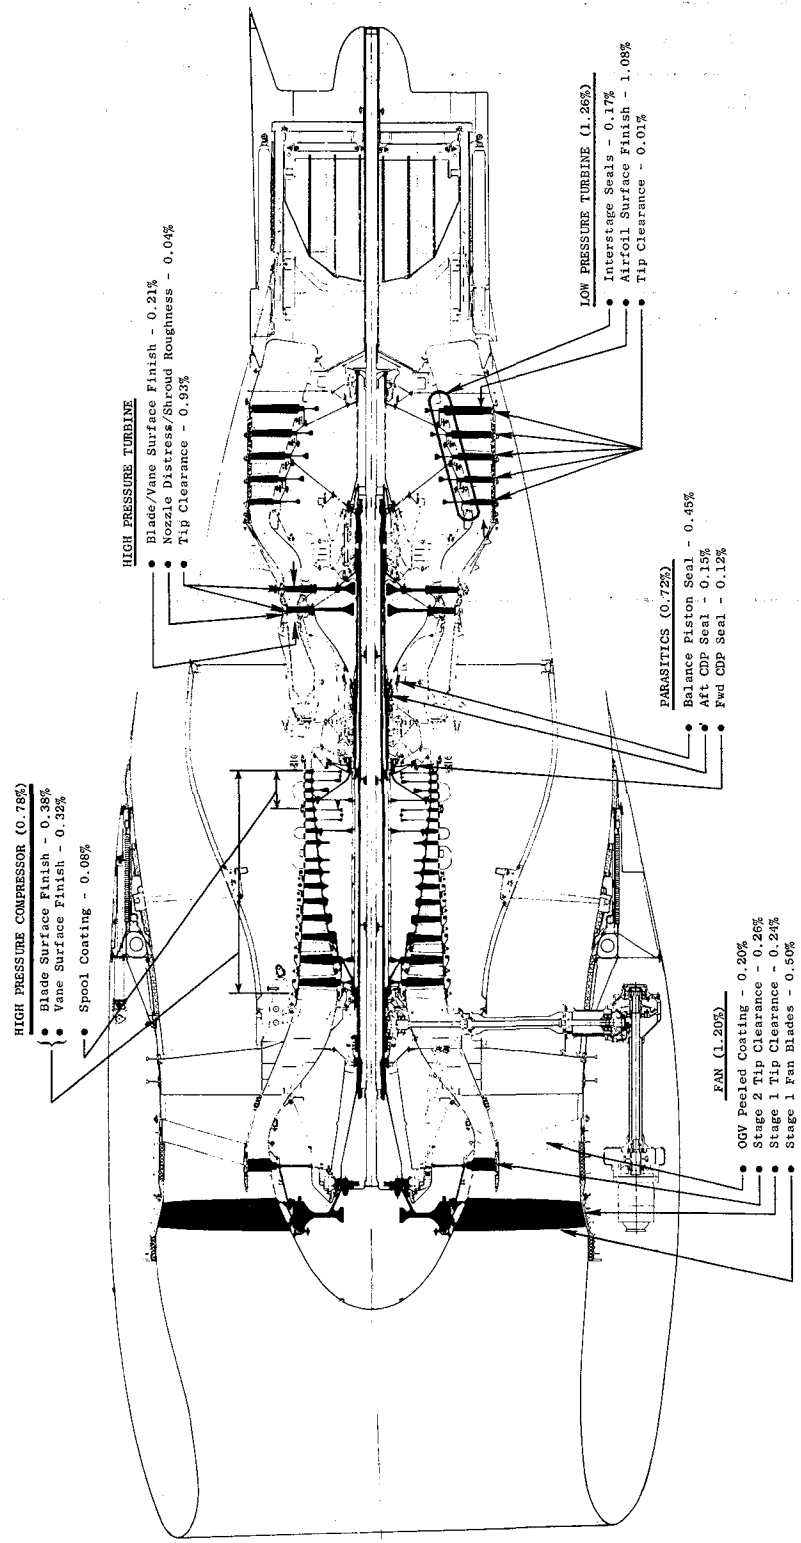
Figure 19. CF6-6 ESN 451-380 Specific Fuel Consumption Deterioration Assessment.

Stage 4 (19 mils)	0.10				
Stage 5 (27 mils)	0.07				
Blade Airfoil Surface Finish	0.72%	5.2° F	0.53%		
Stage 1	0.45				
Stage 2	0.17				
Stage 3	0.05				
Stage 4	0.04				
Stage 5	0.01				
Vane Airfoil Surface Finish	0.74%	5.3° F	0.55%		
Stage 1	0.54				
Stage 2	0.13				
Stage 3	0.04				
Stage 4	0.03				
Stage 5	0.00				
<u>Fan Section</u>					
Stage 1 Blade LE/Cleanliness	0.70%	0°	0.50%		
Stage 1 Blade Tip Clearance (20 mils)	0.34%	2°	0.24%		
Stage 2 Shroud Removed (hub)	1.00%	4°	0.26%		
Outer OGV Peeled Coating	0.28%	0°	0.20%		
Total		85° F	5.14%	121° F	7.1%
See Figure 19 for Engine Cross Section.

The Stage 1 fan blade leading edge contour and airfoil surface cleanliness is another example of hardware condition that cannot be analytically assessed as to performance loss. For this reason, the testing sequence included back-to-back tests comparing performance levels of the blades in the "as-received" condition versus performance levels of the blades after cleaning the airfoils and reworking the leading edges. A 0.5 percent improvement in sfc was demonstrated and is included in the analytical assessment of losses (Table XXV and Figure 19).

Evaluation of the airfoil surfaces prior to cleaning indicated that a performance loss equal to about 1.08% sfc could be attributed to the existing surface condition (roughness) as compared to an airfoil surface when new. After cleaning the airfoils using the vibratory mill process (SWECO), an assessment of the surface condition indicated that only about 67% of this assumed loss had apparently been recovered; i.e., about 0.7% sfc (Table XXVI). This recovery ratio is somewhat lower than the 90% improvement assessed when LPT
