NASA Technical Memorandum 79112

SOME EFFECTS OF CYCLIC INDUCED DEFORMATION IN ROCKET THRUST CHAMBERS

N. P. Hannum, R. J. Quentmeyer, and H. J. Kasper
Lewis Research Center
Cleveland, Ohio

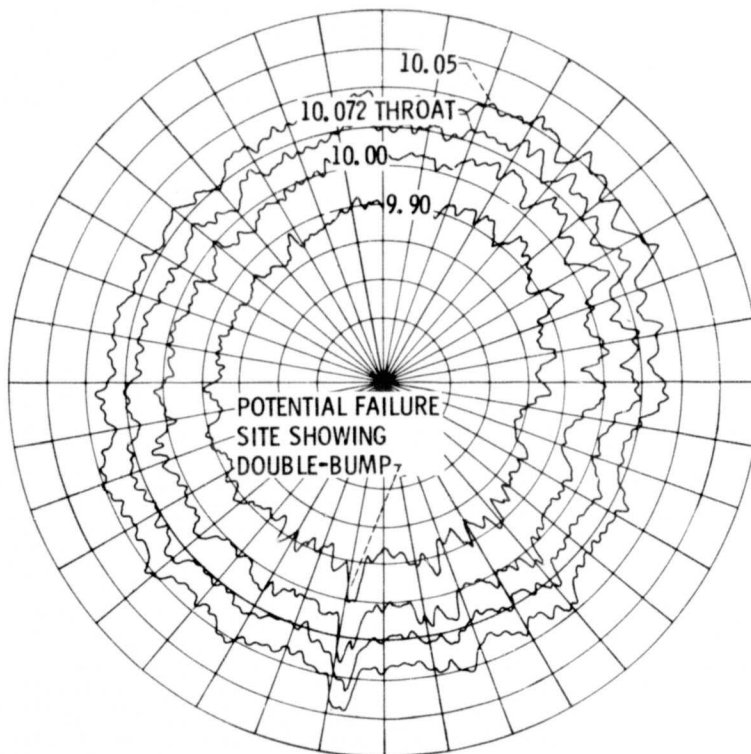
(b) INTERMEDIATE LIFE DATA AFTER 124 CYCLES.

Since the method for measuring deformation was nondestructive, it was also employed to obtain deformation data of intermediate life points. Two variations of the nondestructive method were used. First, the 360° plots previously described could be made at various axial locations, but that required removing the chambers from the thrust stand. Second, it was found that after the most highly deformed area had been located, data could be taken from plaster casts of the area. These intermediate life data are also recorded in Table I. An example of intermediate life hot gas wall deformation data is shown in Fig. 5(b) for OFHC copper chamber S/N 74 after 124 cycles. The polar plots were made at various axial stations in the vicinity of the most highly deformed area. The potential failure site can readily be identified even though the failure did not occur for another 69 cycles. The double-bump characteristic is also evident. As can be seen from Table I there was good agreement between deformation data using the two methods for OFHC copper chamber S/N 74 at 124 cycles. The 360° plots indicated a deformation of 0.173 mm (0.0068 in.) and the plaster cast method indicated 0.155 mm (0.0061 in.).

Figure 5. - Polar plots of OFHC copper chamber S/N 74 showing hot gas wall deformation.
