CF6-6D ENGINE PERFORMANCE DETERIORATION

Ray H. Wulf

GENERAL ELECTRIC COMPANY
AIRCRAFT ENGINE GROUP
CINCINNATI, OHIO 45215

1. Report No. NASA CR159786		2. Government Accession No.		3. Recipient's Catalog No.	
4. Title and Subtitle CF6-6D Engine Performance Deterioration				5. Report Date January 1980

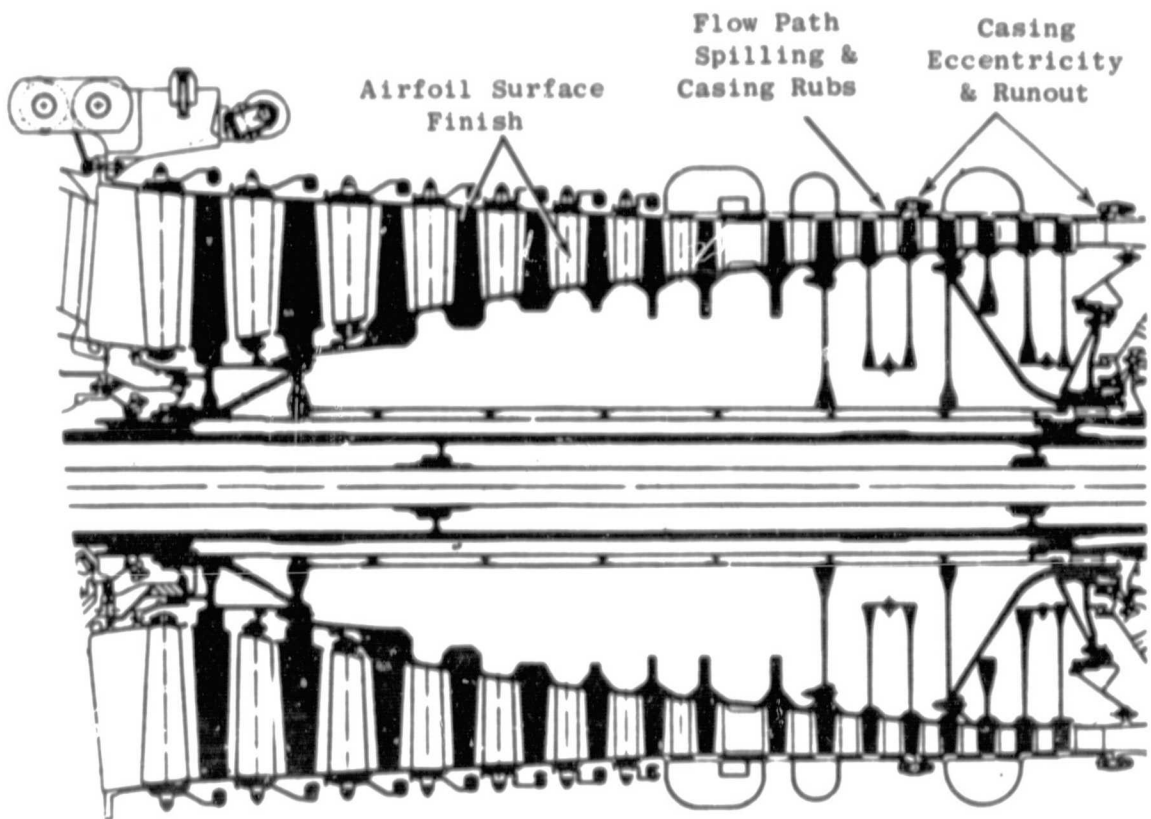
Figure 4-27. CF6-6 Deterioration Modes - HP Compressor Section.

Performance deterioration of the high pressure compressor (HPC) can result from a number of factors. These factors can be generally classified as either airfoil tip clearance changes, airfoil quality degradation or leakage. A cross section of the HPC module showing the deterioration modes is presented in Figure 4-27.

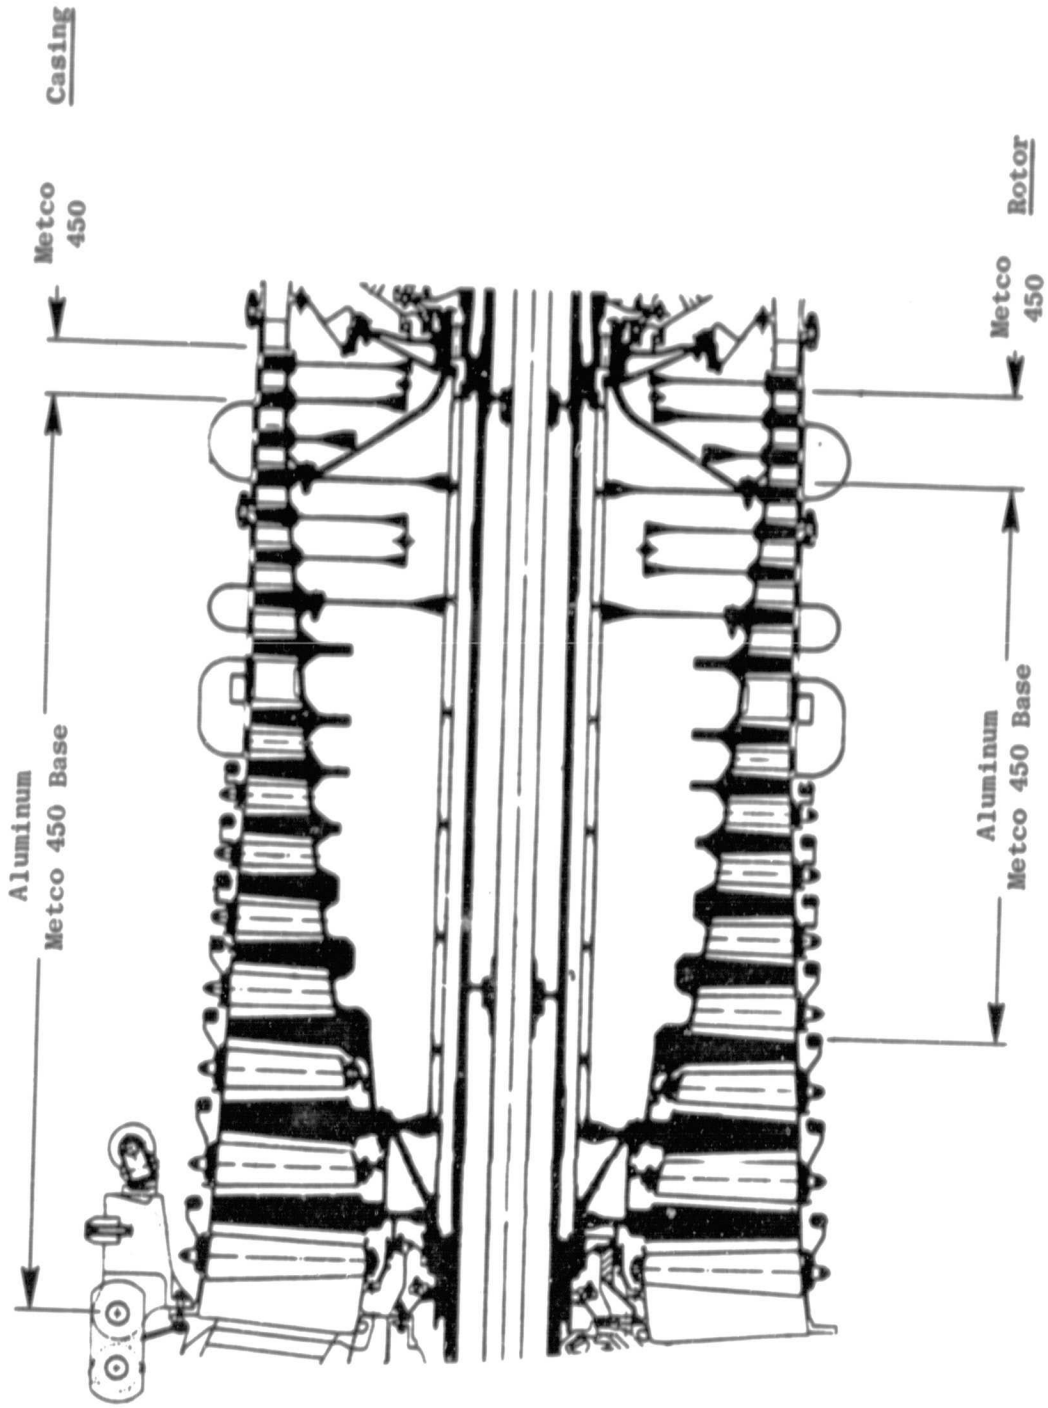
Figure 4-28. CF6-6 Flowpath Coatings - HP Compressor Section.

Flowpath Coatings used in the HPC are intended to provide protection from abrasion of the casing and rotor structure surfaces; to provide an abradable material which tolerates small local rubs without causing a major change in blade or vane length; and to minimize or prevent HPC mechanical damage. A coating, Metco 450 plasma spray, is used to provide abrasive protection for the casing and rotor structural members. This material also provides a bonding surface for an abradable aluminum spray coating used in the forward stages as shown in Figure 4-28. Initially, all stages of casing and rotor lands included the abradable aluminum spray coating. Revenue service experience indicated, however, that the aft stages of aluminum coating suffered degradation due to spalling. This condition occurs as a result of thermal cycling which causes the aluminum/Metco 450 bond coat interface to fail due to the differences in thermal expansion between the aluminum and structural surface. Since the loss of the aluminum coating produces clearance increases on the order of 0.015 inch and additional performance losses due to surface finish degradation, the aluminum coating was replaced with the Metco 450 coating for the aft stages as shown in Figure 4-28. No Metco coating has been lost in service by spalling. Since most field engines incorporate the Metco 450 coating for the aft stages, this configuration will be used for the long-term deterioration study.

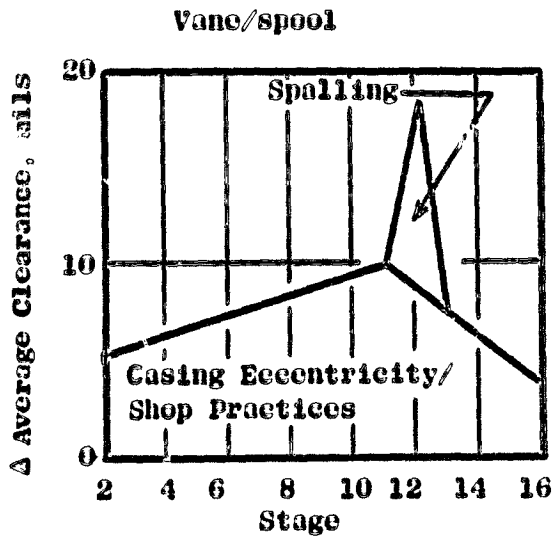
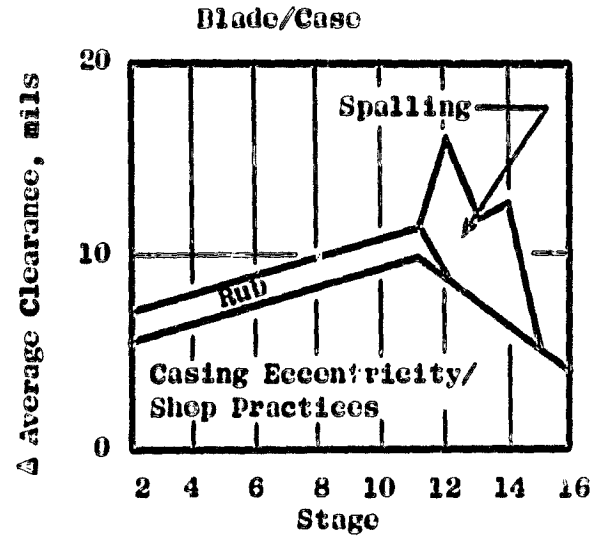
Figure 4-30. CF6-6 High Pressure Compressor - Tip Clearance at 6000 Hours.

Blade Tip Rubs were observed on the forward-to-mid stages generally at or near the twelve o'clock position. These rubs are localized and shallow, producing only a small effect on performance. Rubs are occasionally observed in other locations, but all significant rubs were associated with abnormal events like compressor stalls or mechanical failures. An estimate for clearance effect due to rubs is included in Figure 4-30.

The magnitude of the casing eccentricity was estimated by comparing blade and vane radii in used HP compressors with new production measurements. The average differences ranged from 0.004 inch to 0.012 inch, depending on the stage. Clearances tend to be the largest near Stage 12 (the rabbet location), where the casing eccentricity effect will be largest. The average clearance increase per stage is represented in Figure 4-30. This figure shows the total increase including the effects of spalling and rubs.

The increase in clearance presented in Figure 4-30 results in a loss of 1.31 percent in HP compressor efficiency or 0.73 percent in cruise fuel burn efficiency. This loss can be further broken down into 0.10 percent sfc flowpath spalling, 0.04 percent sfc rubs, 0.17 percent sfc casing distortion (eccentricity), and 0.42 percent sfc short airfoils.

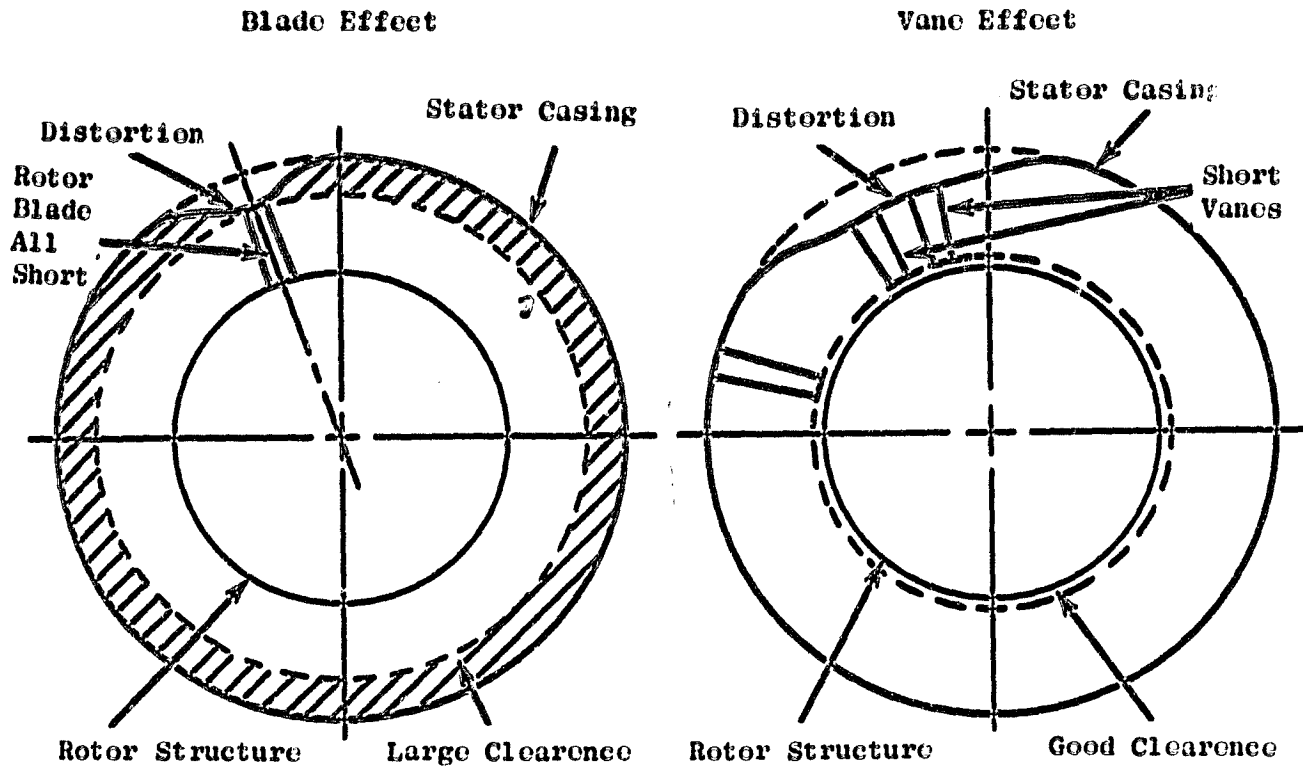
Figure 4-31. Effect of Casing Distortion on Blades and Vanes.

change in diameter can result in an eccentricity between the forward and rear casing during assembly/disassembly due to rabbet looseness. Measurements of local radial casing distortions as large as 0.025 inch have been measured. This out-of-roundness will produce local areas of inward distortion, resulting in less than the minimum required cold clearances. Therefore, all the blades (or vanes) are ground to maintain this required minimum clearance. This rework produces an increase in the average clearances and a resultant performance loss. A schematic of the clearance increase due to casing distortion is shown in Figure 4-31.

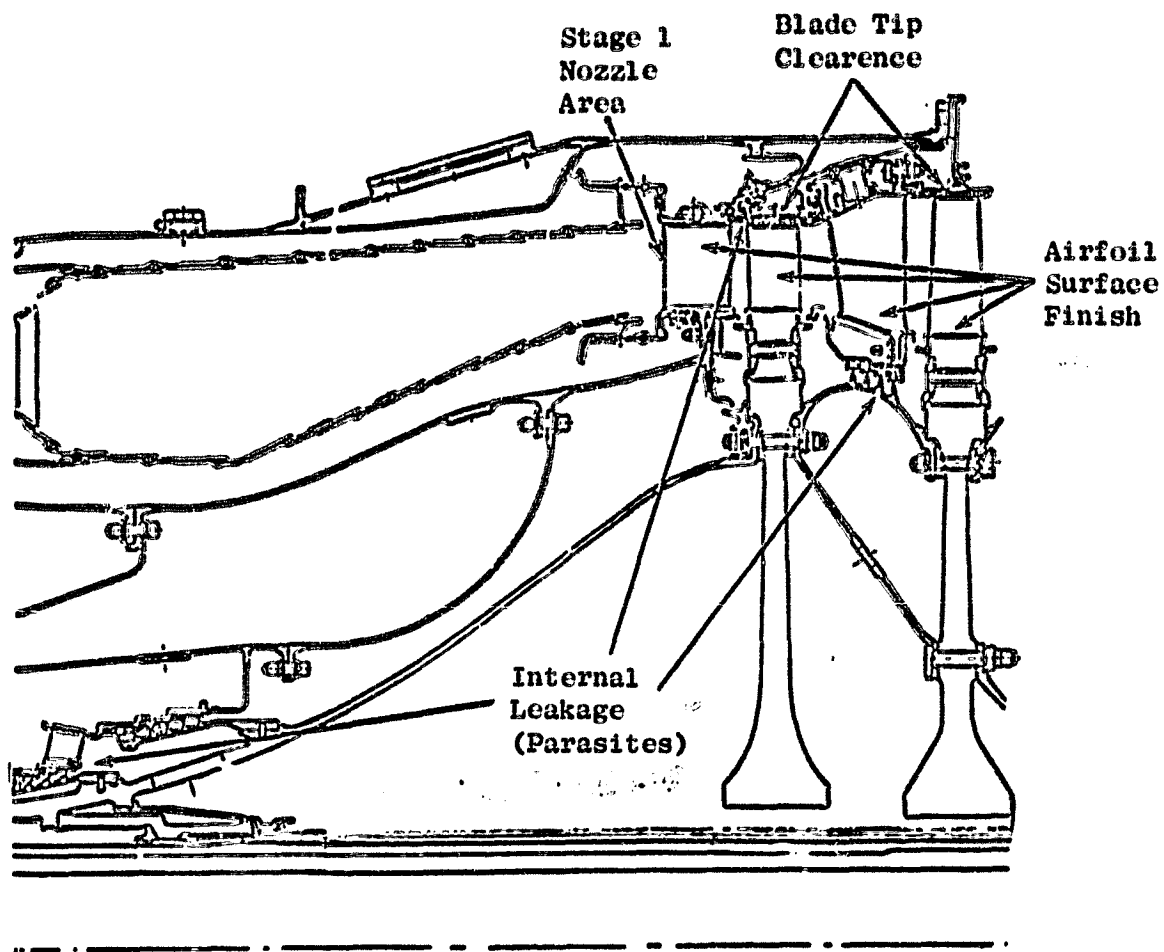
Figure 4-33. CF6-6 Deterioration Modes - HP Turbine Section.

The primary sources of high pressure turbine (HPT) deterioration are changes in blade tip-to-shroud clearance, airfoil surface finish, and internal leakage (parasitics). Figure 4-33 presents a schematic showing the areas of interest.

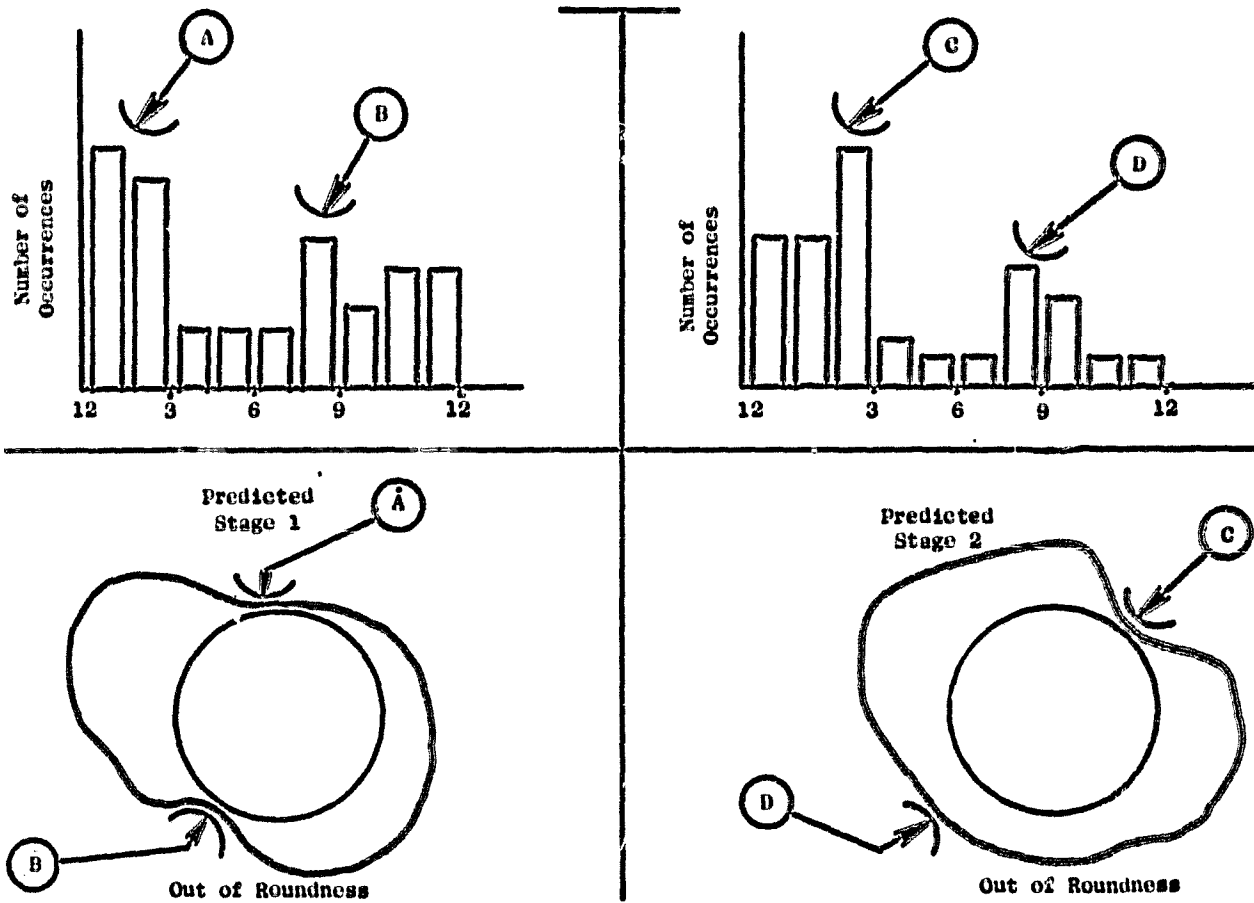
Figure 4-34. Field History - HP Turbine Shroud Rubs.

Analytical predictions of Stages 1 and 2 shroud distortion at takeoff power are shown in the bottom of Figure 4-34. This is an out-of-roundness type of distortion, and the arrows indicate the locations where rubs would be expected. On the top of this same figure is a histogram of the field experience showing the number of occurrences for the various rub locations. Comparison of the predictions and field experience show good agreement.

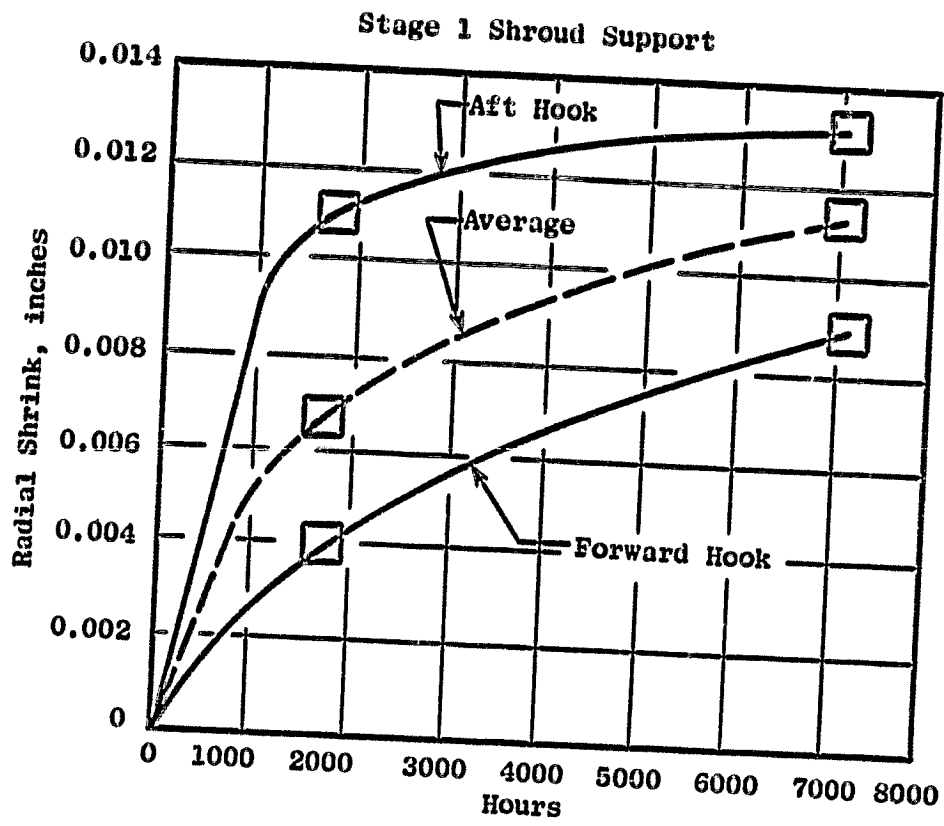
Figure 4-35. Factors Which Affect Blade Tip Rubs.

Another variable that influences shroud rubs is the change ("shrink") in radial dimension of the Stage 1 shroud support. "Shrink" data were available only at 1760 hours and 7100 hours, as shown in Figure 4-35. These data show that the aft end of the shroud support comes further inward radially than the forward end does, but that the difference in deflections becomes less with increasing time. At the 4000-hour mark, the average shrink of the Stage 1 shroud support (forward and aft) is about 0.009 inch.

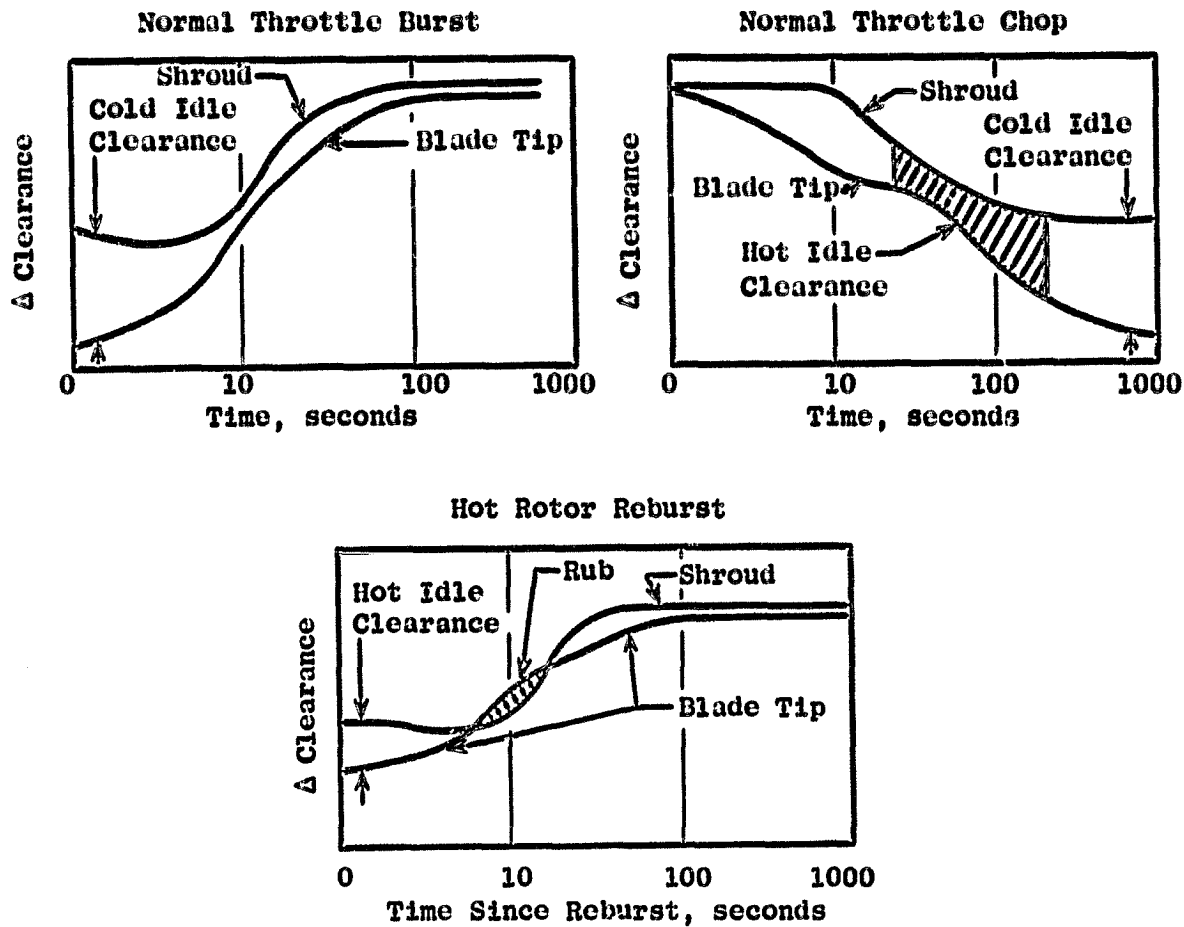
Figure 4-36. Hot Rotor Reburst Typical for Stage 1 HP Turbine.

Hot rotor rebursts can also result in tip rubs and increased blade tip-to-shroud clearances. Figure 4-36 depicts the thermal response of the Stage 1 blade tip clearance when the engine is rapidly accelerated from idle to takeoff, stabilized at takeoff, rapidly decelerated to idle, and then, after a certain period of time, once more rapidly accelerated to takeoff (hot rotor

reburst). These data indicated that while rubs would not be encountered during normal transients, the hot rotor reburst could result in rubs of 0.015 inch depth for Stage 1. It is believed that this, or a similar operational maneuver that produces thermal mismatch between the HPT rotor blade tips and shrouds, is the most likely cause of HPT blade tip rubs in revenue service operation. Revenue service data indicate that blade tip rubs occur randomly and infrequently during a given engine installation. This strongly suggests that HPT tip clearances are event-oriented.

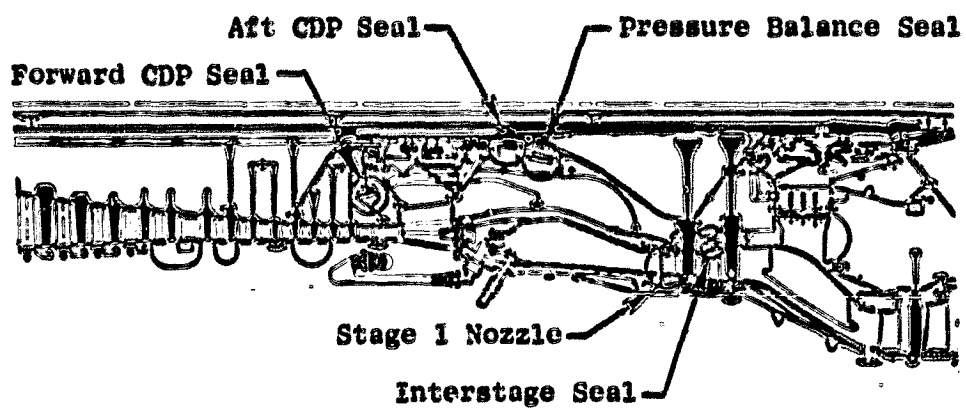
Figure 4-38. Areas of Internal Leakage (Parasitics).

Internal Leakage (Parasitics) - Areas for leakage within the high pressure turbine which may affect performance are the distortion of the Stage 1 nozzle and clearance increases for the pressure balance, inter-stage turbine and forward and aft CDP seals. The location of these areas is illustrated in Figure 4-38.

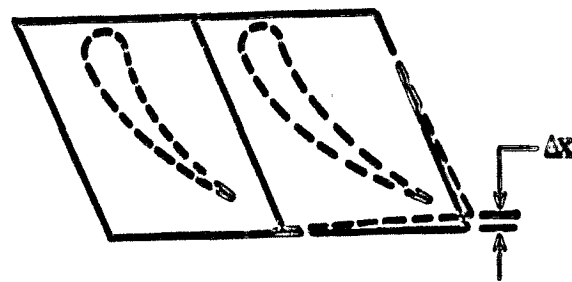
Figure 4-39. Stage 1 HPT Nozzle Vane Outer Band Distortion.

Distortion of the Stage 1 turbine nozzle outer band allows leakage into the flowpath and a resulting mixing loss over the Stage 1 blade. The average change in the "x" dimension (see Figure 4-39) for a 15-engine sample was

0.004 inch which produces a leakage area of 0.104 in.². This in turn results in a loss of 0.06 percent in turbine efficiency which corresponds to a 0.05 percent in cruise fuel burn. The distortion occurs during the first few hours of engine operation and remains constant thereafter.

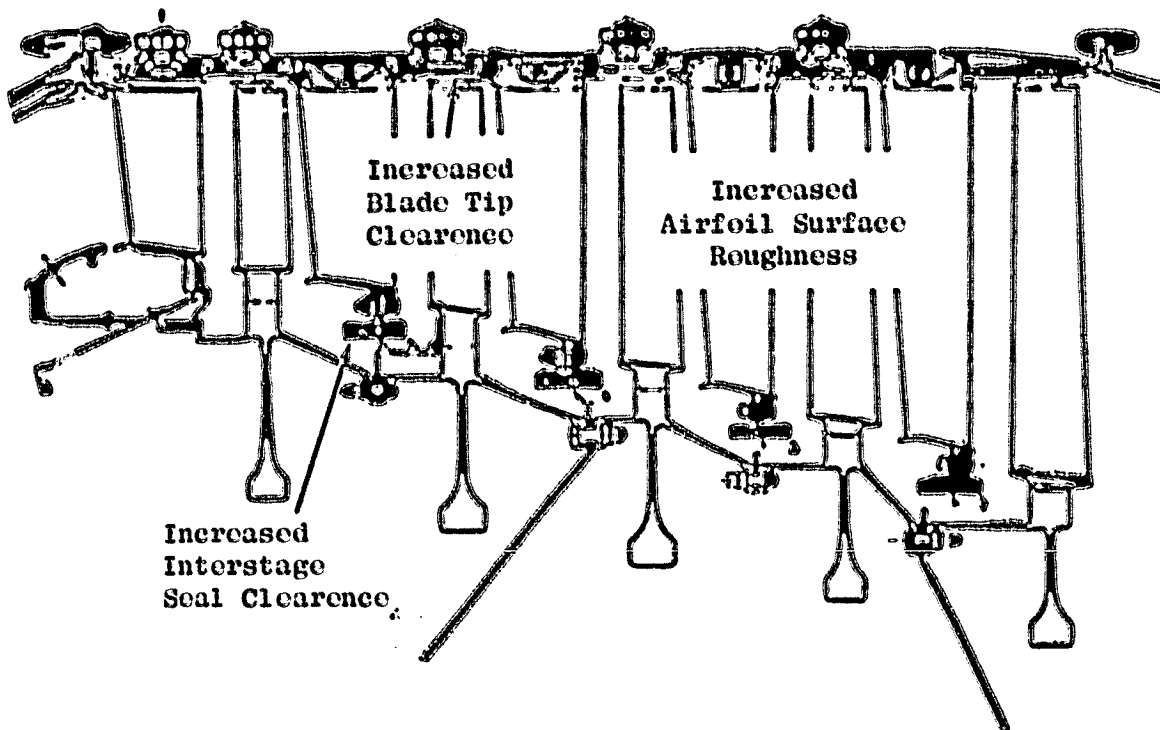
Figure 4-42. CF6-6 LP Turbine Section - Deterioration Modes.

Deterioration of low pressure turbine (LPT) components occurs primarily as a result of increased blade tip/shroud and interstage seal clearances, cracking of the LPT case rail cooling manifold, and increased airfoil surface roughness. These modes of deterioration are illustrated in Figure 4-42.

Another clearance-related deterioration mode is cracking of the LPT case hook cooling tubes. This condition can lead to additional cooling airflow in the cracked area and can also lead to circumferential starving of the flow downstream. These cooling air variations could result in increased operating clearance through hot flowpath gas inflow, loss of hook cooling, and increased thermal distortion. These deterioration modes also result in increased casing temperatures; therefore, it will not be apparent from an examination of honeycomb rub depths. No quantification of this deterioration mechanism will be attempted since it appears to be a random phenomenon and not typical of average CF6-6D LP turbine deterioration. This condition, however, may contribute to differences in deterioration rates for individual modules.

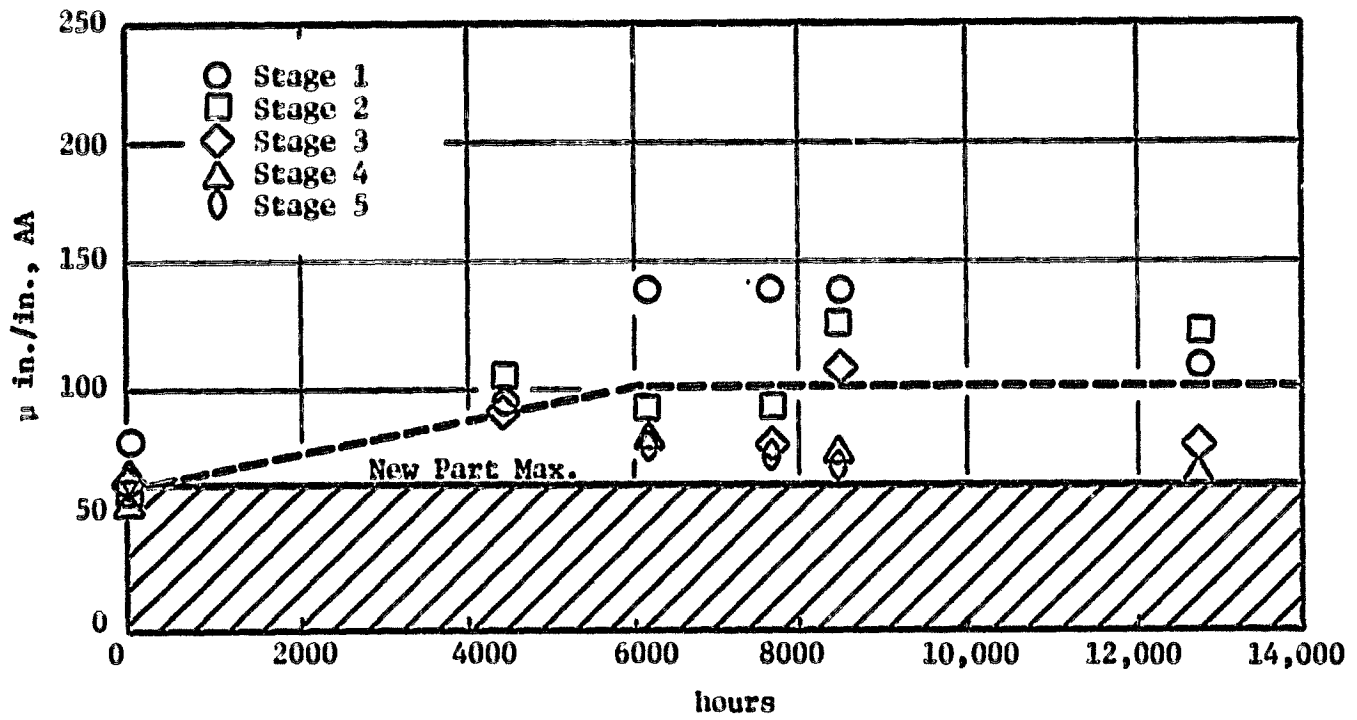
Figure 4-45. LP Turbine Vane Surface Finish - Convex Side.

Airfoil Surface Finish - The other significant deterioration mode identified was increased airfoil surface roughness. Figures 4-45 and 4-46 show summaries of blade and vane measured surface finish versus time for a sample of airfoils. Increased surface roughness results from airborne and engine-induced particulates which can result in surface buildup, oxidation and hot corrosion. There are various corrosion activities which can be accelerated in the temperature ranges in which LPT airfoils operate.

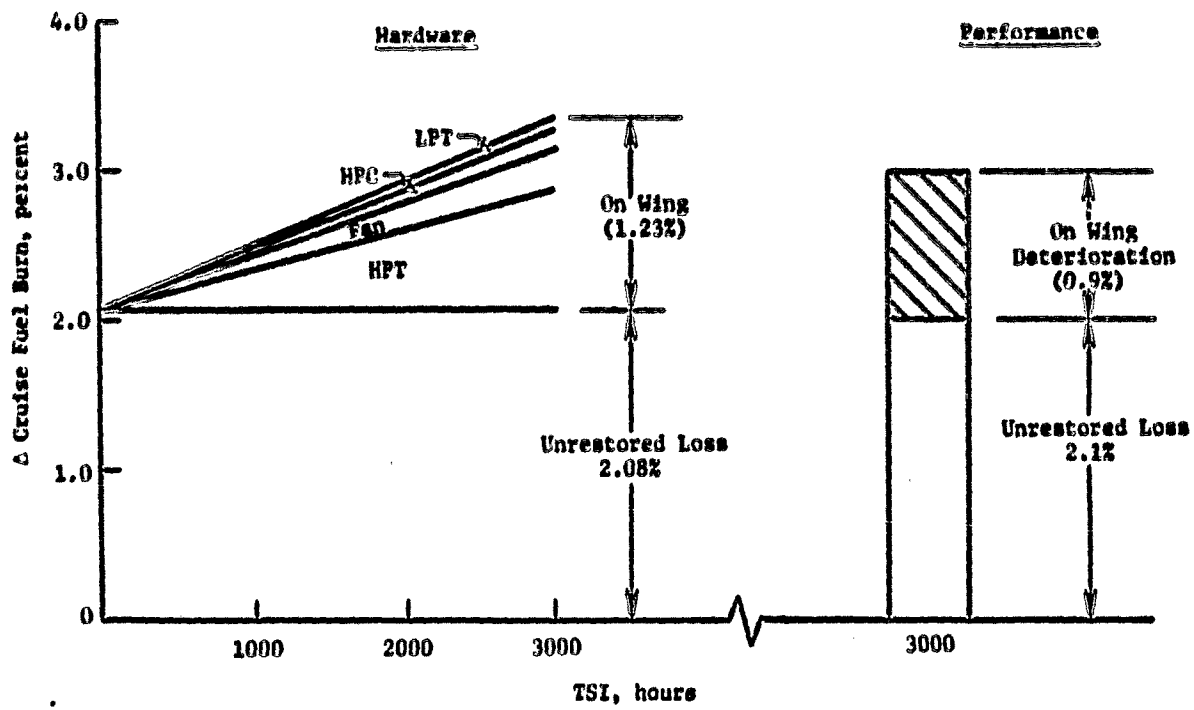
Figure 4-52. Multiple Build Engine Performance Deterioration.

As shown in Figure 4-52, the loss in cruise fuel burn assessed from hardware inspection data (3.3 percent), compared with that measured using performance data (3.0 percent) agrees within 0.3 percent in cruise burn. This good agreement verifies that the independently assessed results are valid and realistic. Note that a different baseline was used for the two data sources which were developed during the studies concerning unrestored losses. As shown, the losses for the multiple build engines are predominately in the high pressure turbine which were shown to be the result of increased blade to shroud clearances from rubs. It is important to remember that these hardware inspection and performance data represent the average for the individual modules, and that a large variation exists between individual assemblies and engines.

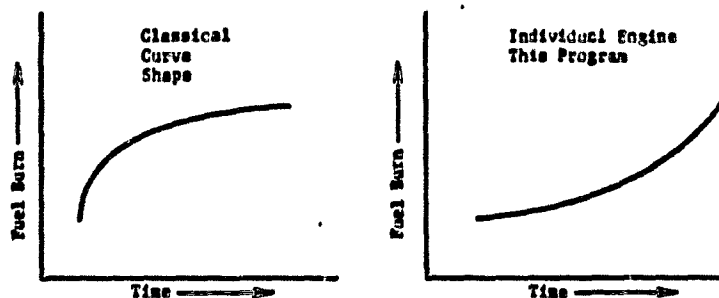
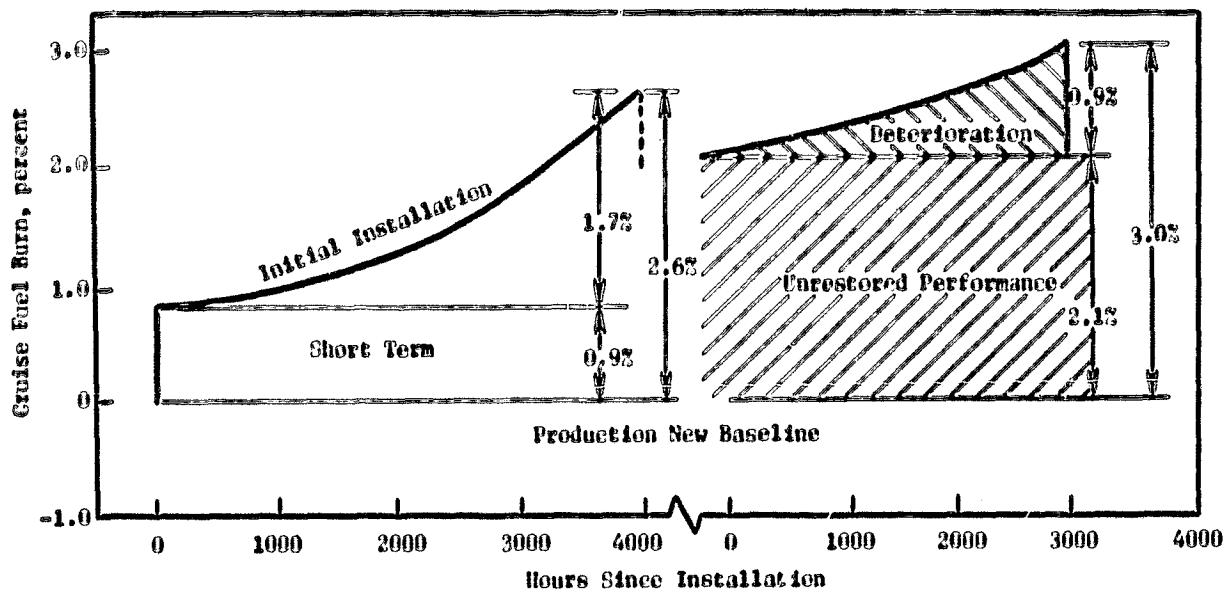
Figure 4-53. Performance Deterioration Model.

Figure 4-53 presents the "Performance Deterioration Model" which describes the magnitude of fuel burn and the rate at which these losses occur with accumulated time. Only performance data is used to construct this model since the necessary hardware data required to describe the curve shape from installation to removal was not available. Sufficient performance data was not available to specifically determine the amount of performance gained for initial installation engines following refurbishment, and is therefore, represented by a dotted line in the schematic.

The deterioration curve shape shown in this model differs from that generally presented to represent airline fleets. The inverted shape of the curve is the result of selectively averaging only a part of the fleet data, to produce a curve that averages individual engines for a very narrow band of engine hours; i.e., 4000 ± 450 hours for the initial-installation engine and 3000 ± 250 hours for the multiple-build engine. While the individual engines in the time families from 2000 to 5000 hours all show the same characteristics, the airline fleet average - which includes infant mortality failures as well as long-time removals - produces the classical curve shape where the rate of deterioration decreases with accumulated time. This is shown in the sketch as follows:

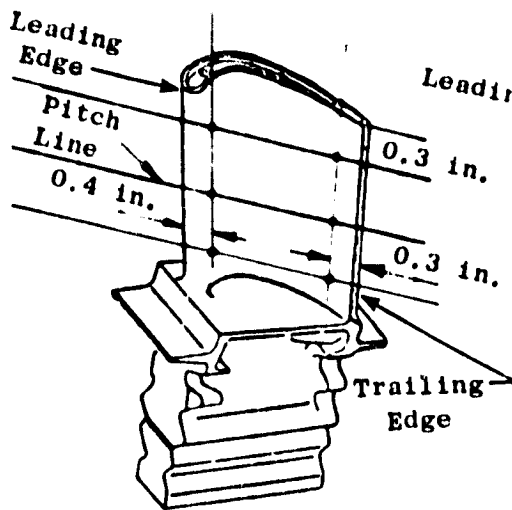
Figure A-19. HPT Turbine Rotor Stage 1 Blade.

A Bendix profilometer was used to measure the airfoil surface finish on incoming high pressure turbine blades and vanes at the airfoil locations shown in Figures A-19 through A-22. All surface finish measurements were recorded for the convex (suction) side. Changes in performance due to airfoil quality degradation on the concave (pressure) side are known to have minimal effect on performance (approximately ten percent of the suction side influence). A summary of the data is shown in Tables A-XXIX through A-XXXII.

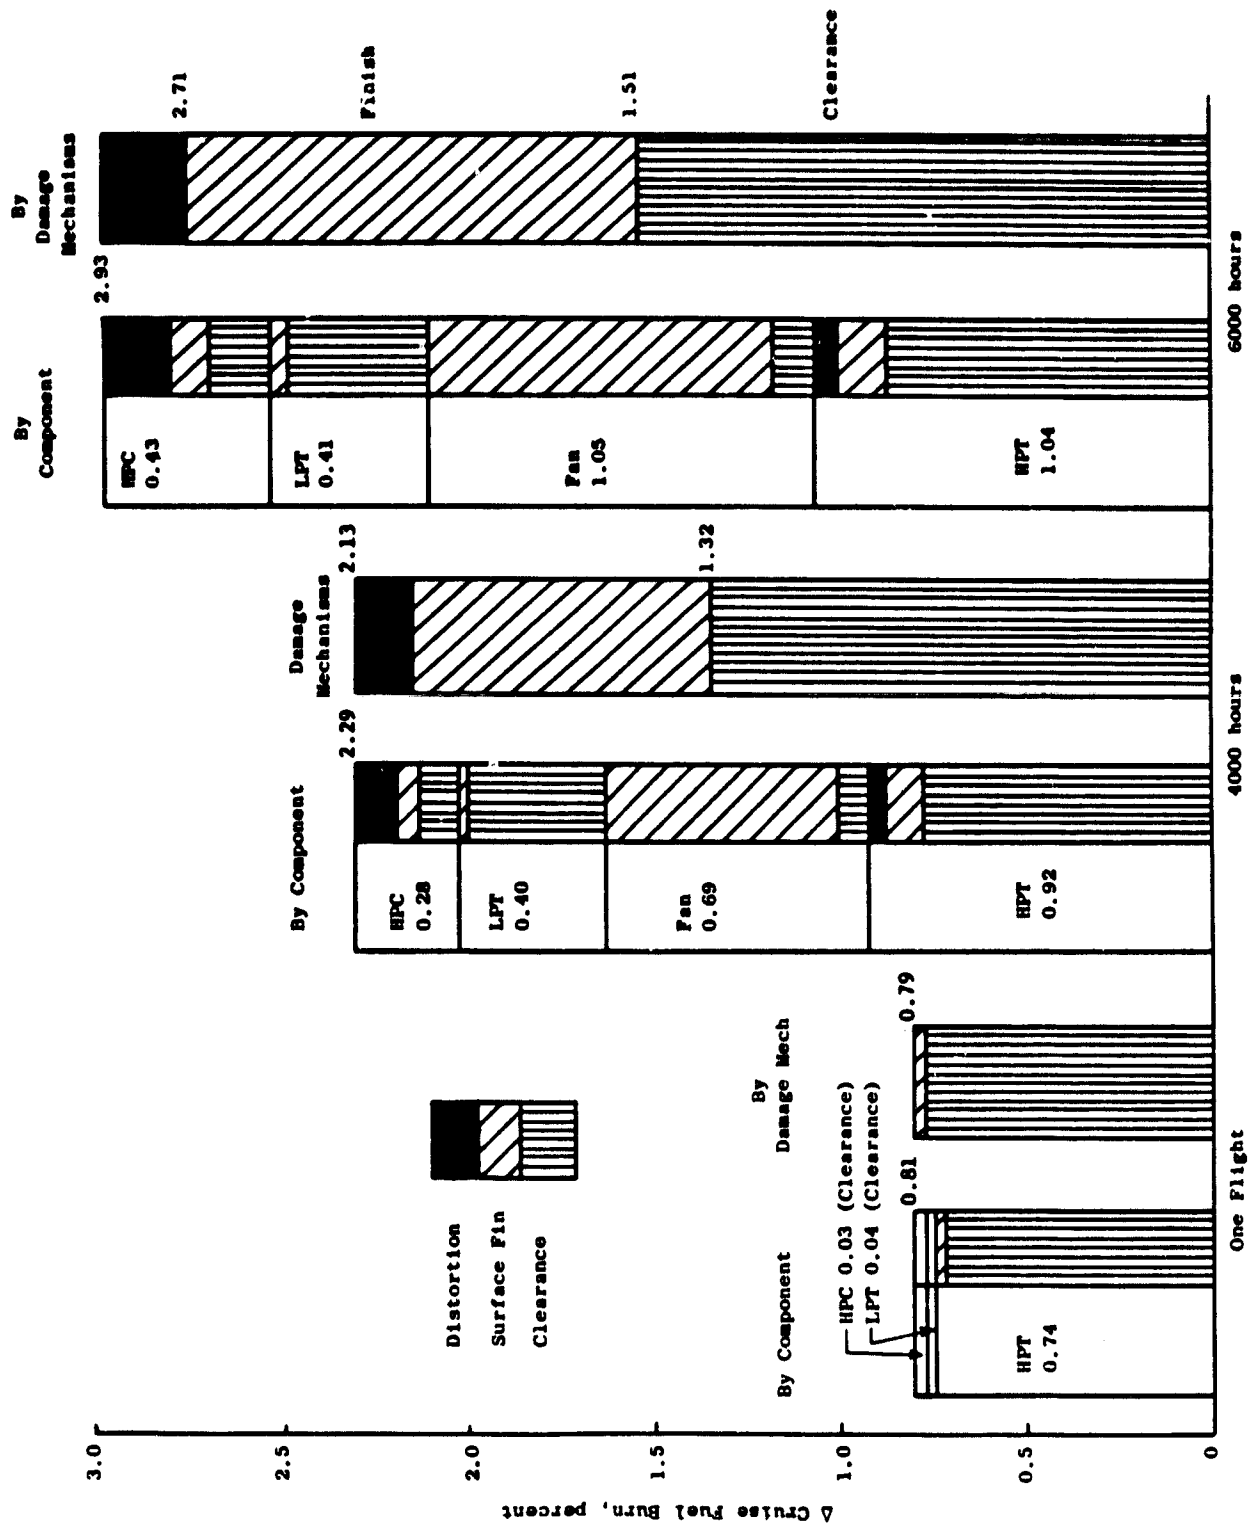
Figure E-1. No-Repair Models (Composite).

Figure E-1 presents the performance deterioration model that was generated for the CF6-6D engine after 6000 hours of operation assuming that no repairs would have been required. For comparative purposes, the deterioration models for the first flight (short-term) and after 4000 hours (initial installation) are also presented. These latter two models were constructed according to data already presented in Sections 3.2 and 4.2. The figure presents composite models, and includes the modular distribution of fuel burn deterioration as well as the damage mechanisms. These two items are presented separately in Figures E-2 and E-3 for clarity.

As presented, the additional performance deterioration estimated for the period between 4000 and 6000 hours is 0.64 percent cruise fuel burn. This does not include the probable effects from losses associated with loss of mechanical integrity. The data presented in Figures E-2 and E-3 do confirm previous assessments as follows. The clearance effect (Figure E-3) generally occur during the initial 4000 hours, but the surface finish effects continue at about the same rate through 6000 hours. The data presented in Figure E-2 show the additional losses in both turbines to be small beyond 4000 hours, while the fan and HP compressor losses continue at the same rate through 6000 hours. This is as expected since clearance changes dominate the turbine distress, while erosion and loss of airfoil surface finish are the major deterioration modes for the fan and HP compressor modules.

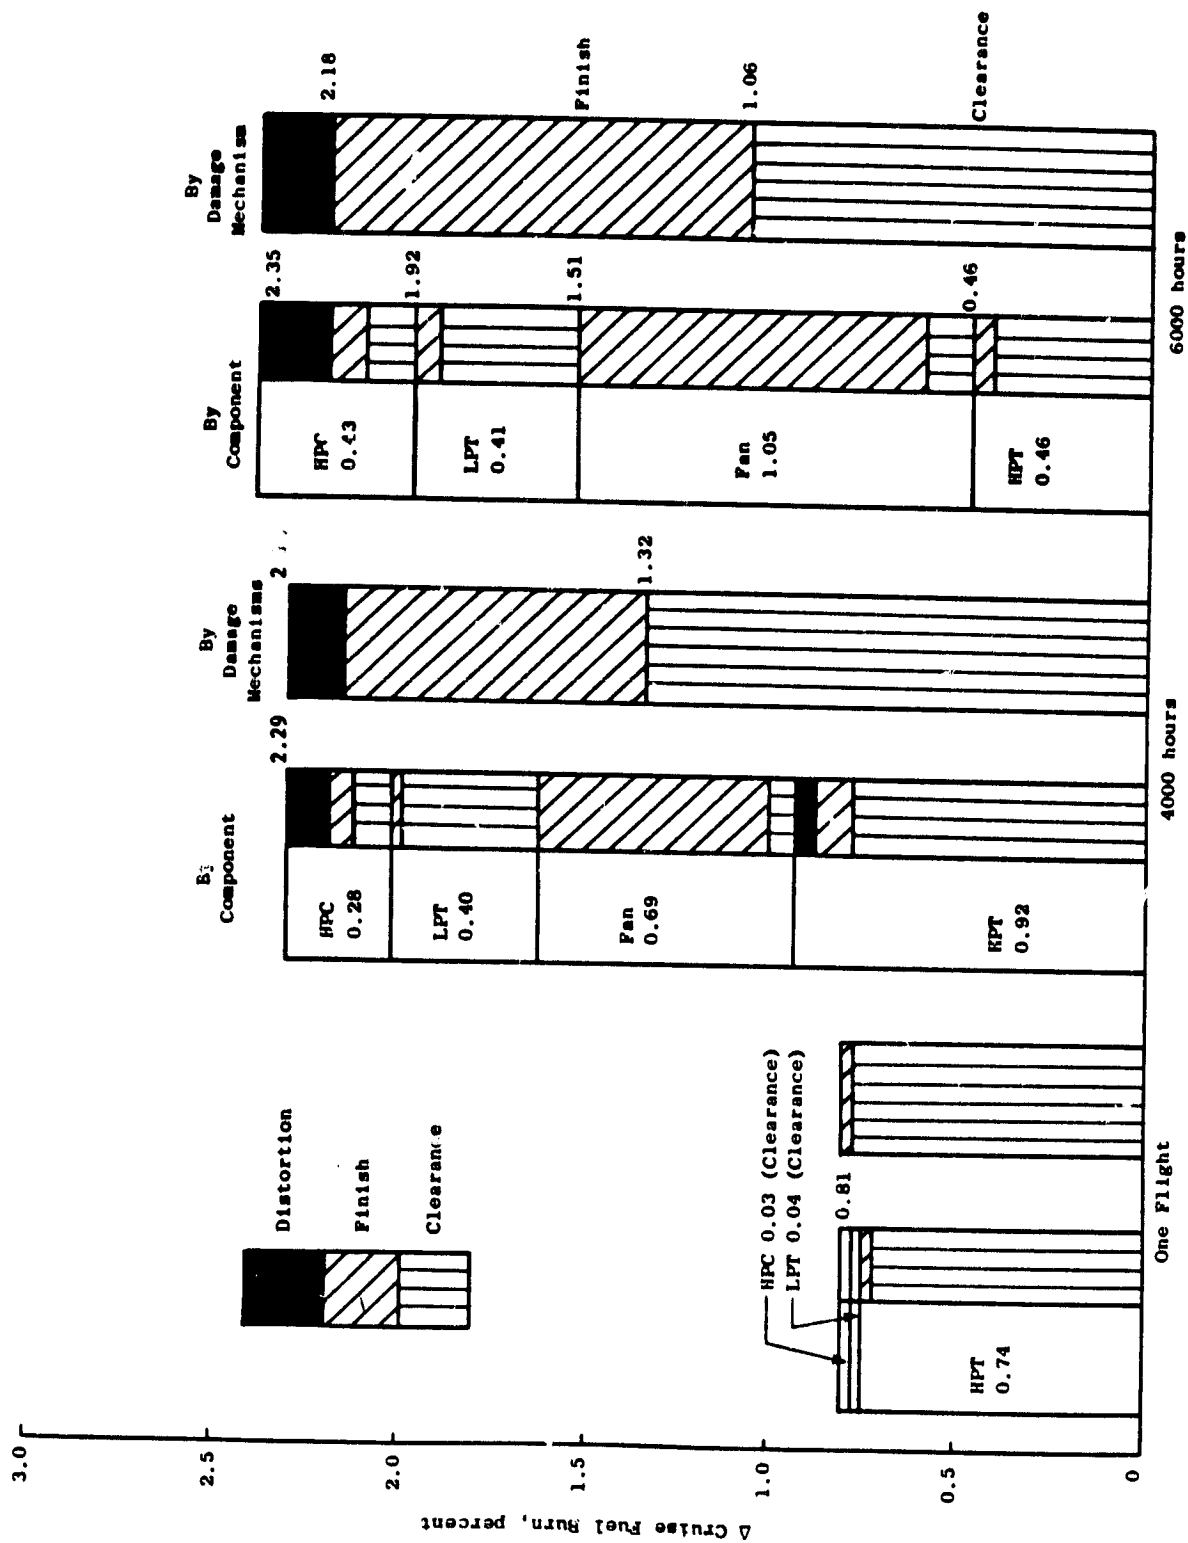
Figure E-4. 6000 Hours With-Repair Model (Composite).

The "6000 Hours With-Repair Model" is shown in Figure E-4 and the assessment by module and damage mechanism is shown separately in Figures E-5 and E-6. These figures also include the deterioration levels without repair after one flight and after 4000 hours for comparison. Note that the total loss at 6000 hours (with repairs after 4000 hours) is very nearly the same as the total loss after 4000 hours prior to repairs. This agrees with an observation noted for the multiple build engines (reference Section 4.1) in that the on-wing loss after shop repairs is the same as that refurbished during the previous shop visit. Since the HPT module is the major source for the on-wing deterioration of a multiple-build engine, and the HPT module was the only modules repaired in this theoretical 6000 hour model, this agreement is not surprising.

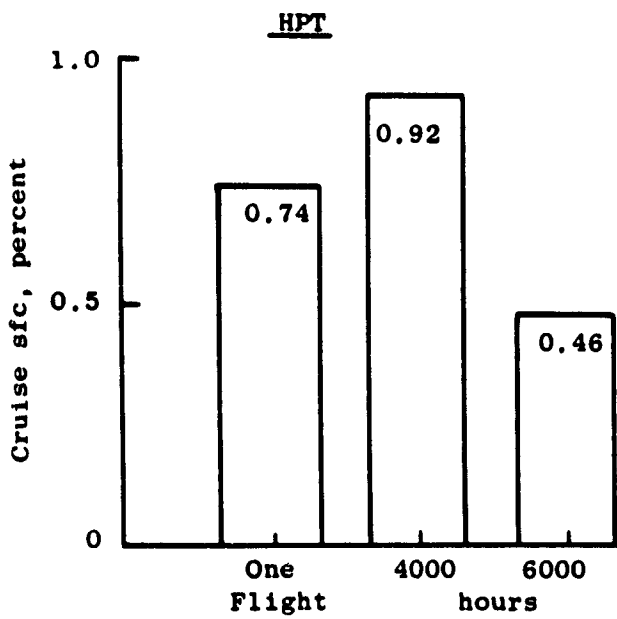
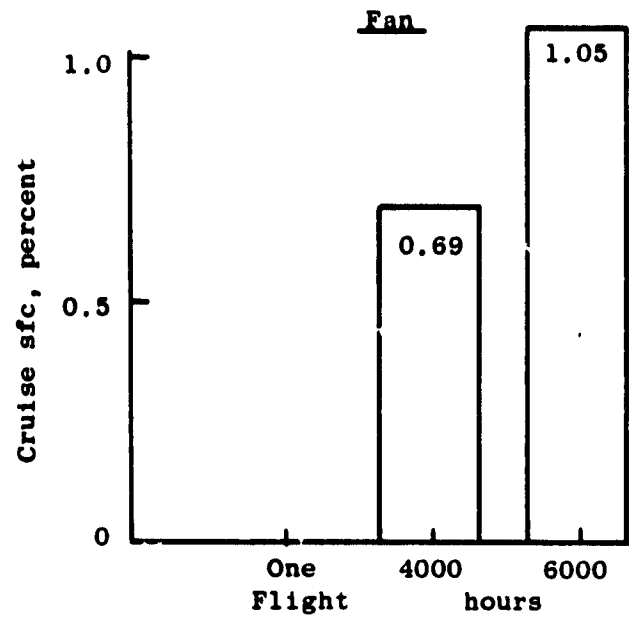
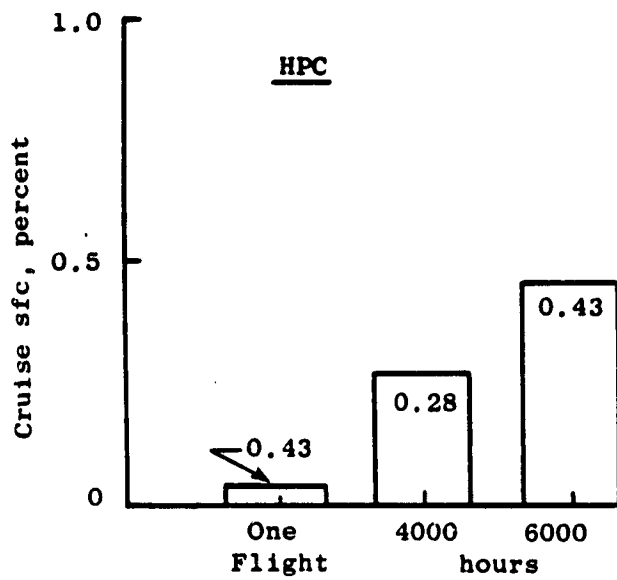
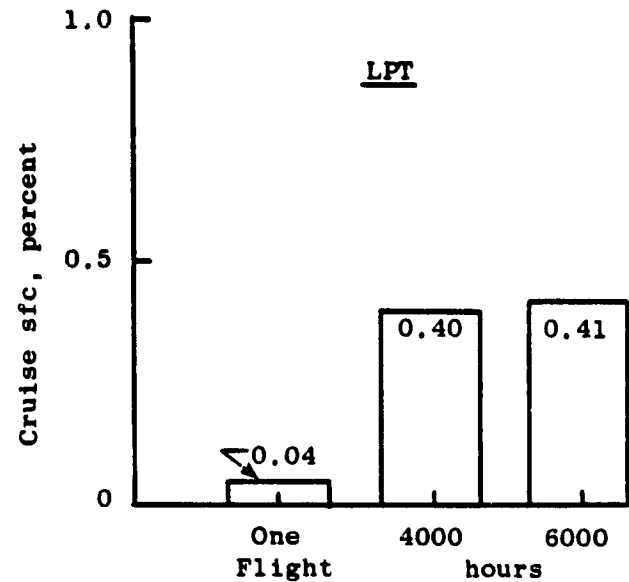
Figure E-5. 6000 Hours With-Repair Model - By Component.

The data presented in Figures E-5 and E-6 show similar results to that presented in Figure E-2 and E-3 for the "6000 Hour-Without-Repair Model". The losses attributed to the turbine modules agree with its dominant damage mechanism, i.e., increase clearances. Similarly, the surface finish changes correlate with the deterioration trends for the fan and high pressure compressor.
