CF6-6D ENGINE PERFORMANCE DETERIORATION

Ray H. Wulf

GENERAL ELECTRIC COMPANY
AIRCRAFT ENGINE GROUP
CINCINNATI, OHIO 45215

1. Report No. NASA CR159786		2. Government Accession No.		3. Recipient's Catalog No.	
4. Title and Subtitle CF6-6D Engine Performance Deterioration				5. Report Date January 1980

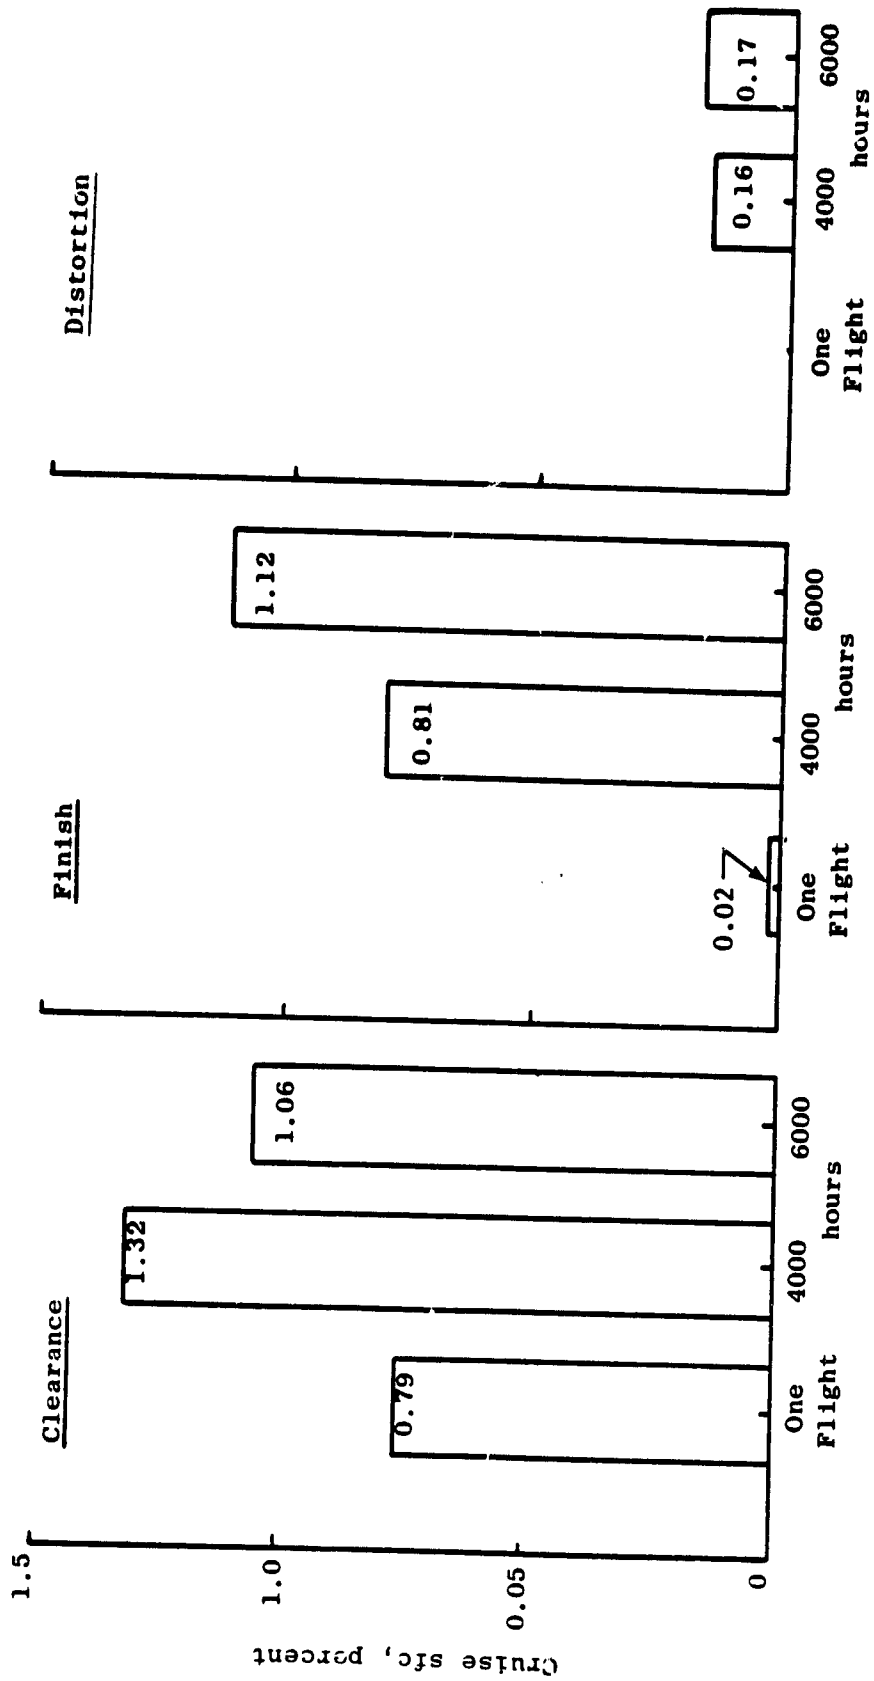
Figure E-6. 6000 Hours With-Repair Model - By Damage Mechanisms.

The data presented in Figures E-5 and E-6 show similar results to that presented in Figure E-2 and E-3 for the "6000 Hour-Without-Repair Model". The losses attributed to the turbine modules agree with its dominant damage mechanism, i.e., increase clearances. Similarly, the surface finish changes correlate with the deterioration trends for the fan and high pressure compressor.
