Test Evaluation of a Laminated Wood Wind Turbine Blade Concept

James R. Faddoul
National Aeronautics and Space Administration
Lewis Research Center

May 1981

Prepared for
U.S. DEPARTMENT OF ENERGY
Conservation and Solar Energy
Division of Wind Energy Systems

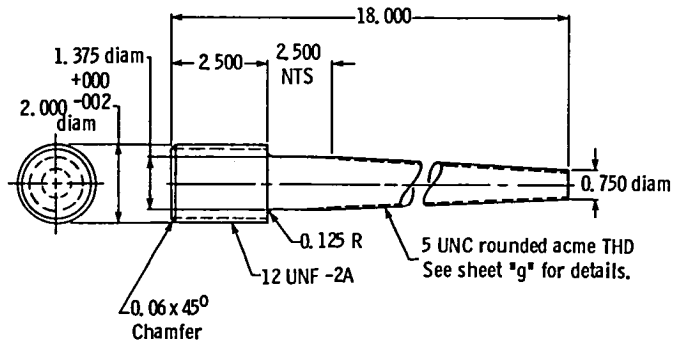
Figure 15. - Tapered stud configurations.

(a) 1 3/8" to 3/4" taper ratio.

1. Stud configuration (imbedded portion) should be tapered similar to that shown in Figure 15(a). Thread type and taper ratio appear to be rather insignificant to overall performance.
2. The hole in the wood should be step tapered.

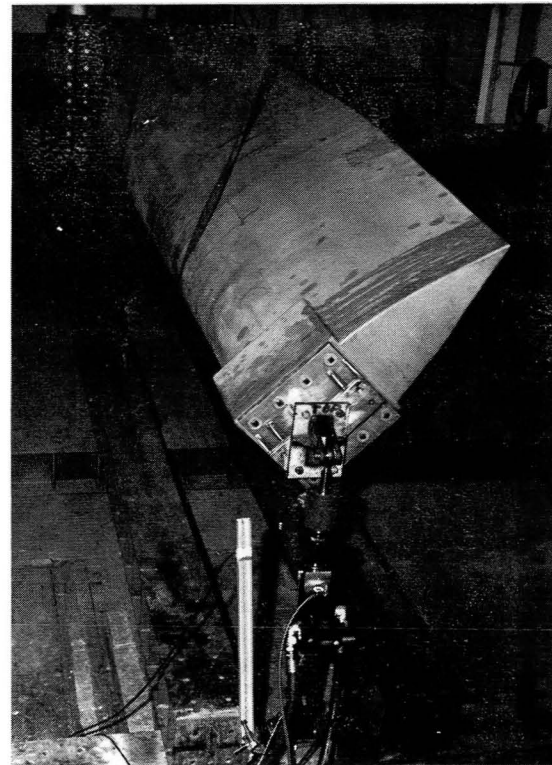
Figure 27. - Twenty foot blade section mounted and ready for test in USARTL (Ft. Eustis) Facility.

blade was mounted as a cantilever beam to a 2 in. thick steel plate (54 in.²) which was backed up with 12 in. "H" beams having reinforced webs. Figures 27 and 28 show the blade as mounted. The free end of the blade was attached to a hydraulic actuator through a load cell and an LVDT. Load was calibrated as a function of actuator stroke and the test was then controlled by the stroke measurement. Periodic checks were made to determine if changes in load/stroke relationships had occurred. To closely approximate the combined flatwise and edgewise design loads, which reach similar peak values at approximately the same time, the blade chord line was set at a 45° angle to the applied load. The innermost 3 ft of the test section then was subjected to loadings which closely approximated those expected in the field. This had little influence on the outboard portion of the test specimen since the applied moment was well below the peak seen by that part of the blade during actual service. Figure 29 shows a plot of the moment on the blade as induced by wind turbine operations and a comparison of the test moment. Eighteen strain gauges were active for this phase of the testing. Using the data obtained in the Phase I testing, strain/moment values were predicted and found to correlate for most of the active gauges during the initial load deflection tests in the Ft. Eustis facility.

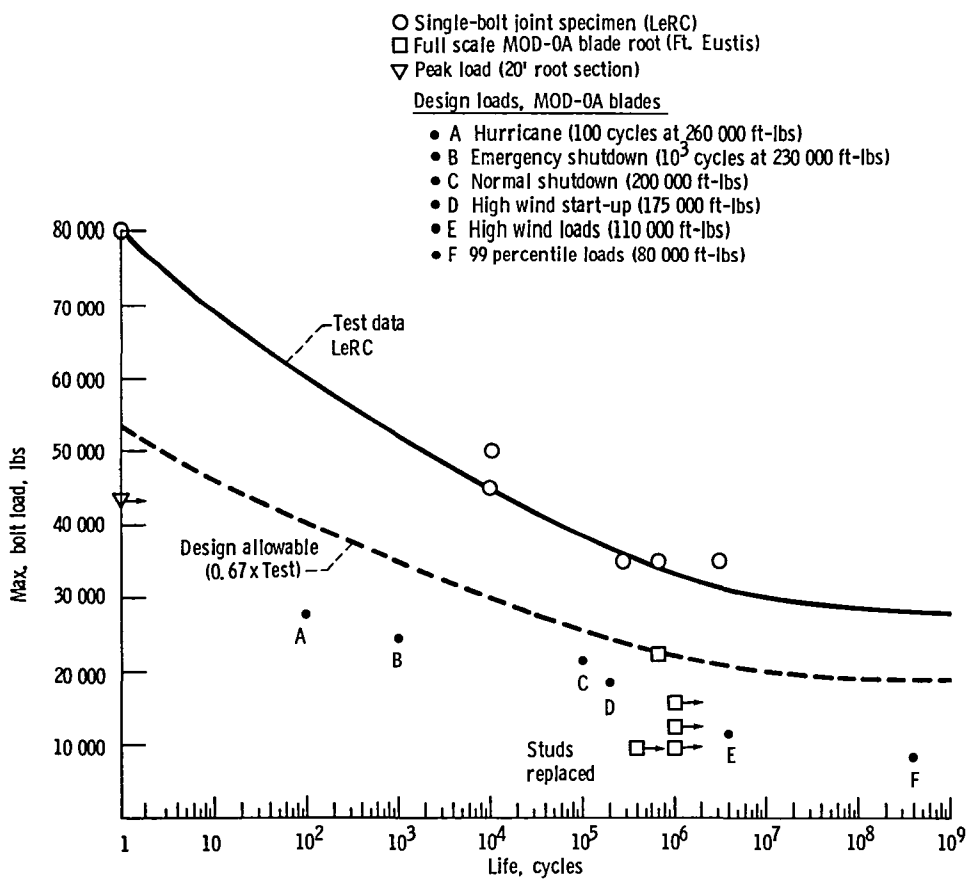
Figure 33. - Fatigue data for bolt-to-wood tension joints fabricated by Gougeon Bros., Inc.

Figure 33 is a summary of the test conditions at Ft. Eustis as compared to both the blade operating requirements and the individual stud test data. It should be noted that Figure 33 has converted the actual test moments to a maximum bolt load based on the number of studs and the bolt circle diameter. To convert back to moment, multiply the bolt load by 9 (approximate) to obtain the moment in ft-lb. The most significant point to be extracted from Figure 33 is, however, that while the actual testing of the blade section was far in excess of the MOD-OA design points there was no failure of the wind or bend joints. In addition, 670,000 cycles were required to fail studs even though there was a severe stress concentration built into the stud and 3×10^6 cycles at lower loads had been previously applied.

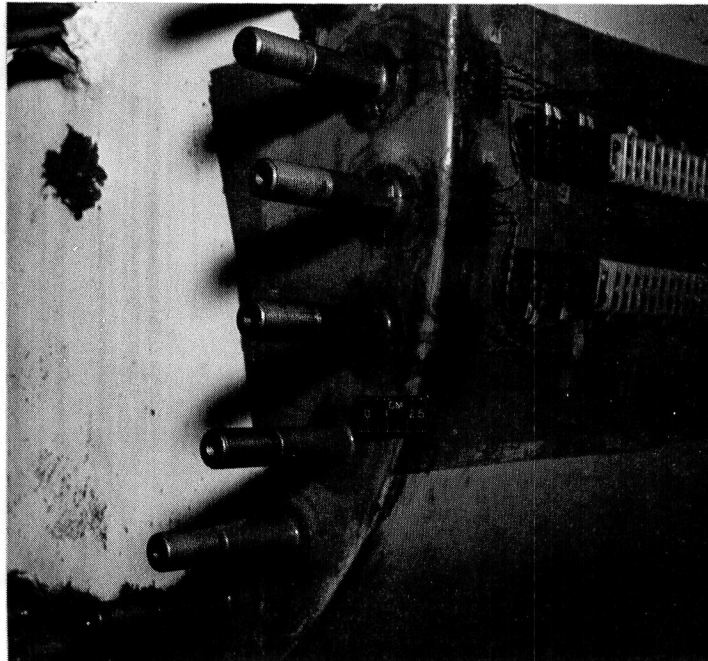
4.3.1. Stud Pretorque Tests. - For this test, three adjacent studs were each instrumented with four strain gauges. The gauges were applied by grinding flats on the unthreaded portion of the 3/4 in. stud. Orientation of the gauges and the studs was as shown in Figure 34. Very fine lead wires (36 gauge) were used and grooves were ground in the face of the stud shoulder to preclude crushing of the wire when the spool was put on and the nuts were torqued. The spool piece was then slipped into position and all the studs but the three having strain gauges (and those broken) were torqued to 150 ft-lb. The blade was then mounted on the test stand as a cantilever beam and the strain gauges on the instrumented studs were zeroed.

Figure 34. - Studs with flats for strain gages (lead wires and strain gages removed).

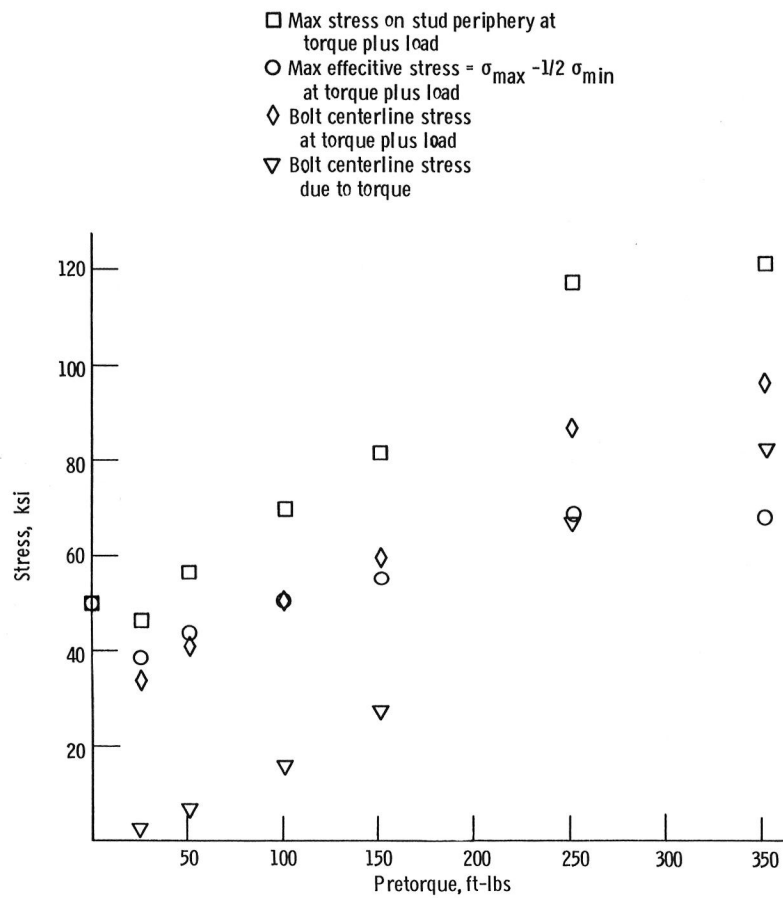
Nuts were then placed on each of the three instrumented studs and pretorque was applied. Then, a bending moment was imposed on the blade in discreet steps and the change in stud strain for each step (including the pretorque step) was measured. The strain data from the four gauges on each stud was then used to determine the center-line stress and a maximum perifial stress for each load level and each stud. Plots of the most highly stressed stud are shown in Figure 35. As can be seen, pretorque of the stud-through-flange configuration of the wood blade does not eliminate the cyclic stresses in the shank of the bolt. This finding is in contrast to the typical flange-to-flange joint where the bolts can be pretorqued to produce a stress that will hold the flange faces together under the highest load to be expected. Normally in a bolted joint with sufficient pretorque in the bolts, subsequent changes in stress in the bolt are very small or non-existent as long as the load does not exceed that for which the pretorque was established. For 3/4 in. bolts, the pretorque can be as high as 400 ft-lb. However, for the stud-to-flange connection of the wood wind turbine blade, pretorque above 250 ft-lb would probably tend to decrease cyclic capability. Additional test data will be developed and reported at a later date. However, it appears that there is a rather broad range of torque values (50 - 200 ft-lb) that will produce satisfactory fatigue results. And, even at 350 ft-lb, the value selected for the fatigue testing at Ft. Eustis, a properly designed stud provides a positive margin of safety on fatigue.

Figure 35. - Effect of pretorque on bolt stresses. (Max loaded tensile stud.)

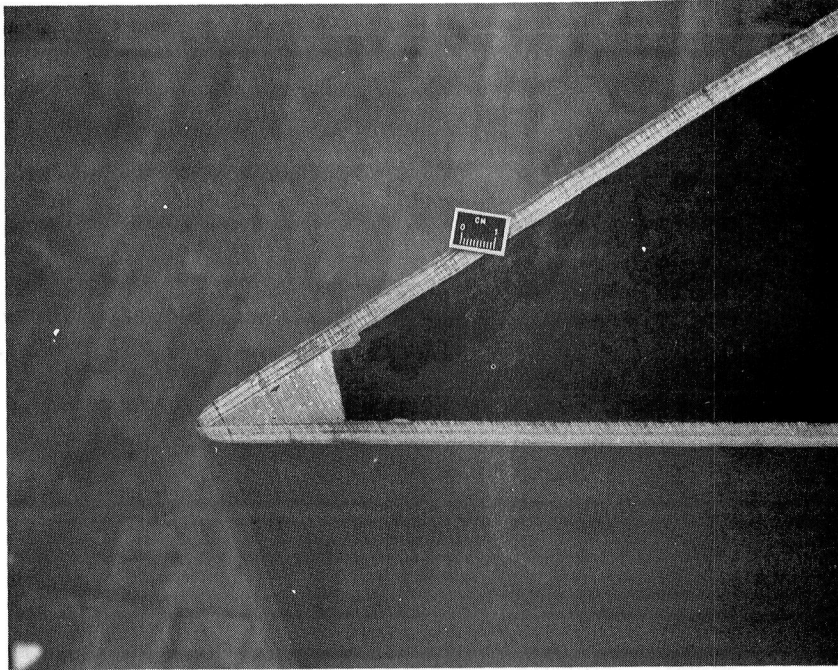
Figure 36. - Trailing edge bond of sectioned 20 foot blade test specimen.

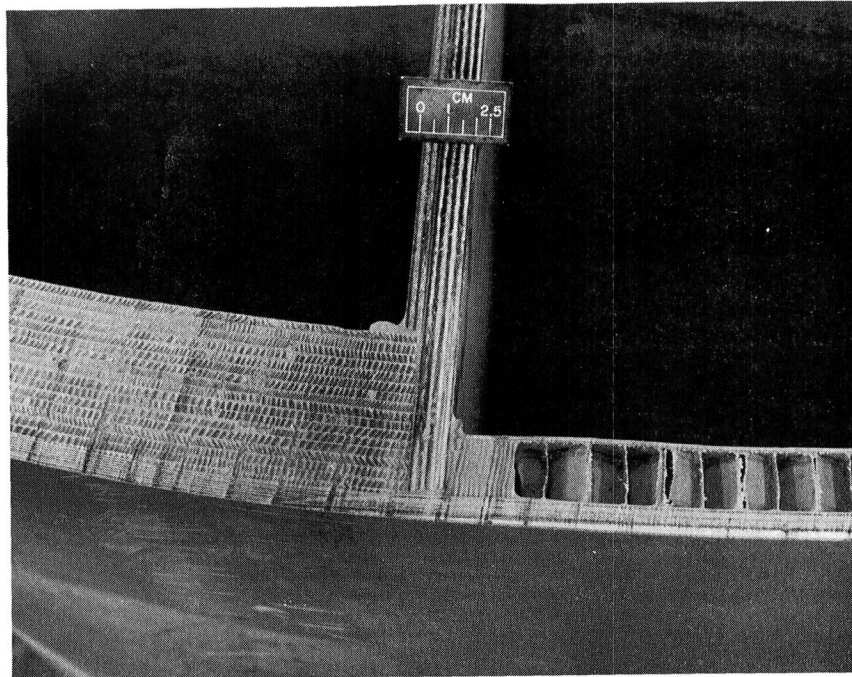
Figure 38. - "D" Spar/Shear web/trailing edge connection of 20 foot wood specimen.

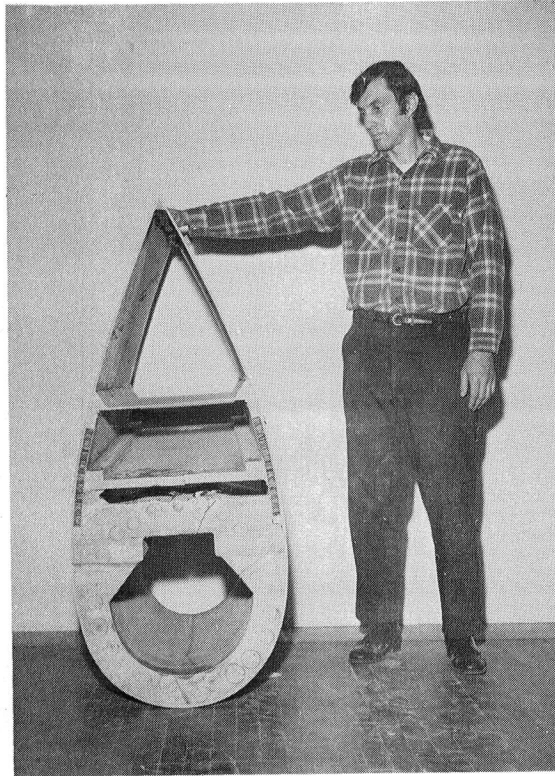
Figure 40. - Inboard section cut from 20 foot wood blade test specimen.

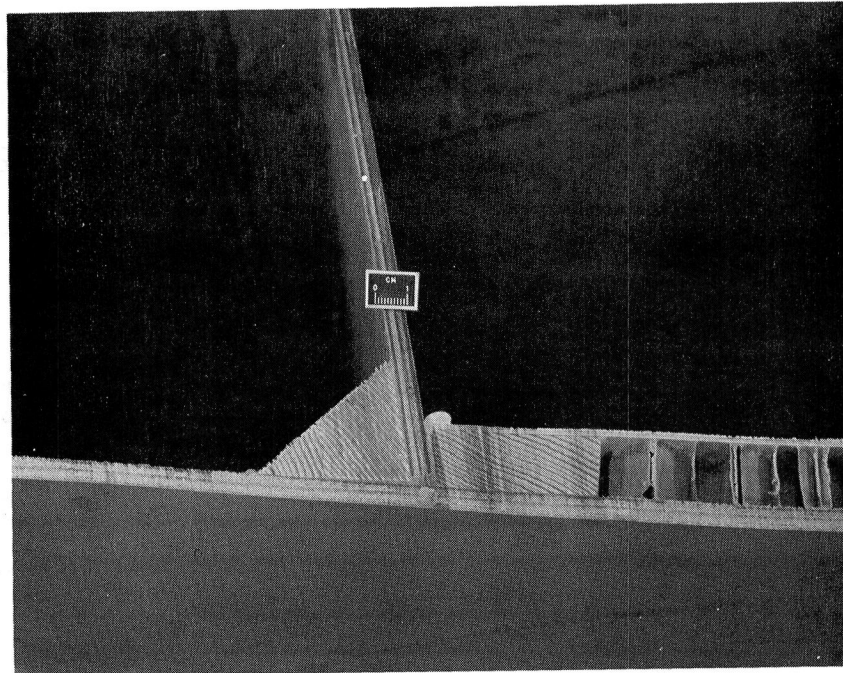
Figure 42. - Shear web and Vertical reinforced afterbody panel in outboard portion of 20 foot test section.
