TR-1530

LIGHTNING PROTECTION SYSTEM FOR SPACE SHUTTLE

PREPARED BY
PLANNING RESEARCH CORPORATION
Systems Services Company
for
DESIGN ENGINEERING
JOHN F. KENNEDY SPACE CENTER, NASA

August 1977

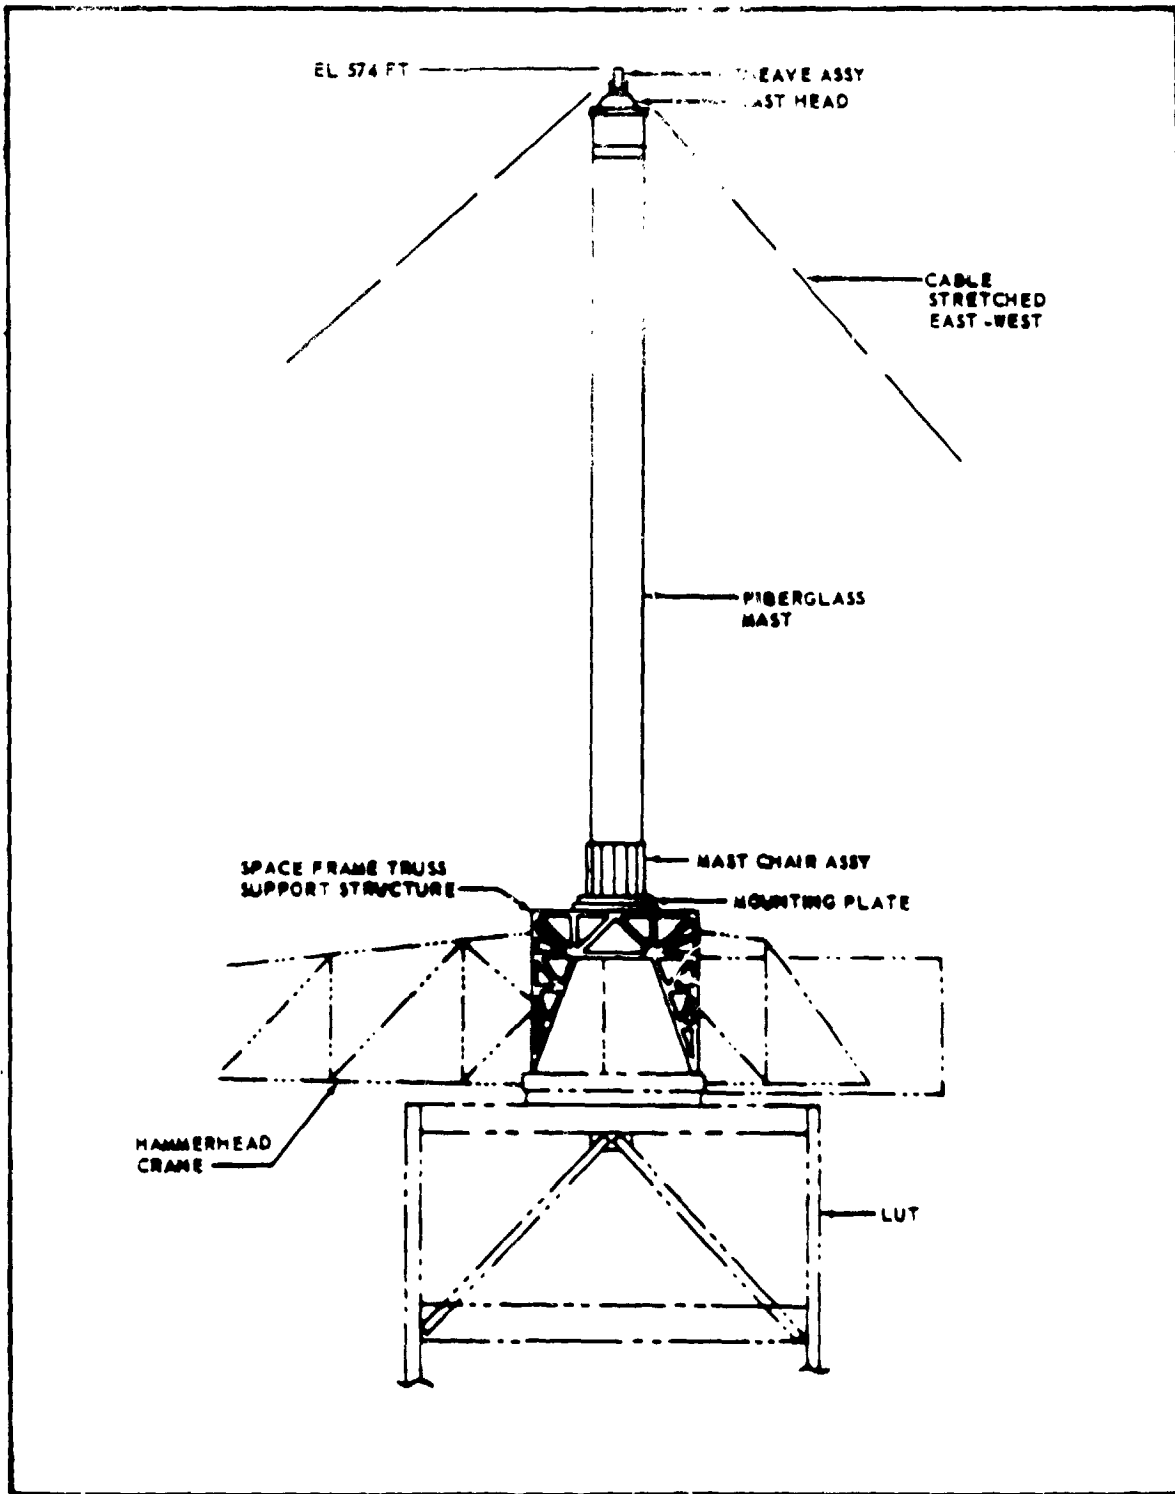
Figure 3-1. ASTP Lightning Protection System

3.1.1.1 ASTP Lightning Protection System. The ASTP lightning protection system was designed to protect the Saturn/Apollo launch vehicle while it was prepared for launch on Complex 39, Pad B. Structurally, the ASTP lightning protection system consists of a 75-ft fiberglass tube with a steel cap/sheave assembly about 5 ft in height attached to its top. The base of the pole incorporates a steel chair assembly in which the pole is bonded and secured. The bottom of the chair assembly is anchored to a structural steel space frame which supports the mast above the hammerhead crane atop the Launch Umbilical Tower (LUT) and ties into the base of the crane itself. A steel wire rope is stretched over the sheave at the top of the mast and anchored at ground level about 1,000 ft both east and west from the centerline of the LUT. The cable hangs with a catenary shape that is required to clear all grounded structures by at least 50 ft. The grounded steel cable affords a three-dimensional cone of protection against lightning strikes within the protected area below the catenary cable. A sketch of the system is shown in figure 3-1. During operations of the crane when it is rotated about the top of the LUT, the lightning mast also rotates with the crane; however, the catenary cable does not rotate and is maintained in an east-west plane as a result of a vertical pivot on the sheave assembly at the top of the mast. This allows the mast to rotate with the crane under the stationary catenary cable.

instead of east-west. The ASTP fiberglass mast and supporting steel structure were designed for only one Saturn launch with no requirement for the effects of repeated exposure to launch-induced loads. The structural components were designed for only operational wind conditions and minimum protection from the natural environment because the ASTP mast could be moved with the mobile launcher umbilical tower to the VAB for protection from more severe environments and for periodic inspection and maintenance.

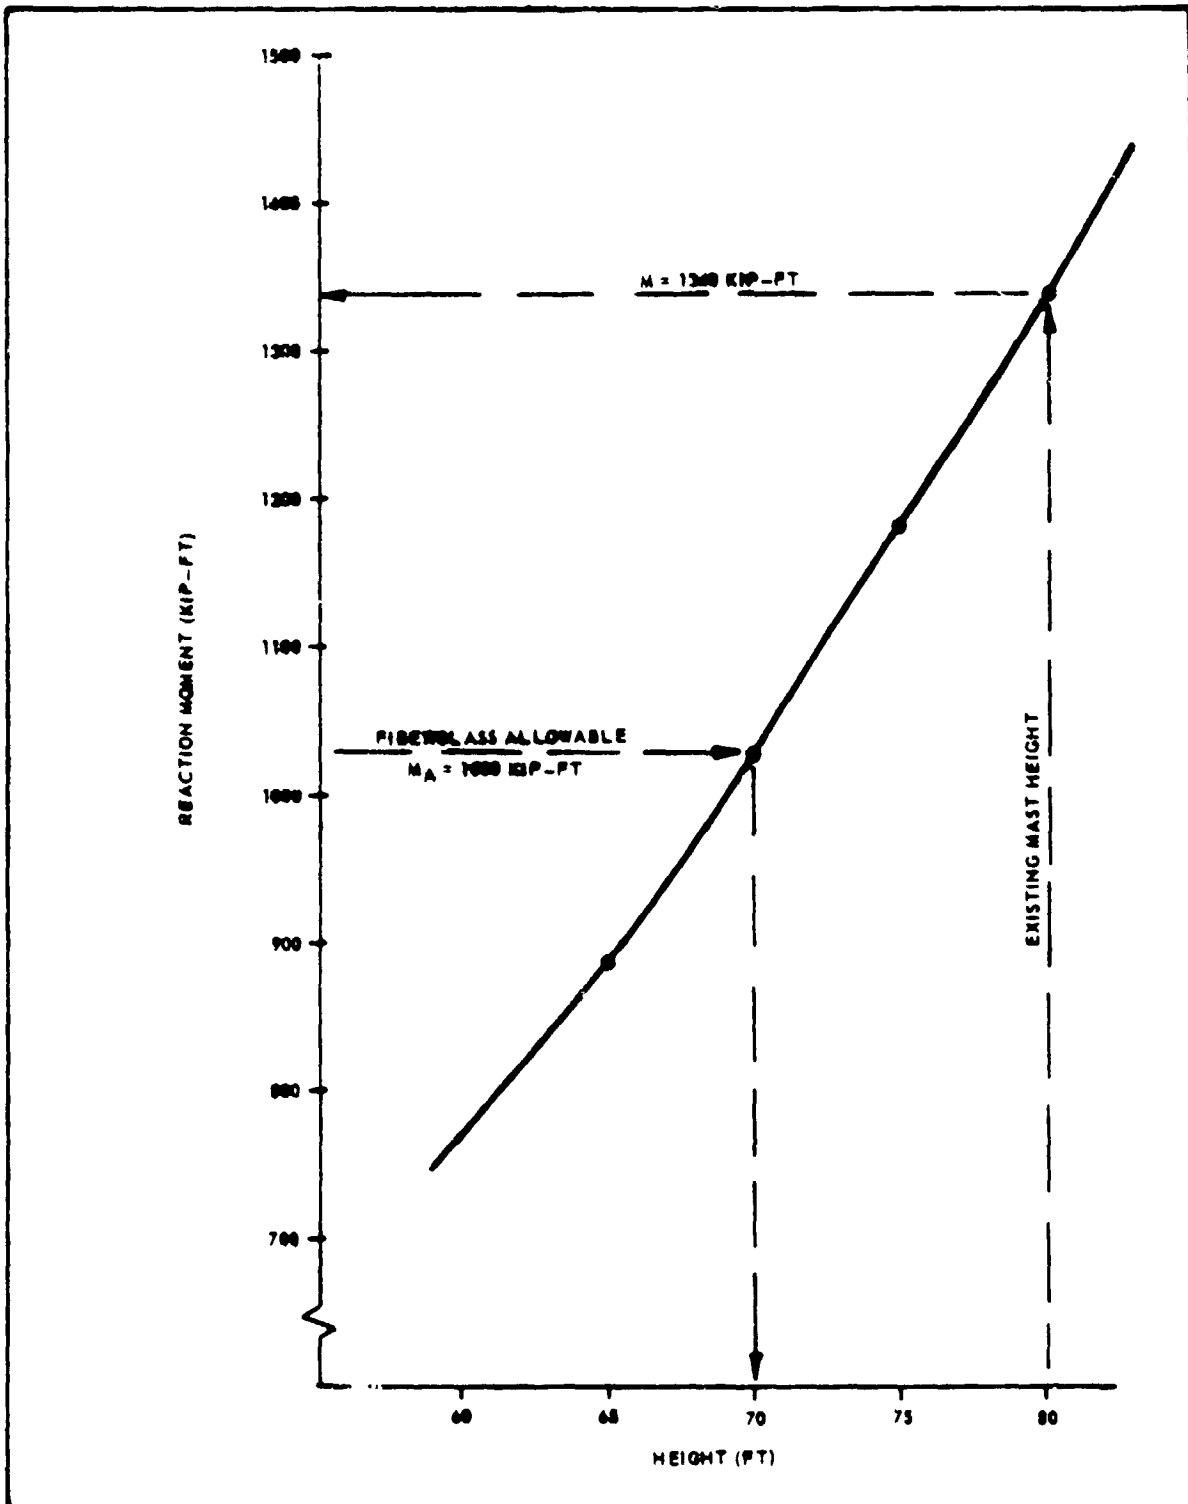
Figure 3-2. Moment Reaction at Mast Base Versus Height of Mast

3.1.3.2 Mast Design Modifications. The ASTP mast rises 80 ft above its support structure. When applying the design wind pressure loading of 83.5 lb/ft², the reaction moment at the base is of the order of 1,340 kip-ft and exceeds the allowable moment for the fiberglass material. Figure 3-2 shows a comparison of reaction moment at the mast base versus the mast height where the reaction moment is a function of mast height squared. To remain within an allowable bending stress, the maximum mast height is 70 ft; therefore, the SSAT mast must be shortened by at least 10 feet by removing a section of the fiberglass tube. Because the top portion of the mast has a thinner wall, a portion should be taken from it here in order to maintain the maximum strength at the bottom of the mast where the greatest moment is carried. A steel ring is provided at the top of the tube to facilitate fastening the mast head and sheave assembly; therefore, the cutting and splicing should be done at a convenient distance below the top of the fiberglass tube and between the top two stiffening diaphragms. The splicing procedure would be that used for the original construction of the mast.

Because of the increased design loads for the SSAT lightning mast, the anchor connection used to secure the mast to its support structure must be strengthened. The ASTP installation utilized 7/8-in \emptyset high-strength bolts through the

1-in bottom plate of the steel chair at the mast base. For the SSAT installation, 1-1/4-in \emptyset high-strength bolts and a 1-in backing plate could be used to obtain the greater required strength.

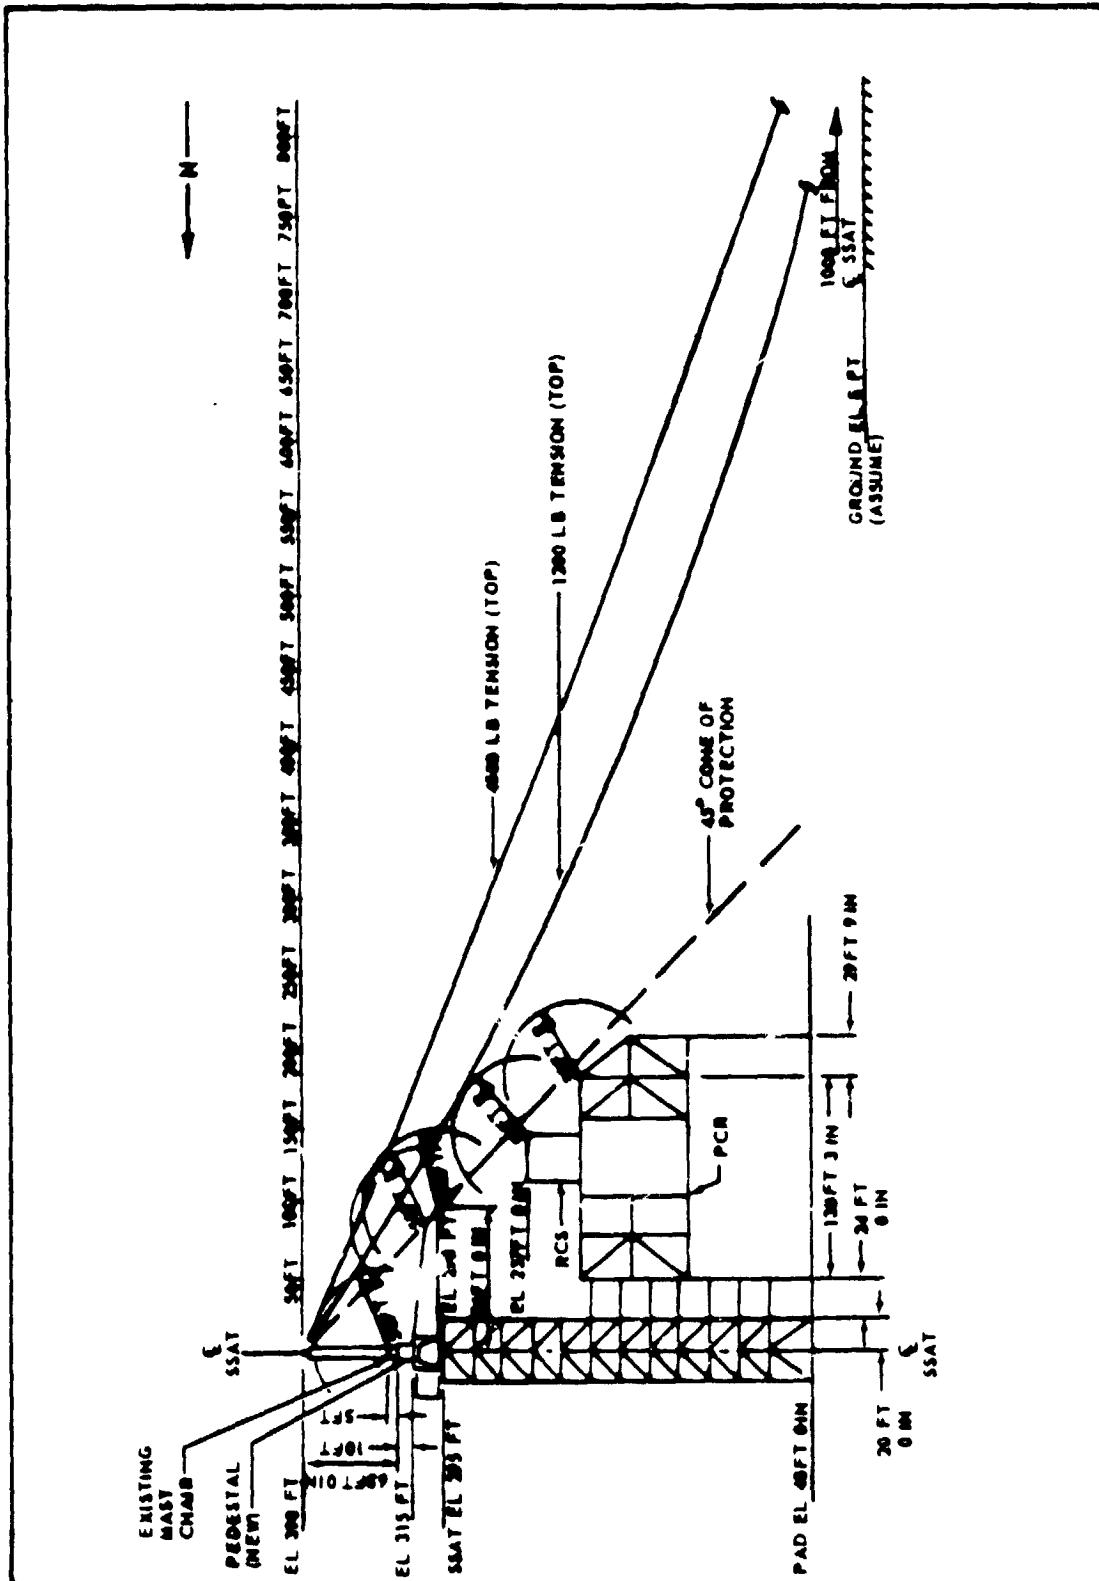
Figure 3-9. Catenary Grounding Cable Clearance Study (65-Ft Fiberglass Pole)

If a 65-ft mast on a 10-ft pedestal is used to reduce the bending moment applied to the steel truss space frame, the elevation of the top of the mast would be reduced 5 ft. The cable clearance study shown in figure 3-9 indicates the cable will clear all grounding structures by 50 ft except for the end of the hammerhead crane boom when it is rotated directly under the cable. By rotating the crane about 20 degrees to either side of the north-south cable, the 50-ft clearance is obtained and all structures are within the cone of protection of the cable.
