NASA Technical Memorandum 84637

FLIGHT SERVICE EVALUATION OF COMPOSITE COMPONENTS
ON BELL 206L AND SIKORSKY S-76 HELICOPTERS

DONALD J. BAKER

MARCH 1983

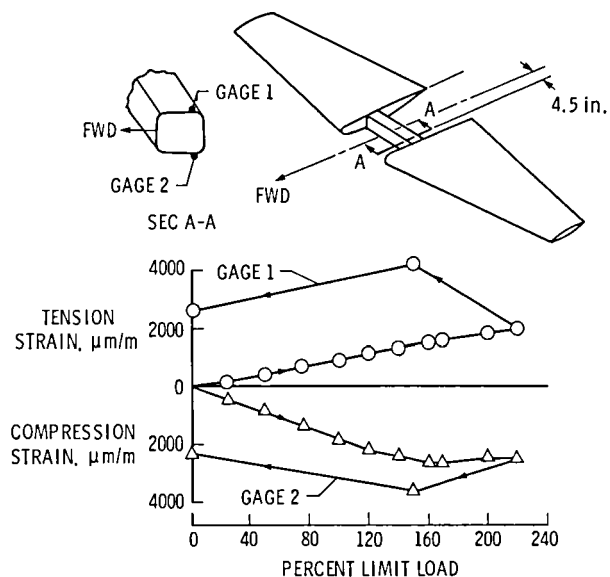
Figure 17. Strain as a Function of Percent Limit Load on S-76 Horizontal Stabilizer Spar, .1 m (4.5 in.) from Centerline.

The first horizontal stabilizer removed from service had accumulated 1600 flight hours over a 17 month period in the Lake Charles, LA area. No defects were found during inspection of the stabilizer. Deflection from the proof load was the same as in the initial acceptance test. Plots of strain as a function of limit load are shown in figure 17. The tension strain response was linear up to 160 percent of design limit load (DLL) and then increased at a reduced slope until the maximum applied load of 220 percent of DLL was reached. The compression strain response was linear to 120 percent of DLL and then increased at a reduced slope until 170 percent of DLL was reached. There was no increase in compression strain after 170 percent of DLL. At 220 percent of DLL a loud "snap" was heard and the load dropped to 150 percent of DLL. Attempts to increase the load beyond the 150 percent DLL resulted in deflection until the test fixture limit was reached. Visual inspection of the stabilizer indicated a buckle in the splice plate on the left hand leading edge of the spar. Teardown of the component indicated a loss of shear transfer capabilities between the composite material and the metal honeycomb (figure 18). At 220 percent of DLL, the shear load had been transferred to the Kevlar/epoxy torque box and eventually buckled the splice plate. The structure still supported 150 percent of DLL but with reduced rigidity. The stabilizer tested for certification did not fail but reached the maximum deflection allowed by the fixture at 268 percent of DLL. Additional tests will be necessary to determine if the change in failure mode is the result of environmental degradation of the composite
