Support and Power Plant Documentation for the Gas Turbine Powered Bus Demonstration Program

D. N. Nigro
R. G. Stewart
S. A. Apple

Detroit Diesel Allison
Division of General Motors Corporation
P.C. Box 894
Indianapolis, IN 46206

March 1982

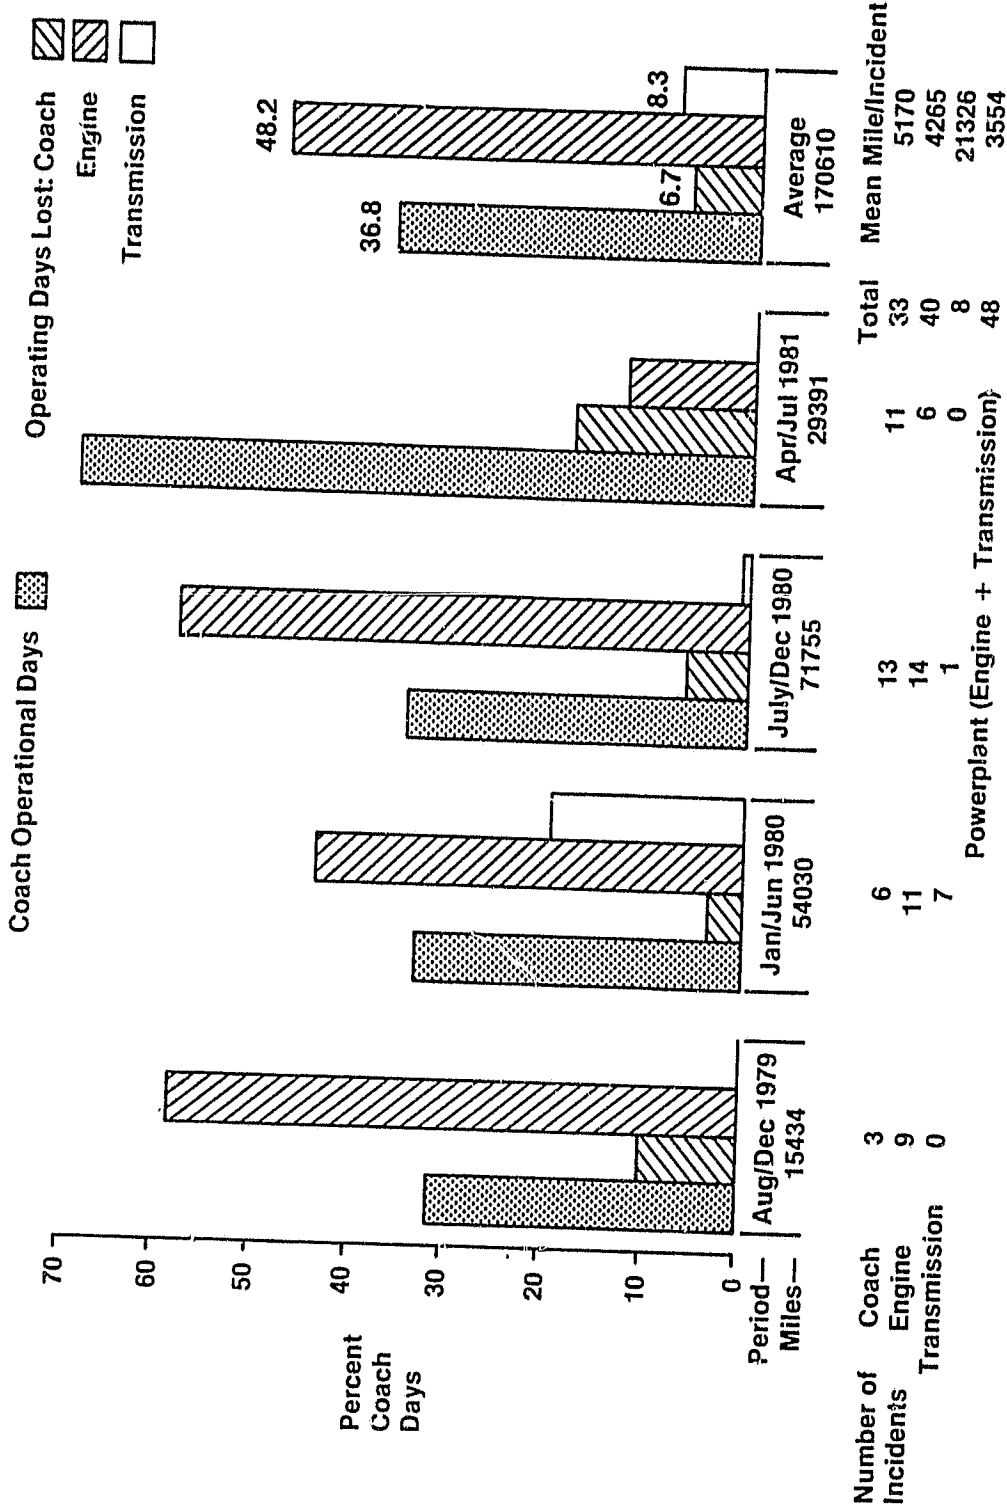
The number of incidents attributable to the engine, transmission, and coach and the mean miles between incidents for the service period are also shown in Figure 4. Major coach problems involved driveline alignment, alternator and oil cooler fan motor malfunctions, and engine intake duct blockage due to leaf ingestion.

The three major engine problems experienced during Greyhound service operation involved design and quality originated deficiencies as noted below. Taken together, the three major engine problems accounted for nearly 60% of the total service days lost due to all engine incidents in the Greyhound program.

Figure 4. Greyhound service experience.

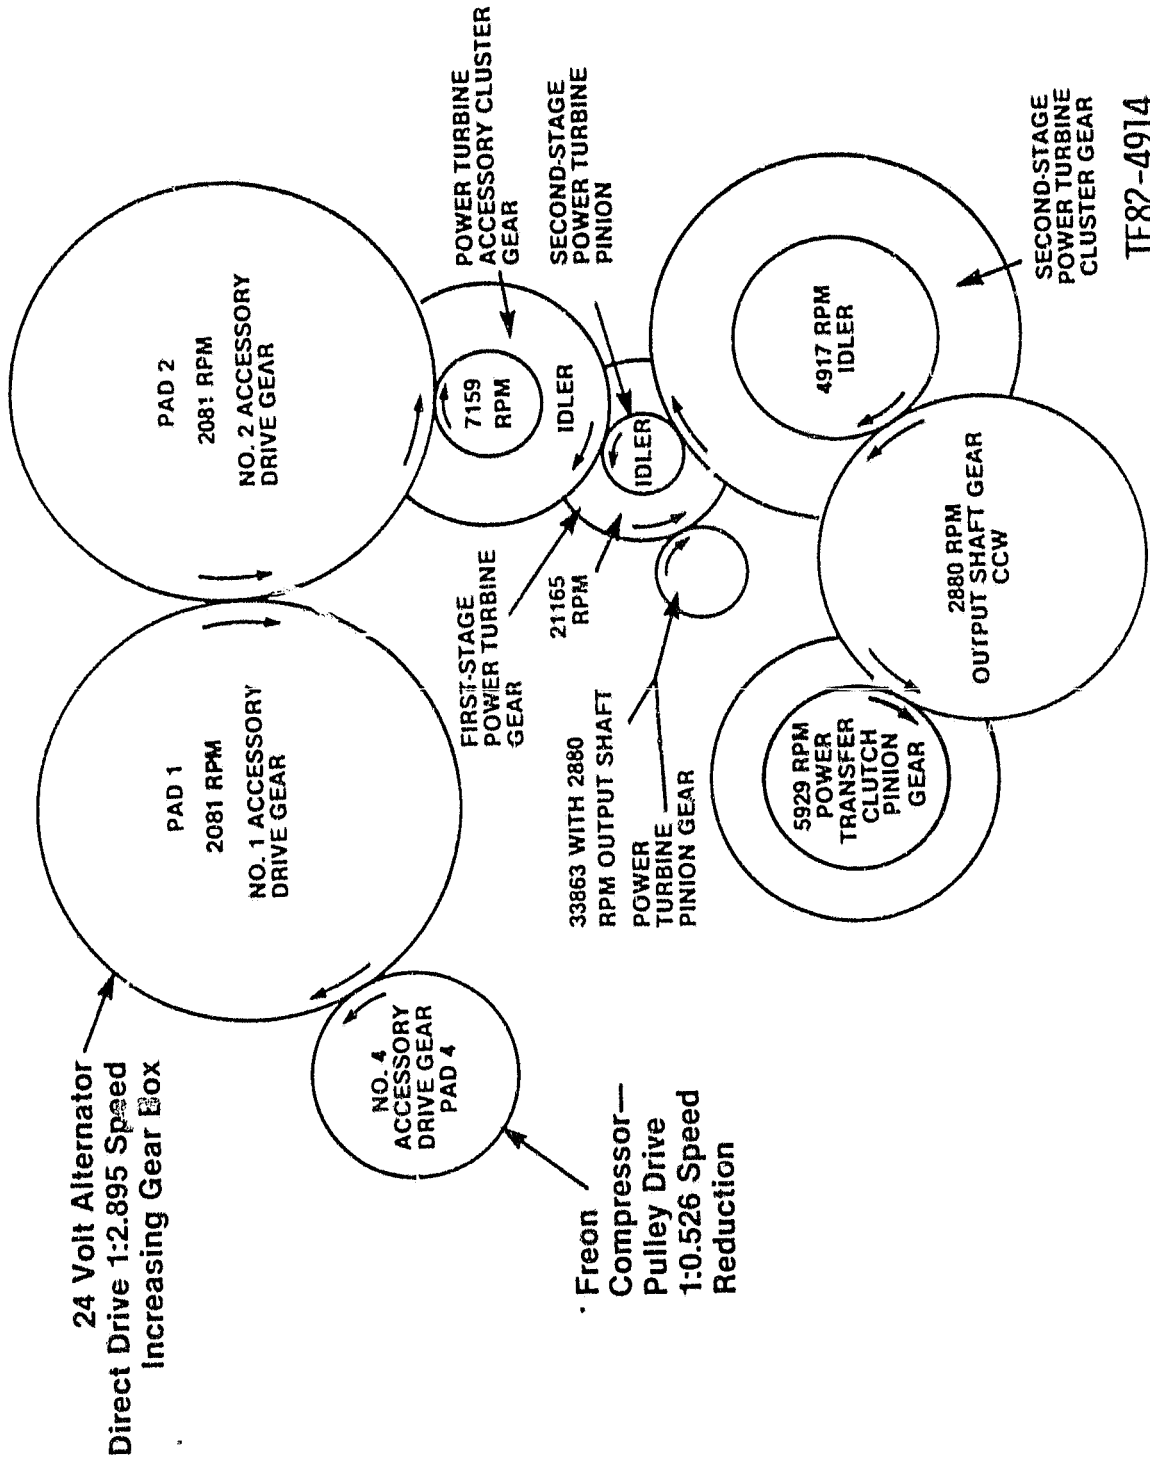
The Greyhound engine power turbine gear train is shown schematically in Figure 5. The power turbine driven accessories are identified in Figure 5 as the coach electrical system's 24-V alternator, direct driven via a 1:2.895 step-up gearbox from the No. 1 accessory drive gear, and the air conditioning (Freon) compressor, pulley driven with 1:0.526 speed reduction from the No. 4 accessory drive gear. At peak accessory load conditions, the alternator imposes 17 hp (12.7 kW) at the No. 1 gear drive and the Freon compressor imposes 20.3 hp (15.1 kW) at the No. 4 gear drive. Power flow is from the power turbine rotor (pinion gear) through the No. 2 accessory drive gear and to the coach accessory drives.

Figure 5. Greyhound engine power turbine gear train schematic.

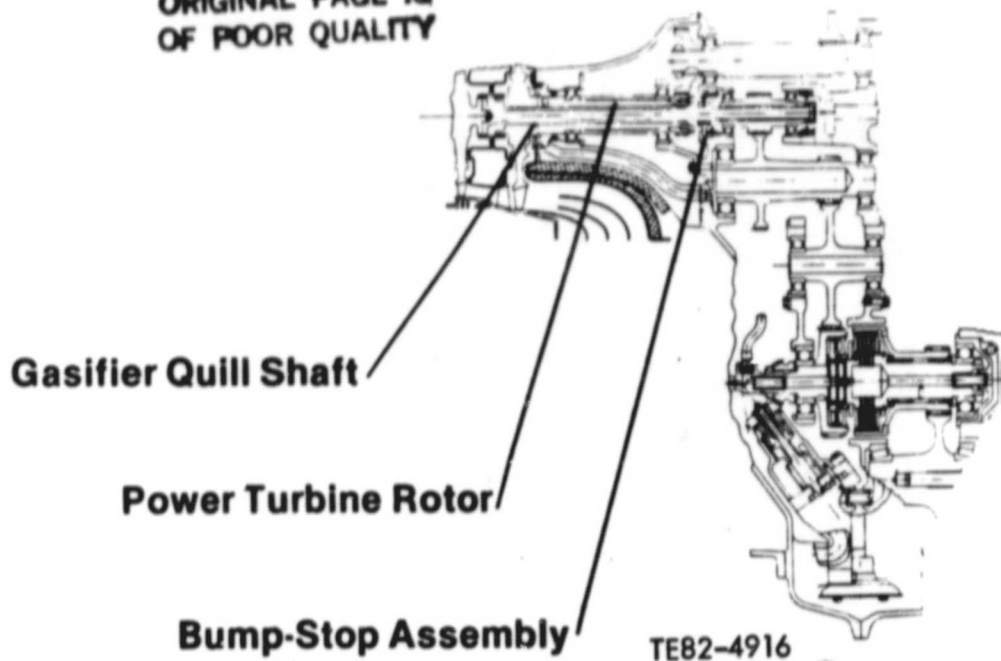
The quill shaft bump-stop assembly is located along the gasifier main shafting and is shown in the engine cross section (see Figure 7). A failure occurred after 16,740 mi (26,940 km) of Greyhound operation on engine S/N T5 and was initiated by the loss of the bump-stop orientation pins, which permitted the bump-stop assembly to creep circumferentially, reorienting itself to create a significant lubrication leak from the bump-stop outer diameter to the gearbox cavity. This leak essentially terminated the supply of pressure oil to the bump-stop bushing and greatly reduced the oil supply pressure in the passages that provide lubrication to the power turbine pinion gear mesh and the power turbine bearings. Figures 8 through 10 show the failed bump-stop assembly and gasifier quill shaft.

Figure 7. GT404-4 engine cross section showing gasifier quill shaft and bump stop.

The quill shaft provides the mechanical connection between the gasifier rotor system and the gasifier gear train. The dynamic modes with major quill shaft bending are positioned outside the engine operating regime with acceptable margin. Thus, the quill shaft passes through a bending critical speed during engine starting and thereafter operates in a supercritical mode with the quill shaft mass center on the rotational center. Shaft inversion (phase change) occurs during the transition from subcritical to supercritical operation and to restore the gasifier quill shaft to stable supercritical operation after a disturbance such as throttle position change, initiation of dynamic braking, or change from power transfer to free shaft operation moves the shaft mass center off the rotational center. Loss of supply oil to the bump-stop bushing terminated the ability of the bump-stop to provide viscous damping to the quill shaft at the critical bending frequency and the viscous force required to promote shaft inversion without large shaft deflections. The quill shaft therefore achieved excessive deflection, exceeding the yield strength of the shaft, contacting the bore of the counterrotating power turbine rotor, and progressing to failure of the quill shaft and power turbine shaft.

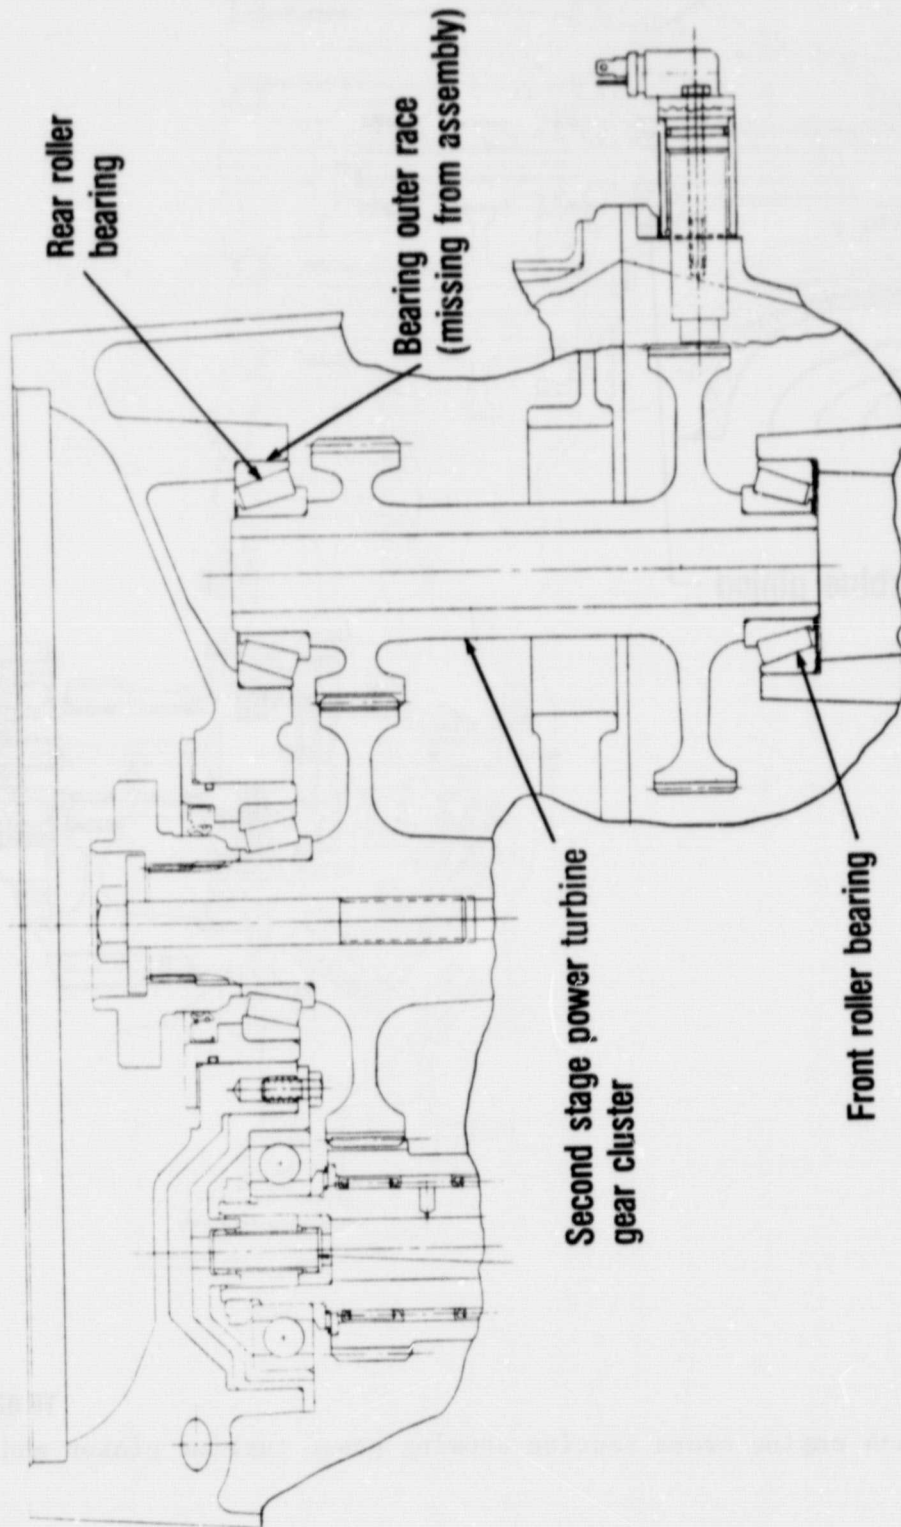
During field assembly of a Greyhound engine gearbox, a bearing outer race was omitted (see Figure 17). The deficiency was not noted as the build progressed and subsequent operation of the engine during coach road testing resulted in gearbox damage.

Figure 17. GT404-4 engine gearbox cross section showing assembly of second-stage PT gear cluster.

In response to these engine assembly problems, inspection check-off sheets were developed for the various assembly sections of the engine. This provided verification that various critical operations, such as proper nut torques and bearings in proper position, were accomplished.

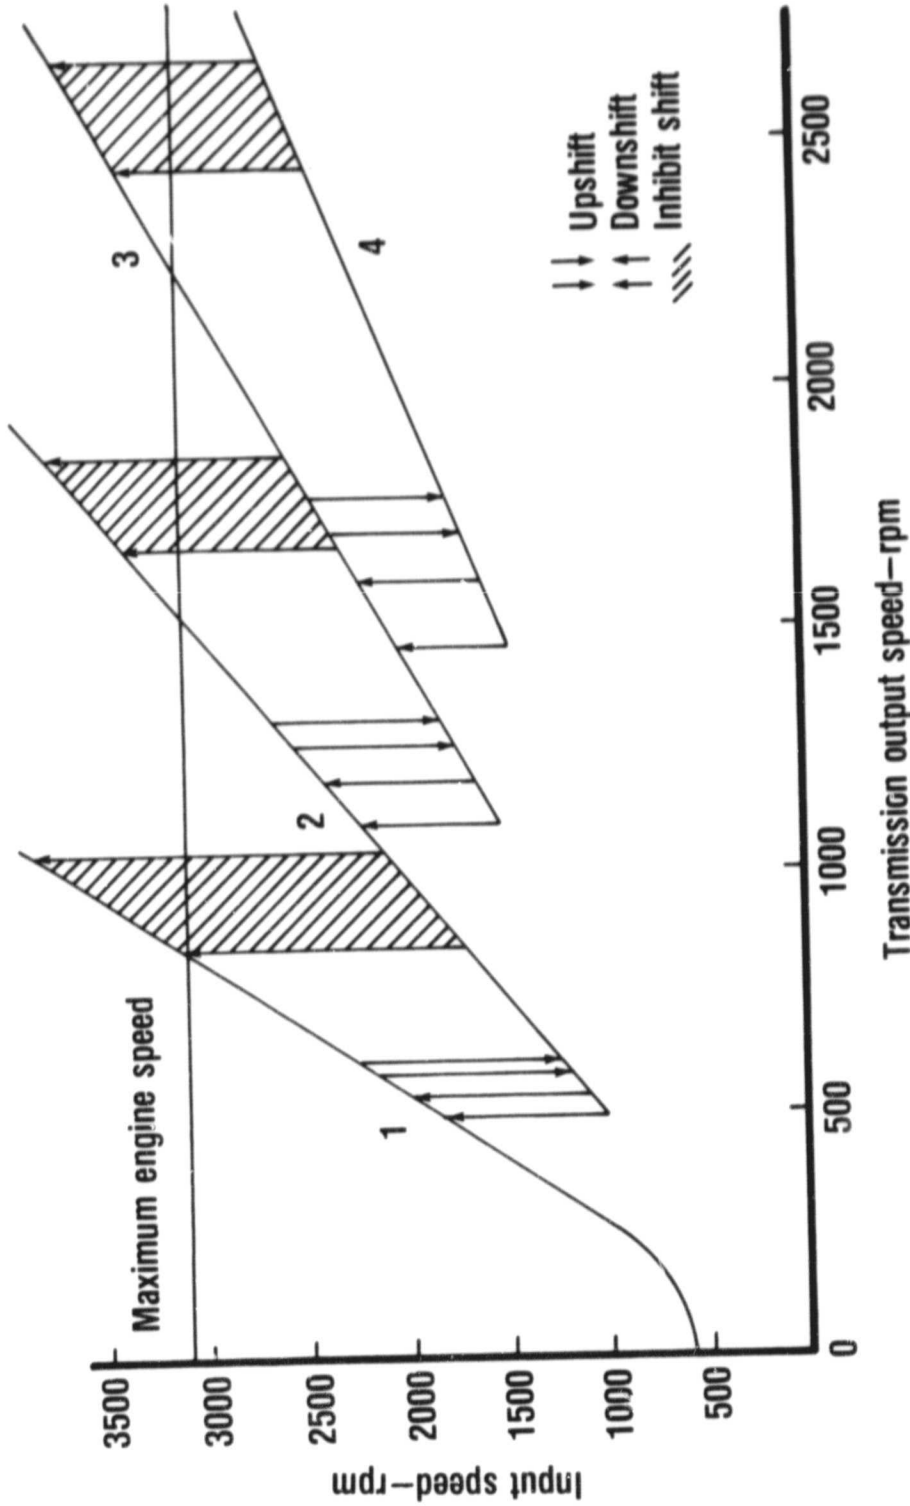
Figure 27 shows the inhibit shifts obtained during coach operation based on the inhibitor settings established during acceptance testing. Figure 28 shows the revised inhibit shift ranges after recalibration, which required a new spring in the hold regulator valve. All of the HT740CT and V730CT coach transmissions required adjustment of the hold regulator valve, and no further problems were experienced.

Figure 27. HT740CT transmission shift point schedule--inhibit downshift speed ranges in coach based on acceptance test.

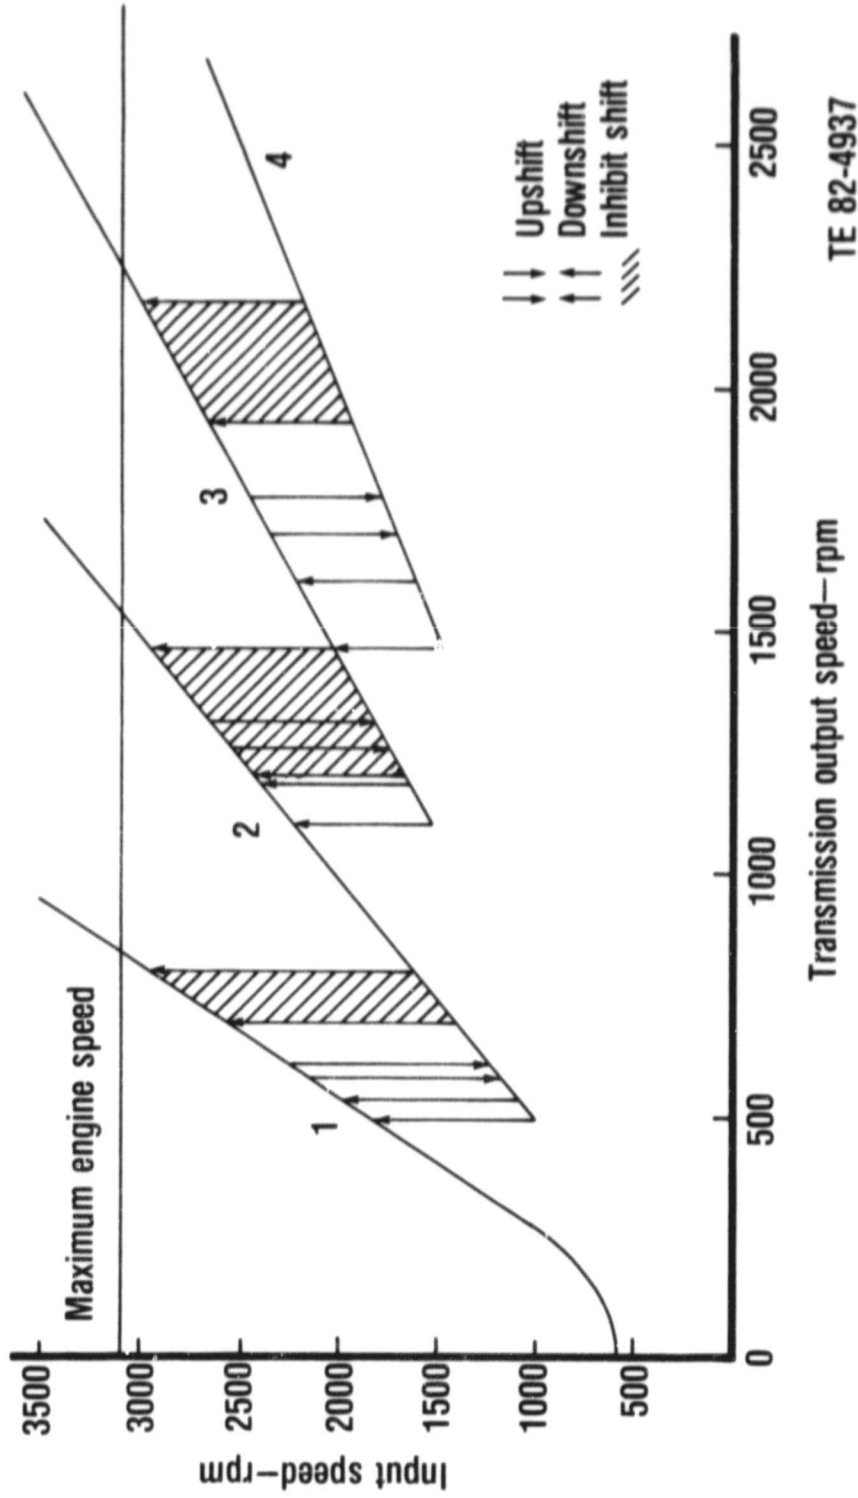
Figure 28. HT740CT transmission shift point schedule--inhibit downshift speed ranges in coach based on decreased hold pressure.

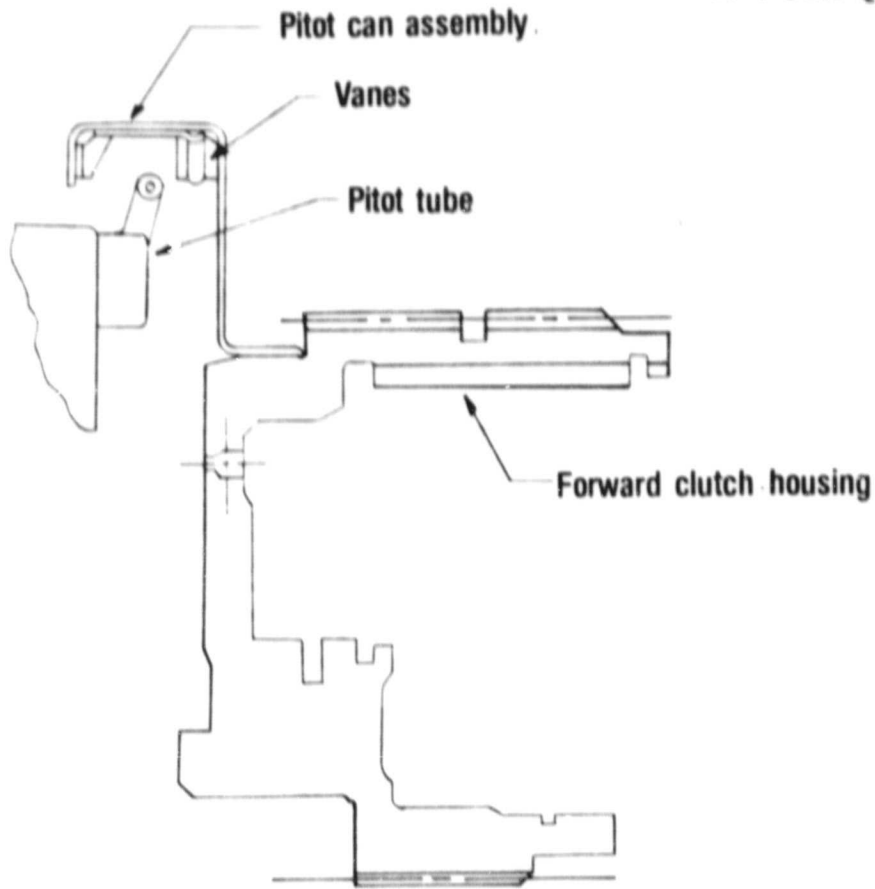
Pitot can failure occurred in fatigue due to vane vibration from transmission operation at the higher input speeds provided by the gas turbine engine. The subsequent loss of pitot pressure signal to the transmission controls was evidenced by deterioration of shift quality. However, no damage was incurred by the transmission as a result of the pitot can failure. This same condition was noted in HT740D high-speed diesel applications, which prompted redesign of the pitot collector to incorporate increased can and vane material thickness and hardness.

Figure 29. HT740CT transmission pitot configuration.

Since failure of the vanes did not cause a loss of drive or secondary failure or result in severe performance degradation, it was decided not to involve a costly and time-consuming service interruption and retrofit of the HT740CT transmission with the redesigned pitot collector until transmission inspection was required. The redesigned pitot can was installed in two transmissions and operated without incident during the remainder of the program.

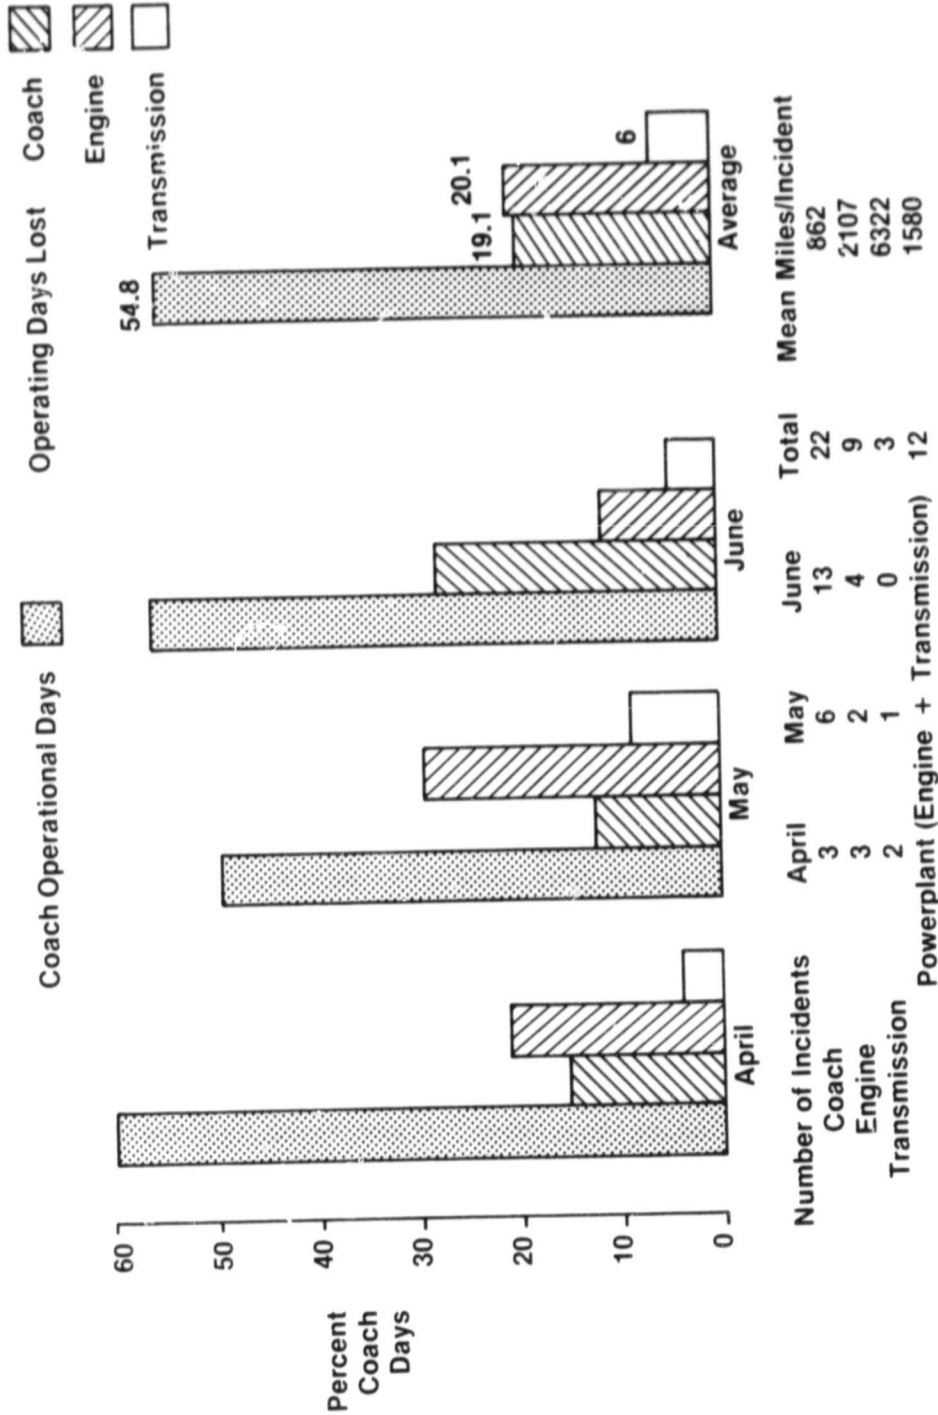
Service experience with the four GT404-4 powered transit coaches operating on the Baltimore to Annapolis run is summarized in Figure 41. Coach operation in March and July was minimal and has not been included in this summary. The service experience is segmented into the three main operating months to profile, as a percentage of available service days, the coach operating days and the service days lost due to incidents that prevented the coach from starting a scheduled revenue run or completing a run in progress. The coaches were operational an average 54.8% of the available service days while lost service time due to engine problems was an average 20.1%. Service time lost due to coach problems, at an average 19.1%, nearly equaled the operating days lost due to engine incidents.

Figure 41. Baltimore transit service experience.

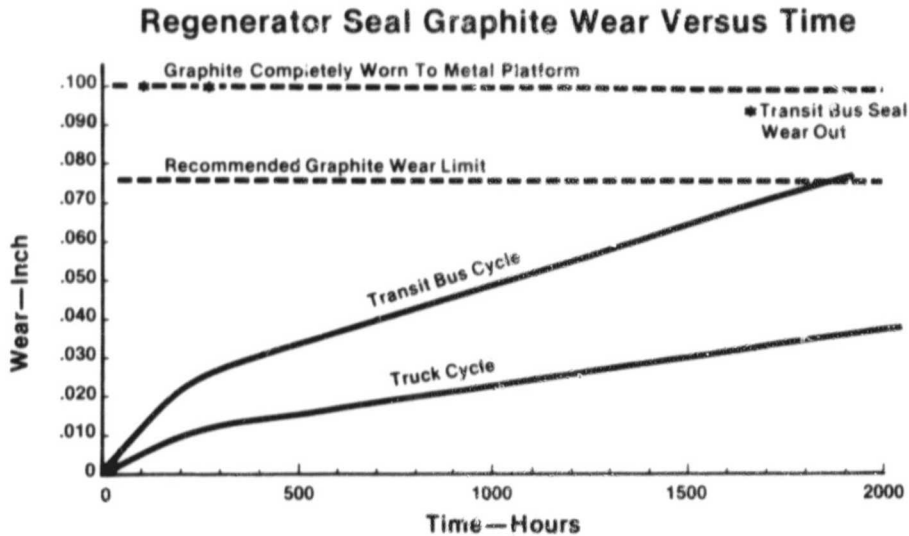
The transit duty cycle may account for part of the faster seal wear. Engine test operation on a simulated transit duty cycle resulted in a projected seal life of 1850 hr whereas truck cycle testing projected 4000 hr seal life. Figure 43 shows seal graphite wear data obtained with ceramic disks. The two regenerator failures in transit service involved seal wear all the way down to the metal platform. The transit bus seal life is based on wear measurements obtained during operation on the simulated ADB duty cycle and projected to the recommended graphite wear limit. The projected seal life in transit bus service is contrasted with data obtained during simulated testing on the less severe truck duty cycle.

Figure 43. Ceramic regenerator seal graphite wear data.
