THEMATIC MAPPER

Prepared for
GODDARD SPACE FLIGHT CENTER
Greenbelt, Maryland 20771
CONTRACT NAS 5-24200

FLIGHT MODEL
PRESHIPMENT REVIEW
DATA PACKAGE
VOLUME II - SUBSYSTEM DATA
PART C
Article IV - 3A

THEMATIC MAPPER
FLIGHT MODEL
PRESHIPMENT REVIEW
VOLUME II
SUBSYSTEMS
TABLE OF CONTENTS

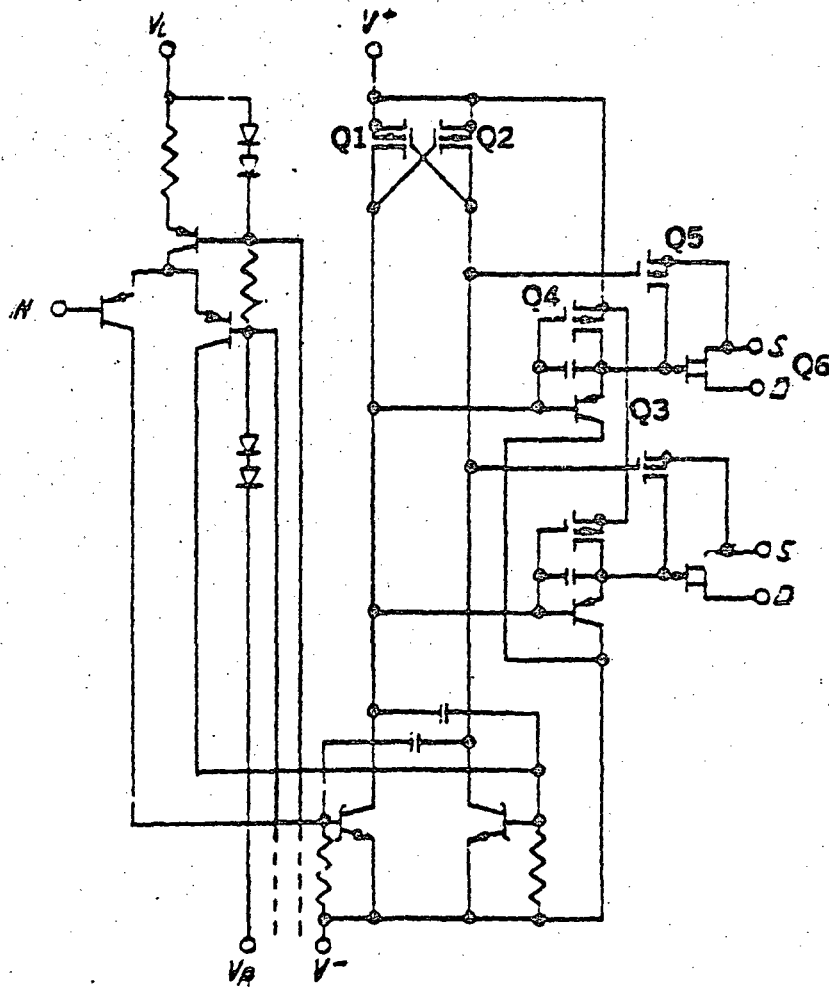
Figure No. 1

Current-voltage characteristics were obtained for each pin to V+ (pin 6) and to V- (pin 9), in both polarities. Pins 1 and 2 were degraded to both V+ and V- as compared to other JFET output pins. No other obvious defects were indicated. See Figures 1 and 2 for pin connection and schematic diagrams.

Pin connection table for the
 912922.
