# Examination, Evaluation, and Repair of Laminated Wood Blades After Service on the Mod-0A Wind Turbine

James R. Faddoul  
National Aeronautics and Space Administration  
Lewis Research Center

Prepared for  
National Conference of the American Wind Energy Association  
San Francisco, California, October 16-19, 1983

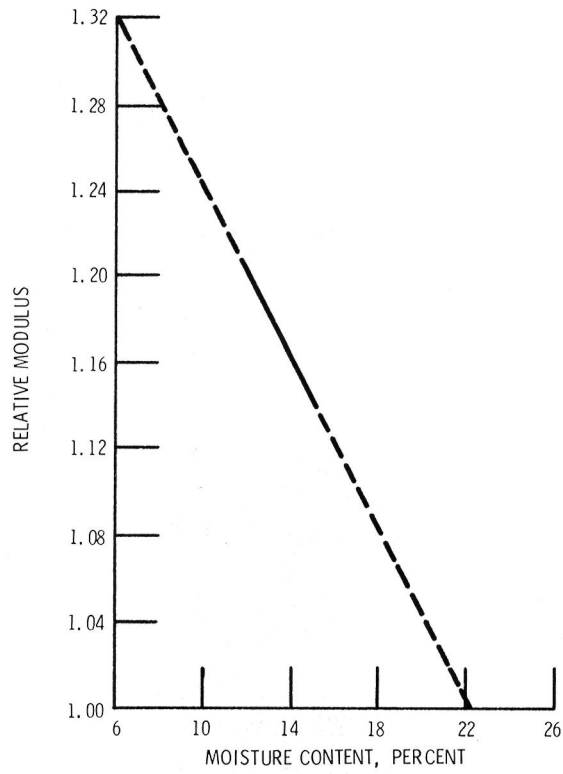
Moisture content study. - To evaluate the specific moisture content of the wood in the Hawaii blade, a series of four core sections were removed from the spar of both blades. Each section was removed by using an extended hole saw without a pilot drill, and each was approximately 1 cm (3/8 in.) in diameter. Lengths of the section were the full laminate thickness of the spar at the point of removal and ranged from about 9 down to 2.5 cm (3-1/2 in. down to 1 in.). The moisture contents for blade 1010 were 4.9, 5.2, 5.3, and 6.1 percent of the total specimen weight. Similarly, for blade 1011, the results were 6.9, 7.5, 7.7, and 7.8 percent. As can be seen, the numbers are quite closely grouped for each blade but are significantly different for the two blades. Blade 1010 had an average of 5.4 percent moisture, and blade 1011 averaged 7.5 percent. Neither of these values is thought to be excessively high and the difference is probably due to the time of year of fabrication. Blade 1010 was constructed during a colder time of year when more shop heating was required, and the probably less humid shop air dried the wood veneers. Subsequent evaluation and knowledge of the effects of veneer moisture content on the structural properties of wood have led to installation by GBI of an elaborate humidity control system in the shop to control the moisture content. The effect of moisture can most vividly be seen in figure 7, which shows a 24 percent decrease in modulus for an increase in moisture content of 16 percent. Strength follows an almost identical trend. In any case, blades 1010 and 1011 were found to be within the expected range of moisture content and therefore would be expected to be at or above the design allowable strength and modulus.

Figure 7. - Effect of moisture content on modulus of wood.

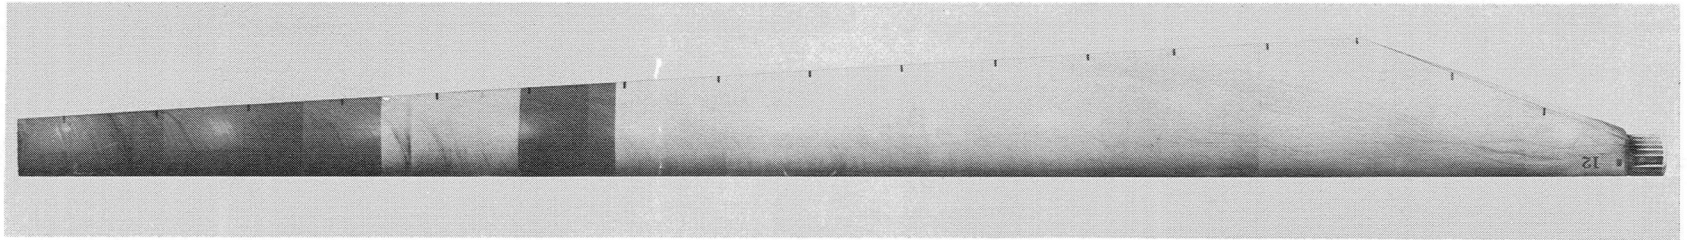
Initial examination. - The Block Island blades were received at Lewis and photographed. The as-received blades are shown in figures 8 to 11. Considerable oil and dirt had accumulated on the blade surface, and this provided evidence of airflow patterns. These patterns have been carefully photographed and are being studied to determine if they have any significance for wind turbine operations. Similar patterns were not evident on the blades returned from Hawaii or on any other Mod-OA rotor blades although they also had oil and dirt on the surface. One possible explanation for the markings on the Block Island blades can be attributed to operating at derated power settings and at a rotor speed of 31 rpm as opposed to 40 rpm for the Kahuku, Hawaii, machine. Further studies of this aerodynamic "striping" will be required.

Figure 8. - High-pressure side of blade 1012.

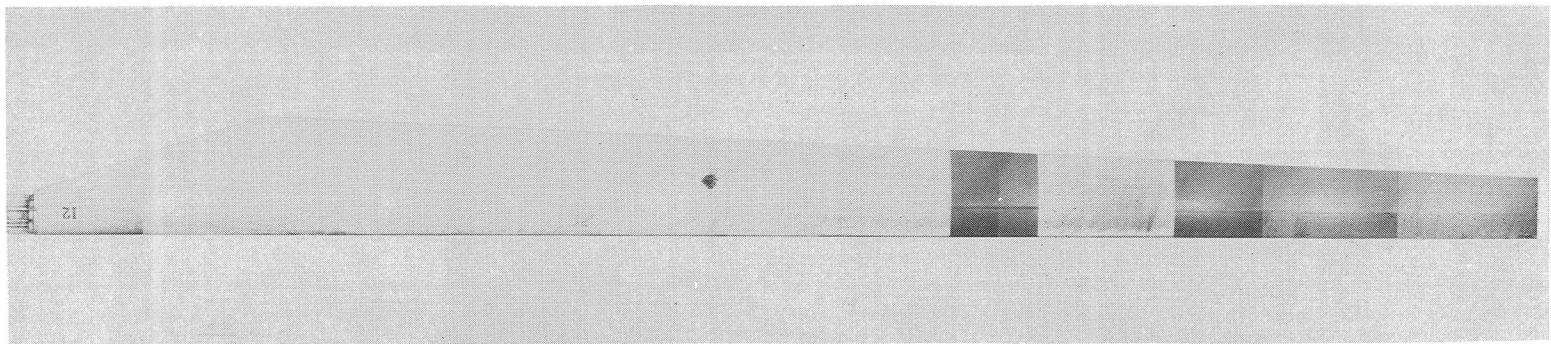
Figure 9. - Low-pressure side of blade 1012.

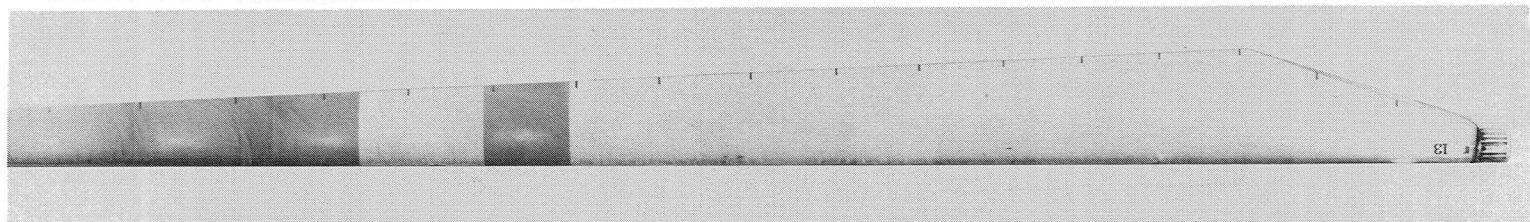
Figure 10. - High-pressure side of blade 1013.

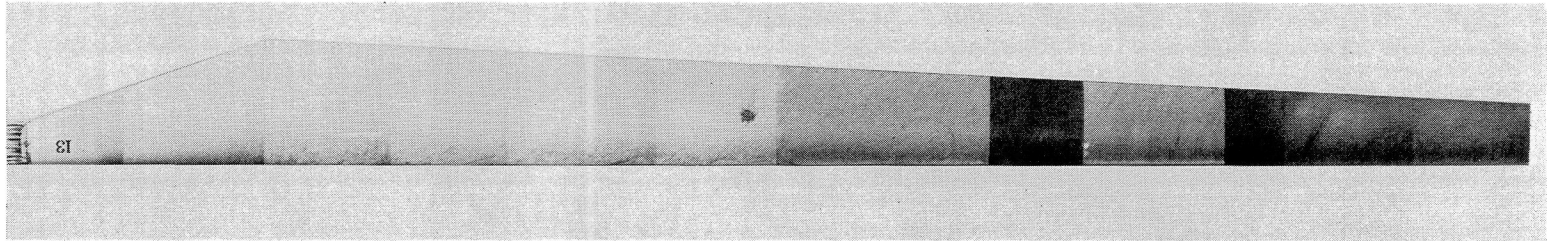
Figure 11. - Low-pressure side of blade 1013.

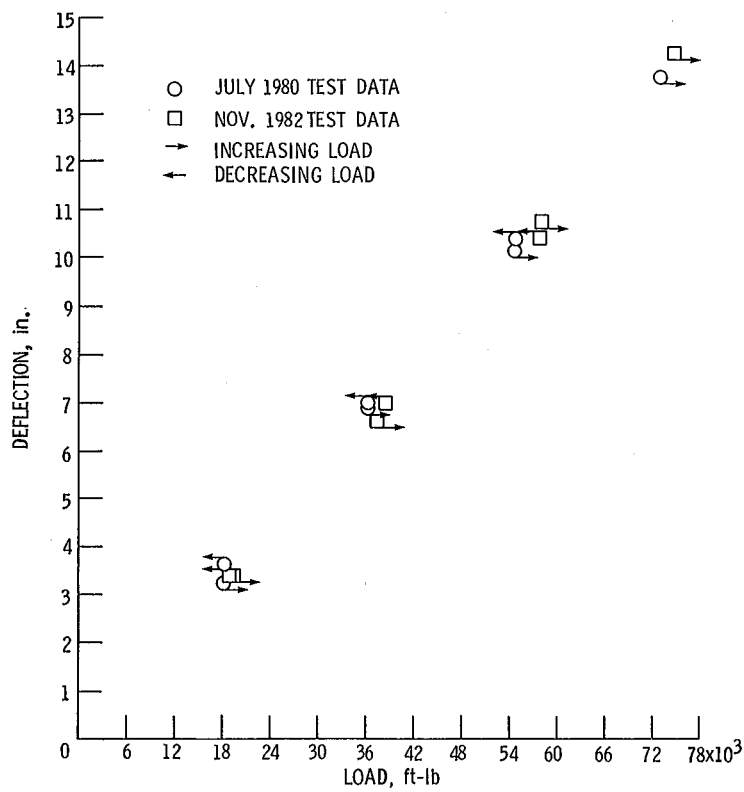
Table I lists the flatwise tip deflections and applied moments for both the July 1980 test and the November 1982 test. When the data were corrected for the small differences in applied moment, the variation between the maximum deflections was less than 1 percent. The correlation of data is shown graphically in figure 22. Because a leading-edge crack would be expected to have the greatest effect on flatwise performance, the very good agreement between the two data sets indicated that the crack had done no significant structural damage. The reader should note that the word "structural" refers to the immediate ability to carry load with a given stiffness. There has obviously been degradation of the material protection system by way of cracking paint and surface erosion. This condition would be expected to worsen and lead to structurally significant damage. The progression would also be expected to be exponential with time in that the older the structure, the more the damage and the faster the next increment of damage would occur.

Figure 22. - Flatwise load-deflection test data for blade 1012 before and after 7564 hr of operation.
