INTERNAL HYSTERESIS EXPERIENCED ON A HIGH

PRESSURE SYN GAS COMPRESSOR

F. Y. Zeidan Qatar Fertiliser Company Umm Said, Qatar

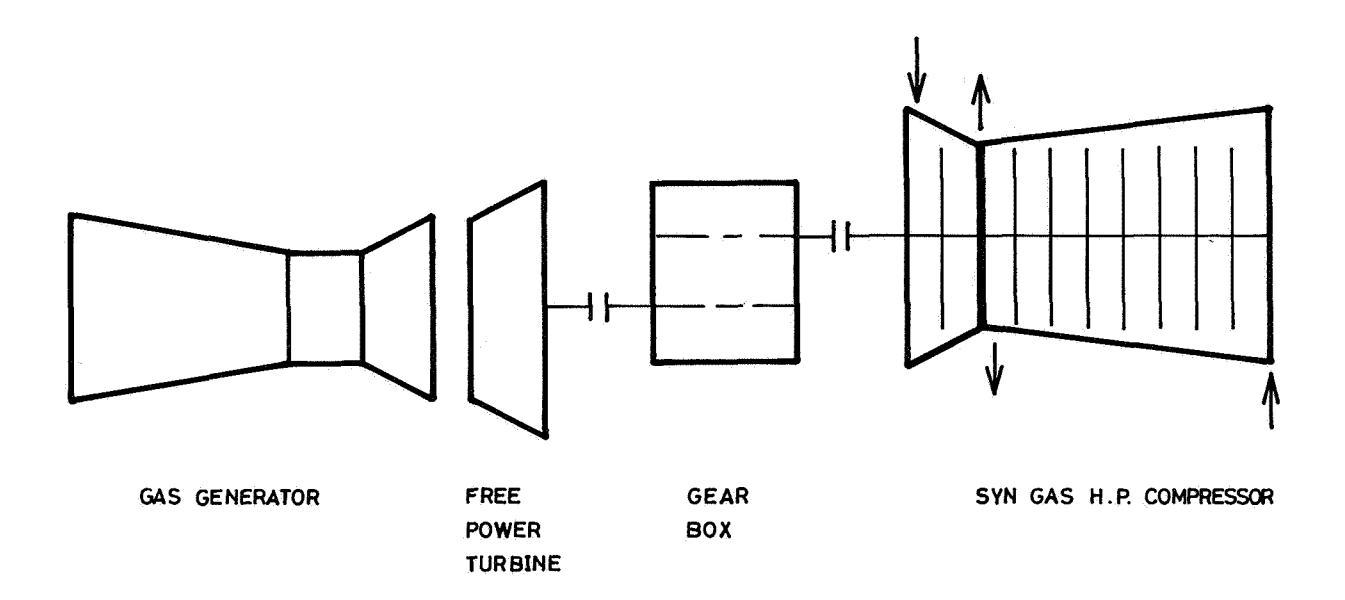
A schematic of the high pressure compressor train is shown in fig. 1. An aircraft derivative gas turbine (gas generator) powers a free power turbine which then drives the high pressure compressor through a speed increasing gear. The normal start-up sequence is to start the gas turbine and hold it at warm-up speed of 1500 rpm, which corresponds to 4500 rpm on the compressor. Upon completion of the warm-up time, the unit is then quickly accelerated to the minimum governed speed, which is equivalent to 11,000 rpm for the compressor. A sketch of the high pressure rotor is shown in figure 2, outlining the major components. The rotor consists of two stages: the high pressure stage consisting of 7 impellers, and the circulator stage with one impeller. The two stages are separated by a long interstage labyrinth seal, and are housed in a common barrel casing. The rotor is supported on tilt pad bearings with 5 pads in a load on pad configuration. The oil seals are of the floating ring type, where the sealing is applied through lapping of the housing lip with the mating face of the outer seal ring. An "O" ring seal is used on the housing face of the inner seal ring.

Figure 1. - Schematic of compressor train.

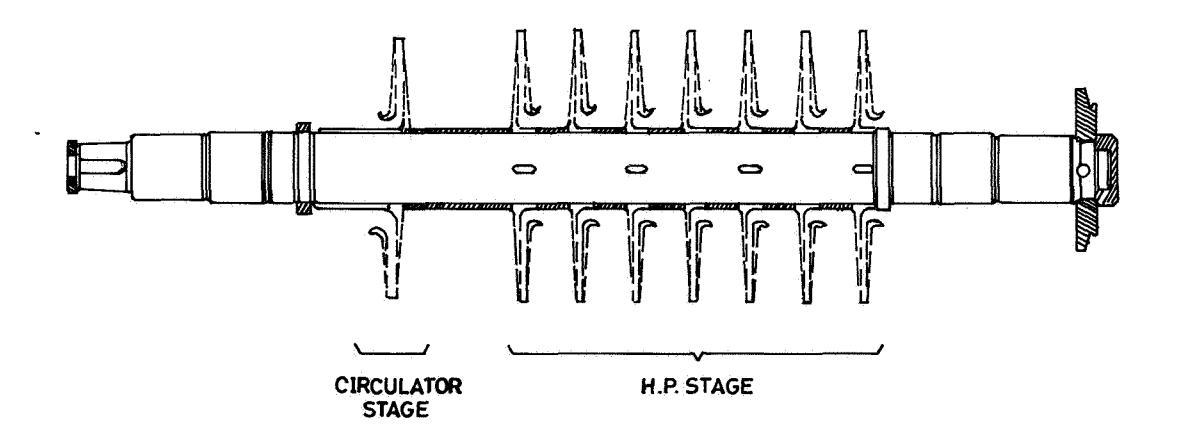
Figure 2. - Syn. gas compressor rotor.
