NASA
Technical Memorandum 86939

Experimental Study of Ceramic-Coated Tip Seals for Turbojet Engines

EXPERIMENTAL STUDY OF CERAMIC-COATED TIP SEALS FOR TURBOJET ENGINES

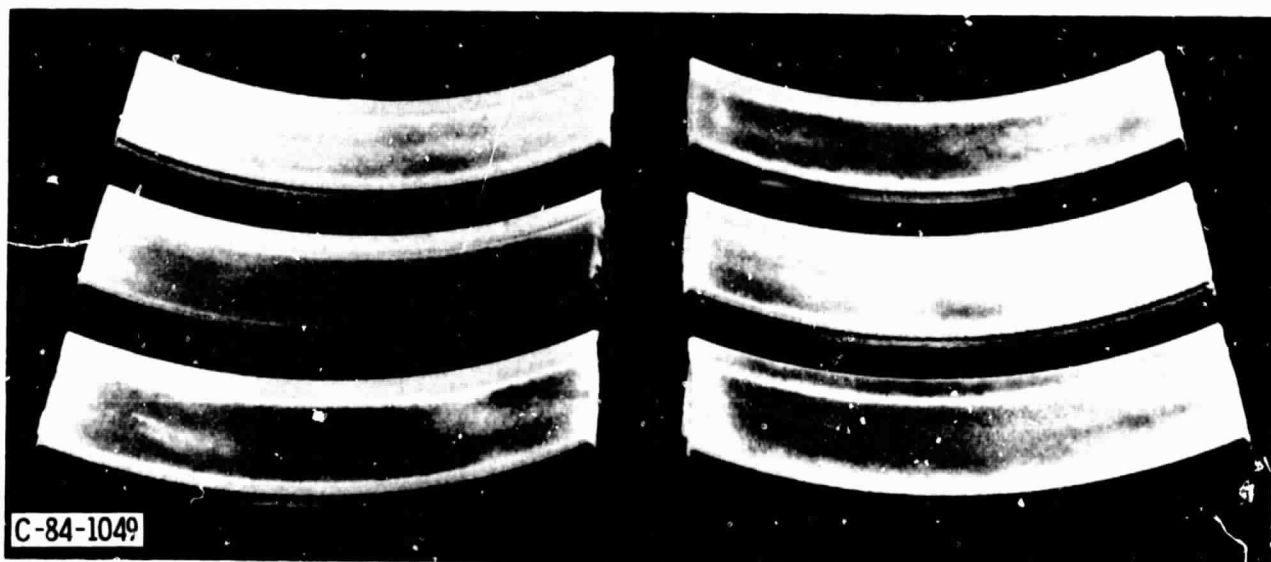
Figure 3. - Shroud segments after plasma spraying.

The shrouds before installation and after removal are shown in figures 3 and 9, respectively. The condition of the shrouds after removal is described in the analysis of the shroud seal material.

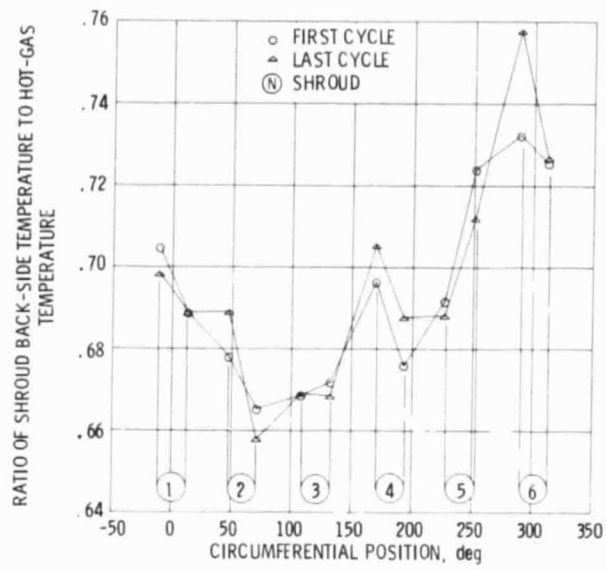
Figure 8. - Normalized shroud back-side temperatures at high power for first and last (1001) cycles.

Normalized, steady-state shroud back-side temperatures after the first and the last (1001) cycles are shown in figure 8. Thermocouples on shroud 6 were somewhat out of agreement with the trend established by the other thermocouples. However, the thermocouples showed no visual or electrical signs of distress under post-test inspection. Possible explanations include cooling hole blockage limiting flow to this shroud; excess coolant bleeds to the hot gas path; a thinner than normal ceramic coating; a variation in combustor temperature profile; and a variation in shroud-to-blade clearance from nominal. This problem has not been resolved.

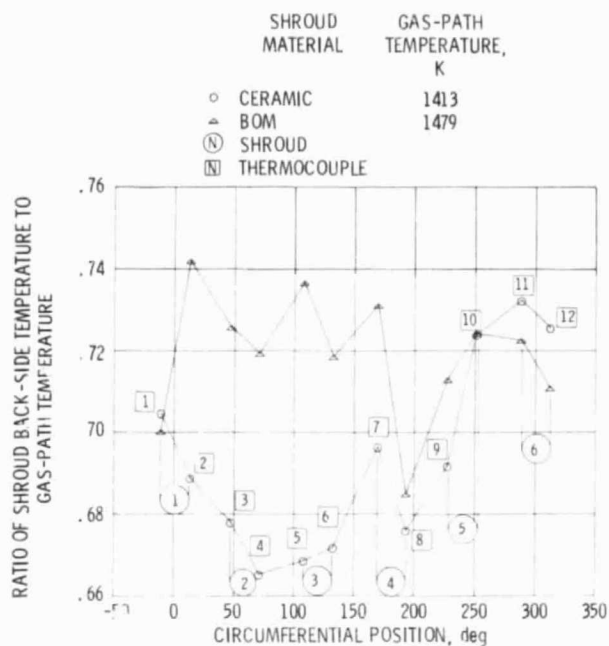
Figure 10. - Ceramic and BOM shroud back-side temperatures at high power after 1 cycle.

The back-side temperatures for the ceramic shroud after the first cycle were on the whole significantly lower than those for the BOM shroud (fig. 10). However, there were anomalies where the opposite was true, such as for thermocouples 1, 10, 11, and 12. This corroborates the previously observed higher-than-nominal temperatures near shroud 6. Excluding these thermocouples, the average temperature difference between the ceramic and BOM shrouds was approximately 78 deg C (140 deg F).
