CONTROLLED IMPACT DEMONSTRATION
ON-BOARD (INTERIOR) PHOTOGRAPHIC SYSTEM

Clyde J. May
NASA Langley Research Center
Hampton, Virginia

NASA/FAA Government/Industry CID Workshop
NASA Langley Research Center
April 10, 1985

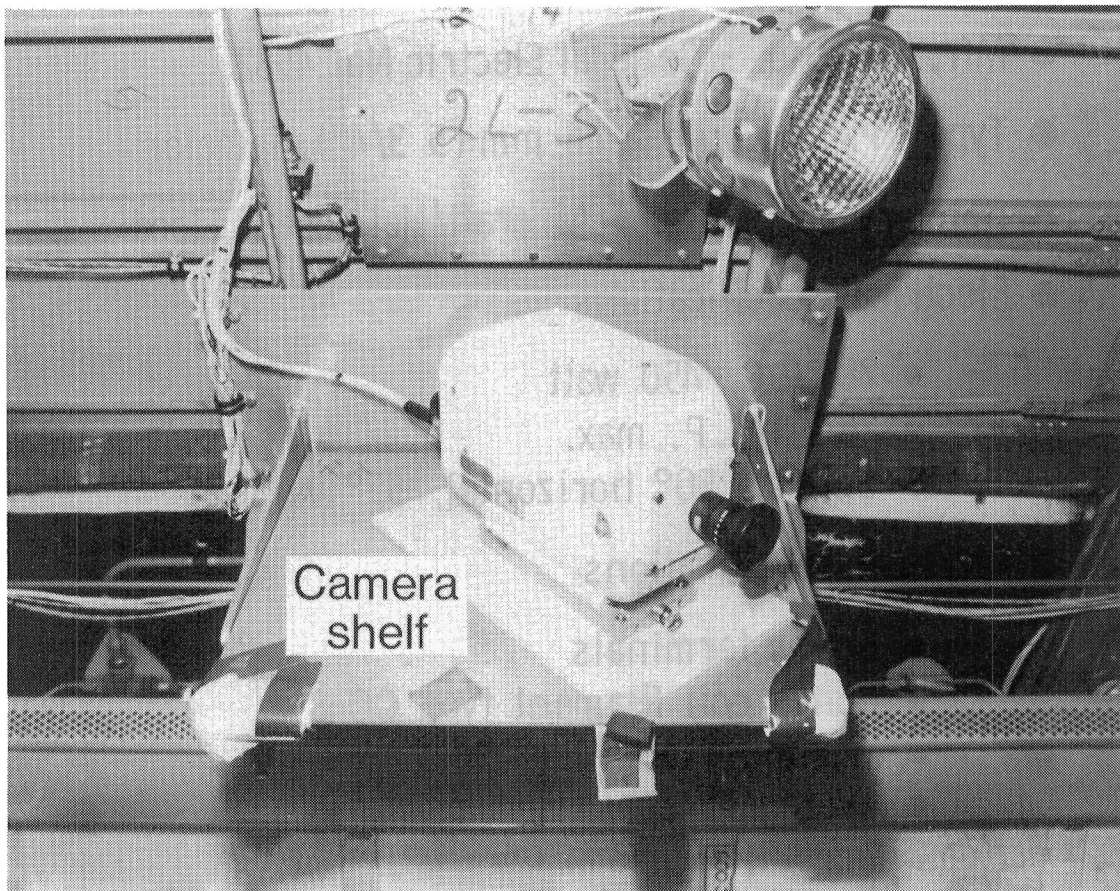
Figure 24

The lamp holders and cameras were attached to the aircraft structure as shown in Figure 24. A swival section of micarta was used between the lamp holder and its mounting bracket so the lamp could be rotated for optimum illumination of the camera field-of-view, then drilled and locked into position with aircraft bolts.
