*Report to the President*

*By The*  
**PRESIDENTIAL  
COMMISSION**  
*on the Space Shuttle  
Challenger Accident*

June 6th, 1986  
Washington, D.C.

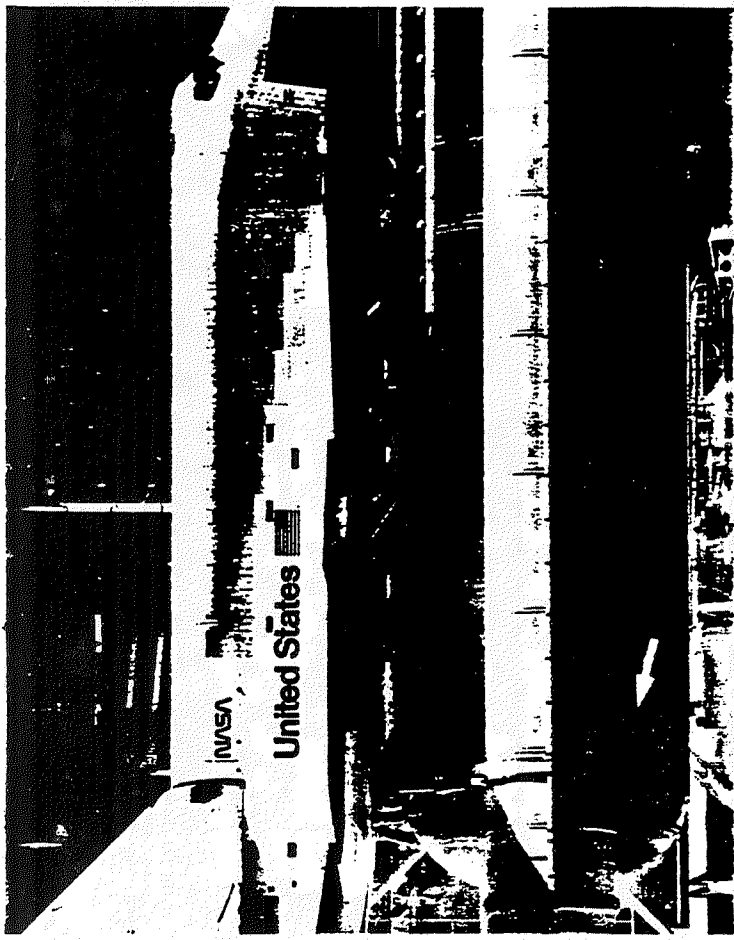
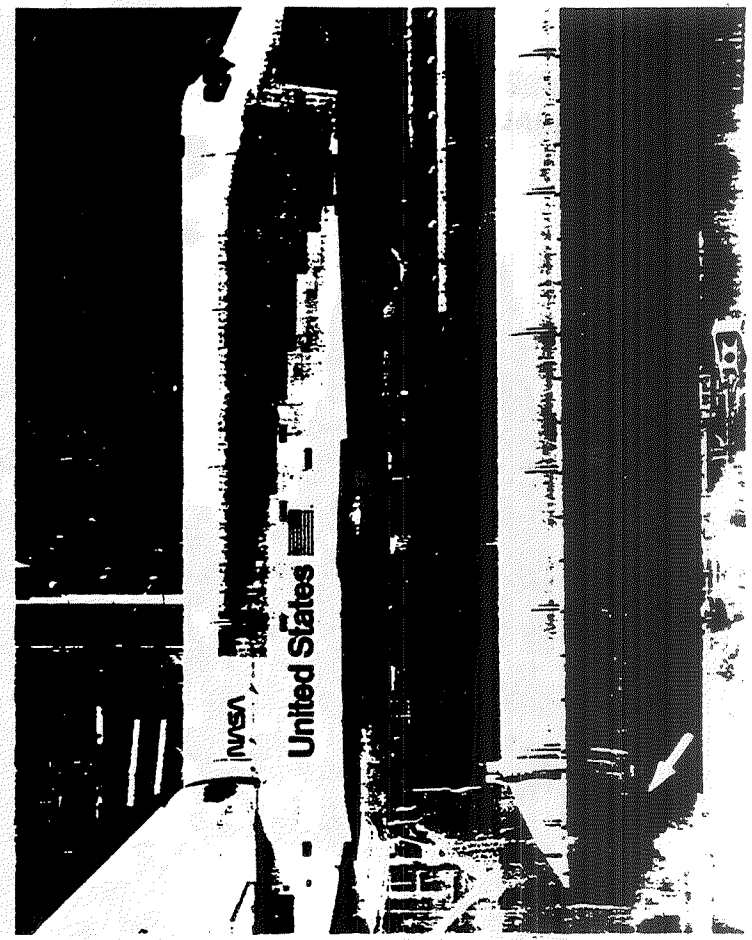
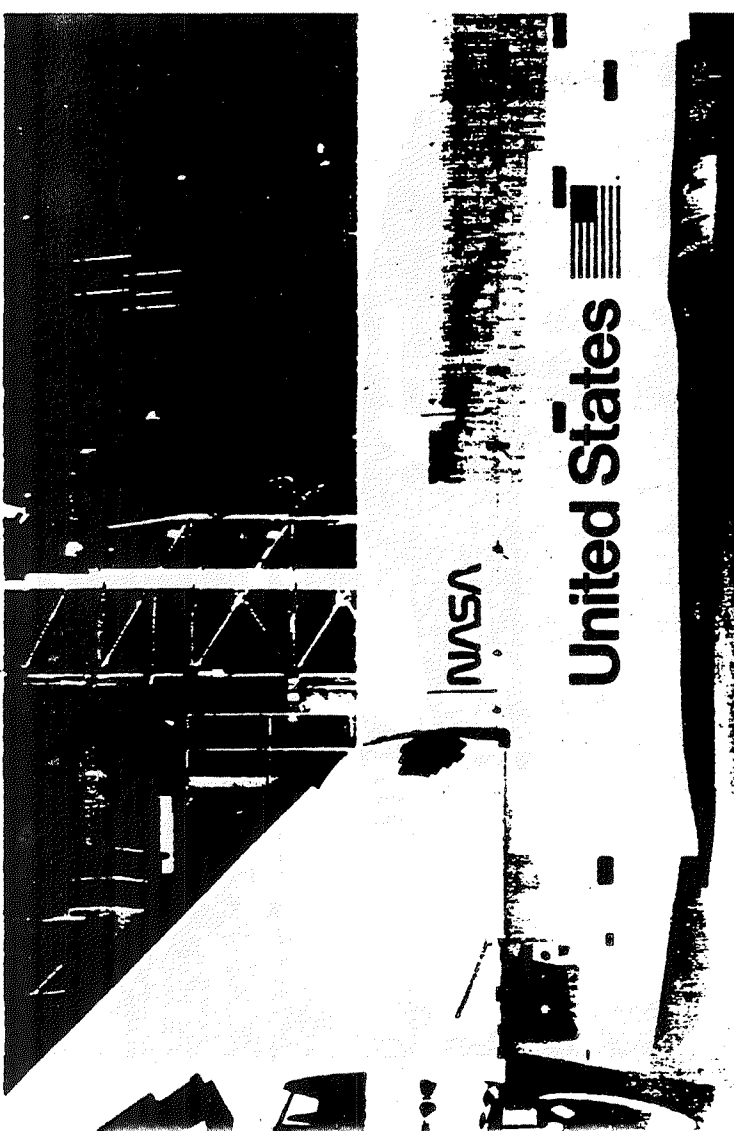
Immediately after solid rocket motor ignition, dark smoke (arrows) swirled out between the right hand booster and the External Tank. The smoke's origin, behavior and duration was approximated by visual analysis and computer enhancement of film from five camera locations. Consensus: smoke was first discernible at .678 seconds Mission Elapsed Time in the vicinity of the right booster's aft field joint.

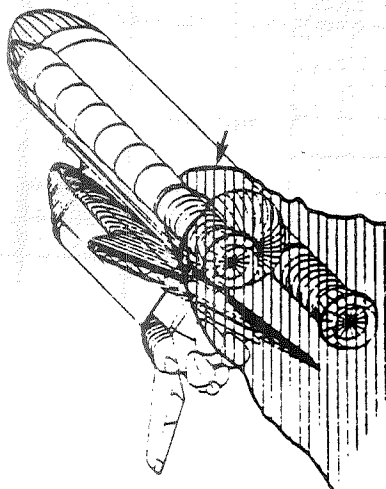
At 58.788 seconds, the first flicker of flame appeared. Barely visible above, it grew into a large plume and began to impinge on the External Tank at about 60 seconds. Flame is pinpointed in the computer drawing between the right booster and the tank, as in the case of earlier smoke puffs. At far right (arrow), vapor is seen escaping from the apparently breached External Tank.

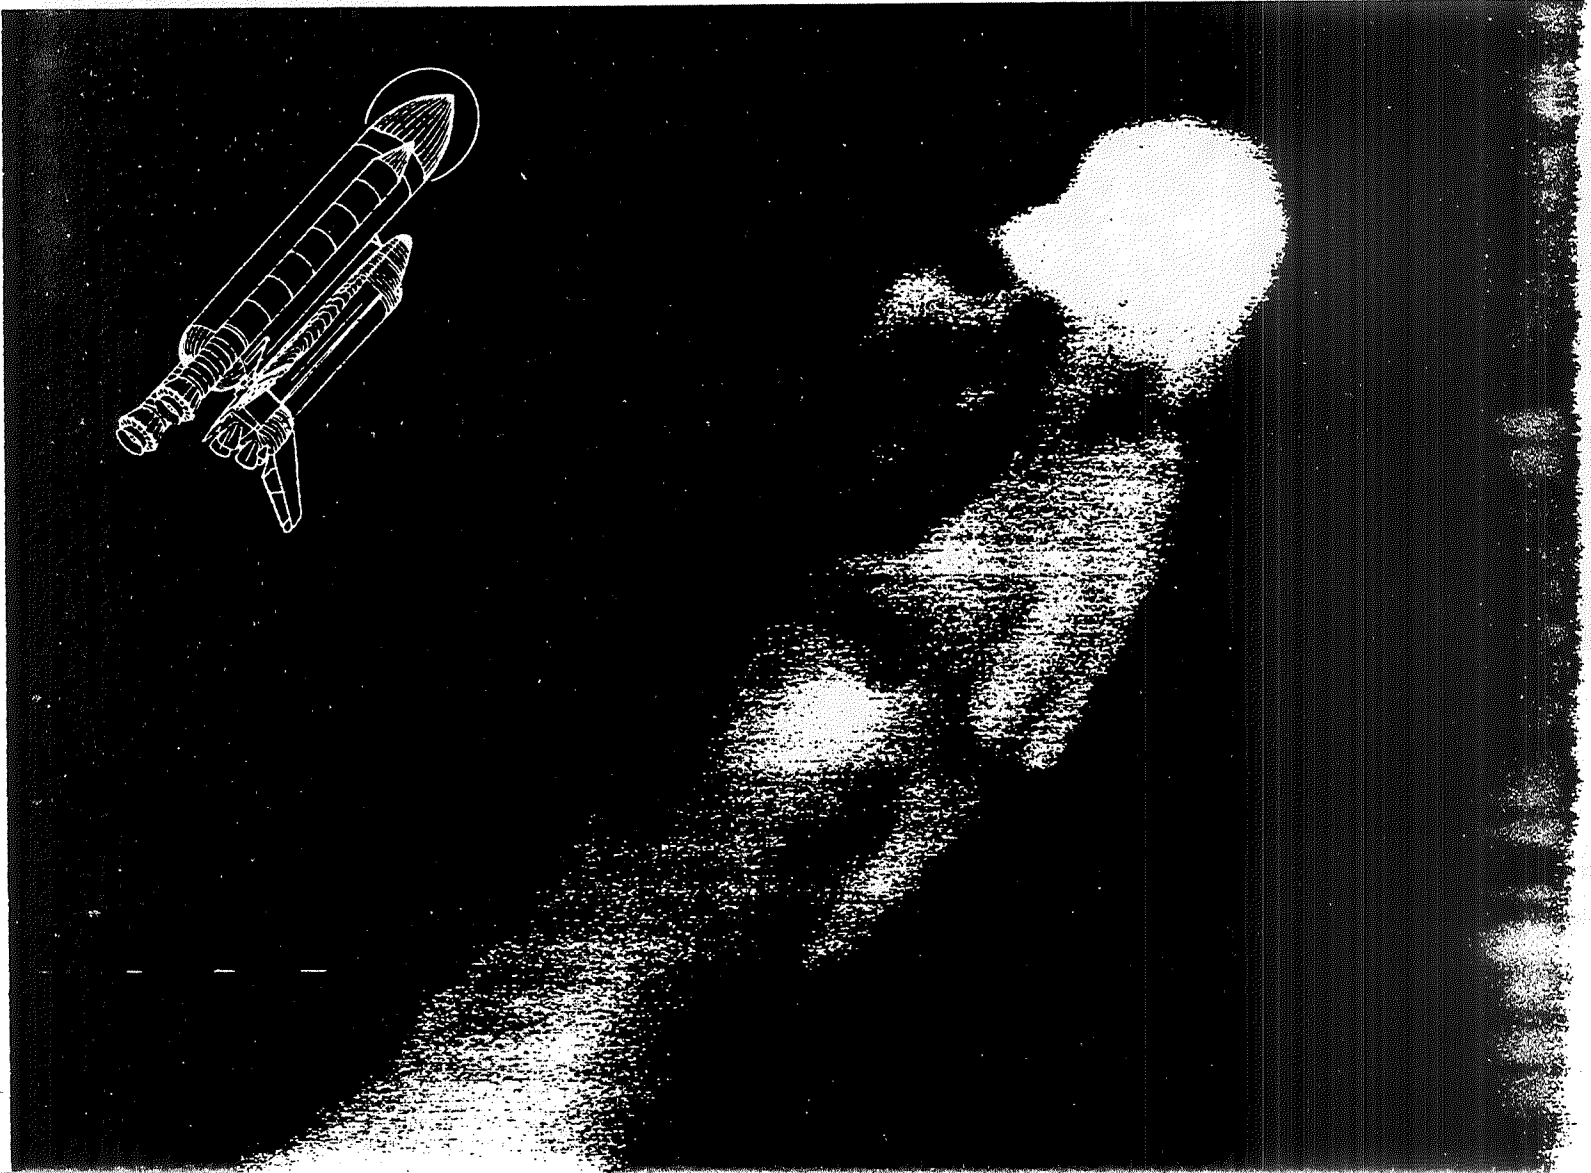
Structural breakup of the vehicle began at approximately 73 seconds. Fire spread very rapidly. Above, a bright flash (arrow) is evident near the nose of the Orbiter, suggesting spillage and ignition of the spacecraft's reaction control system propellants. At left, the two Solid Rocket Boosters thrust away from the fire, crisscrossing to form a "V." The right booster—identifiable by its failure plume—now to the left of its counterpart. At right, the boosters diverge farther; the External Tank wreckage is obscured by smoke and vapor. The Orbiter engines still firing, is visible at bottom center.

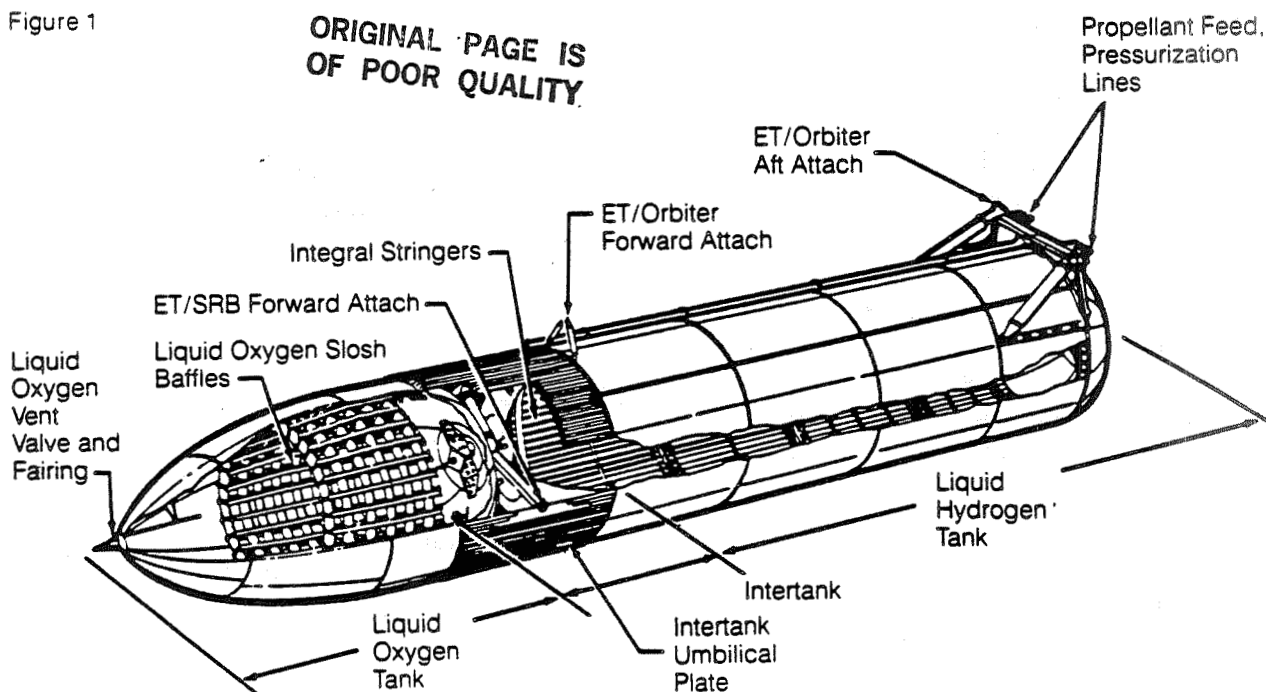
Figure 1

The possibility of an imperfection existing in either the pressurized or nonpressurized External Tank structural elements that could grow to a sufficient size to cause structural failure was examined in detail. All construction history, structural qualification test data, proof test inspection records and x-rays were reviewed. One previously

undetected imperfection that was discovered during a reexamination of the x-rays was found in recovered hardware with no propagation indicated.<sup>3</sup> Other data from the pre-launch ice and frost team inspections, film and video coverage, pressurization records and flight data revealed no evidence of leakage. The Commission concluded that no structural imperfections existed that could have grown to a size to create a leak or cause catastrophic failure of the External Tank.

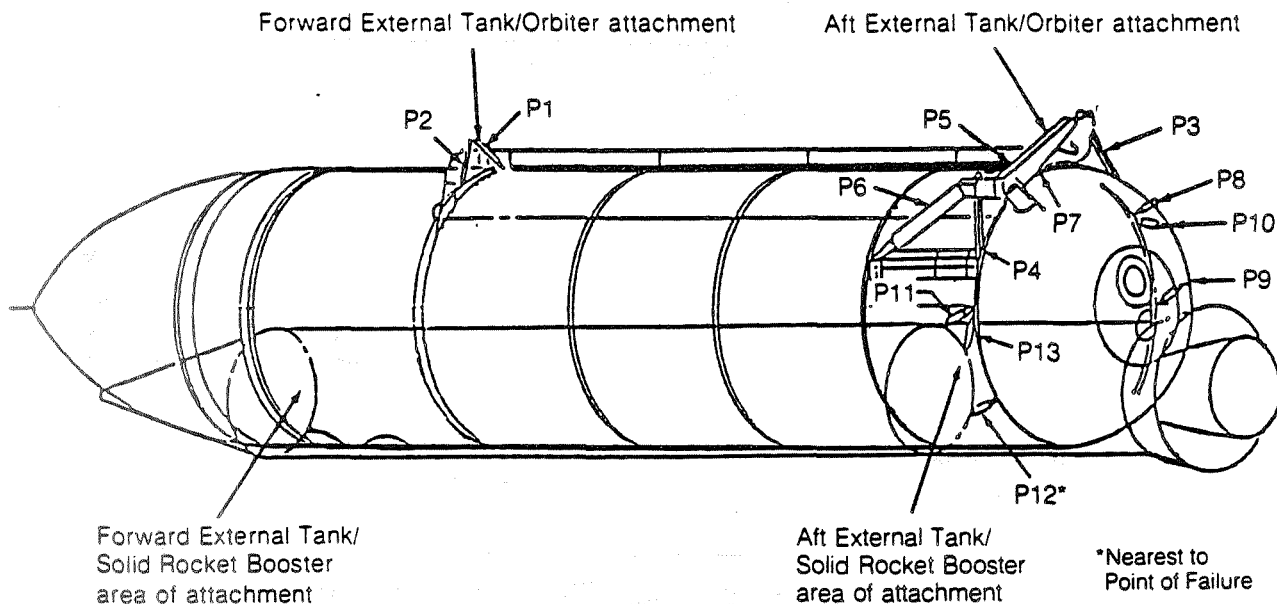
Figure 10  
Drawing of transparent External Tank, with right Solid Rocket Booster on far side, shows location of struts measured in table of strut loads. (Figure 9)

Engine thrust buildup, the resulting forces and moments, vehicle and pad stiffness, and clearances were as expected. The resultant total bending moment experienced by STS 51-L was  $291 \times 10^6$  inch-pounds, which is within the design allowable limit of  $347 \times 10^6$  inch-pounds.

The STS 51-L lift off loads were compared to design loads and flight measured loads for STS-1 through STS-7 (Figure 9). The Shuttle strut identification is shown in Figure 10. The loads measured on the struts are good indicators of stress since all loads between Shuttle elements are carried through the struts. The STS 51-L lift off loads were within the design limit.

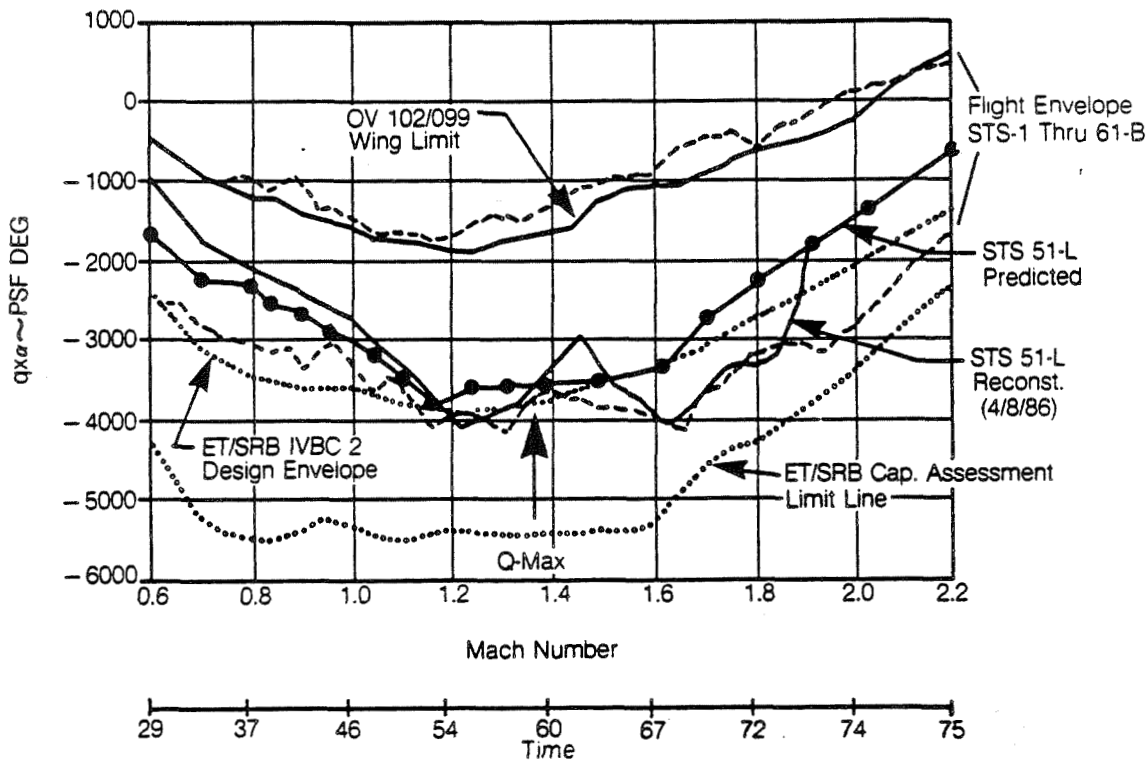
The Solid Rocket Motor field joint axial tension loads were substantially lower at maximum dynamic pressure than at lift off:  $11.6 \times 10^6$  pounds for the forward field joint and  $10.6 \times 10^6$  pounds for the aft field joint. Compared to the internal pressure loads, the dynamic variations due to wind shear were small—about  $\frac{1}{15}$  those of the pressure loads. *These loads were well below the design limit loads and were not considered the cause of the accident.*

Figure 11  
The loads in the pitch plane are shown by the solid line marked "STS 51-L RECONST." The curve "STS 51-L PREDICTED" give the loads expected before the flight. The dashed lines show the limit of experience from STS-1 through 61-B. The present design limits are the two lines marked "OV

102/099 WING LIMIT" above, and "ET/SRB CAP. ASSESSMENT LIMIT LINE" below. (After STS-6, the wing was strengthened. The previous design limits were "ET/SRB IVBC 2 DESIGN ENVELOPE" below, and a curve in the positive region of  $q \times \alpha$  above)

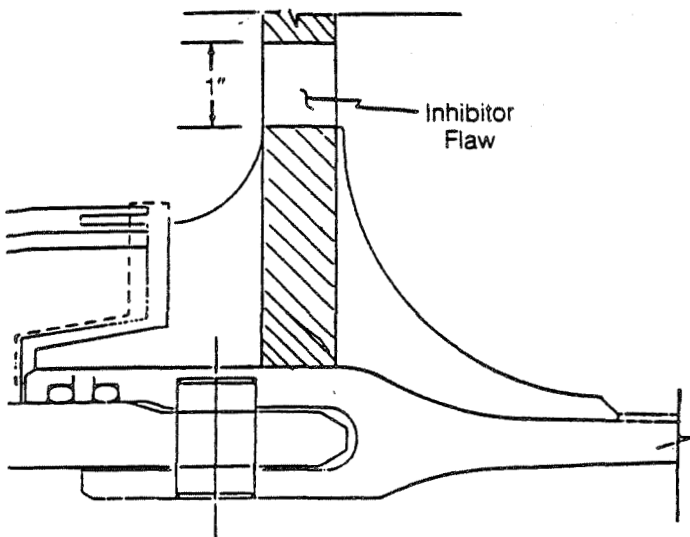
Figure 12  
Sketch shows location of assumed inhibitor flaw used in eliminating such a problem as a possible cause.

Evaluation of potential insulation or inhibitor (see Figure 12) flaws against the three criteria above resulted in elimination of all candidates except a defect in the forward-facing inhibitor. This potential failure mode was evaluated by assuming a 1-inch-diameter hole in the inhibitor. Analysis indicated that the change in motor internal pressure resulting from this failure would probably not be detected. However, an erosion rate substantially higher than the observed values would be required to burn through the membrane by 58 seconds. In addition, the assumed flaw is unlikely since the inhibitor is constructed by vulcanizing eight individual plies of the material. Subsequent damage of the magnitude required is improbable and would be easily detected.

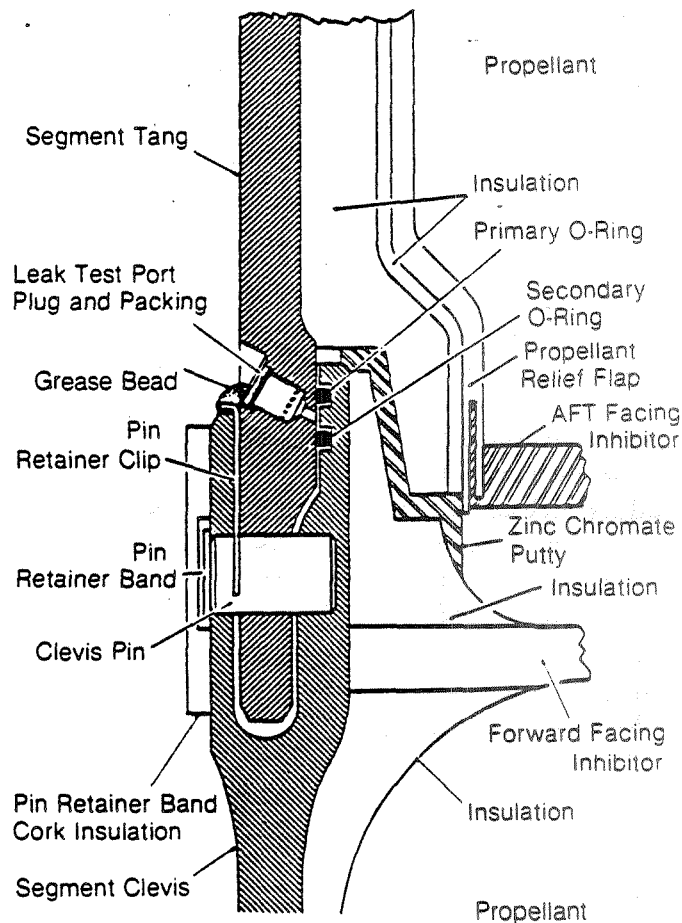
Figure 14  
Solid Rocket Motor cross section shows positions of tang, clevis and O-rings. Putty lines the joint on the side toward the propellant.

pressure loads are applied to the joint during ignition. Should pressure actuation be delayed to the extent that the gap has opened considerably, the possibility exists that the rocket's combustion gases will blow by the O-ring and damage or destroy the seals. The principal factor influencing the size of the gap opening is motor pressure; but, gap opening is also influenced by external loads and other joint dynamics. The investigation has shown that the joint sealing performance is sensitive to the following factors, either independently or in combination:

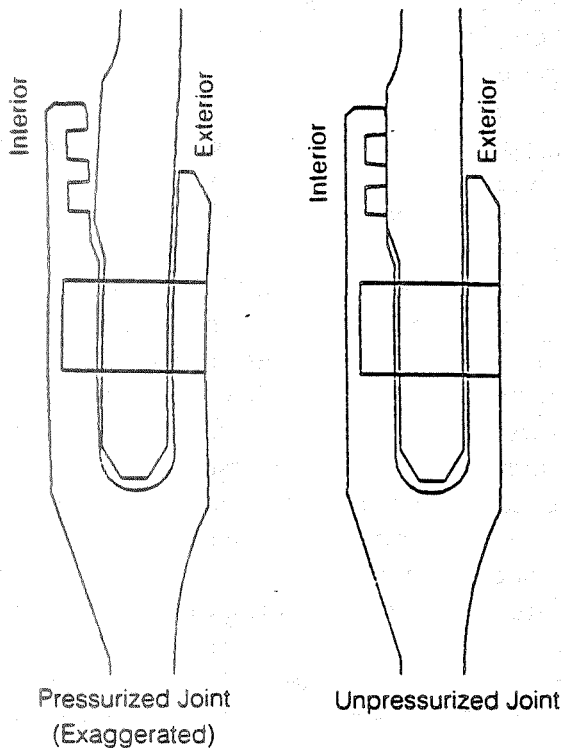
The joint deflection analysis established time histories for gap openings for primary and secondary O-rings for all field joints. For the aft field joints these data indicate gap opening increases of approximately 0.029 inches and 0.017 inches for the primary and secondary O-rings respectively. These values were used for sub-scale dynamic tests. Due to differences in motor pressure and loads, the gap opening increases for forward field joints are approximately 0.008 inches greater than for the aft field joints. Gap opening changes (called delta gap openings) versus time are shown in Figure 17 for the aft field joints. The total gap at any time also depends on the initial static gap, on rounding effects during segment pressurization, and on loadings due to struts and airloads. Sub-scale tests were run containing combinations of the above variables, but did not include the effects of the struts and airloads.

Figure 16  
Drawings show how tang/clevis joint deflects during pressurization to open gap at location of O-ring slots. Inside of motor case and propellant are to left in sketches.

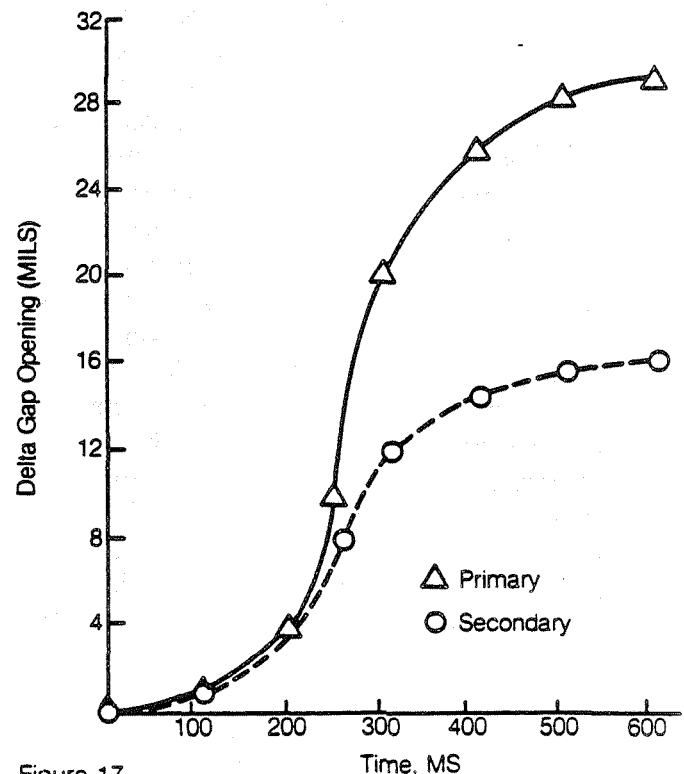
Figure 17  
Graph plots changes in right booster's aft field joint primary and secondary gap openings. Horizontal scale is time in milliseconds from ignition.

Consistent results from numerous O-ring tests have shown a resiliency degradation with reduced temperatures. Figure 23 provides O-ring recovery from 0.040 inches of initial compression versus time. This shows how quickly an O-ring will move back towards its uncompressed shape at temperatures ranging from 10 to 75 degrees Fahrenheit. When these data are compared with the gap openings versus time from Figure 17, it can be seen that the O-rings will not track or

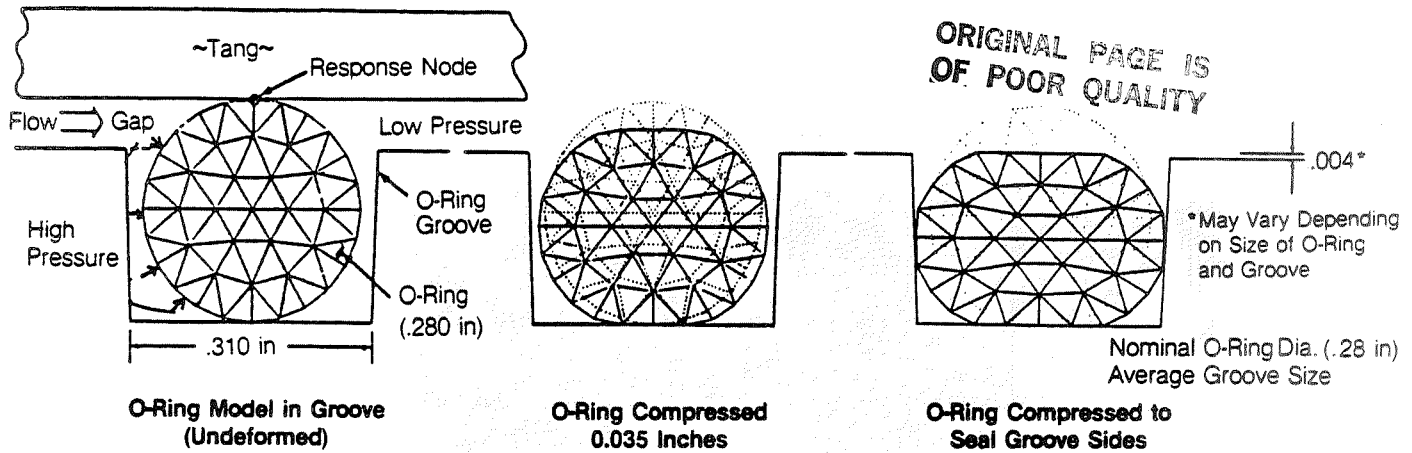
Figure 18  
 Drawings show how progressive reduction of gap between tang and clevis can inhibit and eventually block motor cavity's high-pressure flow from getting behind O-ring.

Recent analysis has shown and tests tend to confirm that O-ring sealing performance is significantly improved when actuating pressure can get behind the entire face of the O-ring on the upstream side of the groove within which the O-ring sits (Figure 18). If the groove is too narrow or if the initial squeeze is so great as to compress the O-ring to the extent that it fills the entire groove and contacts all groove surfaces, pressure actuation of the seal could be inhibited. This latter condition is relieved as the joint gap opens and the O-ring attempts to return to its uncompressed shape. However, if the temperature is low, resiliency is severely reduced and the O-ring is very slow in returning towards its original shape. Thus, it may remain compressed in the

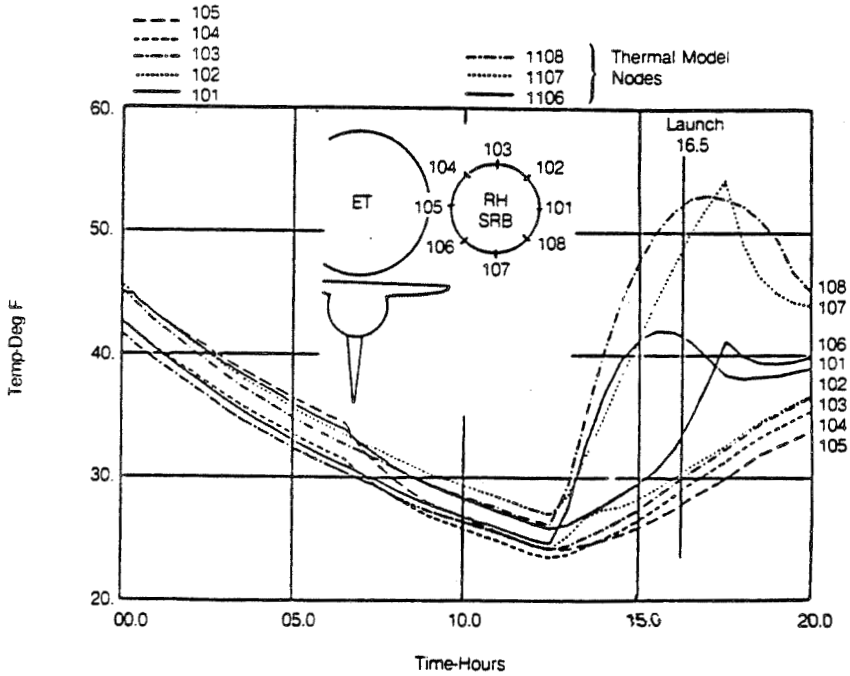
Figure 20  
Temperature model for 51-L right solid booster aft segment circumferential positions from 16.5 hours prior to launch to 3.5 hours after launch.

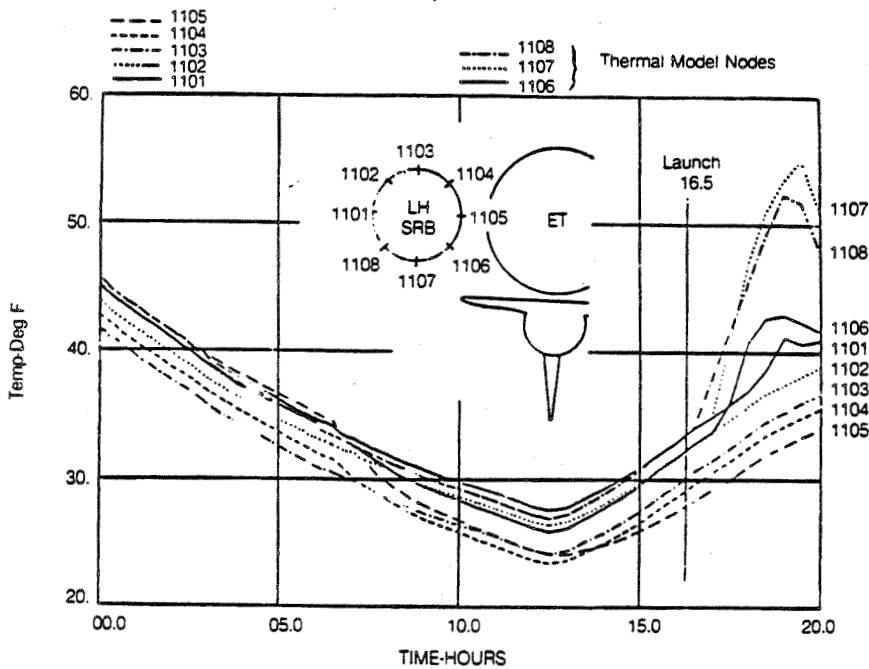
Figure 21  
Temperature model for 51-L left solid booster aft segment circumferential positions from 16.5 hours prior to launch until 3.5 hours after launch.

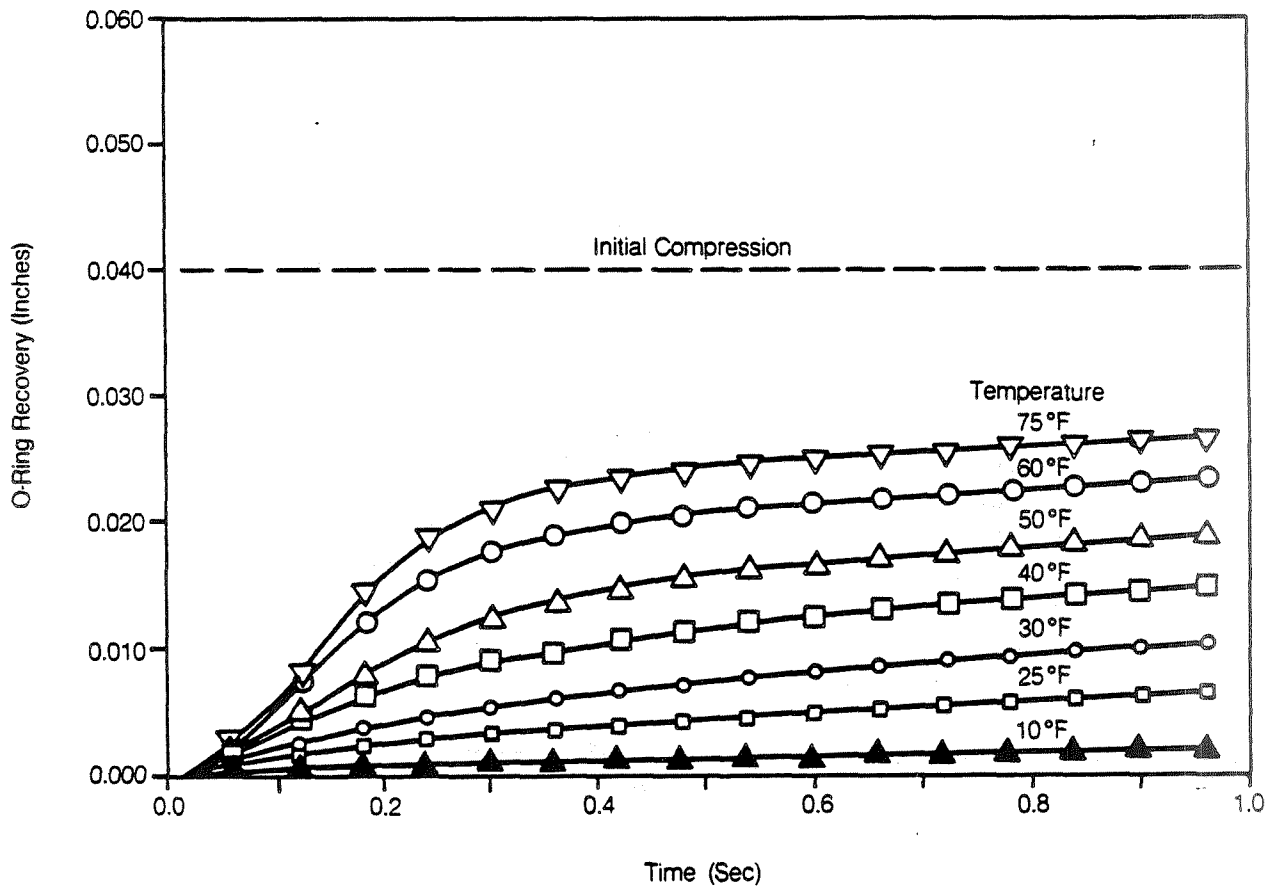
Figure 23  
Graph plots O-ring shape recovery in inches against time in seconds for a variety of temperatures.

Note: Average O-Ring Recovery at Various Test Temperatures During First Second After Load Release. Initial Compression of 40 Mills Was Maintained for 2 Hours.

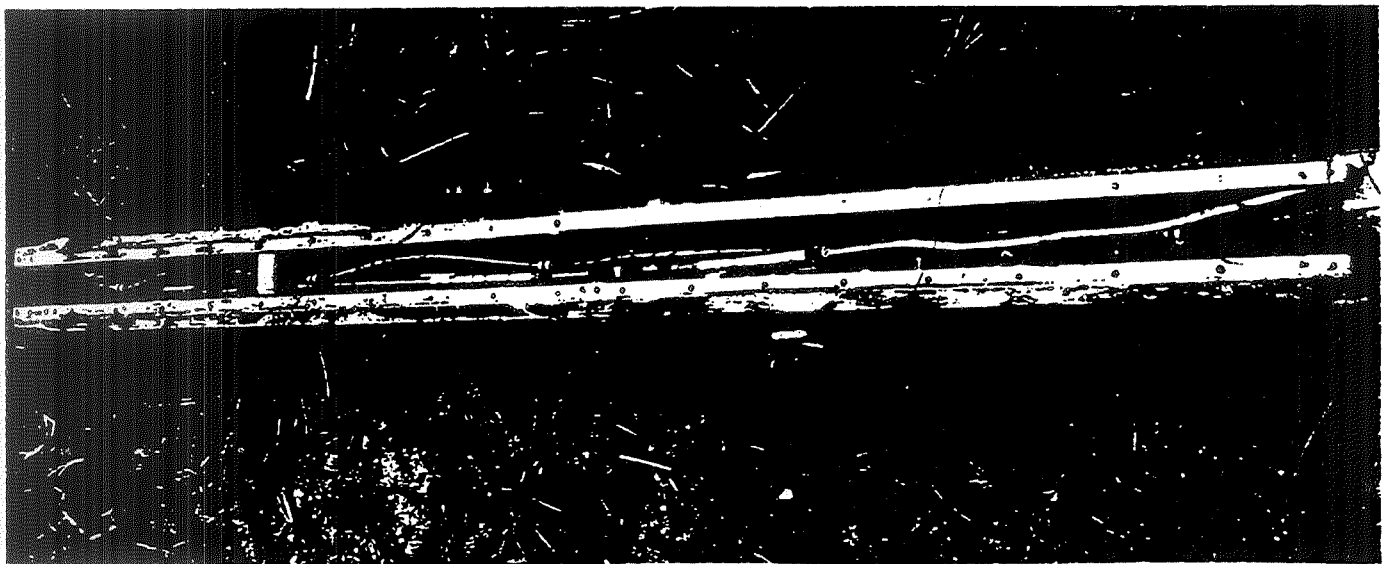
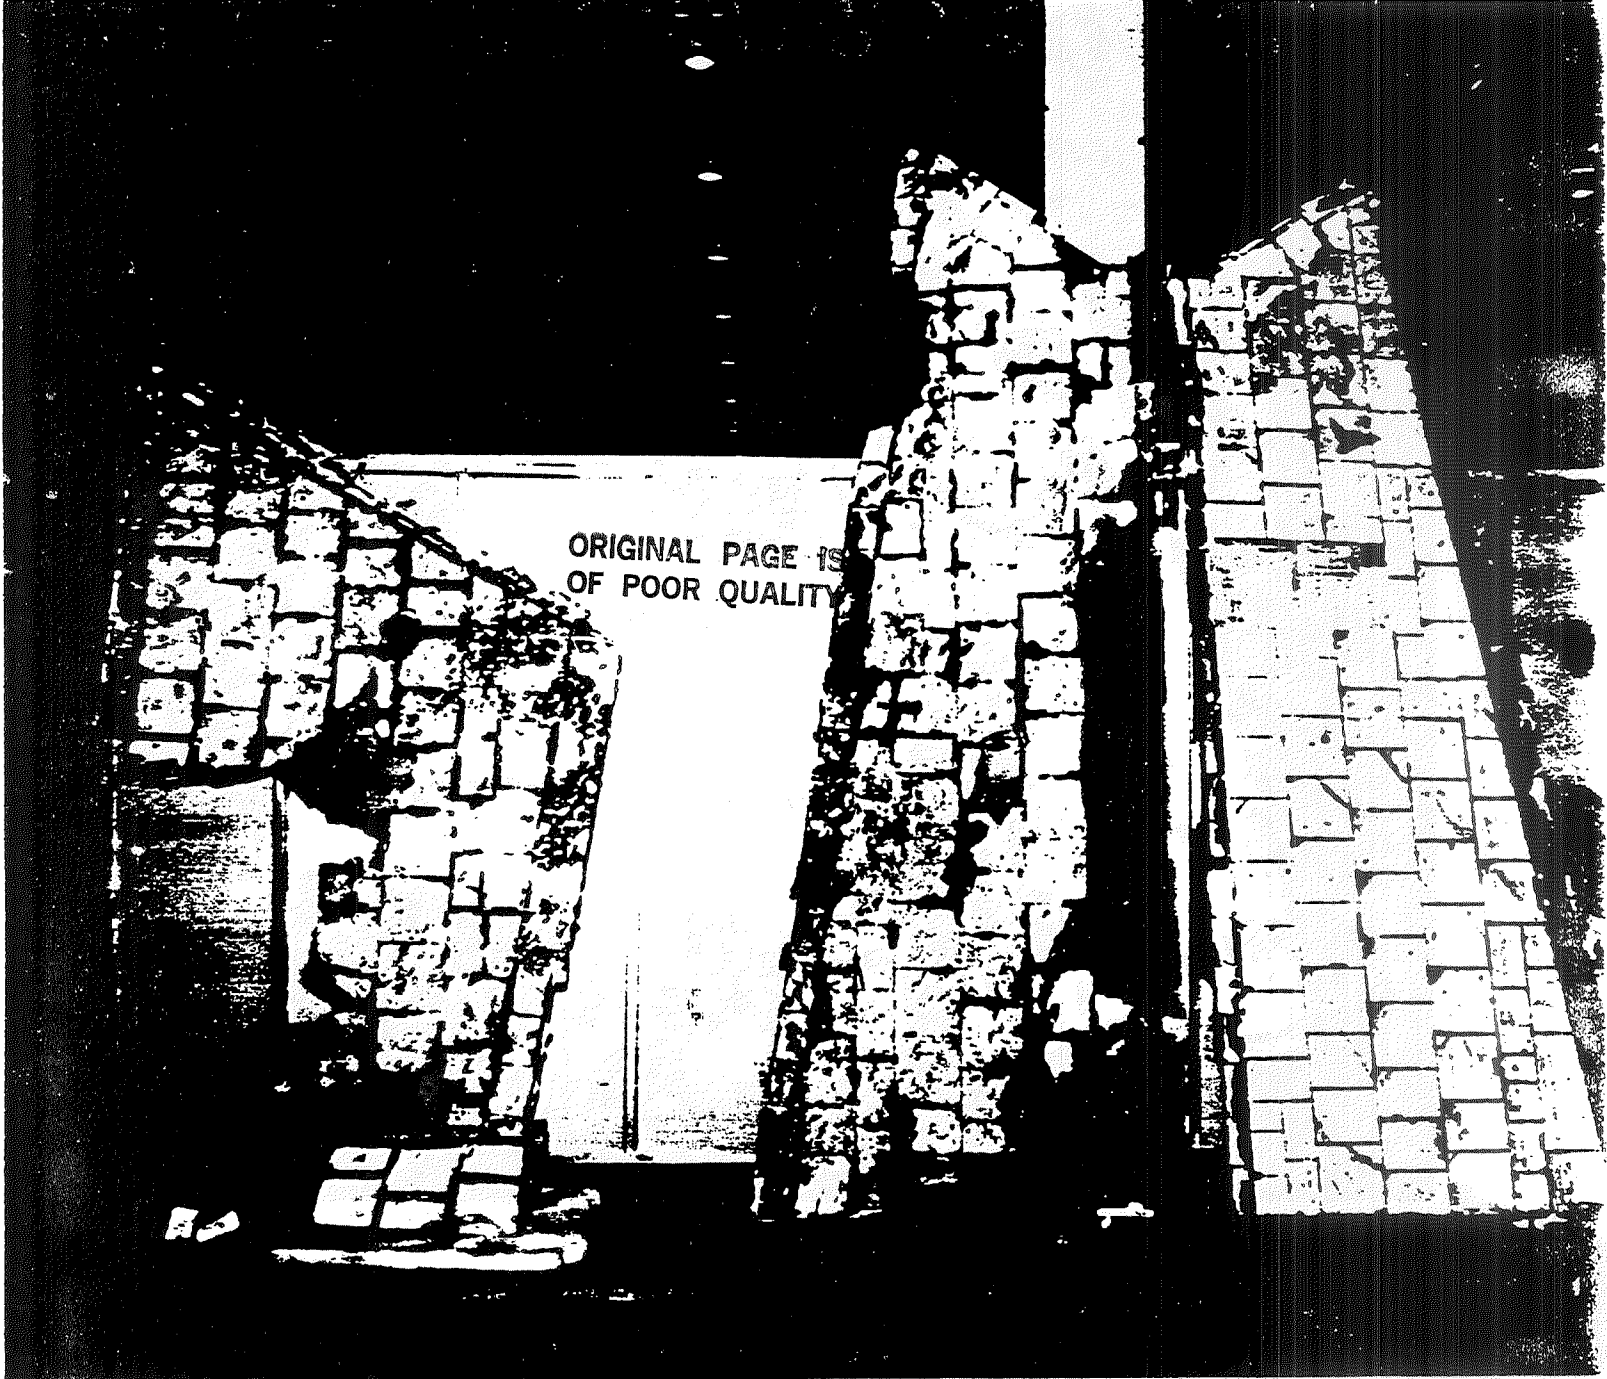
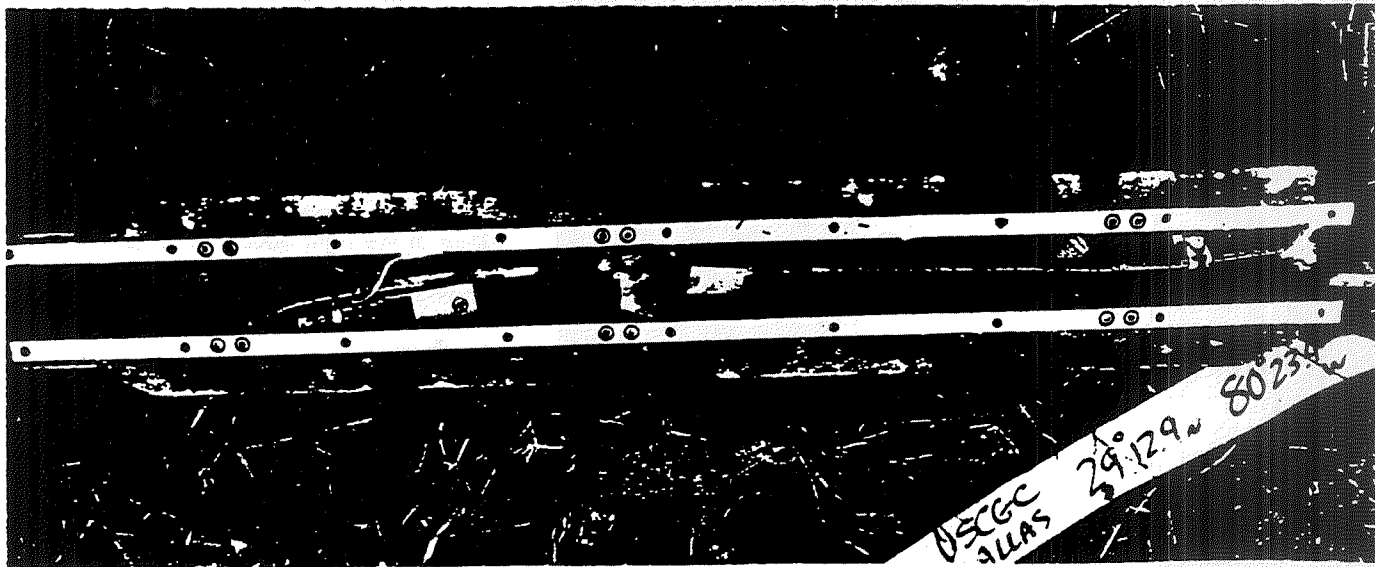
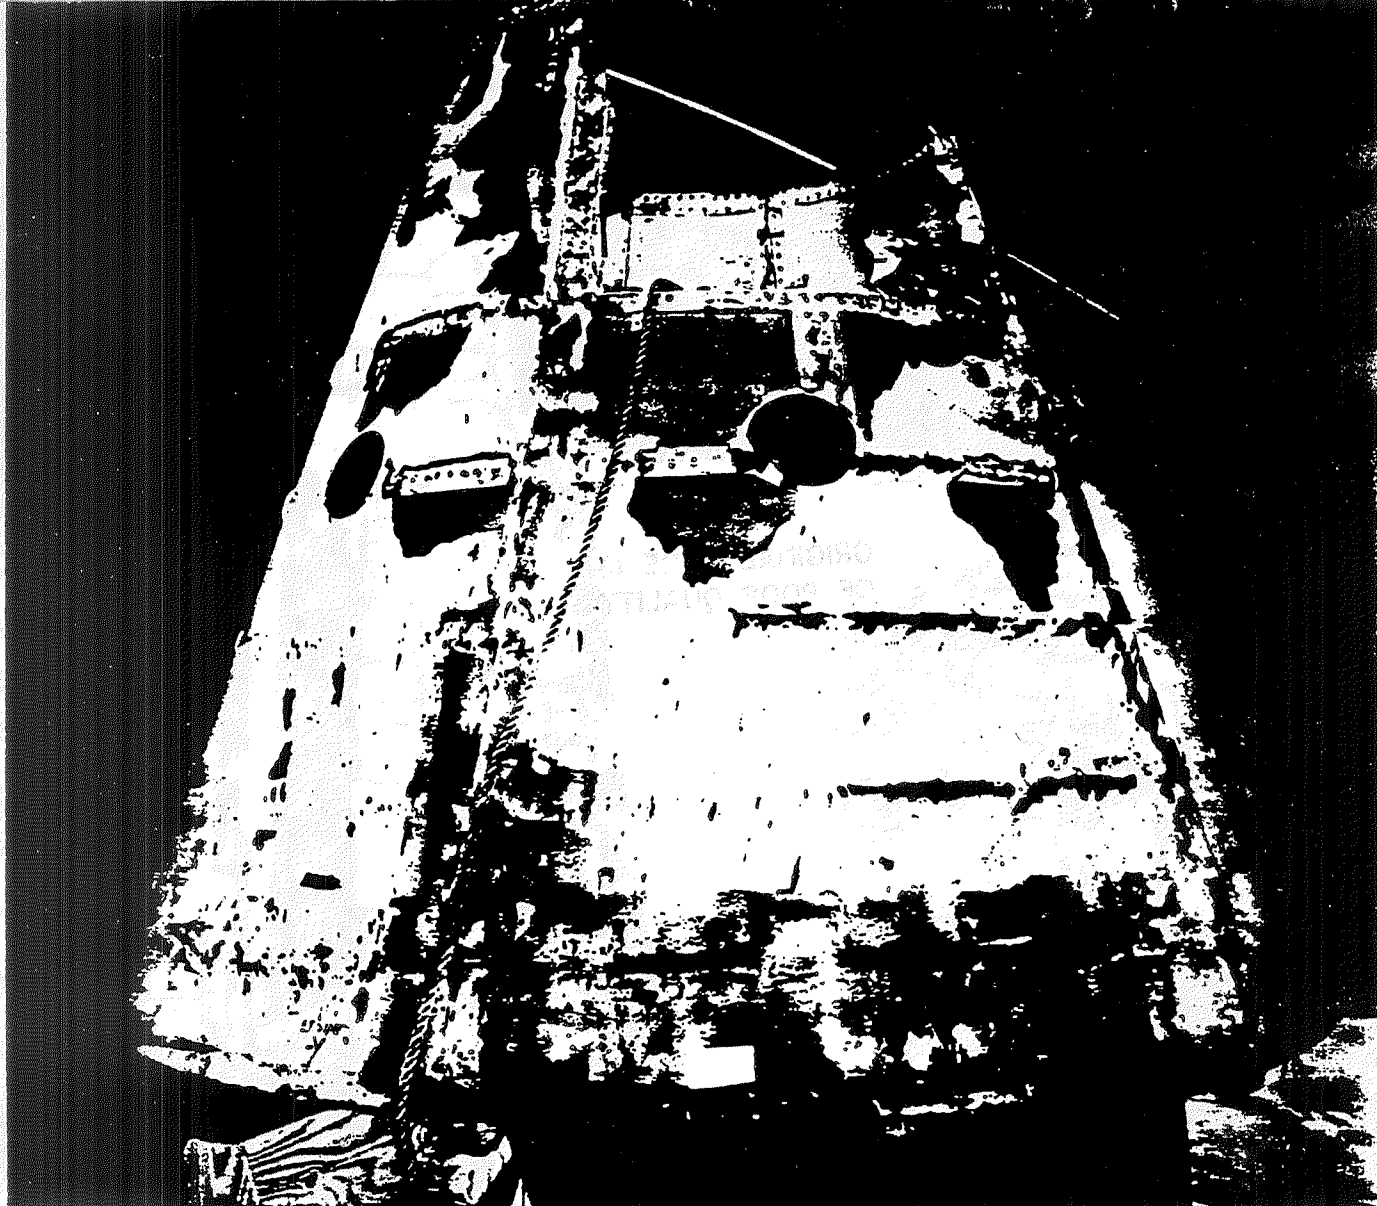
A The upper photos show, from left to right, the left side of the Orbiter (unburned), the right lower and upper rudder speed brake (both burn damaged) and left upper speed brake (unburned), confirmation that the fire was on the

right side of the Shuttle stack. The lower photos show the range safety destruct charges in the External Tank. These charges were exonerated when they were recovered intact and undetonated.

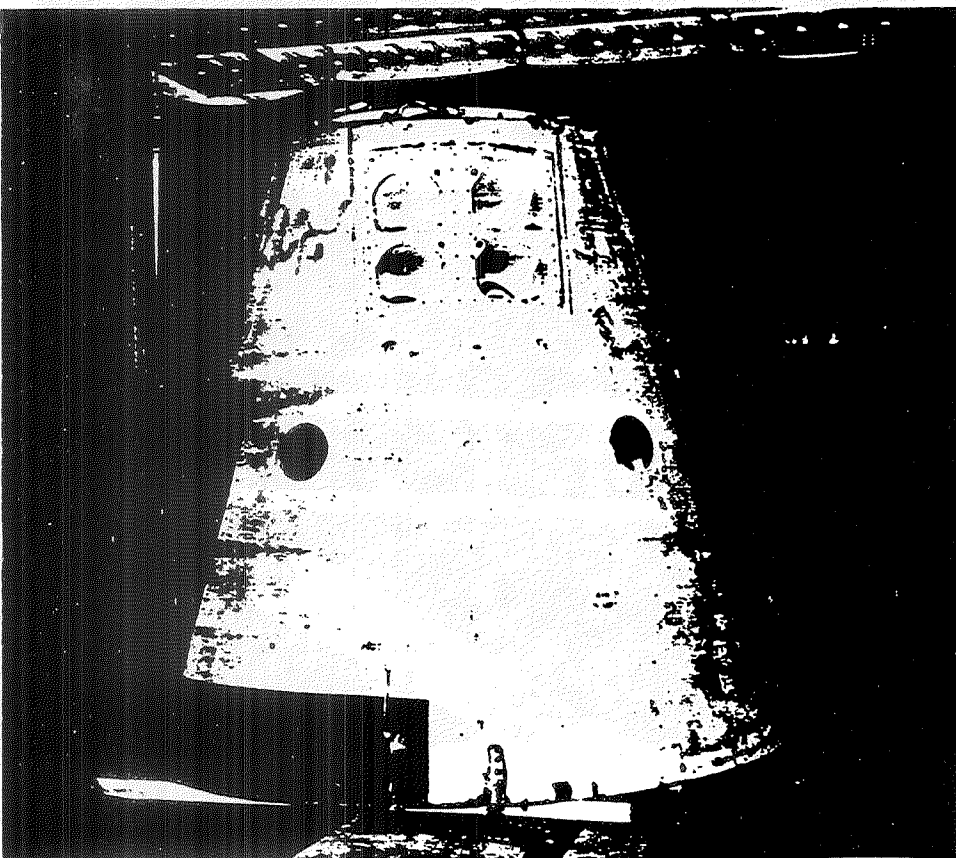
The frustums on the left page are parts of the Solid Rocket Booster forward assemblies that contain recovery parachutes, location aids and flotation devices. The frustum of the left hand booster (lower left) is virtually undamaged. The right frustum shows impact damage at top and burns along the base of the cone; evidence indicates it was damaged when it impacted with the External Tank. Shown at right above is another Solid Rocket Motor stack crosshatched to show the burned area of the right booster's aft joint (diagram at right). The flame from the hole impinged on the External Tank and caused a failure at the aft connection at the External Tank.

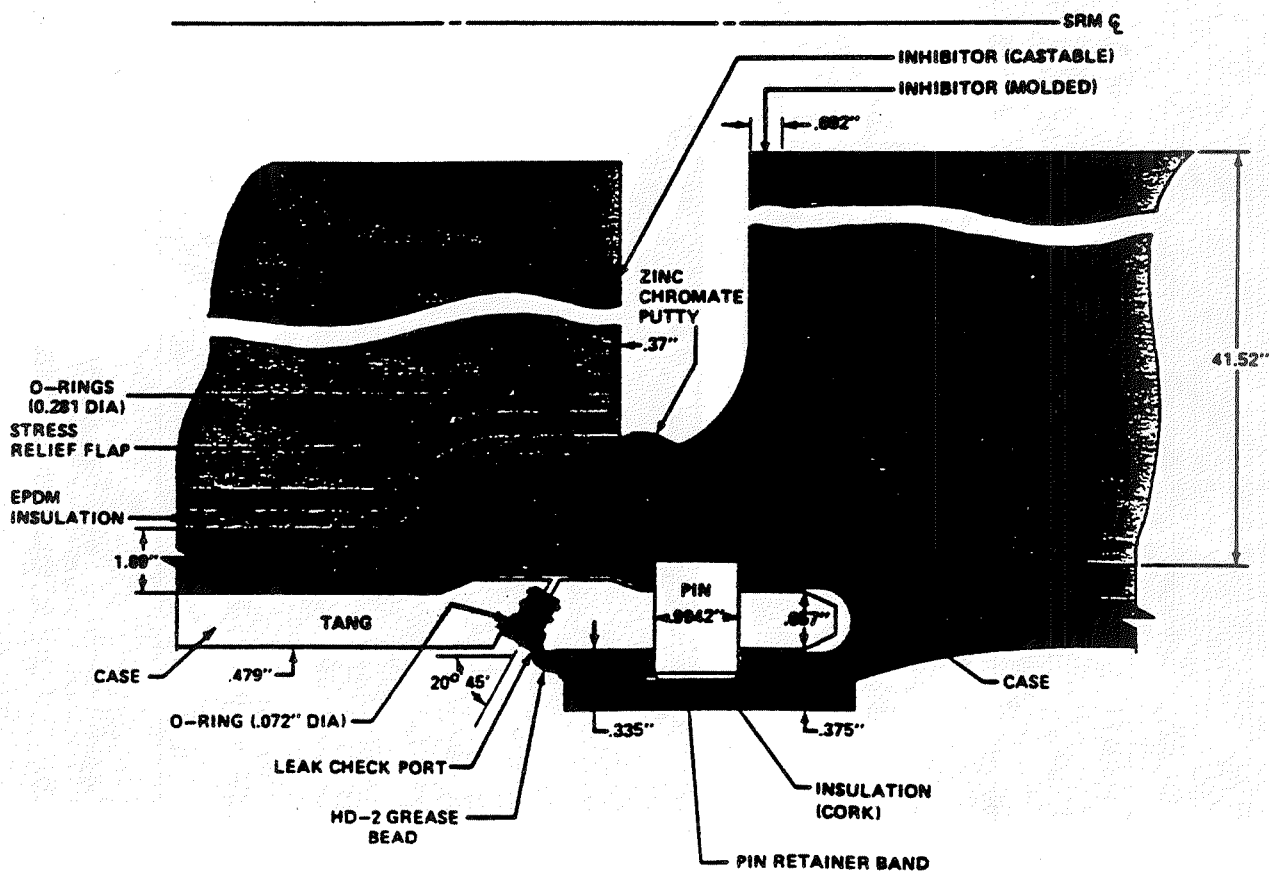
**AFT SEGMENT/AFT CENTER SEGMENT FIELD JOINT CONFIGURATION**

Some observations were made from a detailed examination of the aft center section of the joint, contact 131. This piece (photo I) shows a large hole that is approximately centered on the

307-degree circumferential position. Although irregular, the hole is roughly rectangular in shape, extending approximately 27 inches circumferentially along the tang (296 to 318 degrees) with total burnout extension approximately 15 inches forward of the tang. At either side in the interior of the hole (photo K) the insulation and steel case material showed evidence of hot gas erosion that beveled these surfaces (indicative of combustion products flowing through the hole from the interior of the Solid Rocket Motor). The top surface of the hole was hardly beveled at all. The

Examined at Kennedy Space Center after their recovery from the ocean, these fragments show the extent of burn through the right hand booster's aft field joint. On the left page are sections of the aft center motor segment above the joint. On the right page are sections (inverted) of the aft motor segment showing burn-hole below the joint (bracket). Except for the interior views on lower left, the camera is viewing the parts from outside the casing.

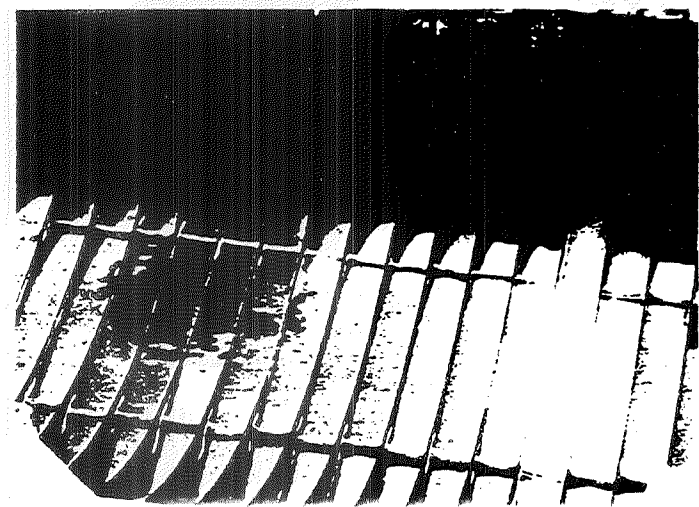
Above, Shuttle 51-L on Kennedy Space Center Pad 39B in the early morning of launch day. Temperatures were well below freezing, as indicated by the lower left photo, which shows thick ice in a water trough despite use of an anti-freeze solution.
