*Report to the President*

*By The*  
**PRESIDENTIAL  
COMMISSION**  
*on the Space Shuttle  
Challenger Accident*

June 6th, 1986  
Washington, D.C.

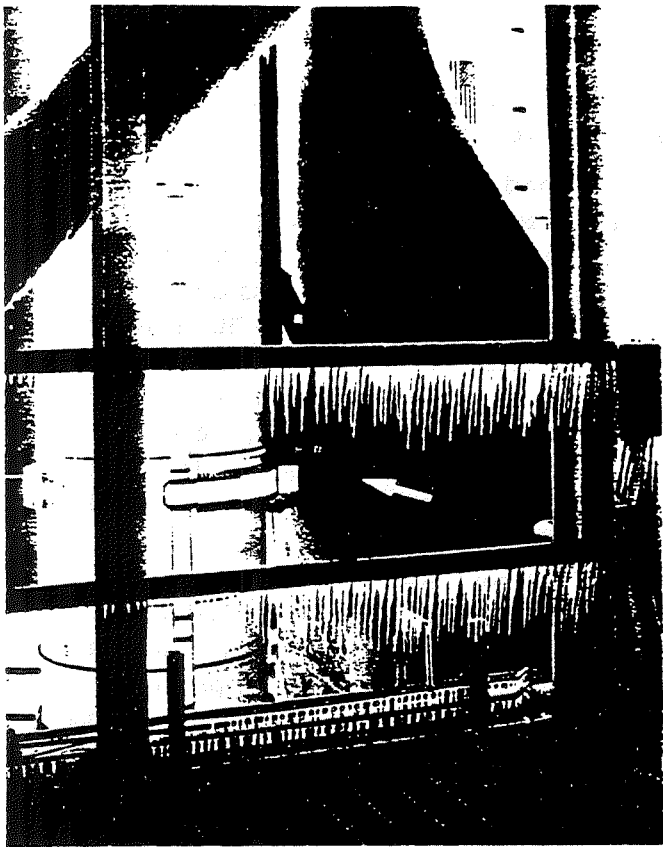
Above, foot long icicles on a lower level of the Fixed Service Structure frame the attachment point where the Orbiter is attached to the external tank (arrow). Icing was even more extensive at upper levels of the service structure (upper right and below). At right below is a ground communications box (not used during launch) rendered inoperable by heavy ice.

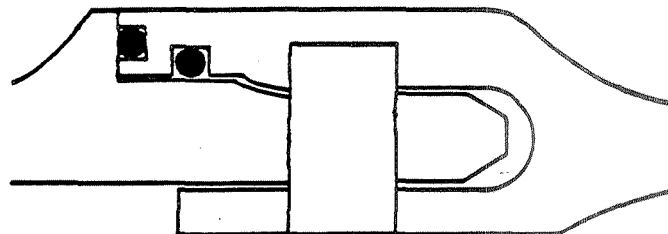
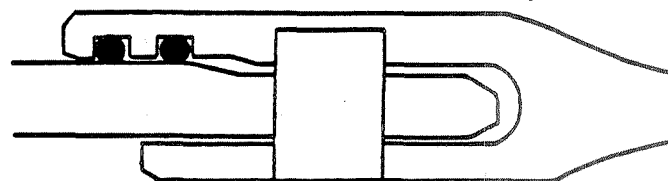
Figure 1

The initial Thiokol design proposal was changed before the production motors were manufactured. Originally, the joint seal design incorporated both a face seal and a bore seal.<sup>16</sup> (Figure 1.) However, the motor that was eventually used had double bore O-rings. The original bore seal/face seal design was chosen because it was anticipated that it “provides [better] redundancy over a double bore ring seal since each is controlled by different manufacturing tolerances, and each responds differently during joint assembly.”<sup>17</sup> Because the early design incorporated tolerances similar to the Titan and it also incorporated a face seal, Thiokol believed it possessed “complete, redundant seal capability.”<sup>18</sup>

Nevertheless, as the Solid Rocket Motor program progressed, Thiokol—with NASA’s concurrence—dropped the face/bore seal design for one using a double bore seal (Figure 1). NASA engineers at Marshall said the original design would have required tapered pins to maintain necessary tolerances and assure enough “squeeze” on the face-sealing O-ring.<sup>19</sup> However, design analysis determined that motor ignition would create tension loads on the joint sufficient to cause the tapered pins to pop out. Solving that would have meant designing some type of pin-retainers. Moreover, the rocket assembly was much easier with the dual bore seals. Because inspections and tests had to be conducted on the Solid Rocket Motor stack, horizontal assembly was required. Thiokol engineer, Howard McIntosh, described this in a Commission interview on April 2, 1986:

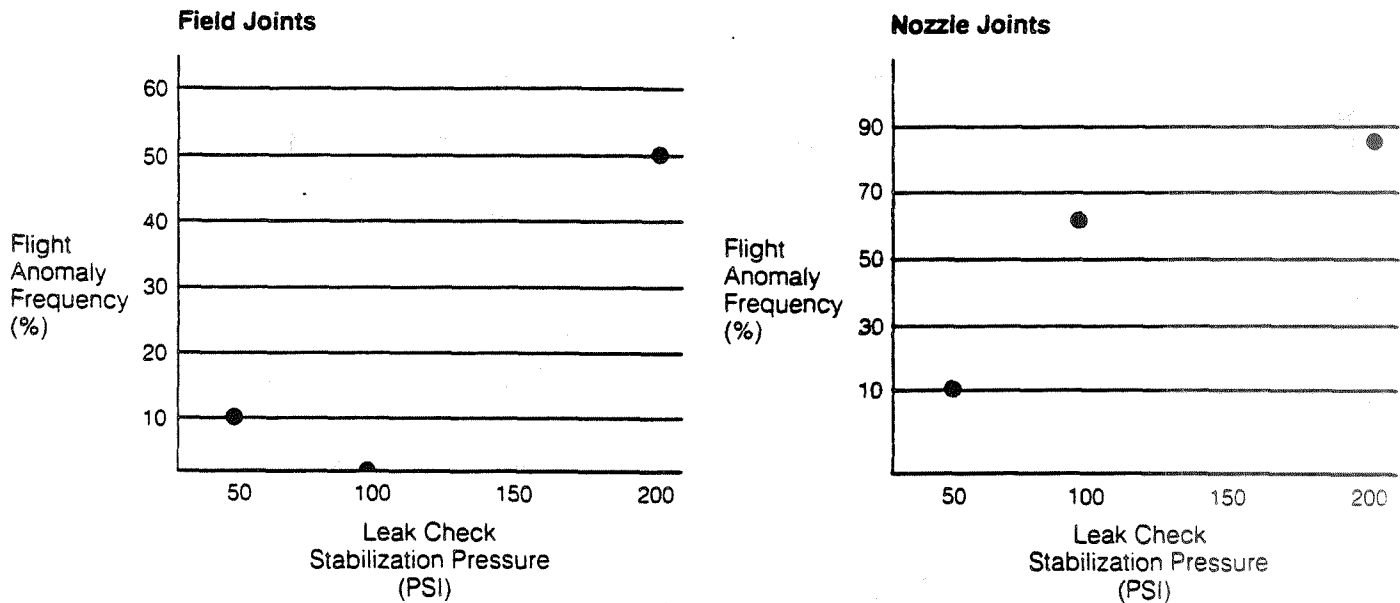
Graphs depict flight anomaly frequency for both field and nozzle joint of solid motors for a variety of leak check pressures. Figure 3

This hypothesis that O-ring erosion is related to putty blow holes is substantiated by the leak check history (Figure 3). Prior to January, 1984, and STS 41-B, when the leak check pressure was

The trends of flight anomalies in relation to leak check stabilization pressure are illustrated for the field joint and the nozzle joint in Figure 3, on page 133. While the data point concerning the 100 pound per square inch field joint leak check is not conclusive since it is based on only two flights, the trend is apparent.

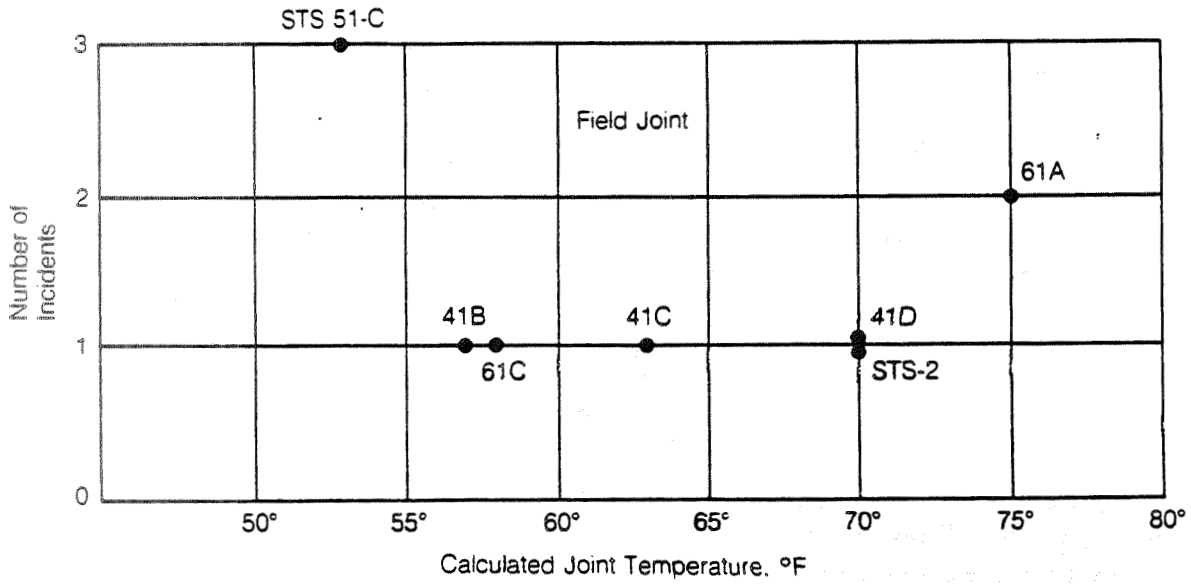
cy of occurrence based on all flights (Figure 6). In such a comparison, there is nothing irregular in the distribution of O-ring "distress" over the spectrum of joint temperatures at launch between 53 degrees Fahrenheit and 75 degrees Fahrenheit. When the entire history of flight experience is considered, including "normal" flights with no erosion or blow-by, the comparison is substantially different (Figure 7).

Figure 6  
Plot of flights with incidents of O-ring thermal distress as function of temperature

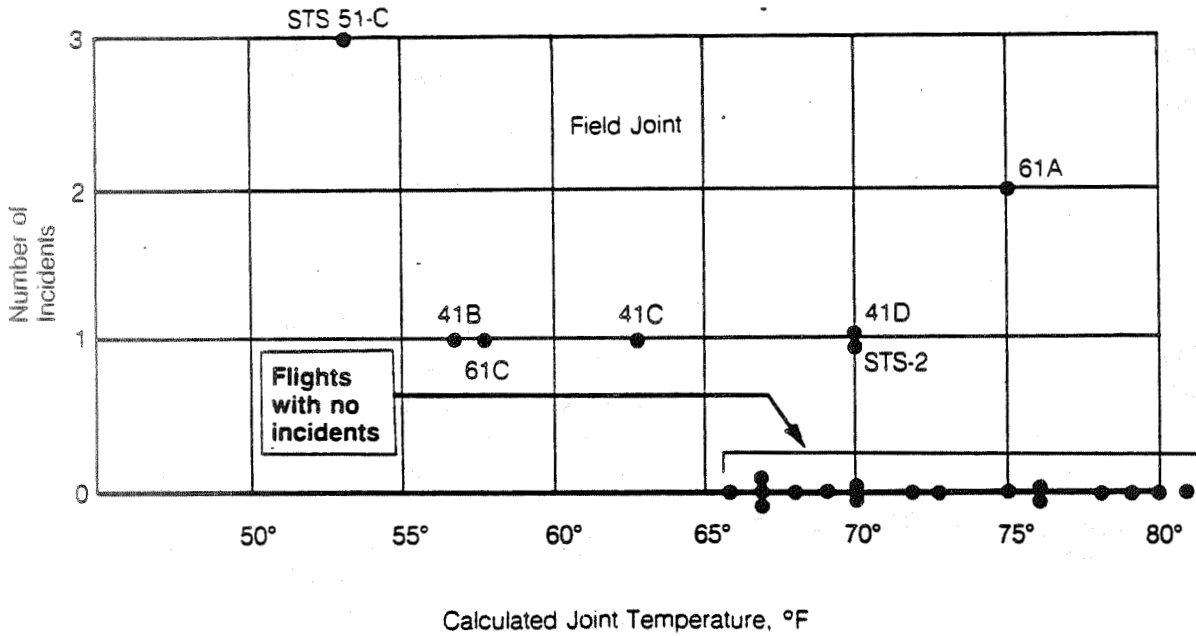
Figure 7  
Plot of flights with and without incidents of O-ring thermal distress

NOTE: Thermal distress defined as O-ring erosion, blow-by, or excessive heating

6. A careful analysis of the flight history of O-ring performance would have revealed the correlation of O-ring damage and low temperature. Neither NASA nor Thiokol carried out such an analysis; consequently, they were unprepared to properly evaluate the risks of launching the 51-L mission in conditions more extreme than they had encountered before. ■
