Solar Thermal Power Systems Project
Parabolic Dish Systems Development

Bearing Development Program for a 25-kWe Solar-Powered Organic Rankine-Cycle Engine

September 15, 1985

JPL Publication 85-81

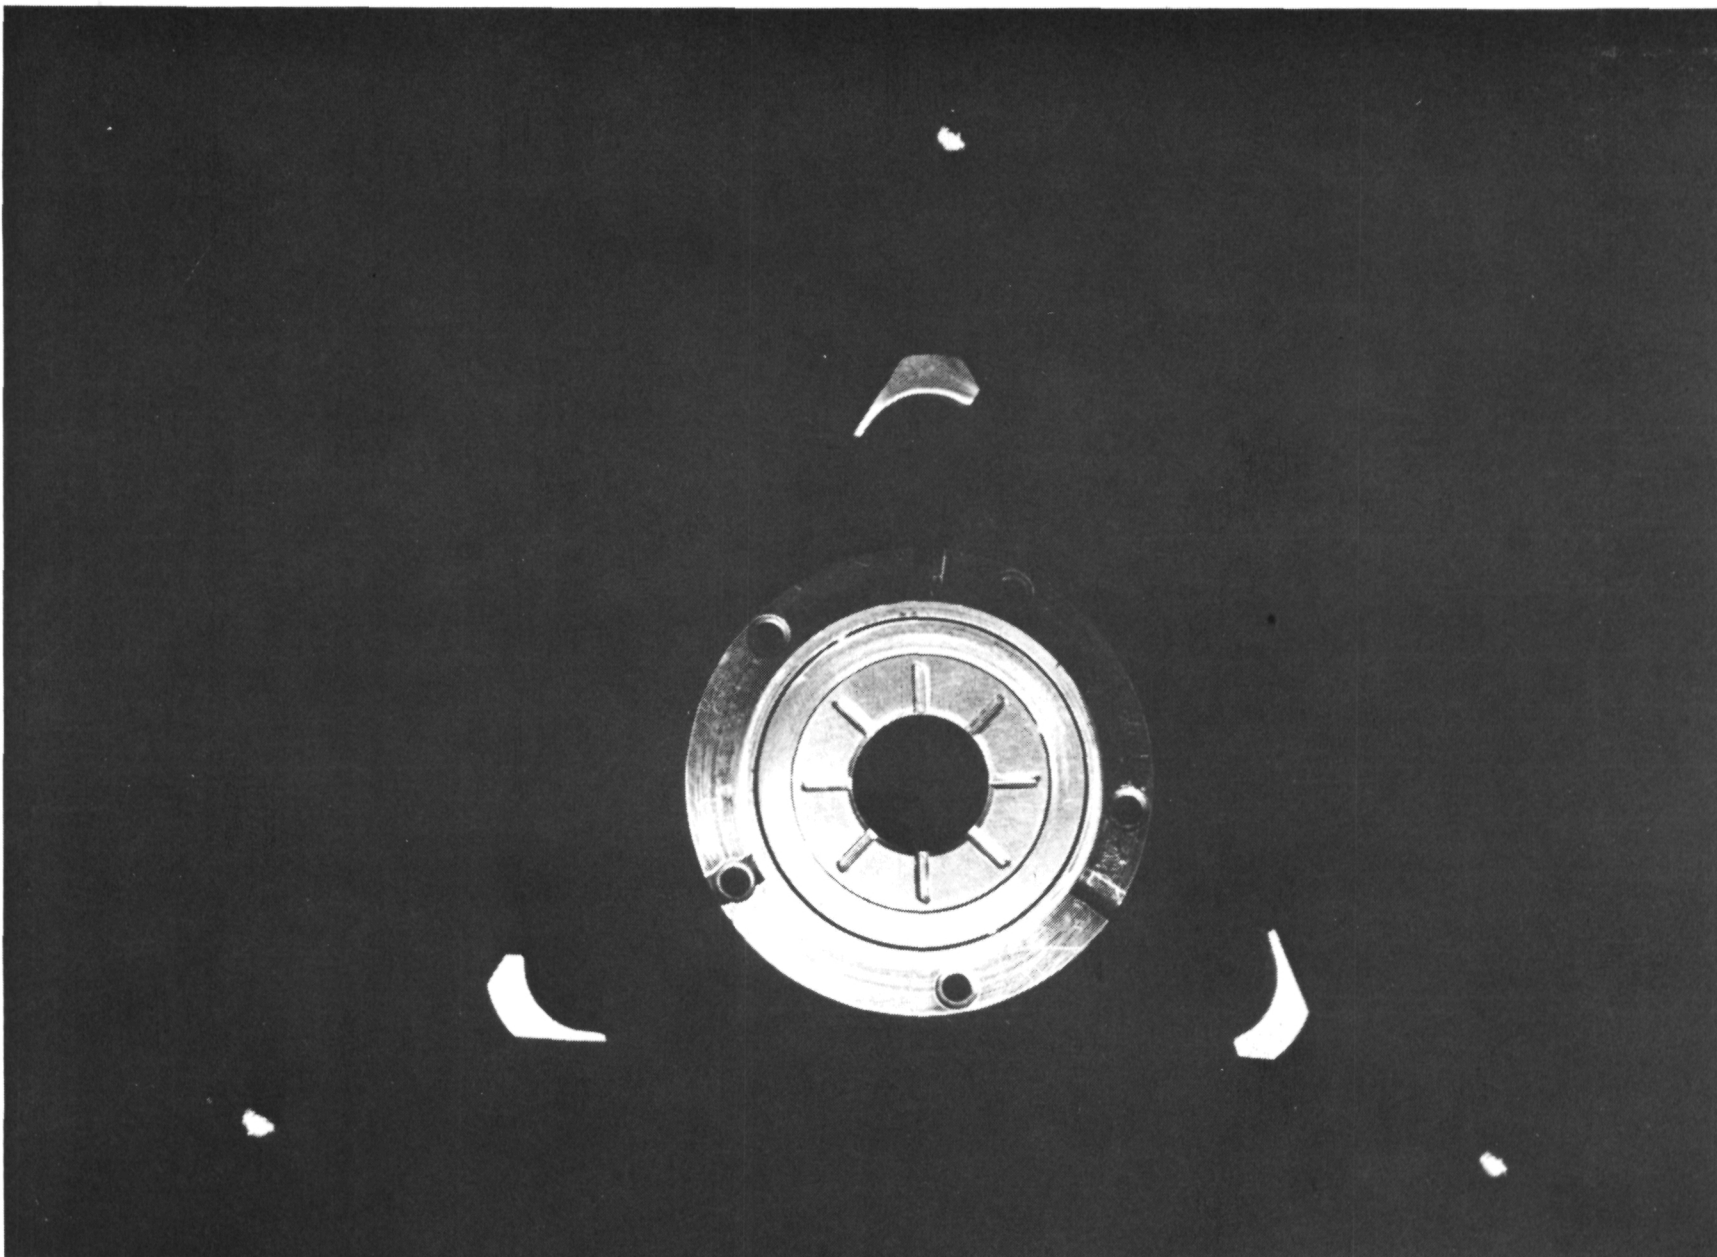
A number of modifications were incorporated into TAP build 3. A grounding strap was attached to the shaft to eliminate the possibility of electrostatic discharge across the bearings to the grounded engine. Helical screw pump-out seals were added to the alternator rotor to eliminate the possibility of liquid hold-up between the PMA rotor and stator and thus to improve the relatively low observed engine efficiency. Each tilting pad was reduced in mass by making linear angular cuts on the backside of the pads from the pivot point socket to the leading and trailing edges, and the rounded leading edge of each pad was replaced with a 10-deg chamfer (Figure 3-2). The lower mass pads would be less susceptible to dynamic problems, and the small chamfer would increase the effective bearing area and provide a more uniform leading edge. Side clearances on each pad were reduced to correct observed edge wear (Figure 3-3), which resembled patterns expected with excessive yaw of the pad. Each pivot ball was spring-loaded to ensure proper orientation during engine start-up.

Figure 3-2. Reduced-Mass Tilting Pads with 10-deg Leading Edge Chamfer

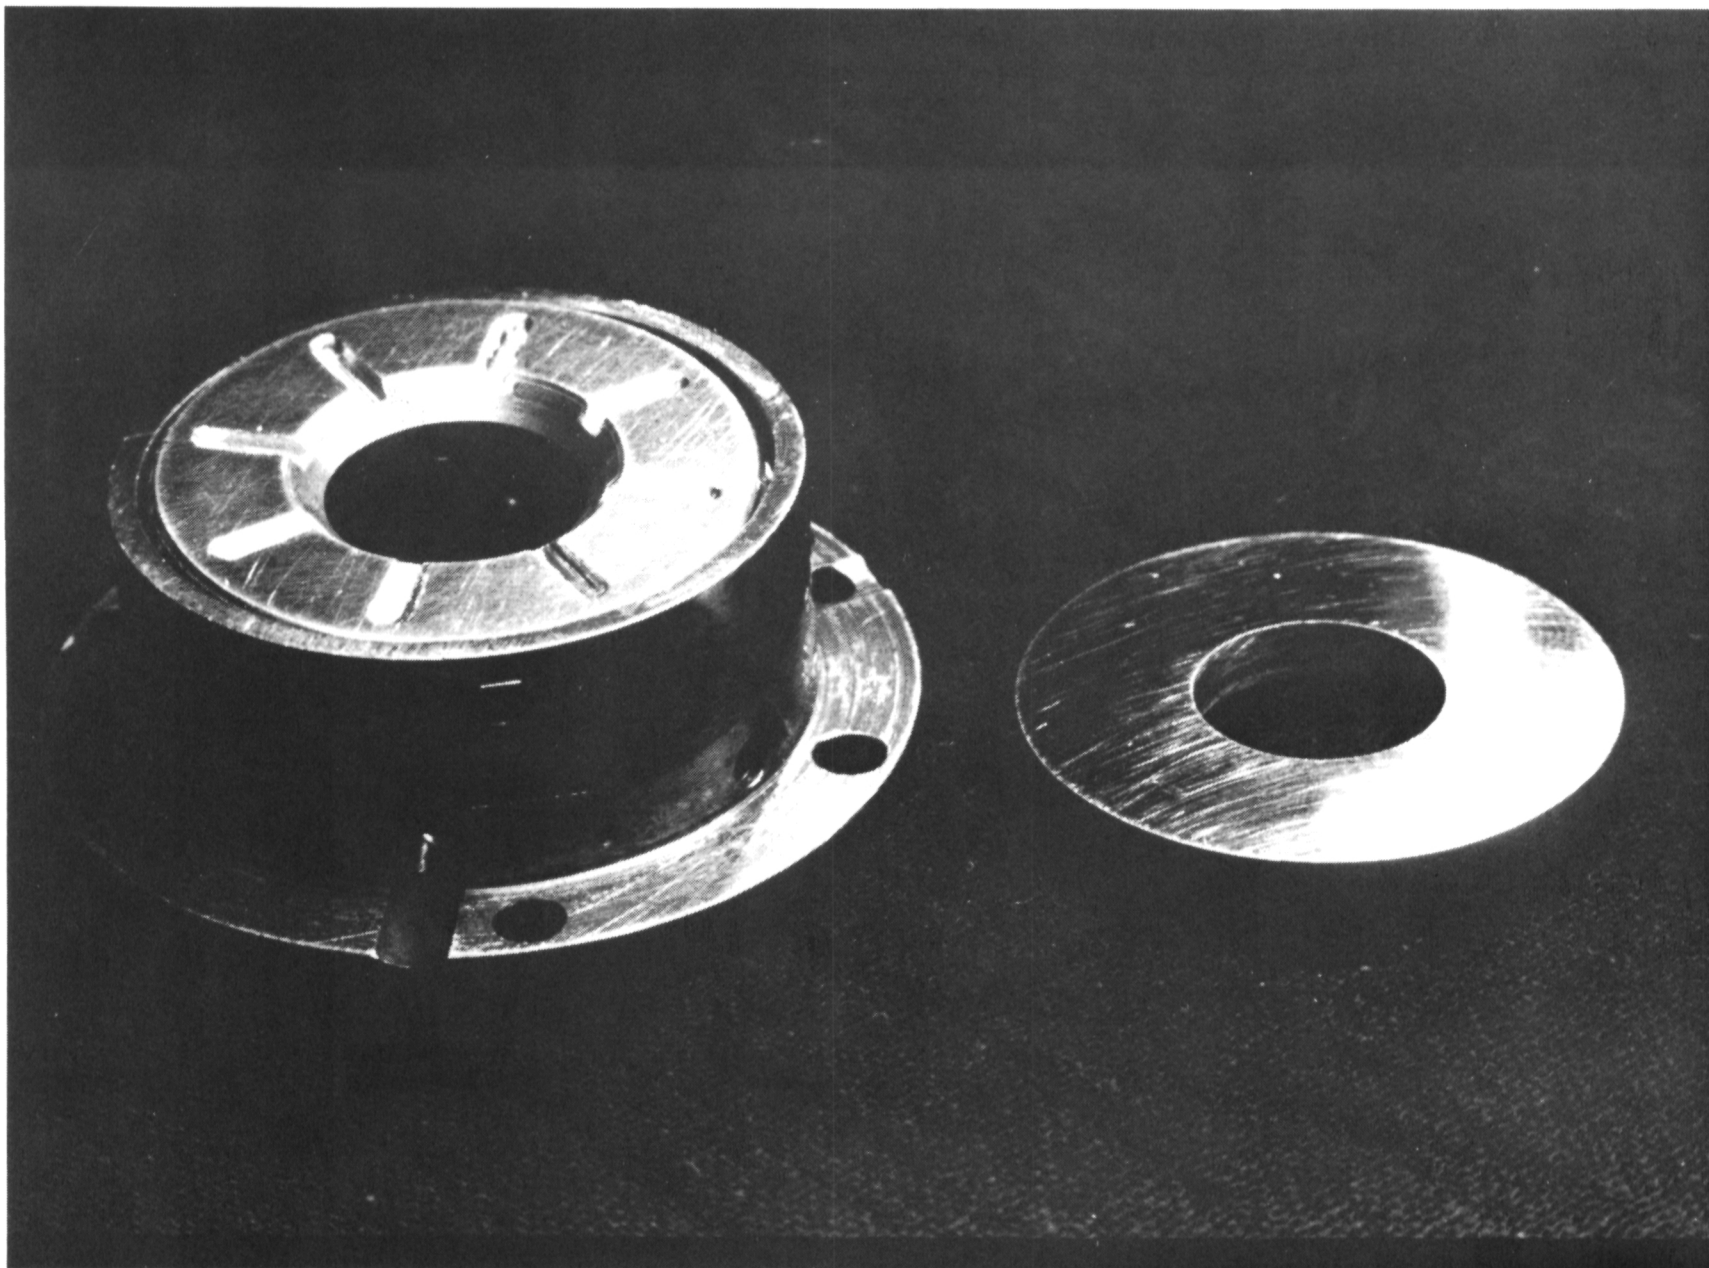
All accelerometer measurements were extremely high and fluctuating both in frequency and amplitude, making conclusive results impossible. In TAP build 8 the turbine end thrust bearing was redesigned to increase the diameter from 1.19 to 1.5 in., and the bearing material was changed from bronze to flame-sprayed babbitt on 52100 steel (Figure 3-4). The thrust runner diameter was also increased, and the material was changed from 304 stainless to 17-4 PH steel. A silver flash coating was applied over the babbitt on the journal bearing pads in an effort to further minimize start-up and shutdown contact wear.

Figure 3-4. Thermal Wedge (Fogg) Turbine End Thrust Bearing (left) made of 52100 Steel with Flame-Sprayed Babbitt Surface and Thrust Runner (1.5-in. diameter) made of 17-4 PH Steel

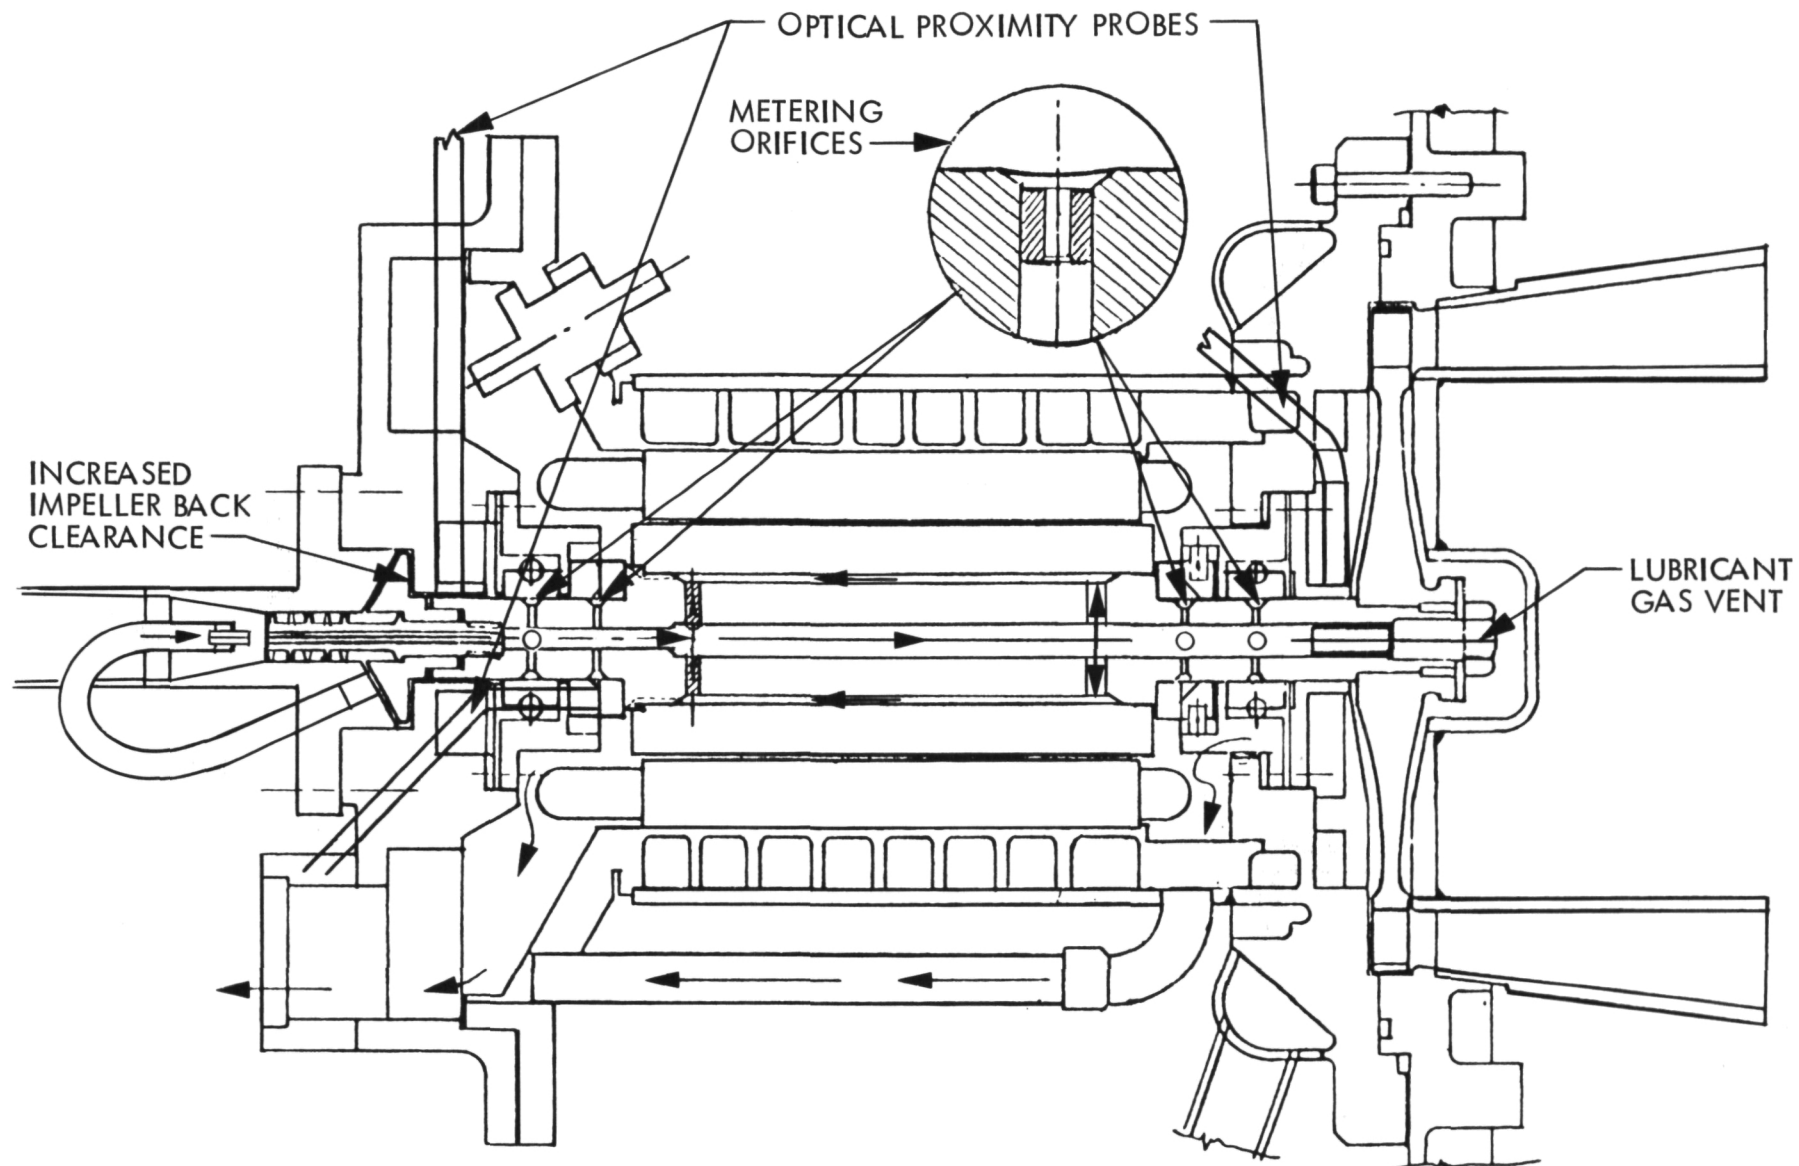
The bearing lubrication and rotor coolant channels within the rotating shaft were the most obvious unconventional aspect of the TAP design and were extensively analyzed by B-N, FACC, and JPL personnel. Because of the extreme complexity of the fluid dynamics, only a few general conclusions were made. Cavitation was occurring at the entrance of each radial bearing lube hole and limiting the amount of fluid delivered to each bearing. The combination of cavitation and fluid momentum introducing vapor and dividing the hydrodynamic film under the pad may have significantly altered the stiffness and damping of the bearings and thus introduced rotordynamic instabilities. Modifications made to reduce this possibility were: (1) to install small orifices at the exit of each radial lube hole to minimize cavitation in the lube channels (Figure 7-2), (2) to enlarge the jet pump exit and shaft lubricant inlet to

Figure 7-2. Metering Orifices Installed in each Radial Lubricant Hole (TAP Build 14)

increase total flow and pressure, and (3) to install a small vent on the shaft centerline at the turbine end to eliminate any possibility of trapped gases restricting flow to the bearings.

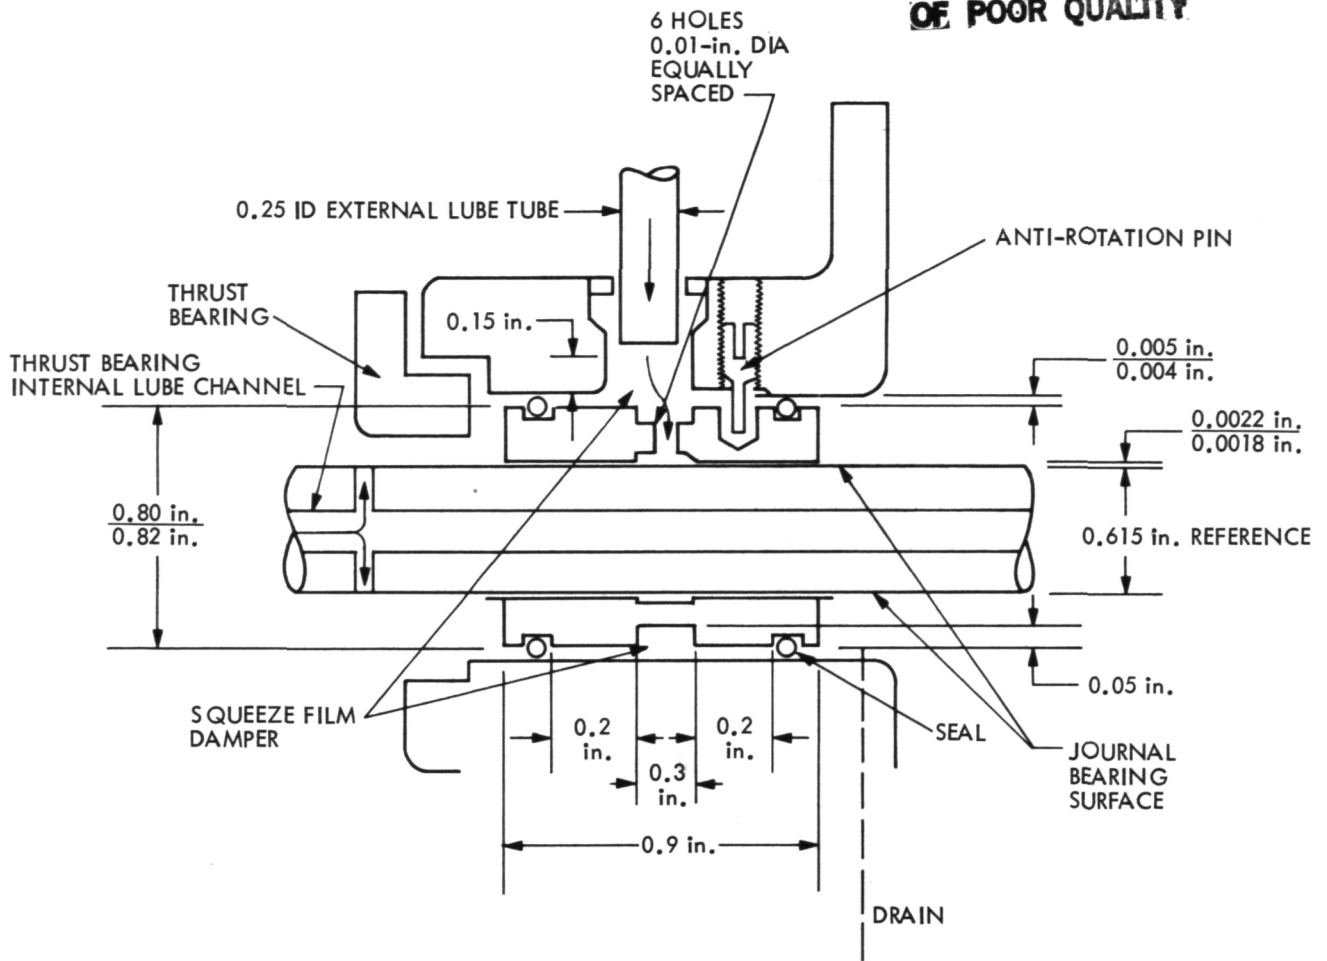
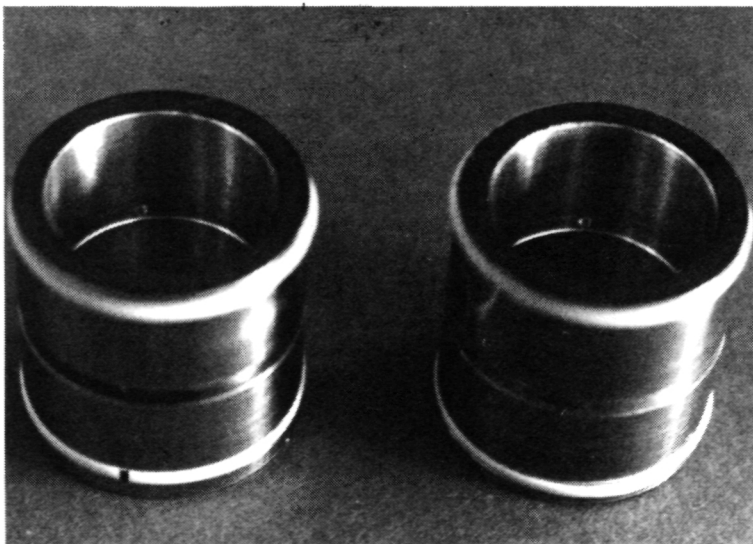
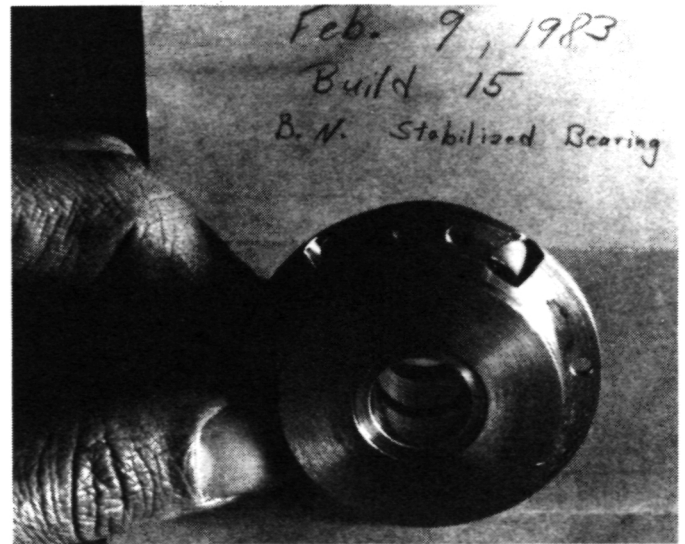
After extensive analysis of the proximity probe data, three concurrent courses of action were initiated in an attempt to resolve the rotordynamic instability problem. The squeeze-film-damped journal bearings (designed, installed, and tested by B-N) were the first to be tested because they had the shortest lead time (Figure 7-4). It was thought that by providing the proper amount of external damping to a simple journal bearing, the rotor bearing system could be stabilized. This was considered to be only a temporary fix to continue testing because vertical operation eventually would be required, and the journal bearing would probably be unstable in that position. The second parallel approach was a fully flooded five-pad tilting-pad journal bearing (from Waukesha Bearings Corporation) that was lubricated by externally supplied fluid from a dedicated bearing lube pump. This more conventional approach would eliminate all bearing and shaft dynamic uncertainties introduced by the lubrication system. A final backup approach was for Mechanical Technology, Inc. (MTI) to analyze and design a four-pad tilting-pad bearing and deliver drawings to Centritek for fabrication if the first two approaches failed.

Figure 7-4. Squeeze-Film-Damped Journal Bearing (Stabilized Bearing)
(a) Schematic, (b) Journal Bearing with Elastic Damper Seals
Attached, and (c) Complete Bearing and Carrier

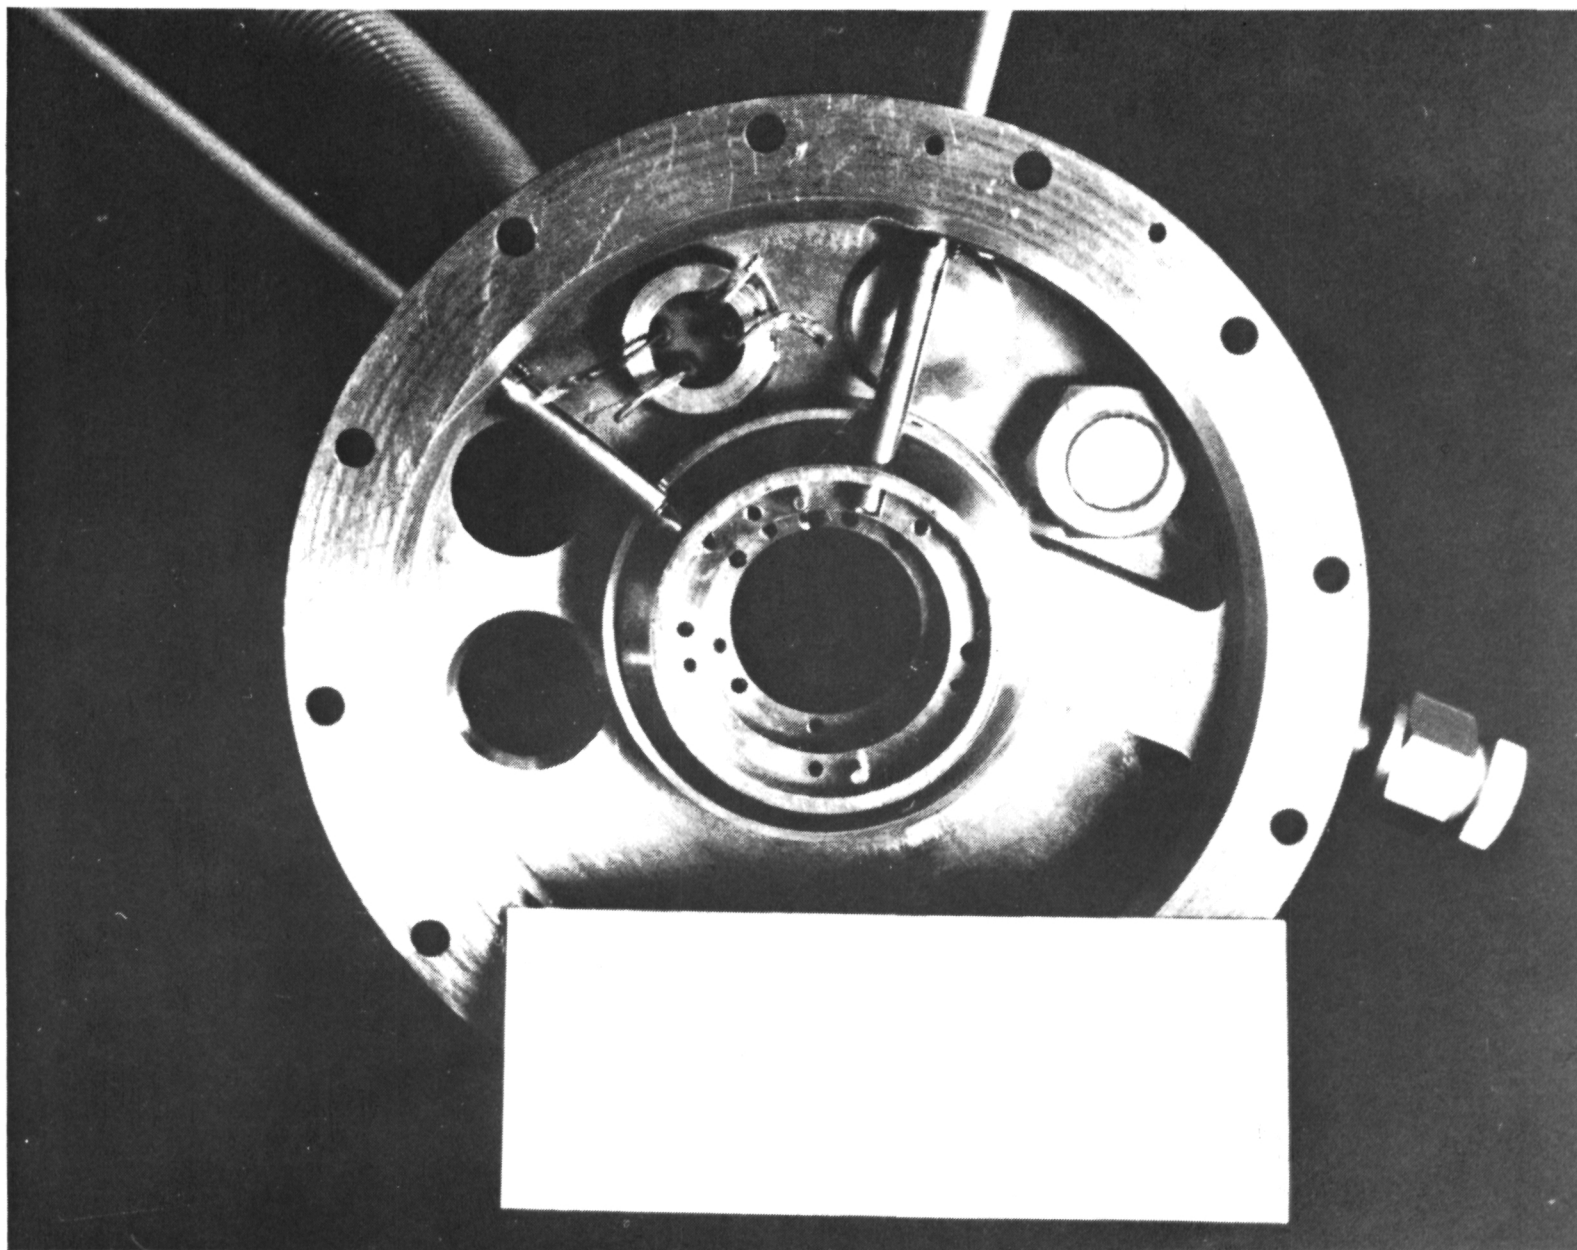
TAP builds 15 through 19 incorporated two squeeze-film-damped journal bearings with external lubrication (Figure 7-5) and two internally lubricated thrust bearings.

Figure 7-5. Method of External Lubrication for Stabilized Bearings

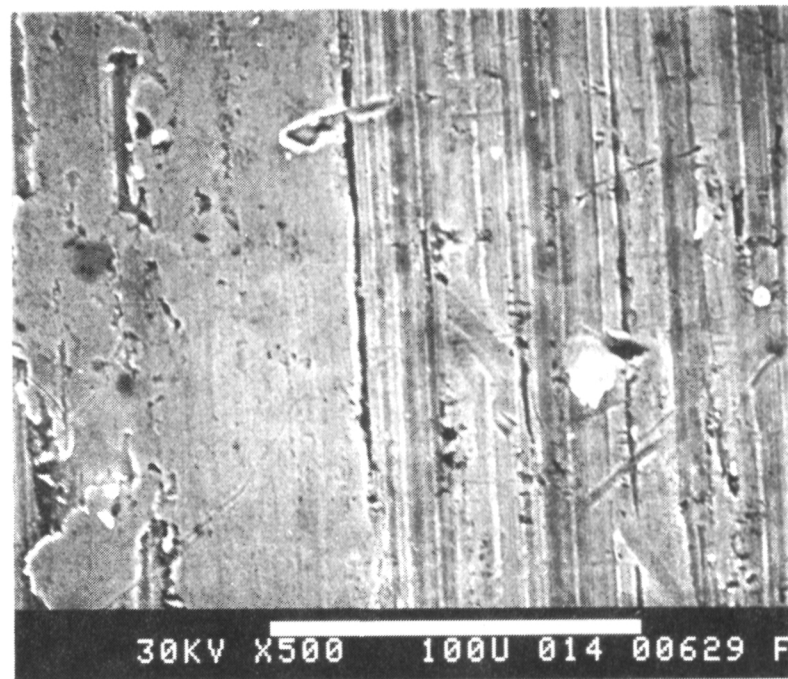
An extensive analysis of the build 21 damaged bearing surfaces was conducted by FACC using an electron beam microscope. The damaged surface on each pad had a frosted appearance, which was determined to be a number of separate but closely packed pits. Figures 7-12 and 7-13 show various magnifications of the pitted surfaces and compare them to unpitted zones. A chemical analysis inside the pits revealed high concentrations of zinc and chlorine, which were not present in the virgin babbitt or bearing material. This change is shown in Figure 7-14 where the virgin material analysis and an analysis inside a single pit are compared on one plot.

Figure 7-13. Leading Edge Surface of a Waukesha Pad without Electrical Discharge Pitting

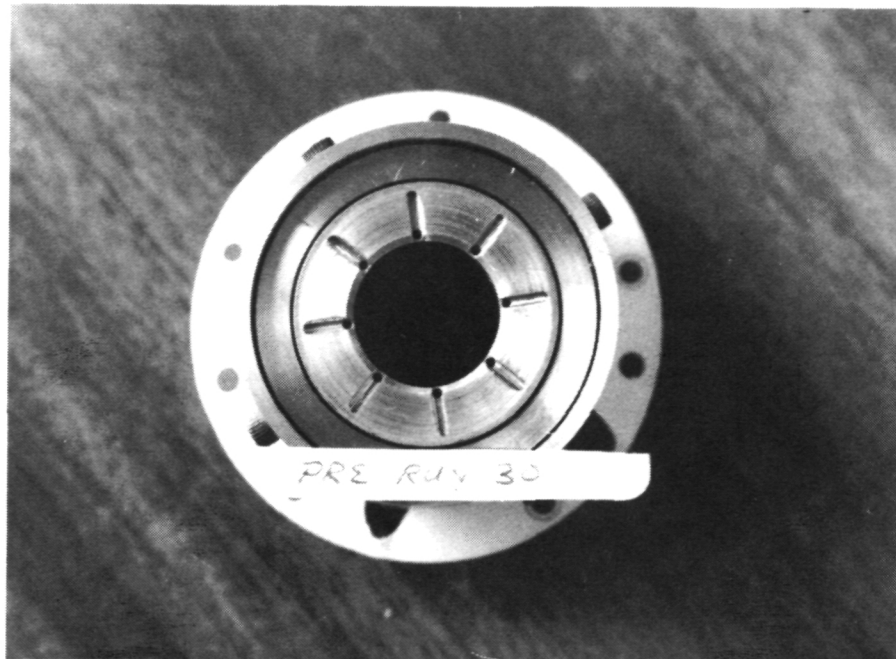
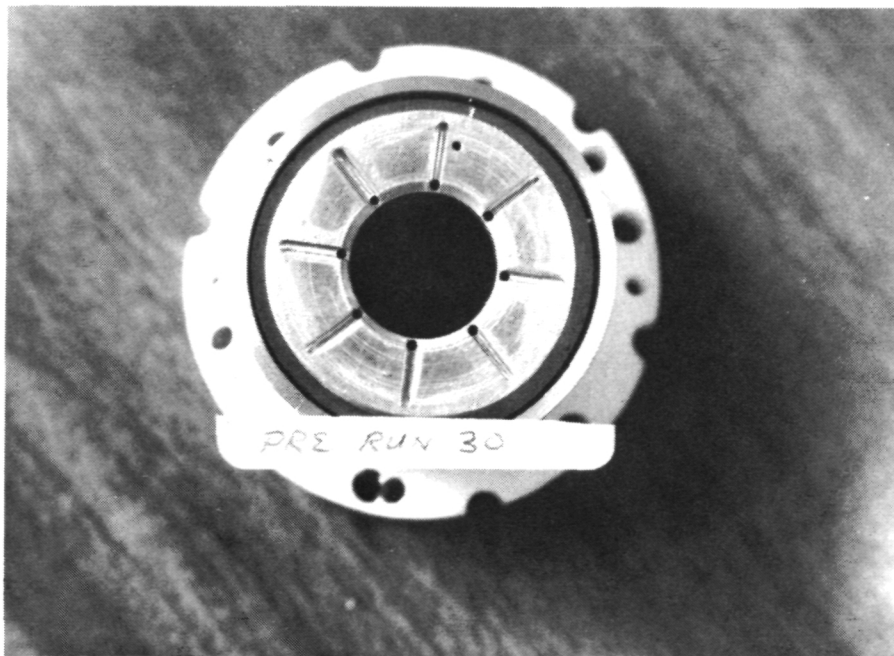
The five-pad Waukesha tilting-pad bearings, using B-N-fabricated pads and mounted in an electrically insulated nylon bearing carrier (Figure 7-16), were used in TAP builds 30 to 35 with essentially no changes. Figure 7-17 shows the pump and turbine end thrust bearings mounted on the insulated bearing carriers and provides a good view of the grooves that disperse the lubricant over the bearing face and the holes supplying fluid from the flooded bearing reservoir to the grooves. A total of approximately 21 h of operation were accumulated on these builds with no bearing distress or electrical arcing. The success of these tests at various altitude angles from horizontal to vertical and various powers and speeds indicated that the bearings were ready for hot testing in the engine.

Figure 7-17. Electrically Insulated Bearing Carriers with (a) Pump End and (b) Turbine End Thrust Bearings Mounted

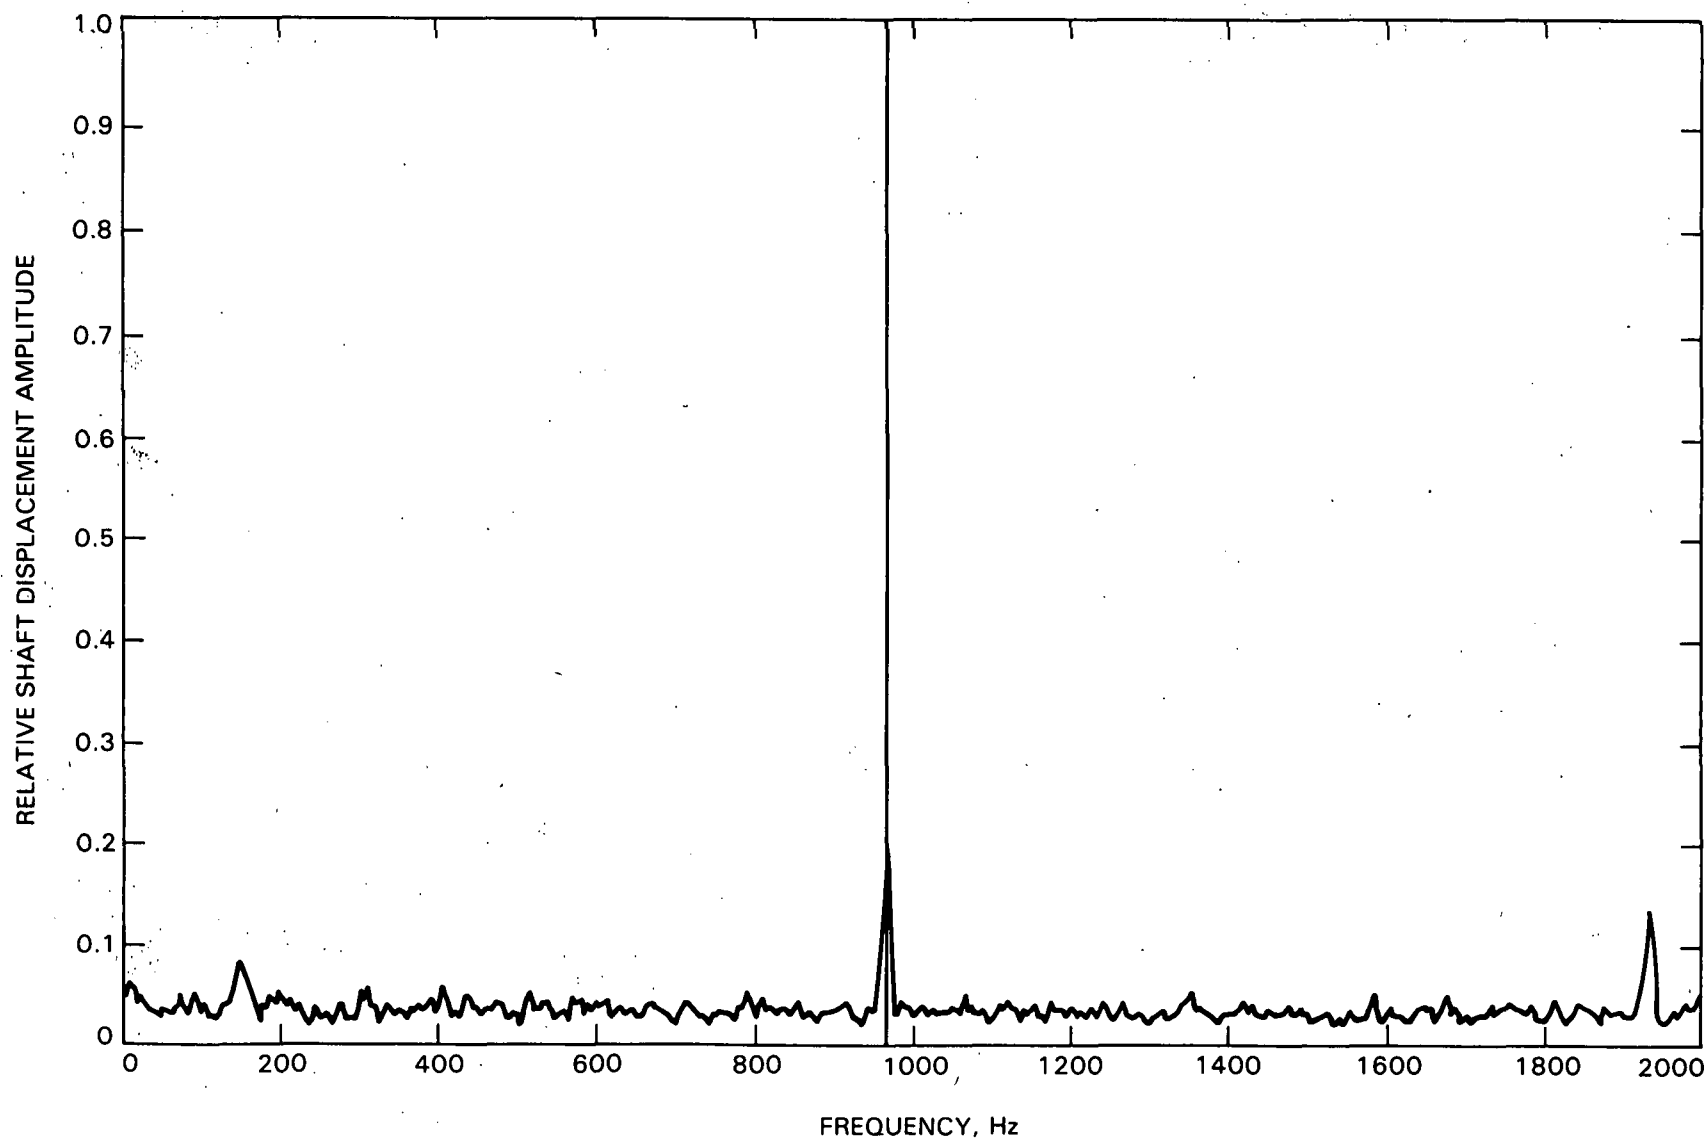
allowing the 100-h test results to be available for the November 1, 1983, DOE-scheduled ORC review. The only effect this had was that additional hours were run at 5 and 90 deg, and fewer hours were run at 45 deg. Figures 8-1 and 8-2 are shaft displacement amplitude versus frequency for TAP builds 38 and 39 (90- and 5-deg inclination) using comparable amplitude scales. Results of the test showed inclination angle does not seem to affect shaft dynamics and no bearing wear or component damage was observed.

Figure 8-1. Typical Shaft Displacement Spectrum of Waukesha Five-Pad Bearing at 90 deg on October 19, 1983 (Pump End "Y" Probe, TAP Build 38).

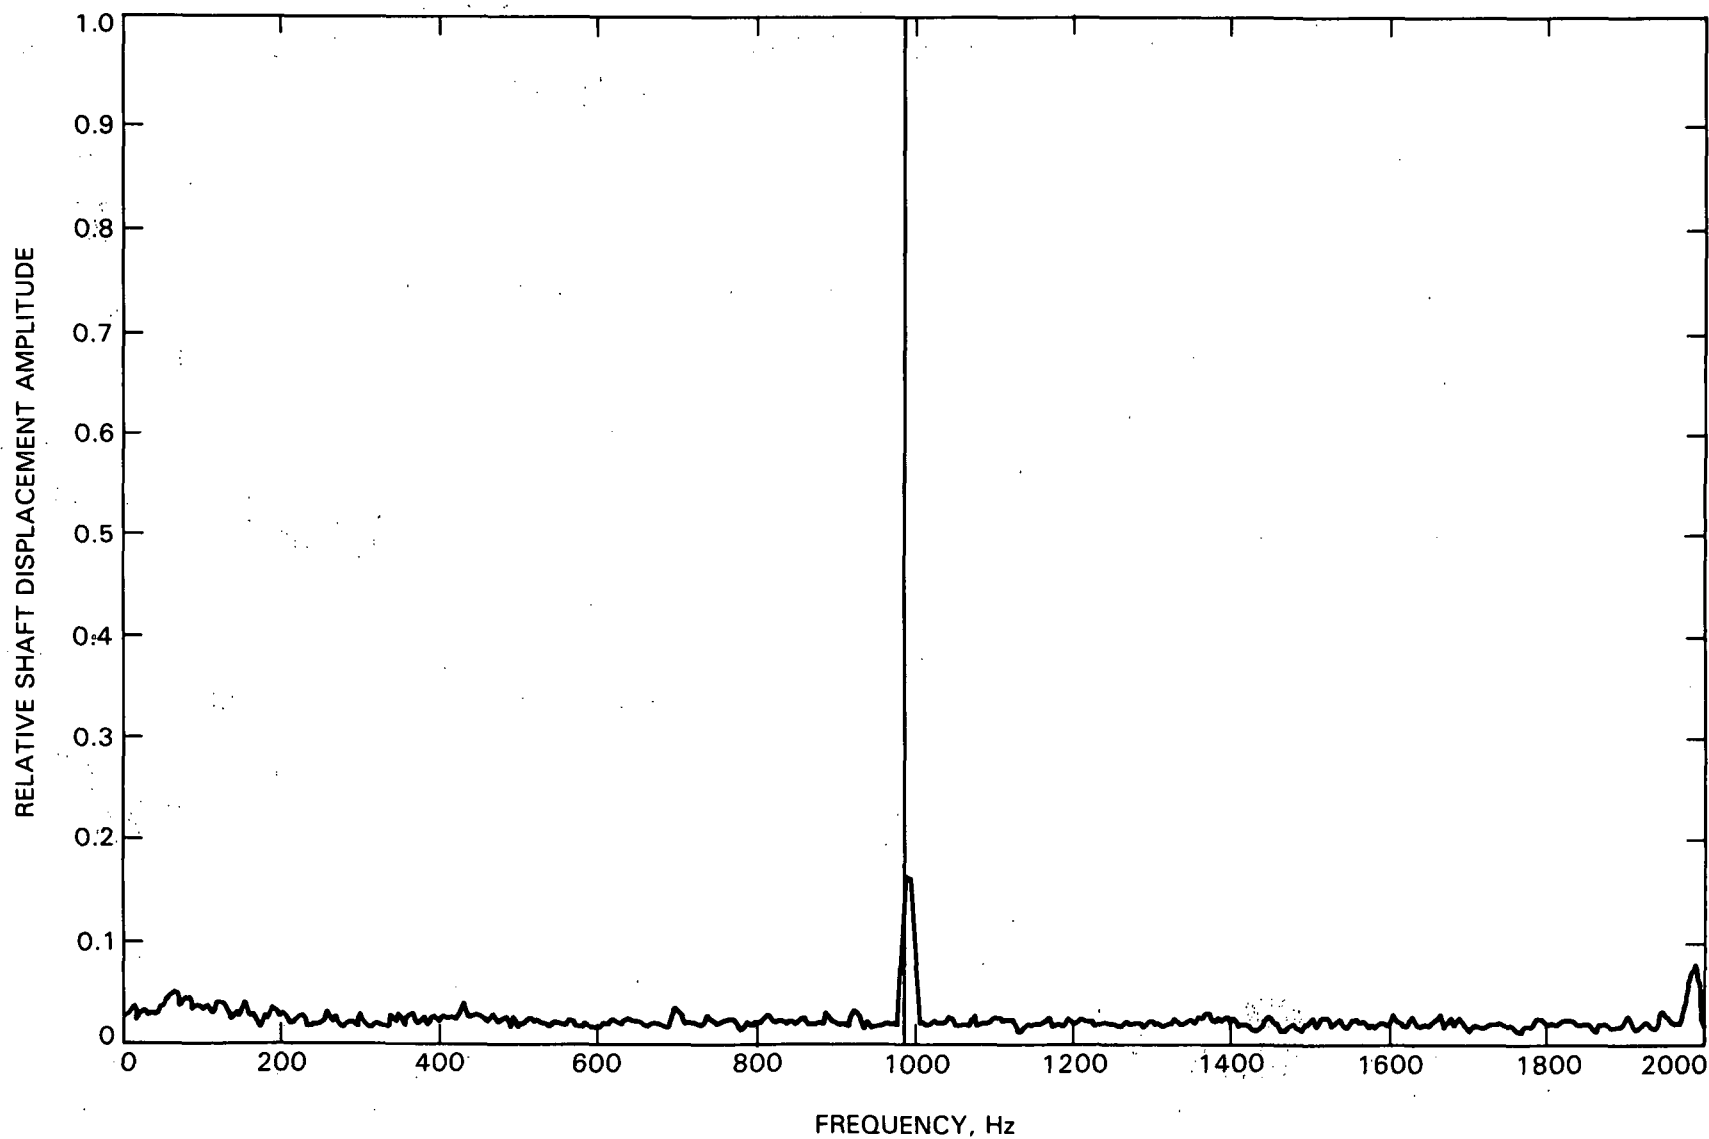
Figure 8-2. Typical Shaft Displacement Spectrum of Waukesha Five-Pad Bearing at 5 deg on October 29, 1983 (Pump End "X" Probe, TAP Build 39)
