ROTOR-TO-STATOR RUB VIBRATION IN CENTRIFUGAL COMPRESSOR

Gao Jin Ji and Qi Qi Min
Liaoyang Petrochemical Fiber Company
Liaoning, The People's Republic of China

This paper discusses one example of excessive vibration encountered during loading of a centrifugal compressor train (H type compressor with HP casing).

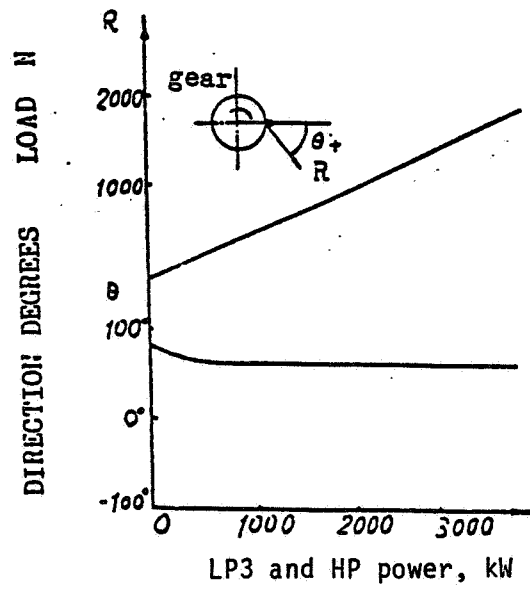
The results of calculation and analysis show that the high speed rotor and the #3, #4 bearings in the LP casing belong in the variable stiffness bearing system. It is different from most compressors. With an increase in dynamic load during opening the guide vane, both machine power and load of the #3, #4 bearings are increased. Fig. 5 shows radial load of the #3 bearing and direction angle vs. power of the machine. Because the bearing stiffness directly affects the critical speed of the rotor-bearing system (Fig. 6), at the moment when the dynamic load reaches a certain value, the critical speed can coincide with the operation speed, and the resonance will occur. This value of dynamic load is called "threshold load." In normal cases the machine runs smoothly as soon as it passes through the threshold load (Ref. 2).

Figure 5.- Radial load versus machine power.
